ENVIROMENTAL SITE ASSESSMENT WORKPLAN

AMERADA HESS CORPORATION

RE: **Ground Water Investigations**
Durham State A Battery Site
Chevron Graham NCT B Battery Site

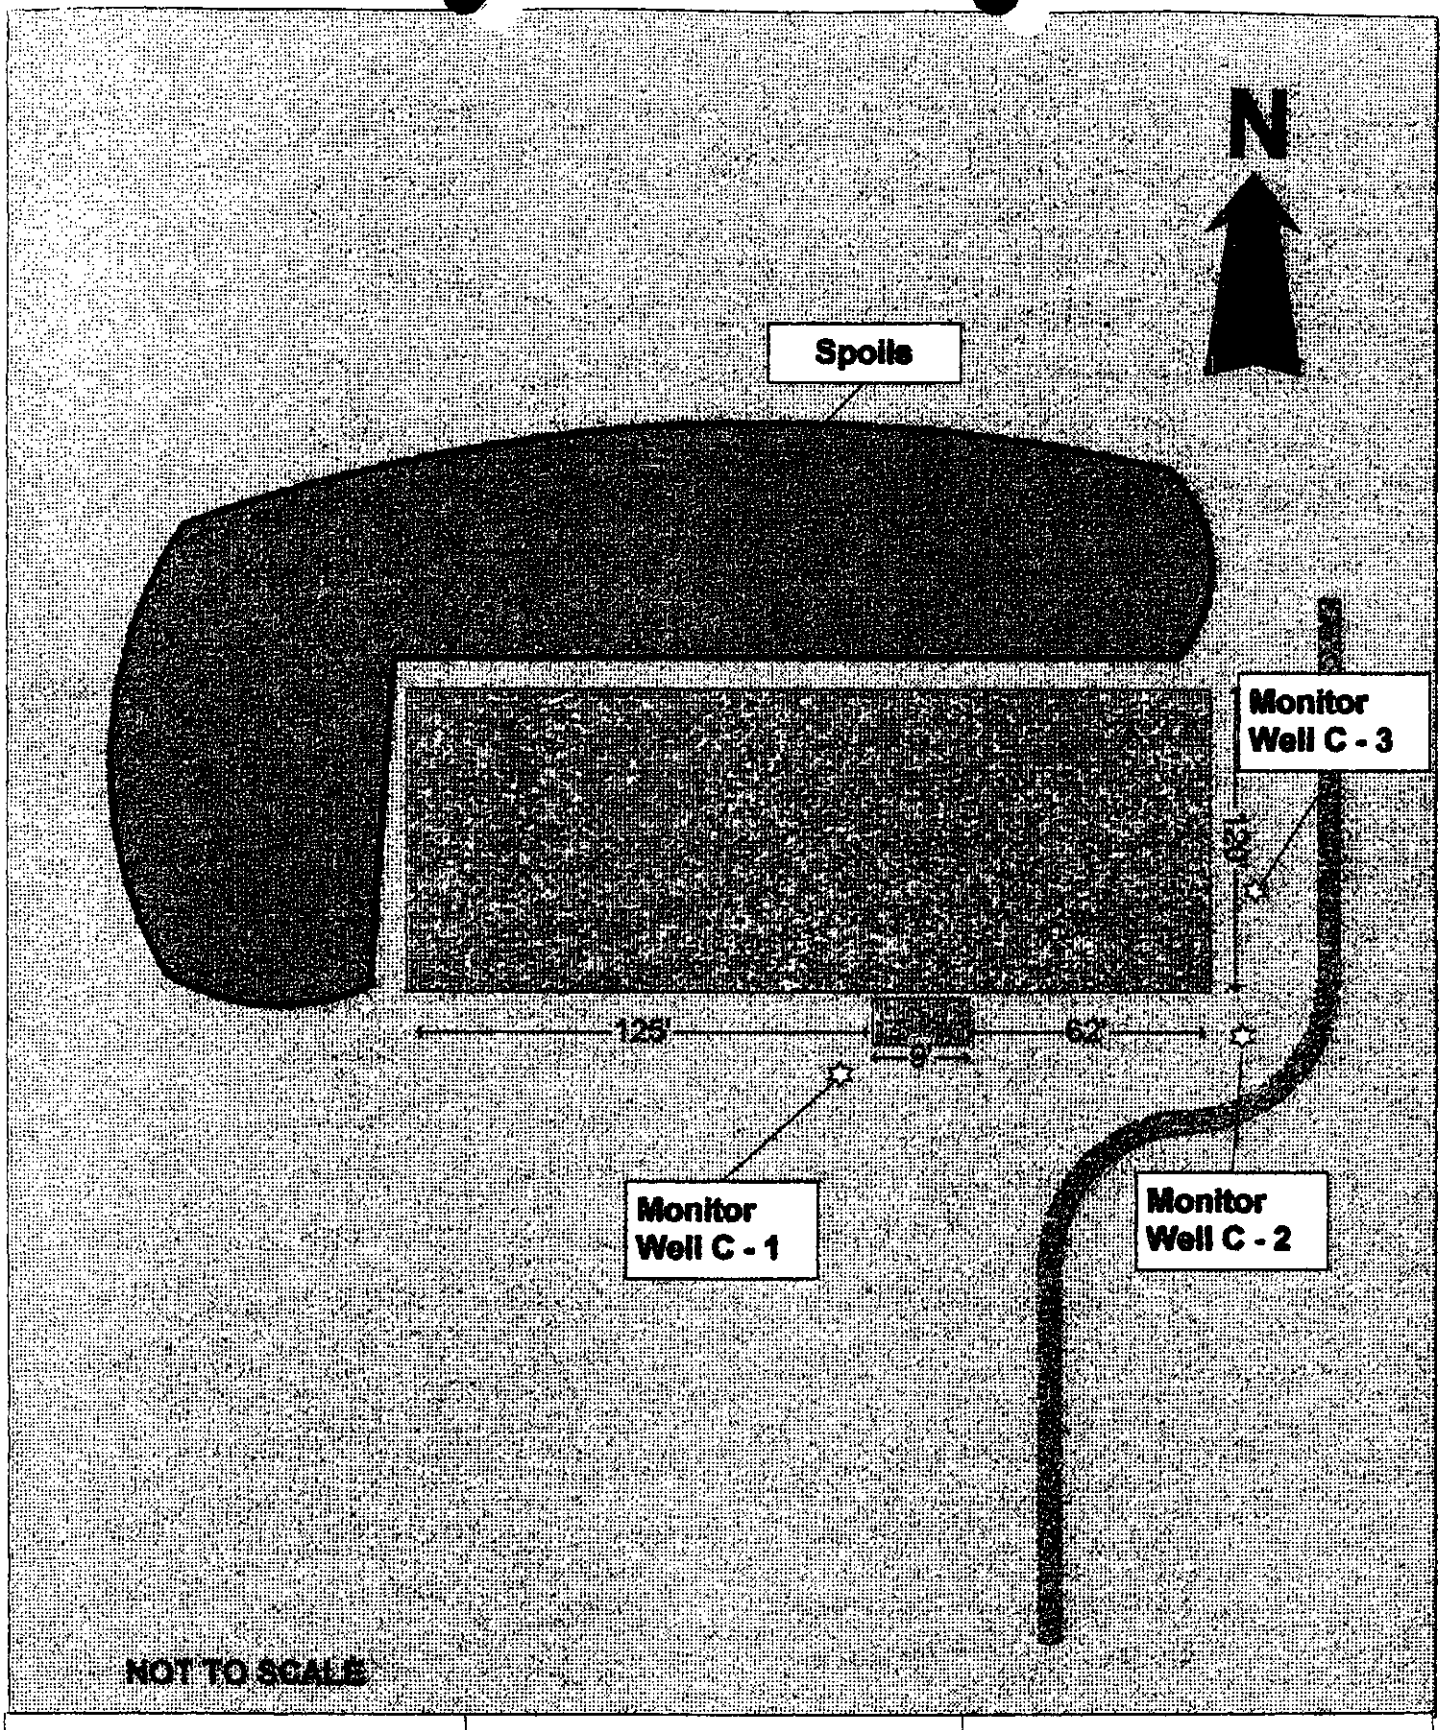
Amerada Hess Corporation	Site Plan Chevron NCBT	Safety & Environmental Solutions, Inc. Hobbs, New Mexico

TDS and chloride concentrations exceed Safe Drinking Water Standards (SDWS) in six of the seven wells including the up-gradient well at the Durham State A (site D-1 on the plat). The ground water gradient in this area is generally assumed to be from the NW to the SE, which is confirmed by fluid levels measured at the two sites and in nearby water wells (Table 3). Fluid levels observed in the monitor wells indicate that there is little or no gradient across the locations. On November 25, 1996, water from the seven monitor wells was re-sampled and analyzed for TDS and chloride concentrations. Analytical results are consistent with the initial tests, however, a slight sheen was noted on the water sample obtained from well D-4 (analysis attached).

As a result of the ground water investigations, AHC proposes to resume battery site reclamation activities by backfilling the excavations at both battery sites with five (5) feet of clean material (< 100 ppm TPH , < 50 ppm BTEX and < 10 ppm benzene), capped with two (2) feet of clay. The remainder of backfill material used to bring the locations to grade, approximately 30 feet, will be the caliche and soil removed from the excavations which will be remediated to 1000 ppm TPH, 50 ppm BTEX and 10 ppm benzene. AHC, also proposes to re-sample the monitor wells in March, 1997 and if no appreciable change is noted in the TDS or chloride concentrations and if there is no visible or analytical evidence of hydrocarbon contamination, the seven monitor wells will be plugged with cement containing 5% bentonite.

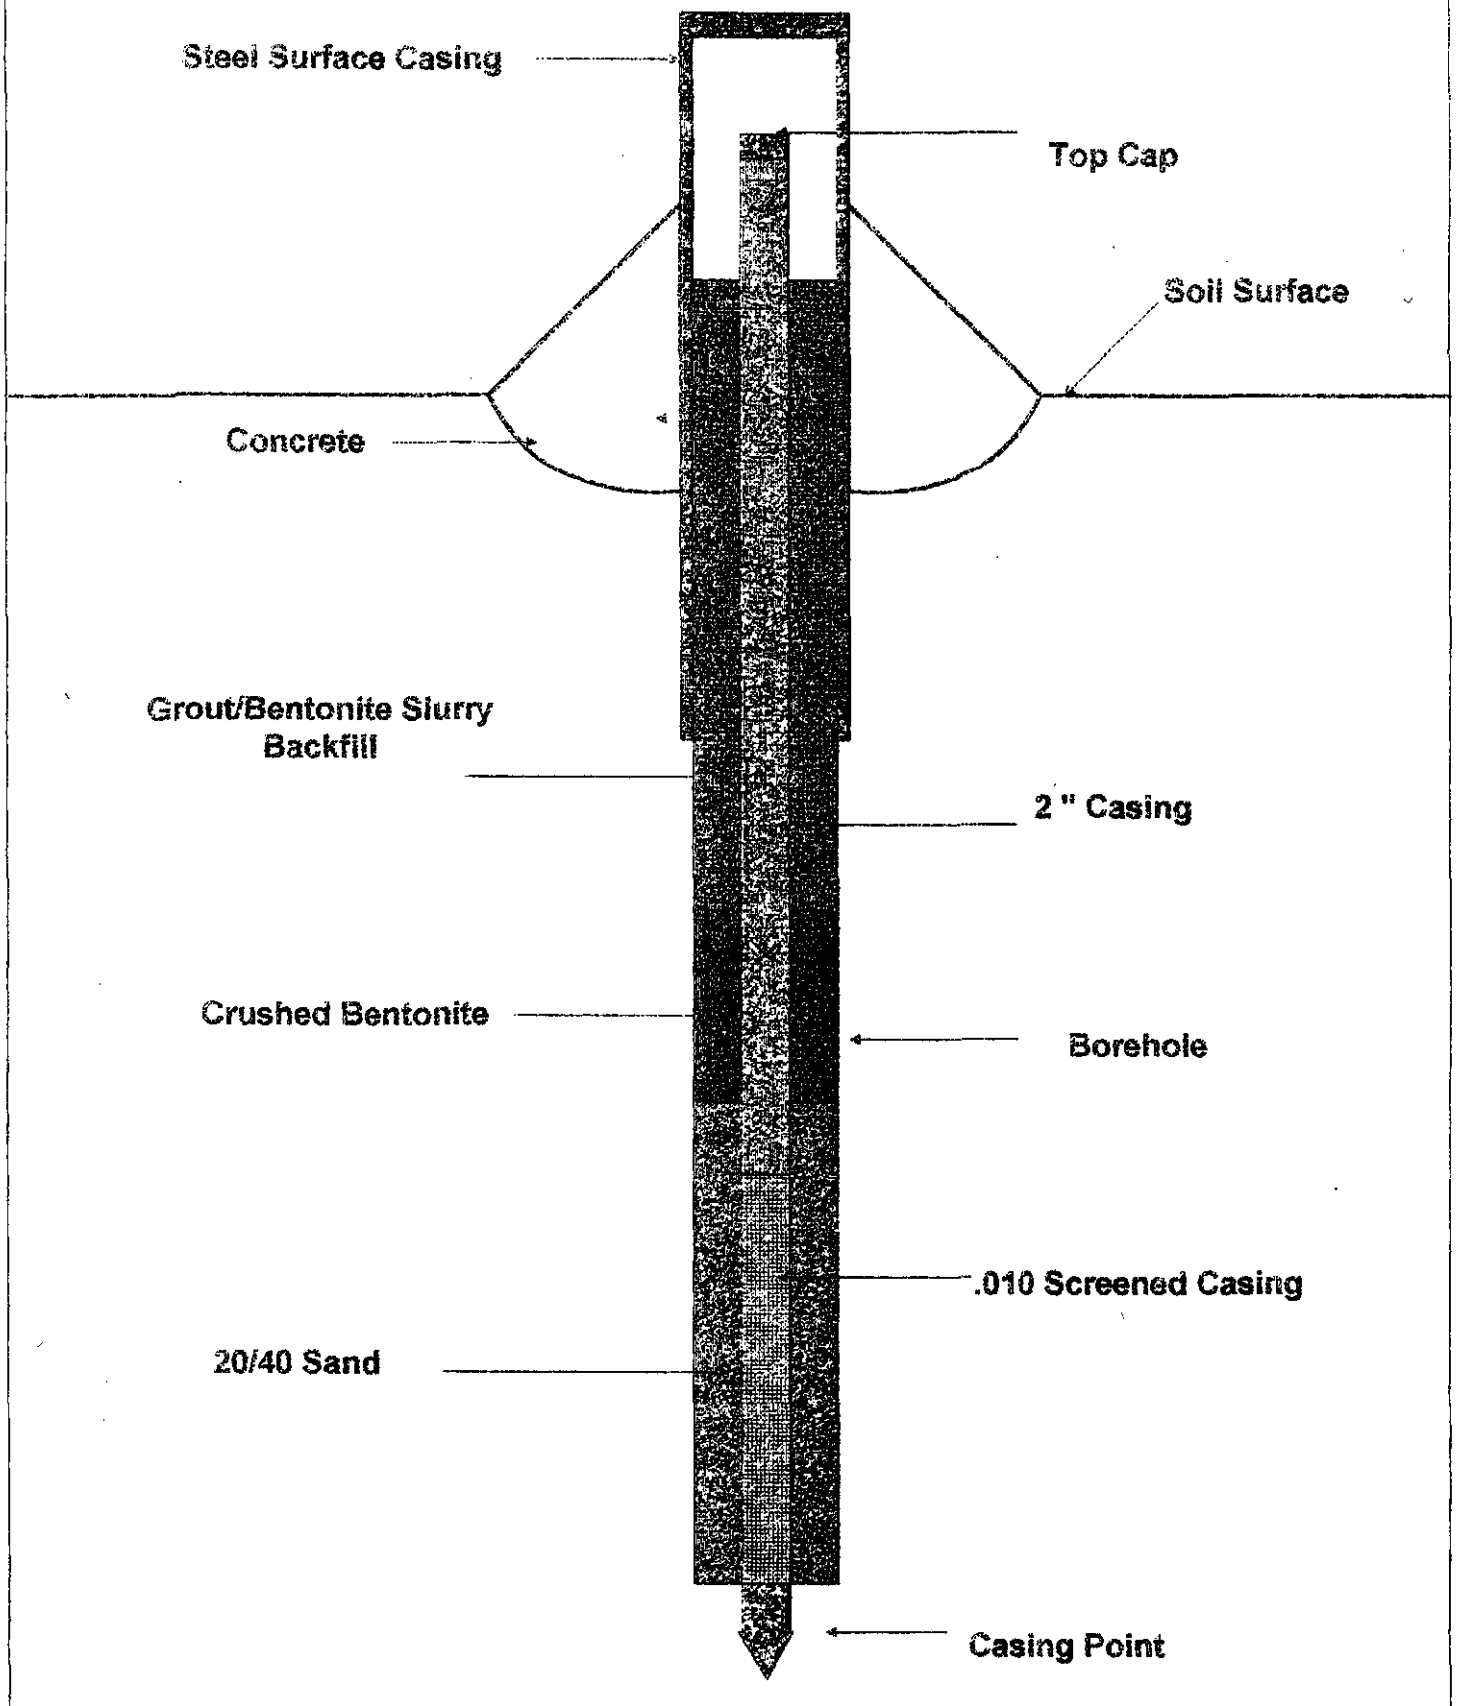
Amerada Hess Corporation | Ground Water Monitor Well | Safety & Environmental Solutions, Inc.

During the week of September 23, 1996, ground water monitor wells were drilled adjacent to the excavations at the abandoned Chevron NCT B and Durham State A battery sites. The wells were drilled pursuant to the Tank Battery Site Reclamation Plan submitted by Amerada Hess Corporation (AHC) on June 5, 1996 and the NMOCD letter of June 13, 1996, approving the plan with conditions. Soil samples were obtained from each well at approximate five foot intervals and were analyzed for TPH, BTEX and chloride concentrations. Ground water samples were obtained after completing each well and were analyzed for RCRA metals, cations and anions, TDS and BTEX. Plats of each site with the well locations indicated are attached along with a typical wellbore completion diagram, driller's logs and a summary of the test results (Tables 1 & 2).
