Re: Temporary Pit Closure Report
SND Javelina Unit 613 (509H, 510H, 613H, 614H and 615H)
BLM Lease No. USA NMNM 141882
Section 11 & 14 of T24S, R31E
Eddy County, New Mexico
Facility ID: fJMB2221553059

Photographic Log

Javelina Unit 613 (613H, 614H, 615H, 509H, 510H)

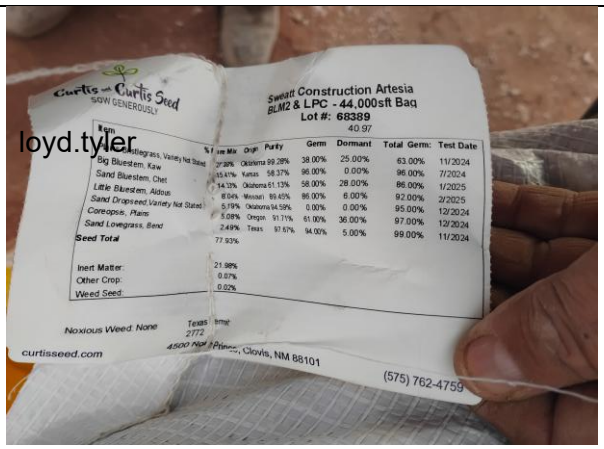
Photo 1: Photo of seed mix used post-backfill.
