Site Assessment/Characterization

Closure

Re: Site Assessment, and Closure Report
Green Wave 20 CTB 3
API No. N/A
GPS: Latitude 32.031780 Longitude -103.493815
UL –F Section 20, T26S, R34E
Lea County, NM
NMOCD Ref. No. NAPP2316553894

SITE PHOTOGRAPHS
DEVON ENERGY
GREEN WAVE 20 CTB 3

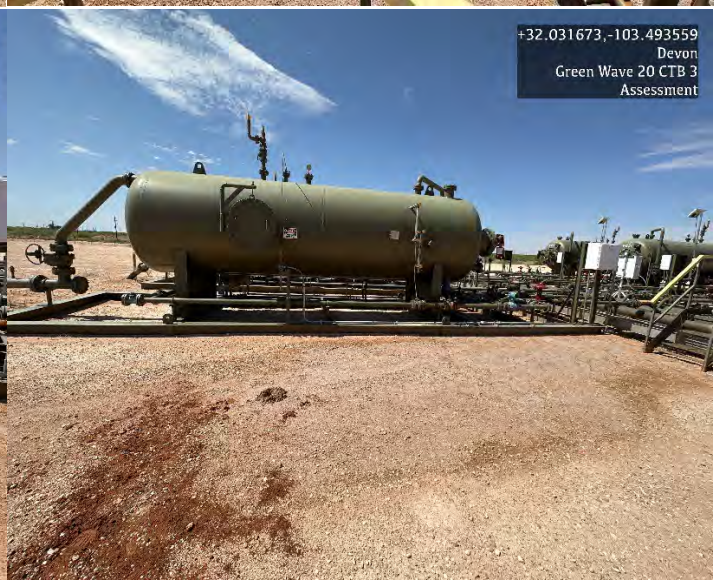
Site Assessment

NAPP2316553894: On June 14, 2023, a pin hole developed on a flow line, causing a fluid to be released. The released fluids were calculated to be approximately 9.1 barrels (bbls) of produced water. A vacuum truck was able to recover 8 bbls of standing fluid.

Based on the sample results, the bottoms and sidewalls were below NMOCD Closure Criteria 19.15.29 NMAC. See Appendix D for Photographic Documentation.
