Re: Reclamation Report
Abe 1 TB
Incident Number nAPP2406265359
Lea County, New Mexico

Ensolum, LLC (Ensolum), on behalf of Matador Production Company (Matador), has prepared the following *Reclamation Report* for the Abe 1 TB (Site). The *Reclamation Report* documents the Site history and reclamation activities completed to date.

Photographic Log
Matador Production Company
ABE 1 TB
Incident Number: nAPP2406265359

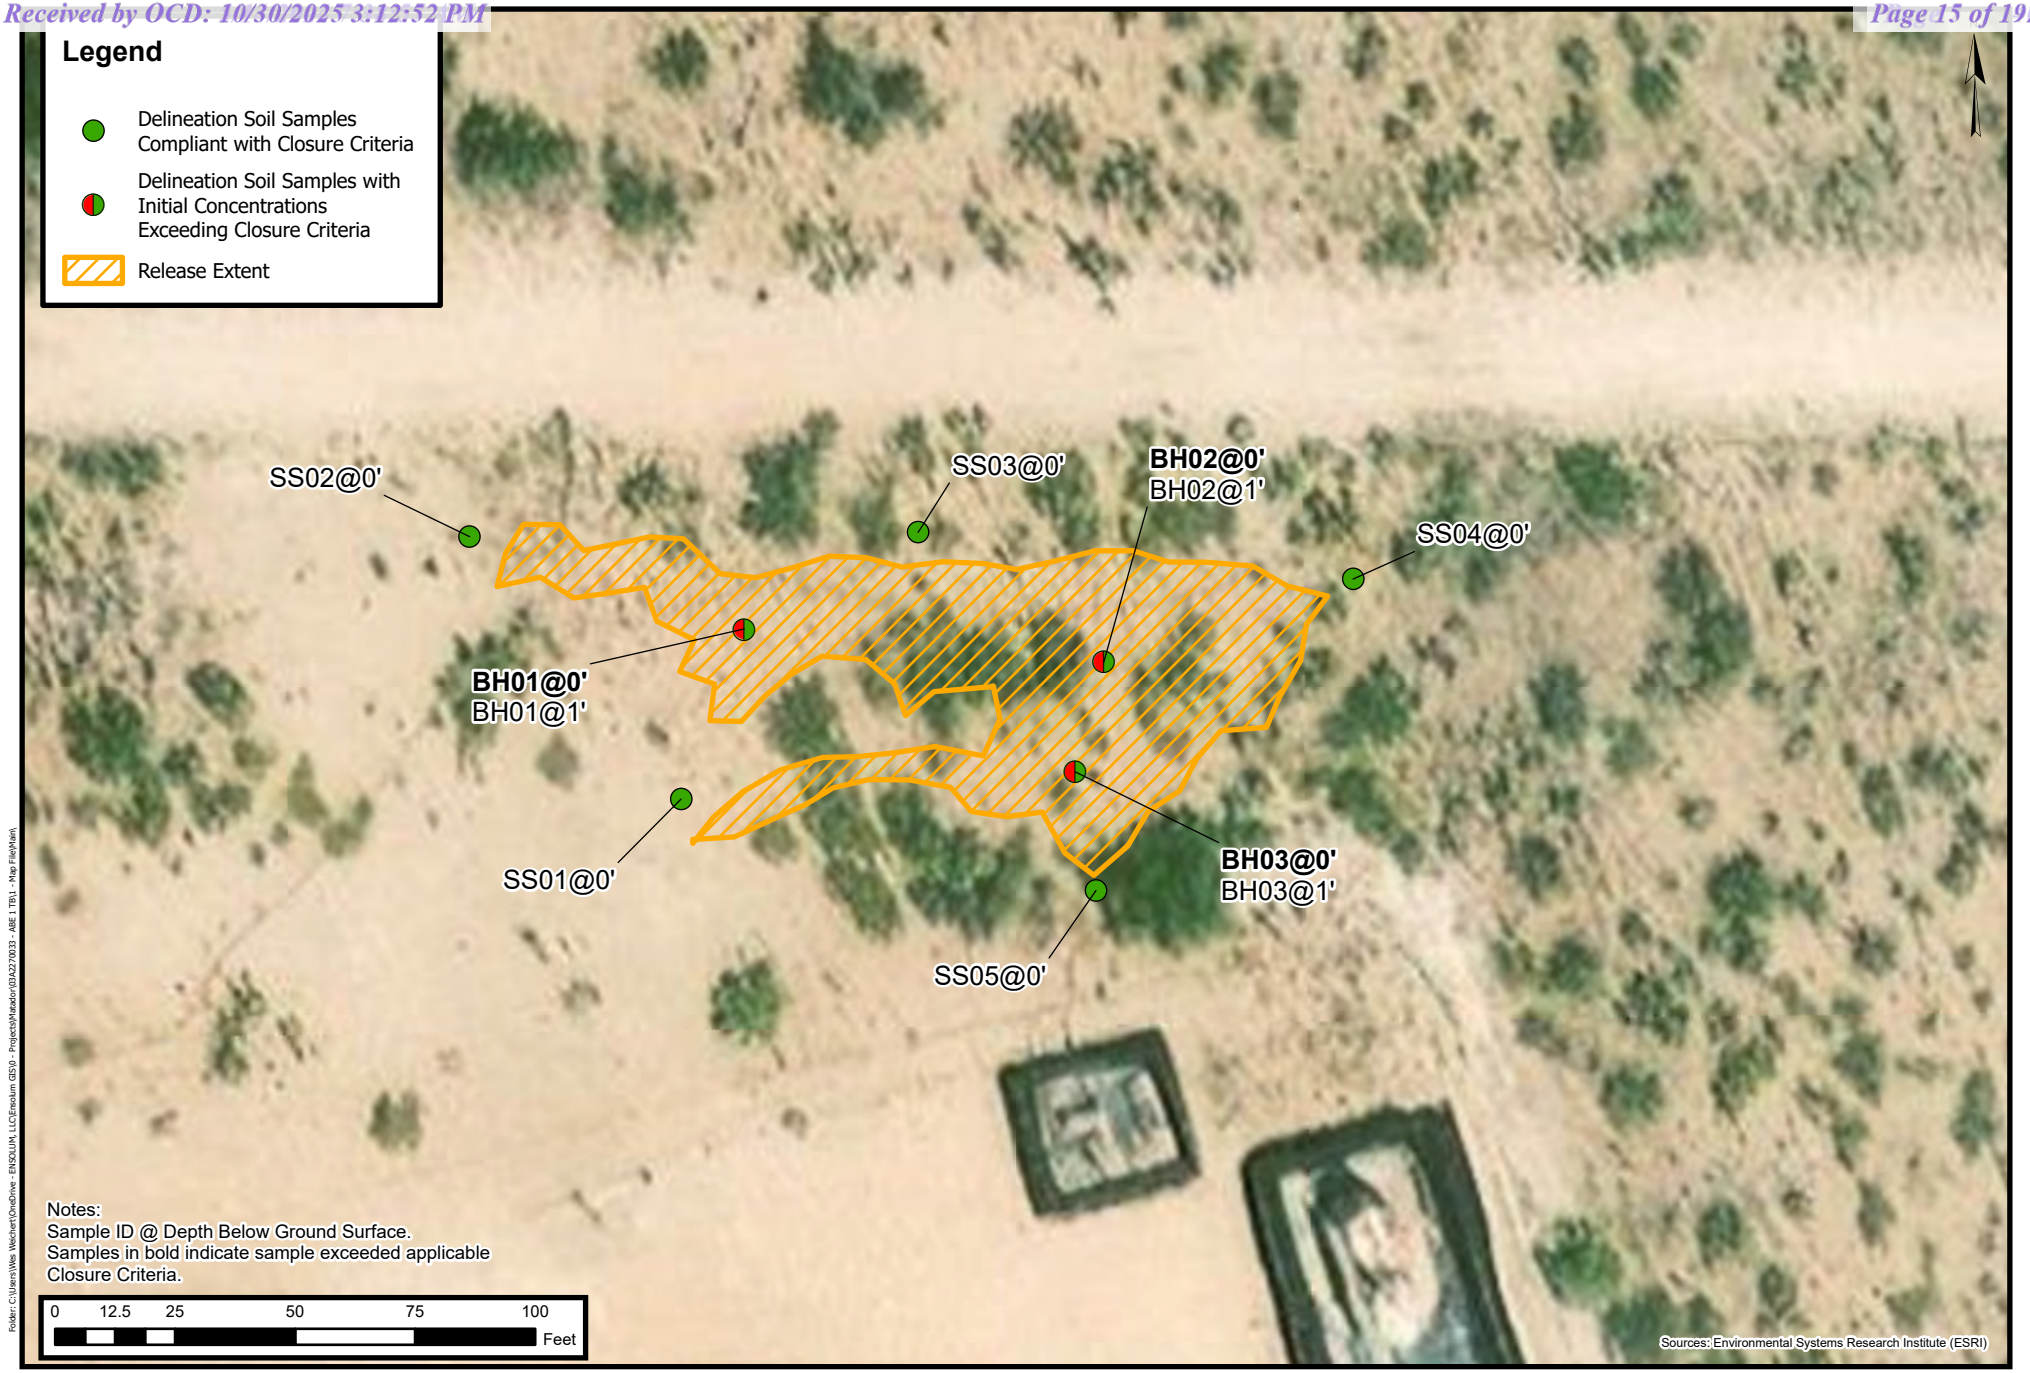
FIGURE 2

On March 7, 2024, Ensolum personnel were onsite to conduct lateral and vertical delineation sampling activities. Five delineation soil samples (SS01 through SS05) were collected from around the release extent at ground surface to assess the lateral extent of affected soil. Three boreholes were advanced via hand auger within the release extent to assess the vertical extent of the release area. Boreholes BH01 through BH03 were advanced to a depth of 1-foot bgs. Discrete delineation soil samples were collected from each borehole at depths ranging from ground surface to 1-foot bgs. Soil from the discrete delineation soil samples was field screened for chloride utilizing Hach® chloride QuanTab® test strips. Field screening results and observations for the boreholes were logged on lithologic/soil sampling logs, which are included in Appendix C. The delineation soil sample locations are depicted on Figure 2.

Delineation Soil Sample Locations

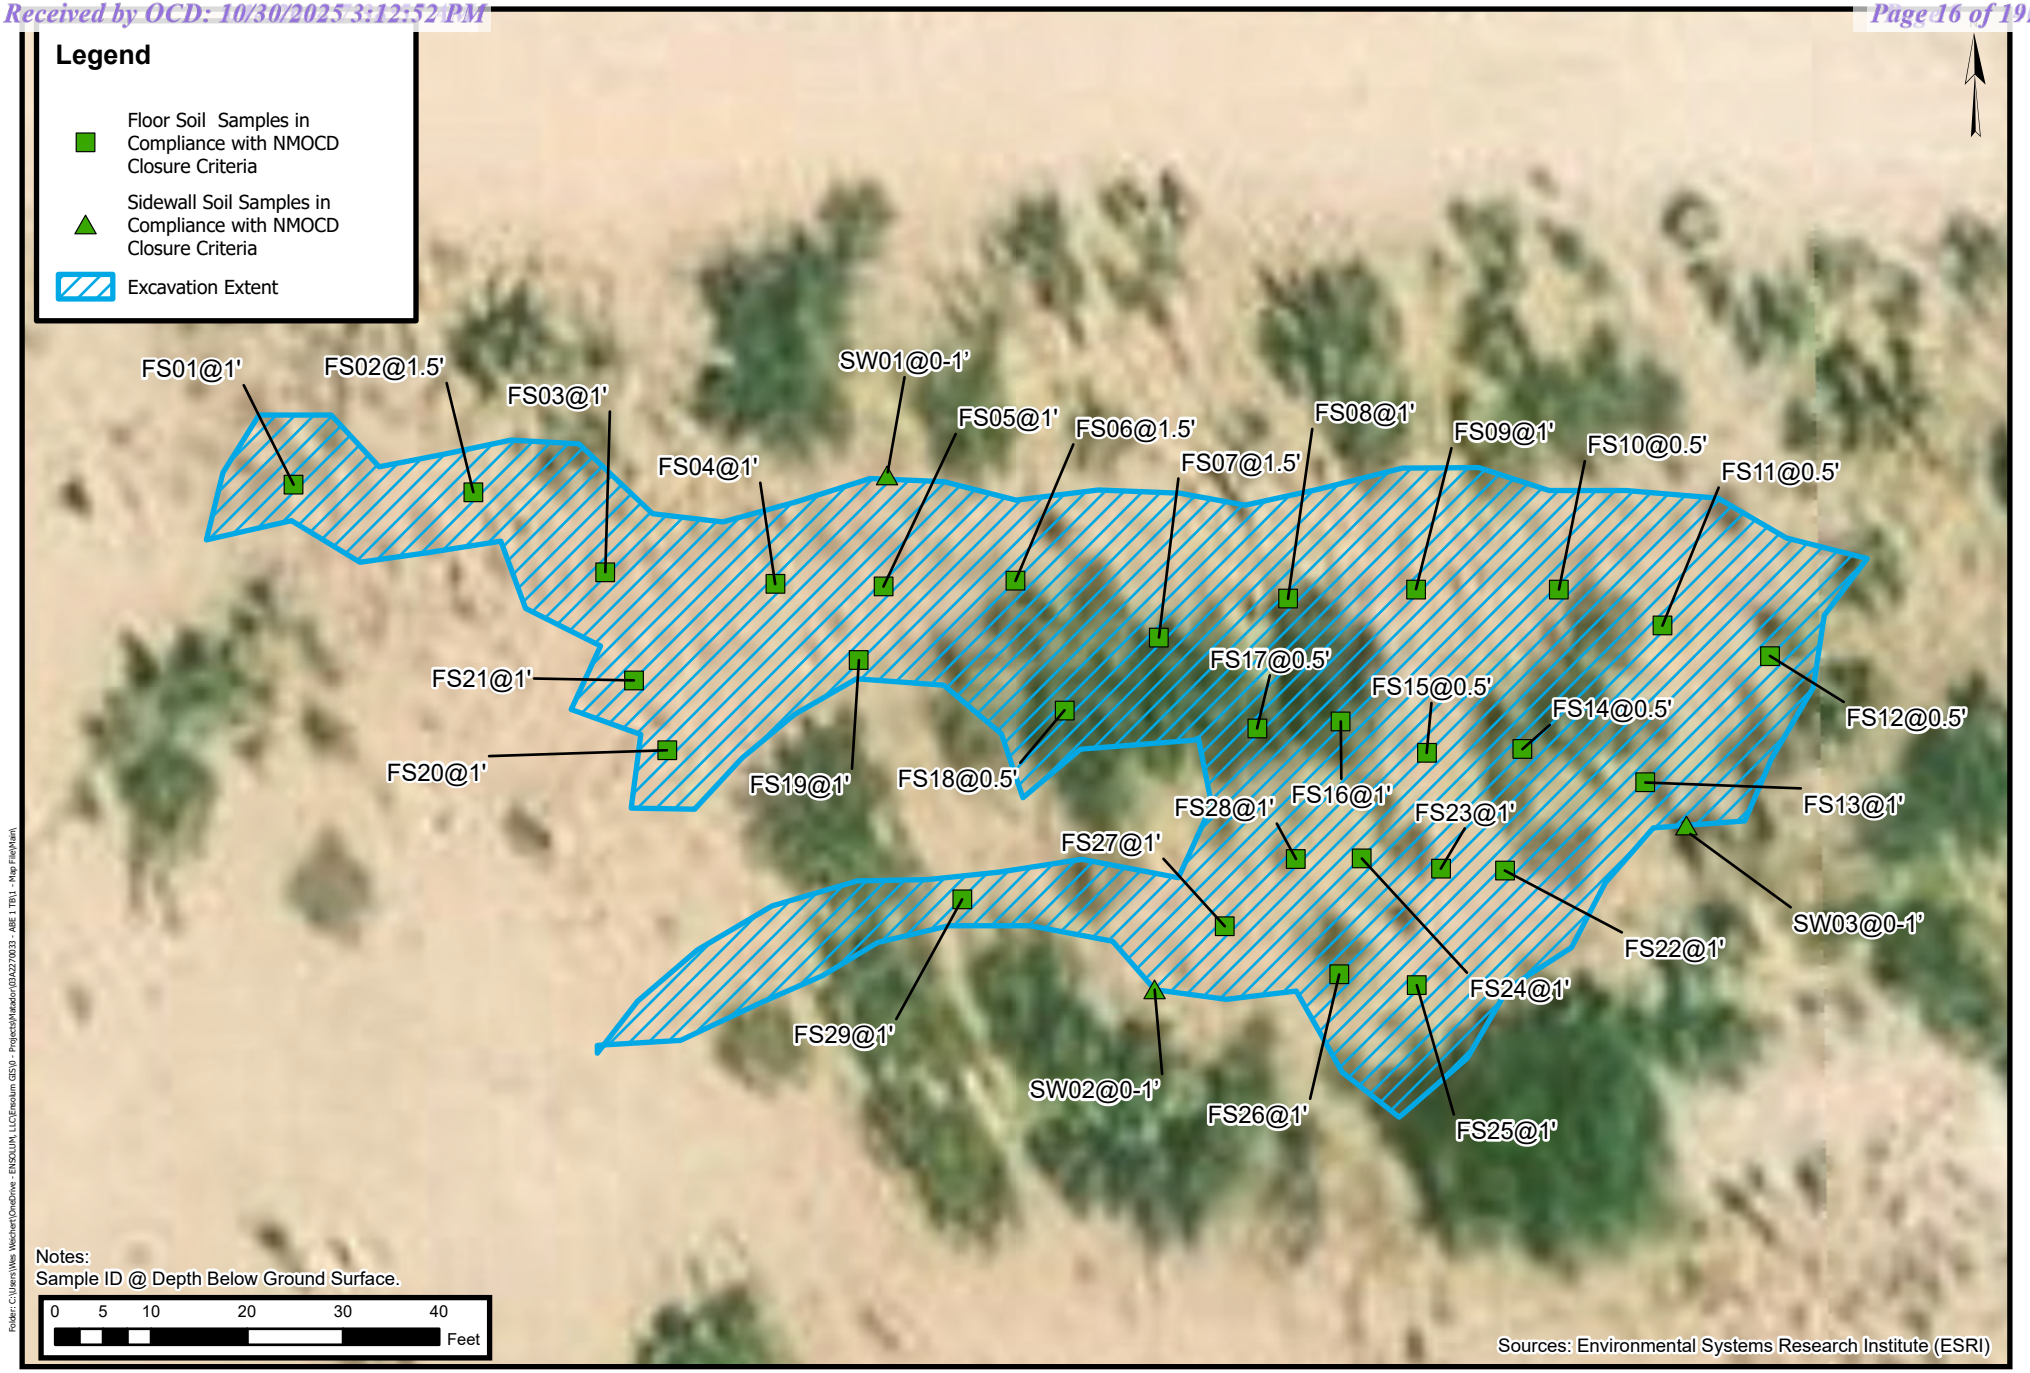
FIGURE 3

Following the removal of waste-containing soil, Ensolum personnel collected 5-point composite soil samples representing at least 200 square feet from the floor of the excavation. The 5-point composite samples were collected by placing five equivalent aliquots of soil into a 1-gallon, resealable plastic bag and homogenizing the samples by thoroughly mixing. Composite soil samples (FS01 through FS29) were collected from the floor of the excavation at depths ranging from 0.5 feet to 1.5 feet bgs. Confirmation sidewall soil samples (SW01 through SW03) were collected at depths ranging from ground surface to 1-foot bgs. The excavation soil samples were collected, handled, and analyzed following the same procedures as described above. The excavation extent and excavation soil sample locations are presented on Figure 3.

Confirmation Soil Sample Locations

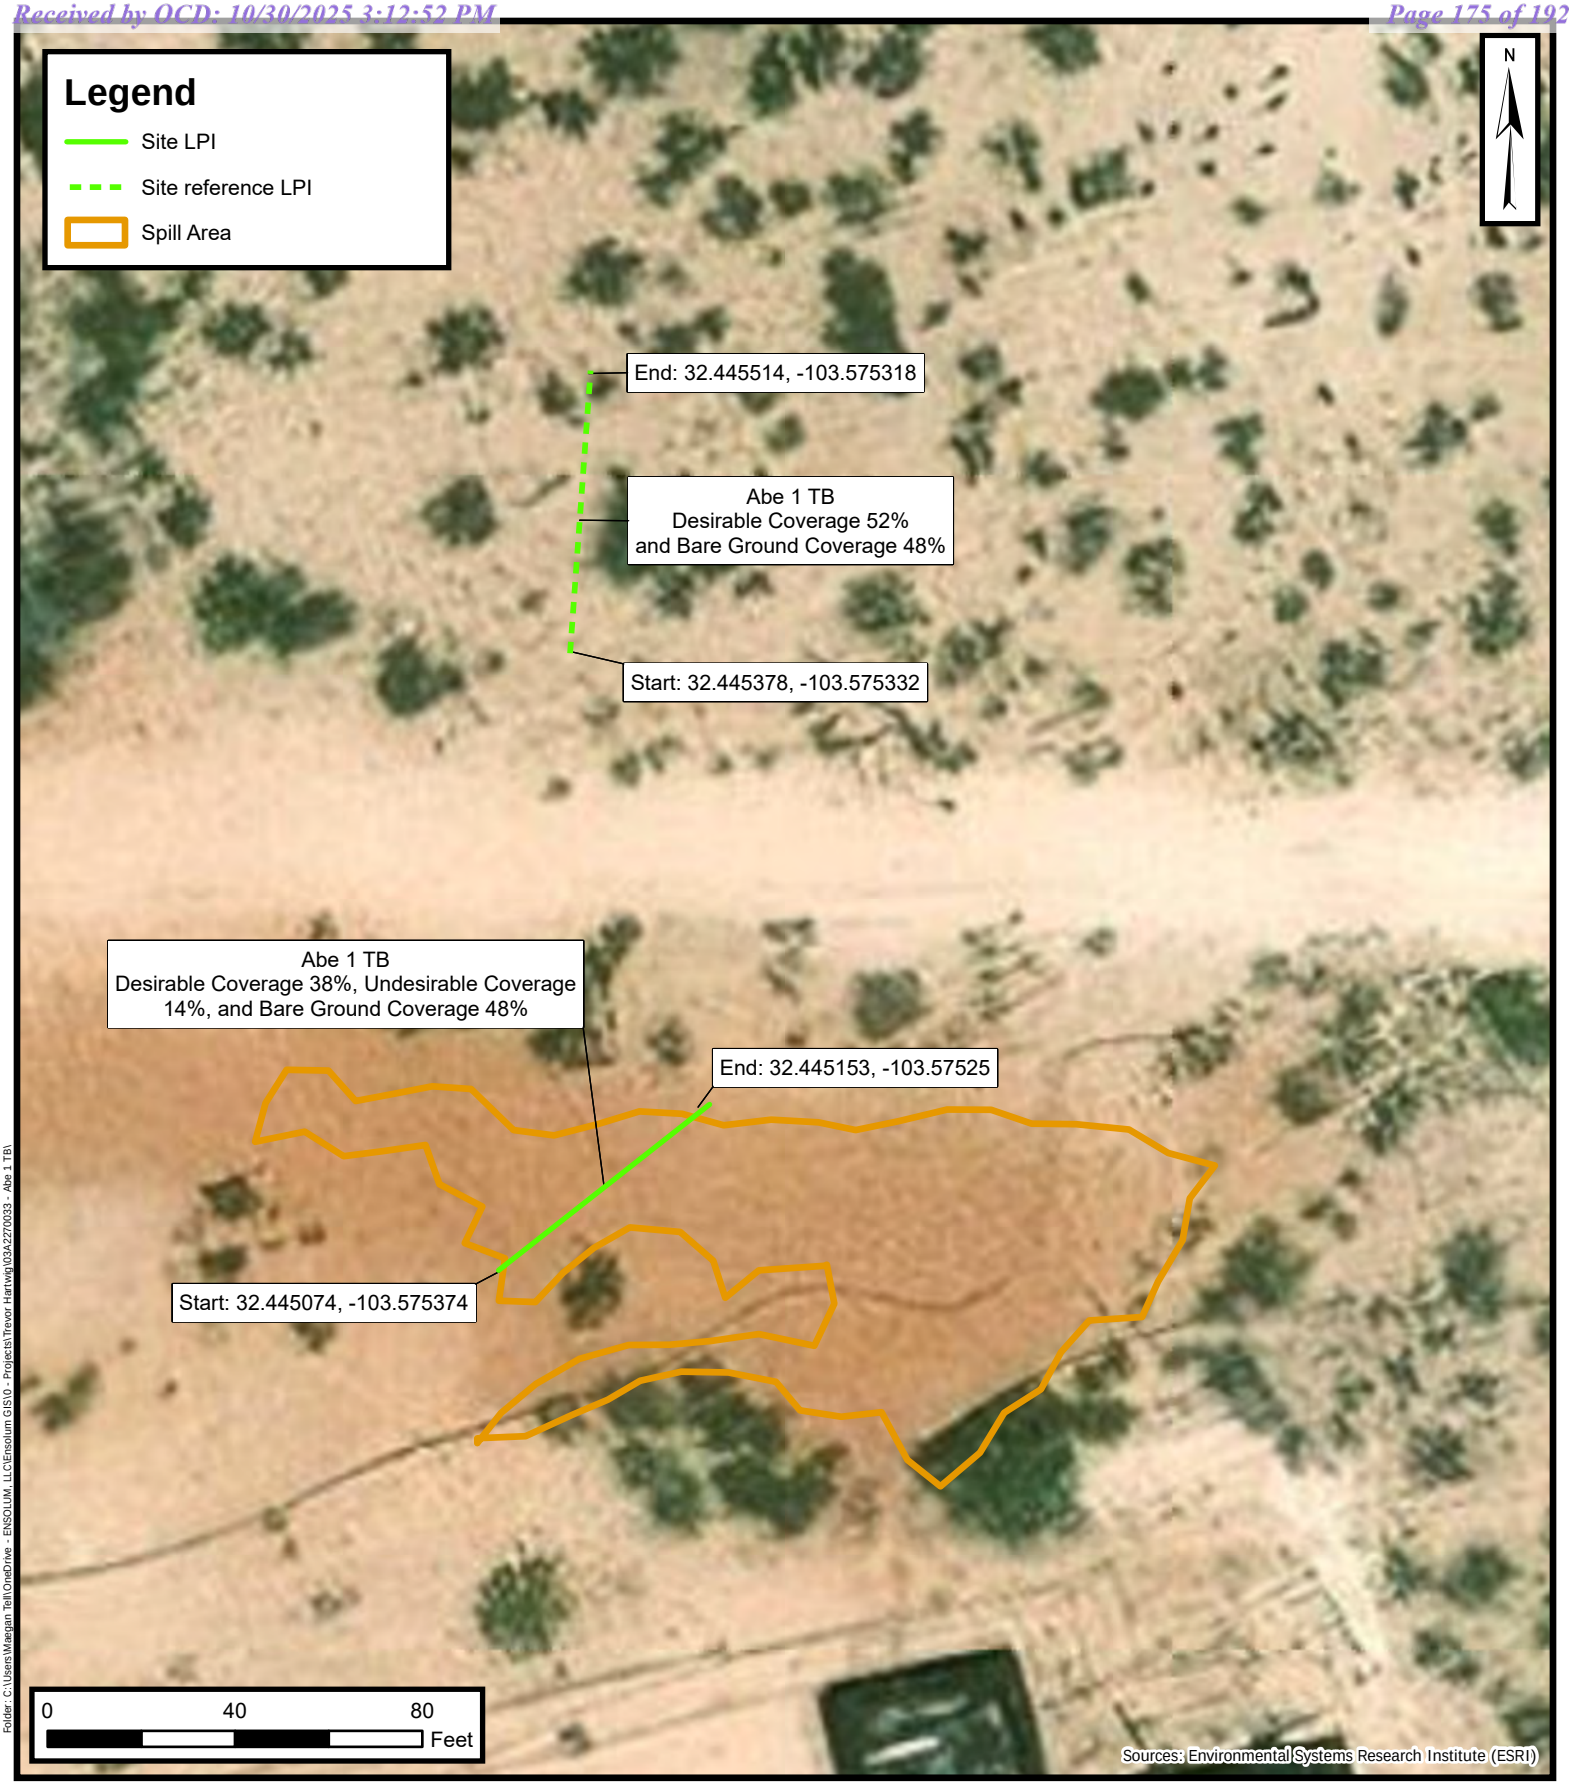
FIGURE
3

According to NMOCD, once vegetation growth in the reclaimed pasture area has a uniform vegetative cover that reflects a life-form ratio of plus or minus 50 percent (%) of pre-disturbance levels and a total percent plant cover of at least 70% of pre-disturbance levels, excluding noxious weeds, per NMAC 19.15.29.13 D.(3). The Line-Point Intercept (LPI) method was used to evaluate the vegetative cover across the well pad and access road in comparison to adjacent undisturbed native reference areas. This method was selected to determine whether the reclaimed areas meet or exceed the 70 percent (%) vegetation cover threshold required for final reclamation success, as measured against native baseline conditions. At each assessment location, a 50-foot transect line was established within the most representative portion of both the reclaimed area and its corresponding reference site. Vegetation presence was recorded at 1-foot intervals along each transect. If vegetation was absent at a given point, the location was recorded as bare ground. Global positioning system (GPS) coordinates for each transect were collected using a GPS receiver and Field Maps application. The location of each LPI transect is presented in Figure 3.

Figure 3 – Spill Line Point Survey Data Site Map

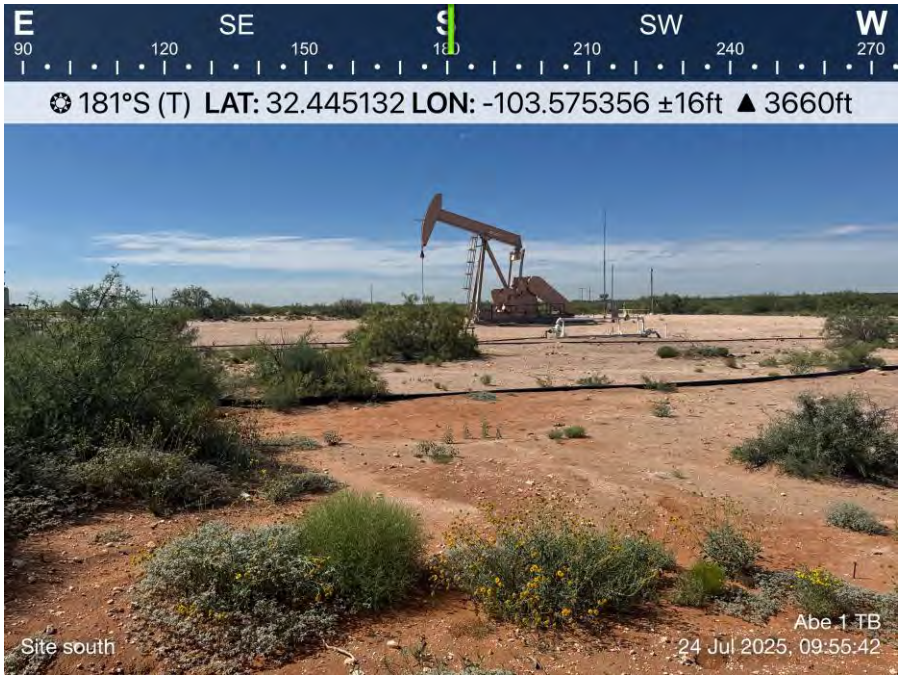
Photo Description:
View south from the spill area.

Photo taken:
07/24/2025

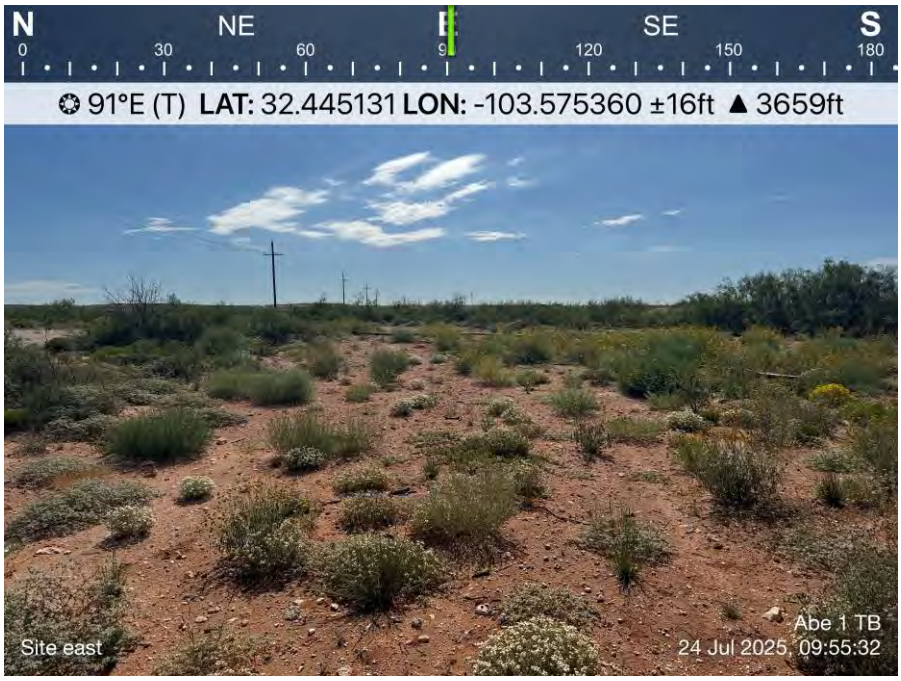
Photograph No. 3

Photo Direction:
East

Photo Description:
View east from the spill area.

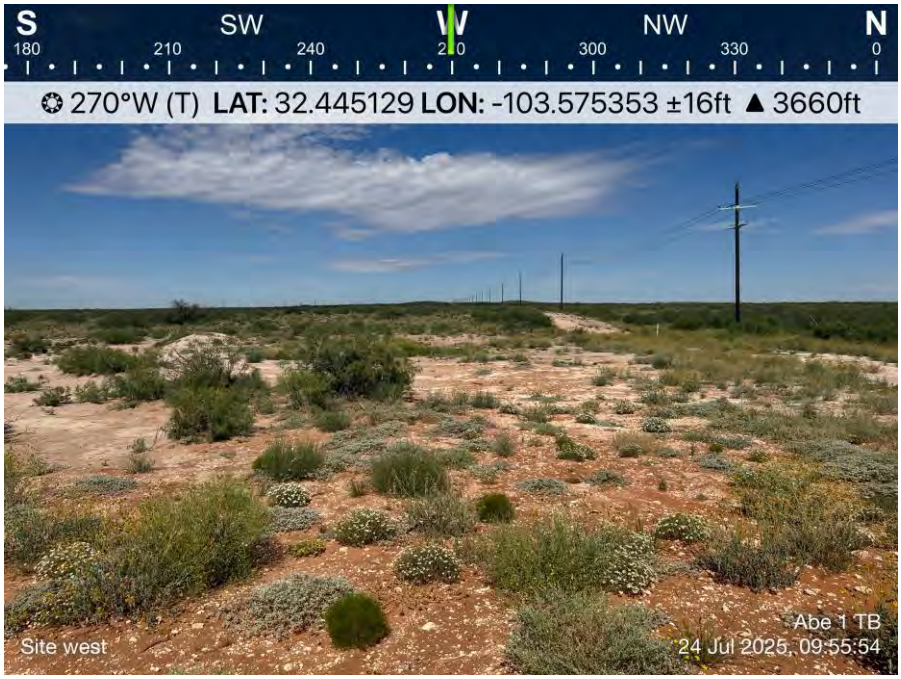
Photograph No. 4

Photo Direction:
West

Photo Description:
View west from the spill area.

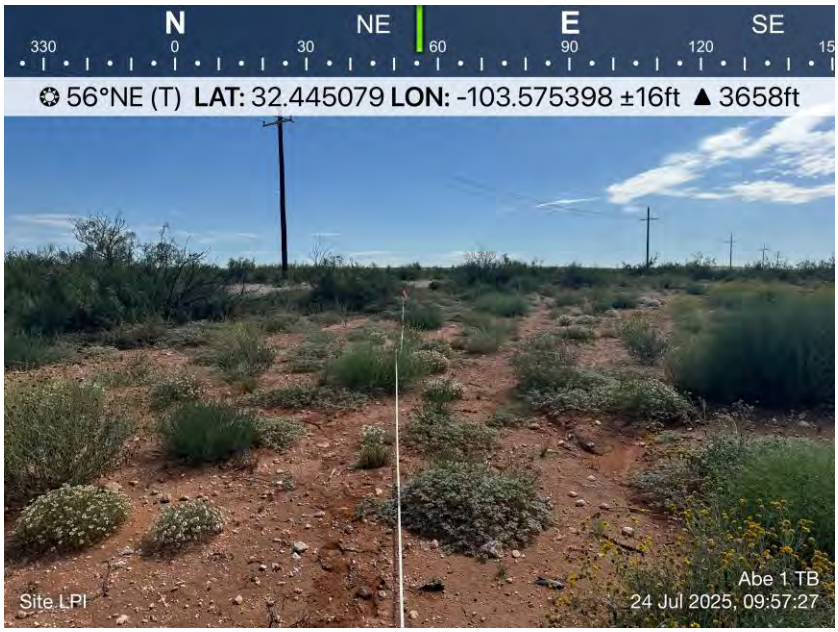
Photograph No. 5

Photo Direction:
North

Photo Description:
Overview of the spill area.
