February 19, 2026

RE: **Nailed It B CTB - Closure Request Report**
Incident Number: nAPP2519532647
GPS: 32.002686°, -103.842251°
Eddy County, New Mexico
ESRR Project No. 422

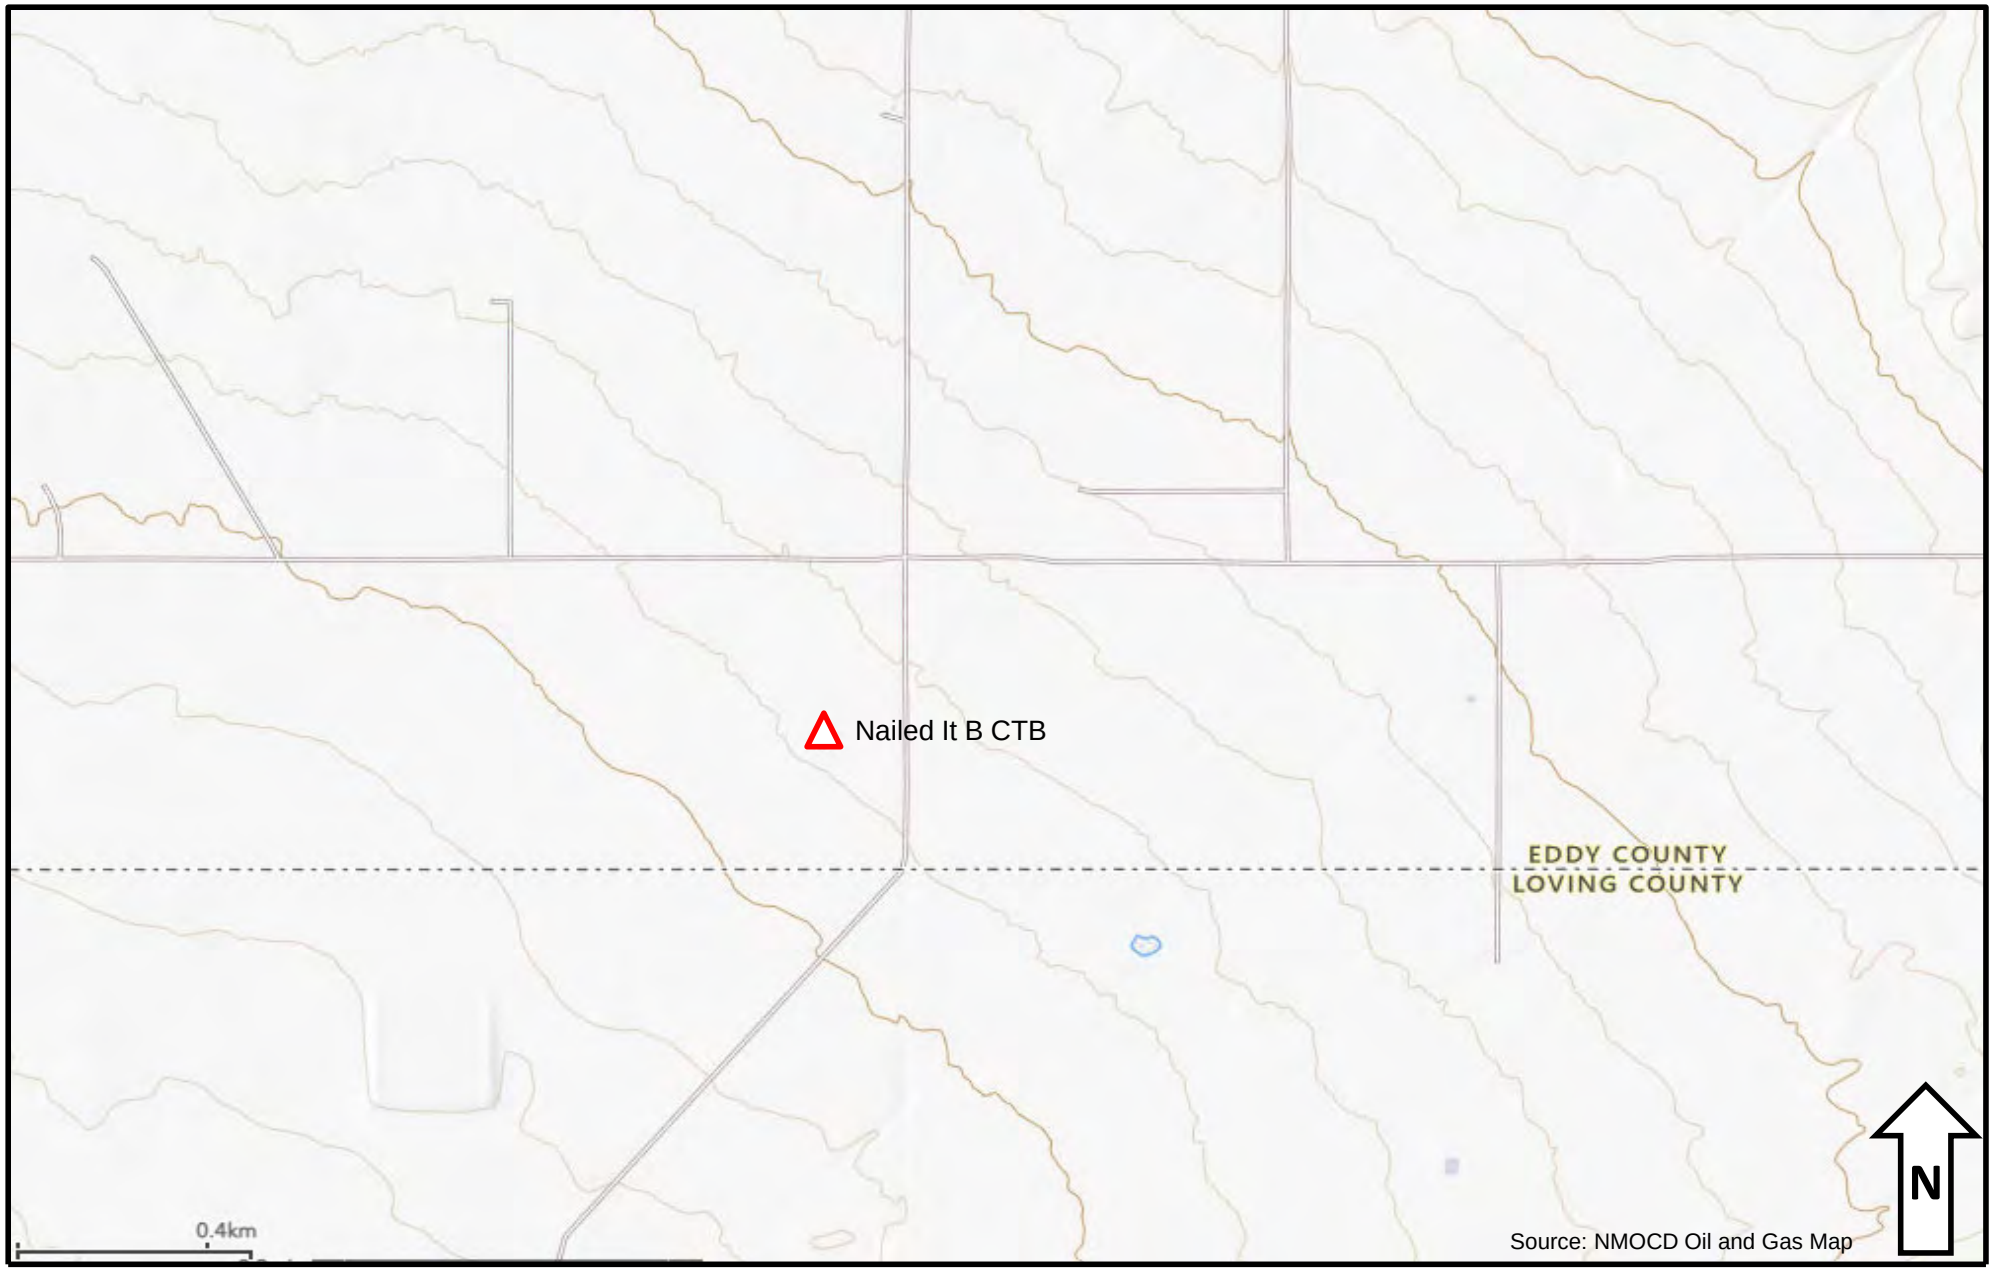
Figure 1 – Site Map

The Site is located in Unit D, Section 36, Township 26 South, Range 30 East, in Eddy County, New Mexico (32.002686°, -103.842251°) and is associated with oil and gas exploration and production operations on State Land managed by the New Mexico State Land Office (NMSLO) (**Figure 1**).

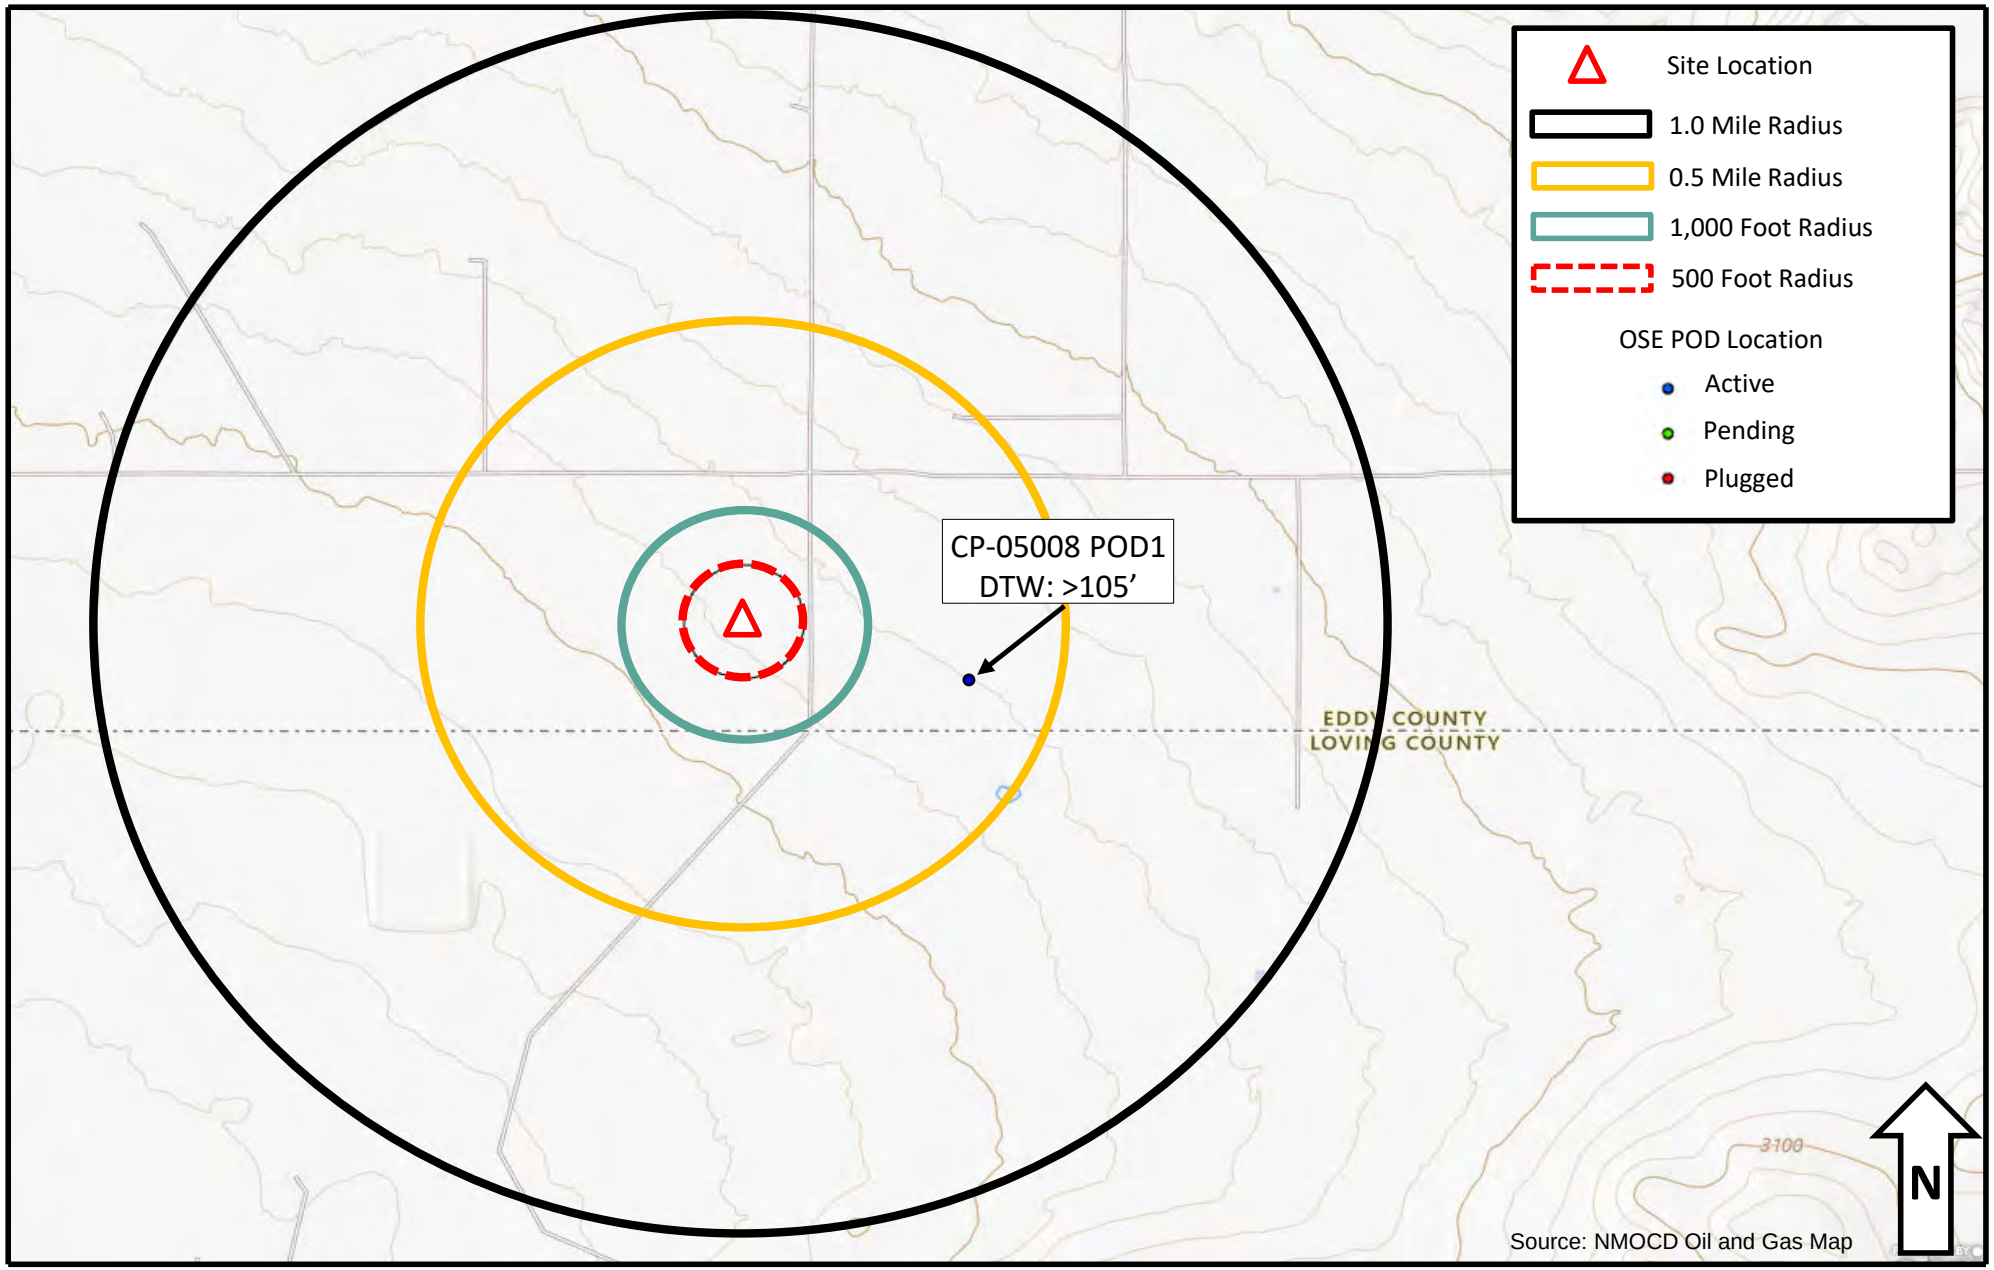
Figure 1A – Groundwater

Receptor details used to determine the Site characterization are included in **Figure 1A** and **Figure 1B**. The **Environmental Karst Study Report** and **Referenced Well Records** for the closest depth to water well are attached.

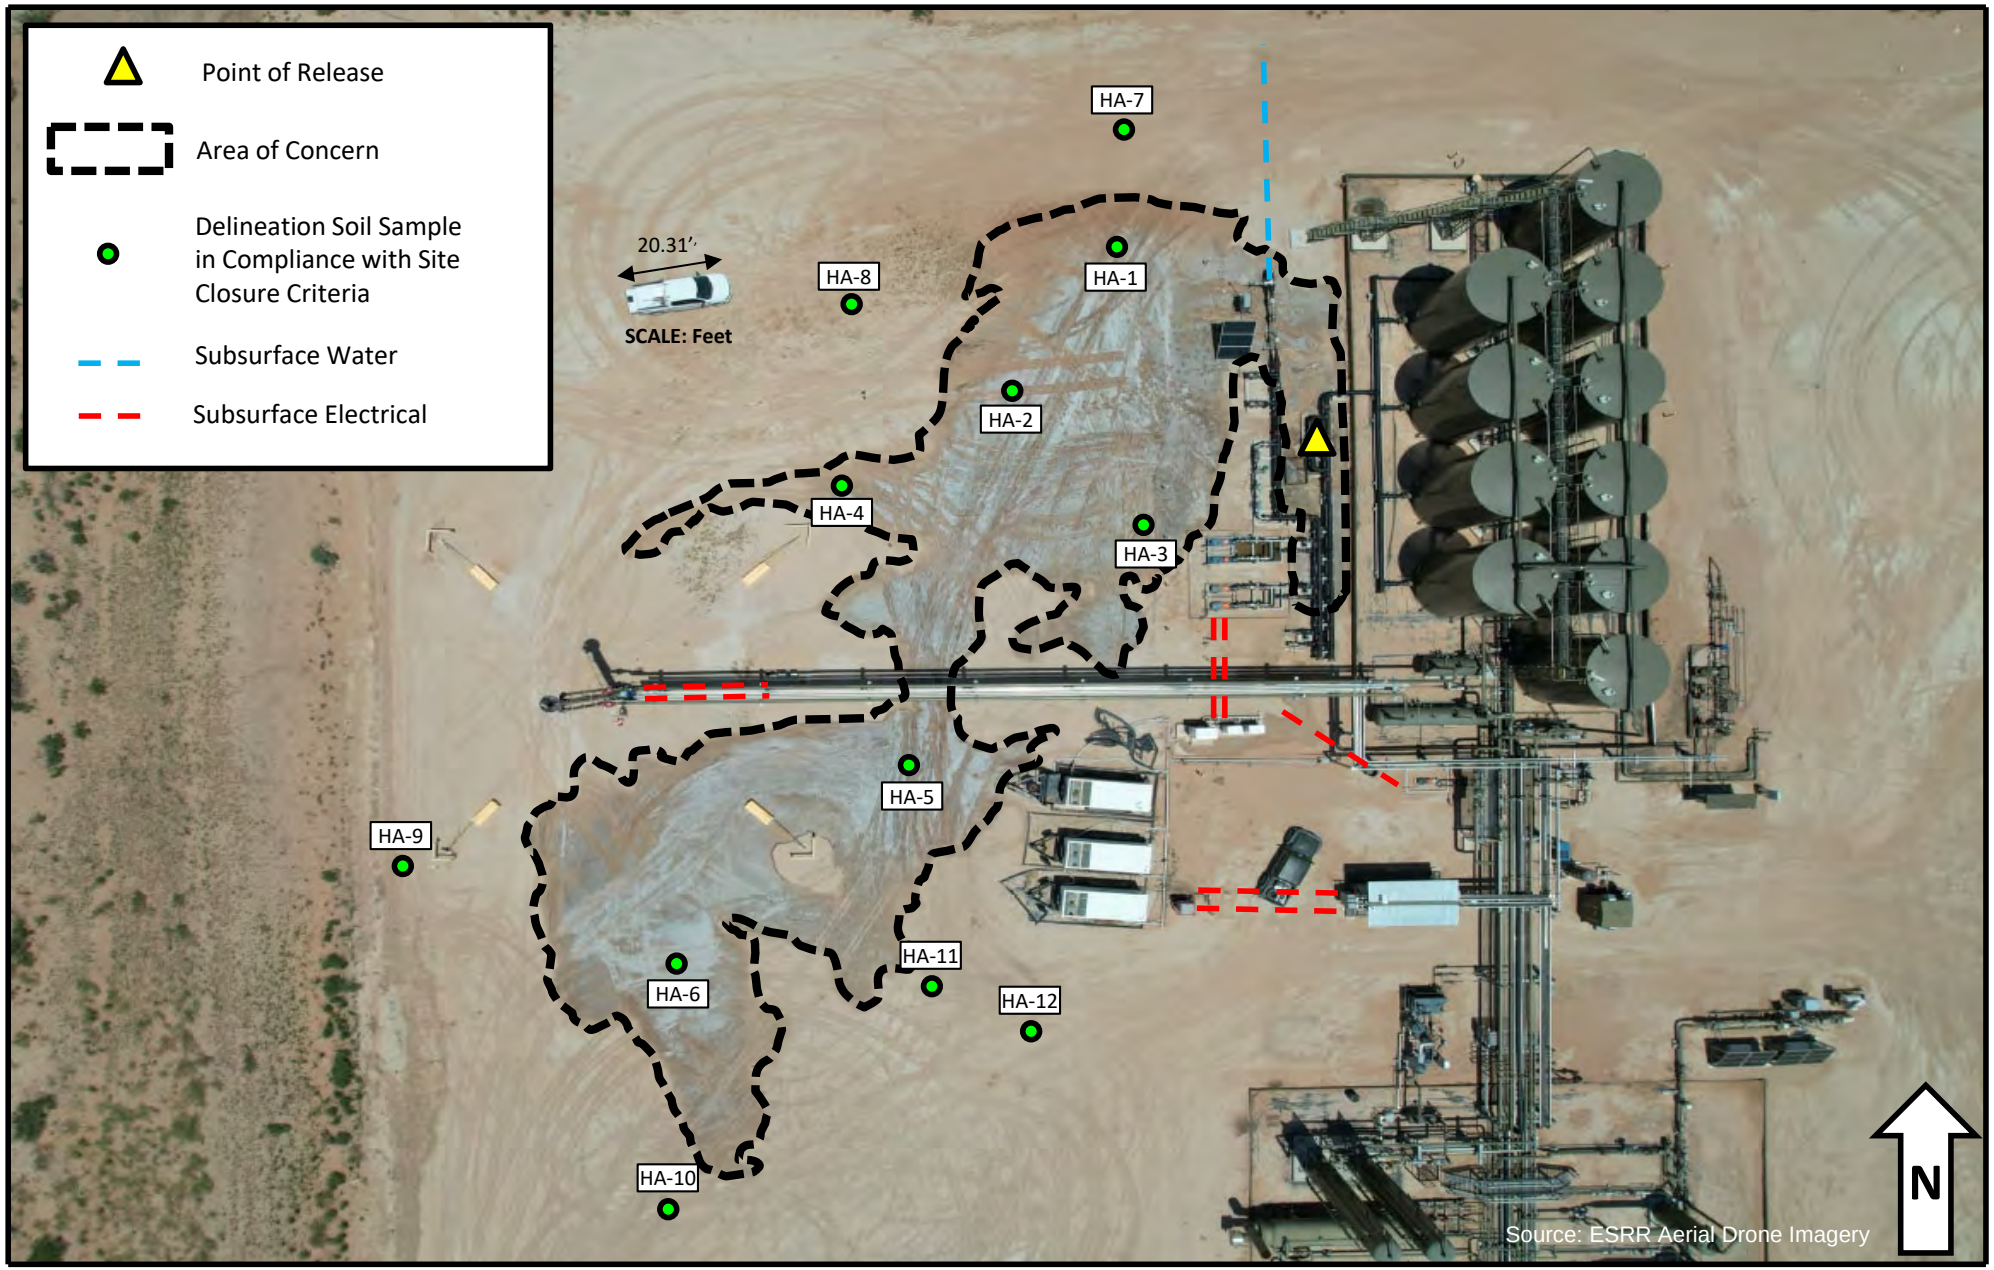
Figure 2 – Delineation Soil Sample Locations

Laboratory analytical results for all delineation soil samples collected within and surrounding the AOC (HA-1 through HA-12) were below the Site Closure Criteria and/or the reclamation standard within the top 2 feet bgs of the AOC. Laboratory results are summarized in **Table 1**, included in the attachments. The locations of all delineation soil samples are shown in **Figure 2**.

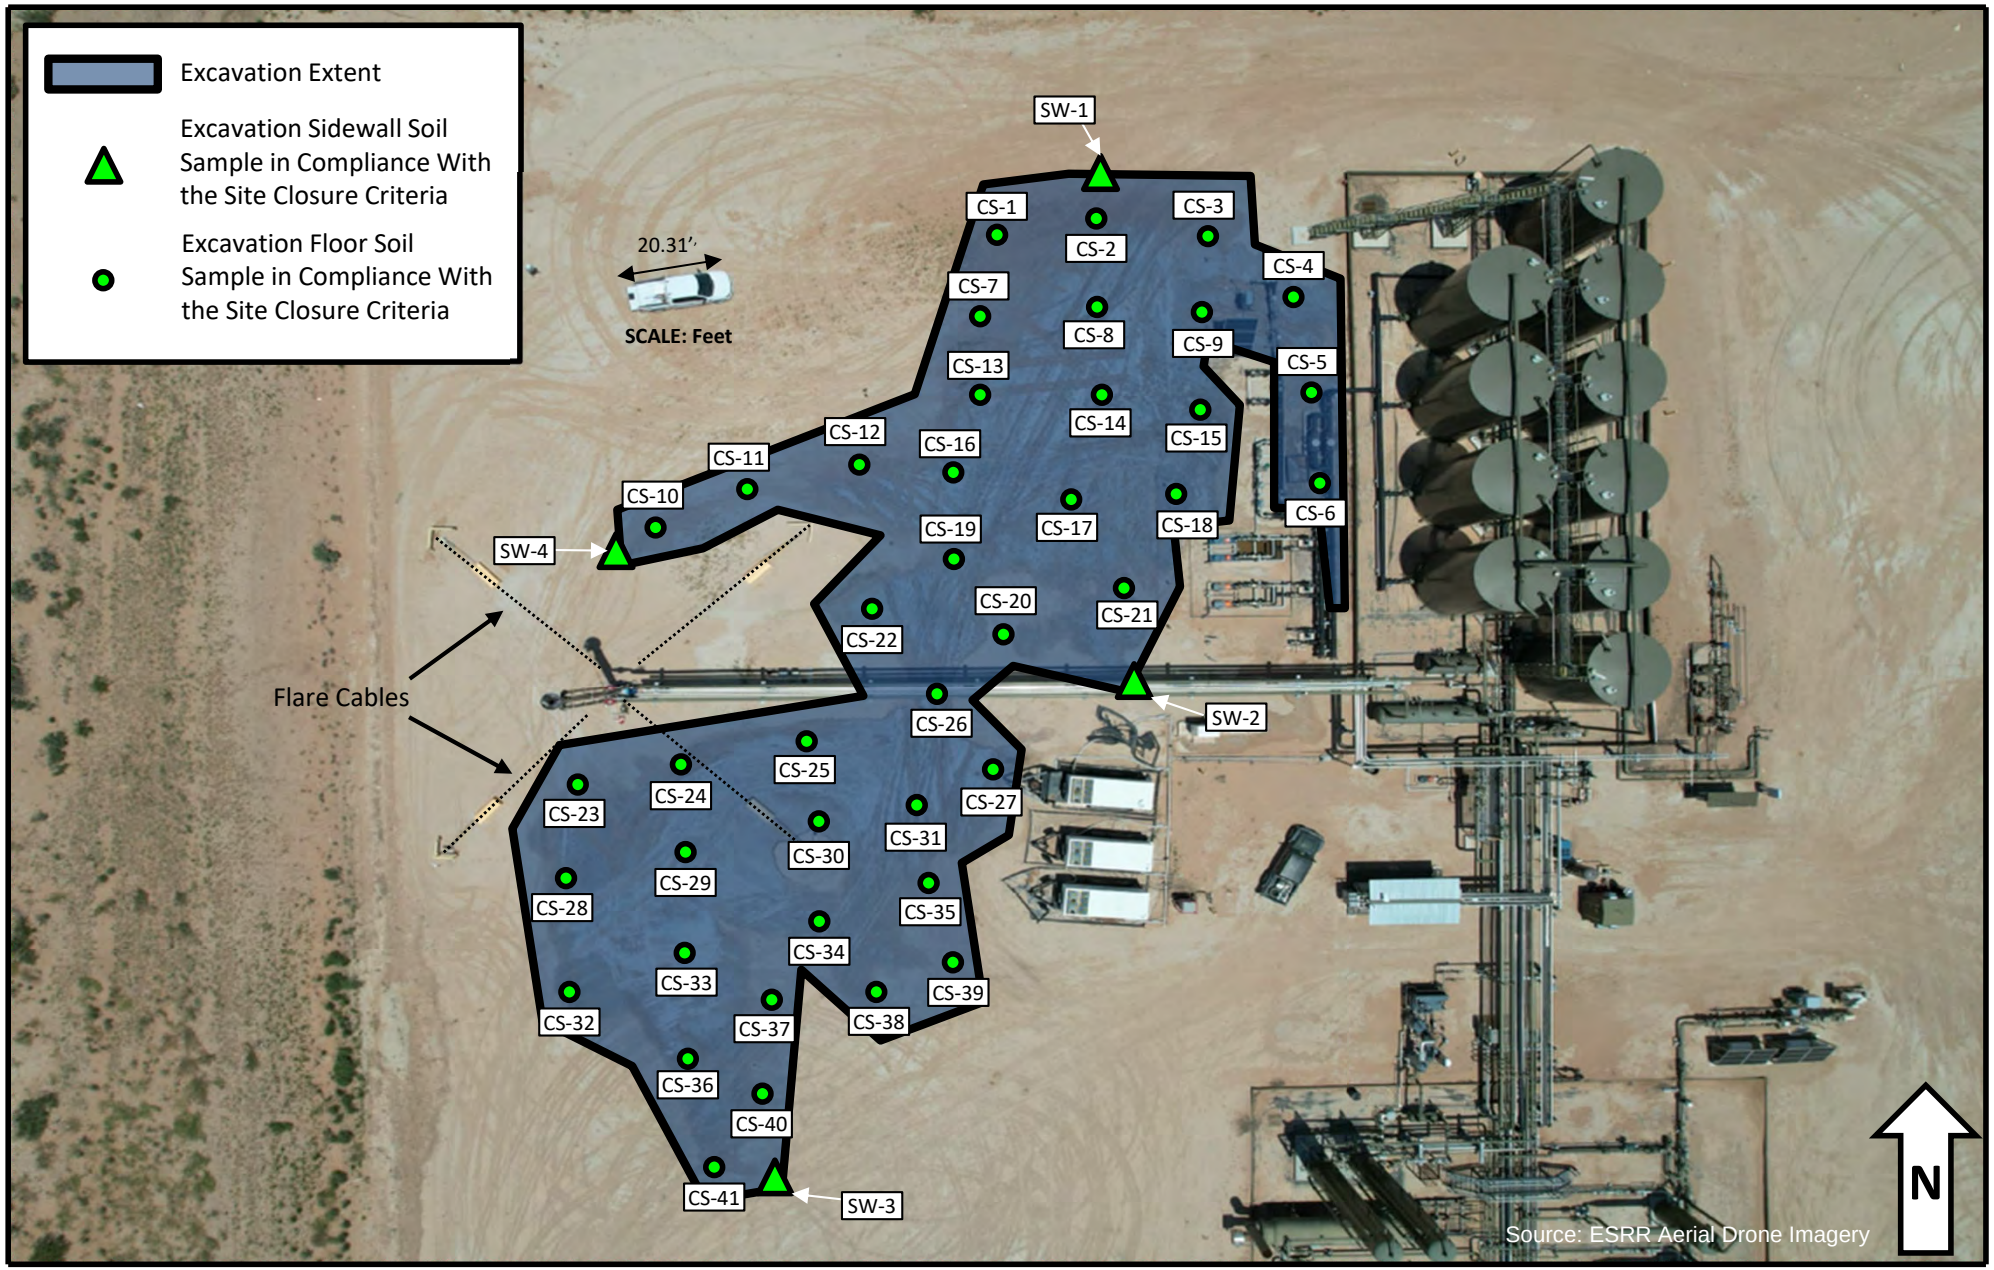
Figure 3 – Excavation Soil Sample Locations

Laboratory analytical results indicated that concentrations of COCs for all final confirmation soil samples were below the applicable Site Closure Criteria and/or reclamation standard. Laboratory results are summarized in **Table 1**, included in the attachments. The locations of all final confirmation soil samples are shown in **Figure 3**.

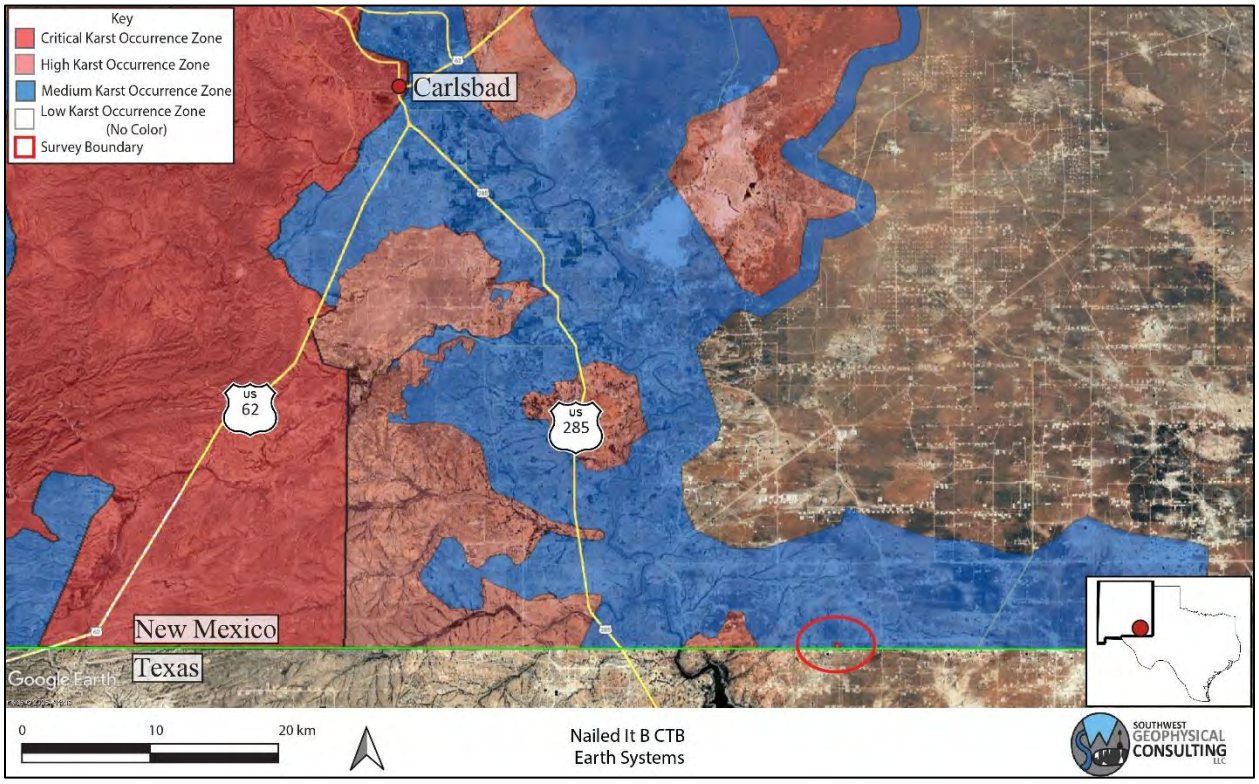
Figure 1: Karst occurrence zone overview. Background image credit: Google Earth. Image date: August 21, 2024. Image datum: WGS-84.

The Bureau of Land Management (BLM) categorizes all areas within the Carlsbad Field Office (CFO) zone of responsibility as having either low, medium, high, or critical cave potential based on geology, occurrence of known caves, density of karst features, and potential impacts to freshwater aquifers[4]. These designations are also recognized by the New Mexico State Land Office (NMSLO). This project occurs within a **MEDIUM** karst occurrence zone (MKOZ)[5] (**Figure 1**).

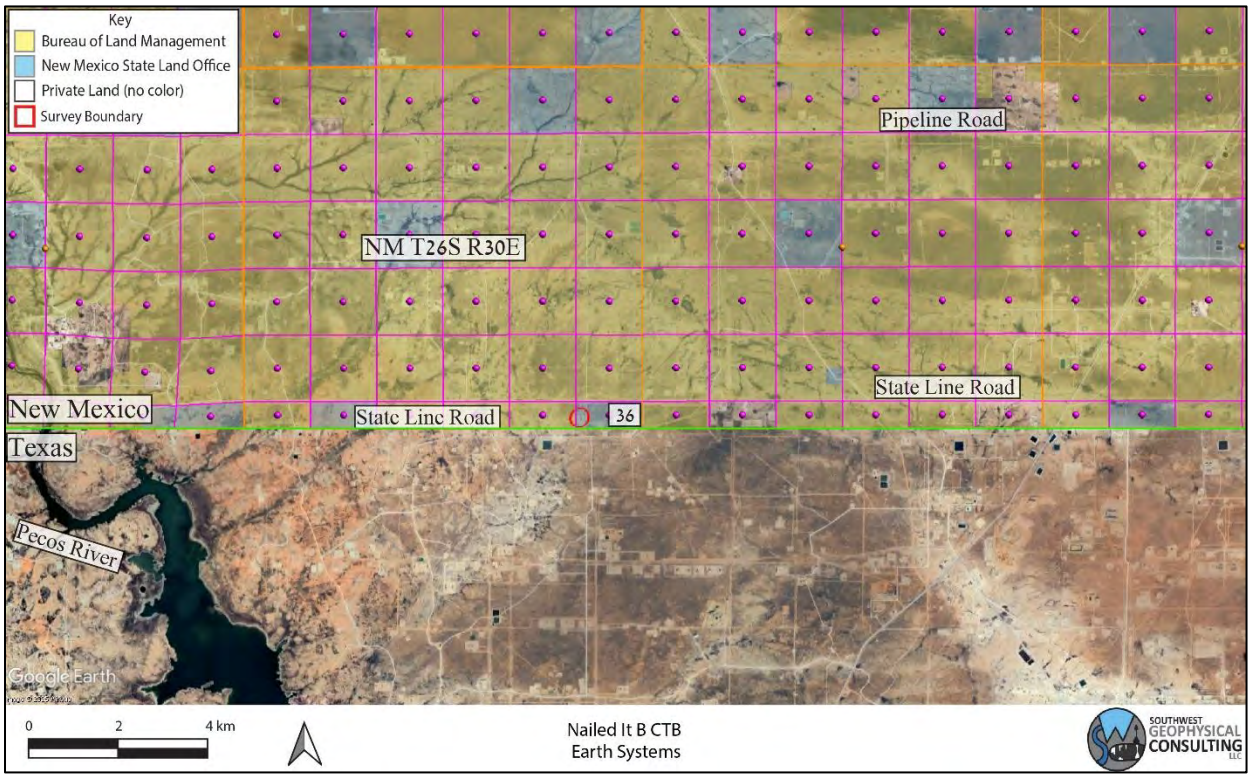
The site is located 58.7 kilometers (36.5 miles) southeast of Carlsbad, New Mexico, south of State Line Road and north of the New Mexico – Texas border in an area known as Red Bluffs. The spill delineation boundary is located within the western half of section 36, NM T26S R30E[6] (**Figure 1** and **Figure 2**). The region has rolling terrain with karstification occurring in the gypsite soils and underlying gypsum and dolomite bedrock[7] (see section ***2.2 Local Geology Summary*** for further information). The climate in this area of southeast New Mexico is semi-arid with an average annual precipitation of approximately 13 inches, of which about two-thirds falls as rain during summer thunderstorms from June to October. Summers are hot and sunny while winters are generally mild, with an average maximum temperature of 96°F in July and an average minimum temperature of 28°F in January[8]. This area is within the Chihuahuan Desert Thornscrub as defined by the Southwestern Regional ReGAP Vegetation map[9] and the vegetation consists mostly of areas of blue grama, nine-awned pappus grass, burro grass and low scrub including yucca. The spill delineation boundary is located within an MKOZ[5] (**Figure 1**) and within NMSLO managed land[10] (**Figure 2**).

Figure 2: Land ownership and PLSS overview. Background image credit: Google Earth. Image date: December 31, 2023. Image datum: WGS-84.

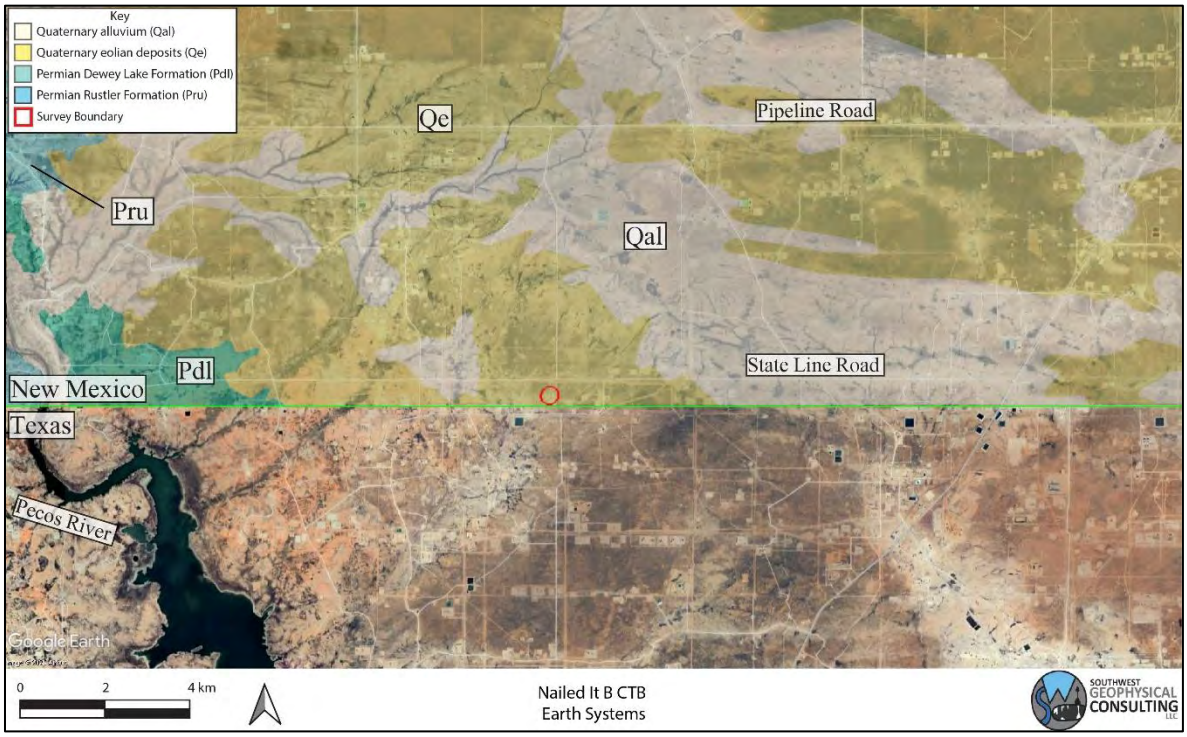
The site for the NIBC survey is located at an elevation of 919 meters (3,015 feet), ± 2 meters (6.6 feet), and is located within a region entirely underlain by the Permian Dewey Lake (Pdl) and Rustler (Pru) Formations. The area is mantled by thin gypsiferous soils (gypsite), Quaternary alluvium (Qal) and eolian sands (Qe)[11] up to 5 meters in depth (**Figure 3**).

Figure 3: Geology overview. Geology map credit: The Digital Geologic Map of New Mexico in ARC/INFO Format. Background image credit: Google Earth. Image date: December 31, 2023. Image datum: WGS-84.

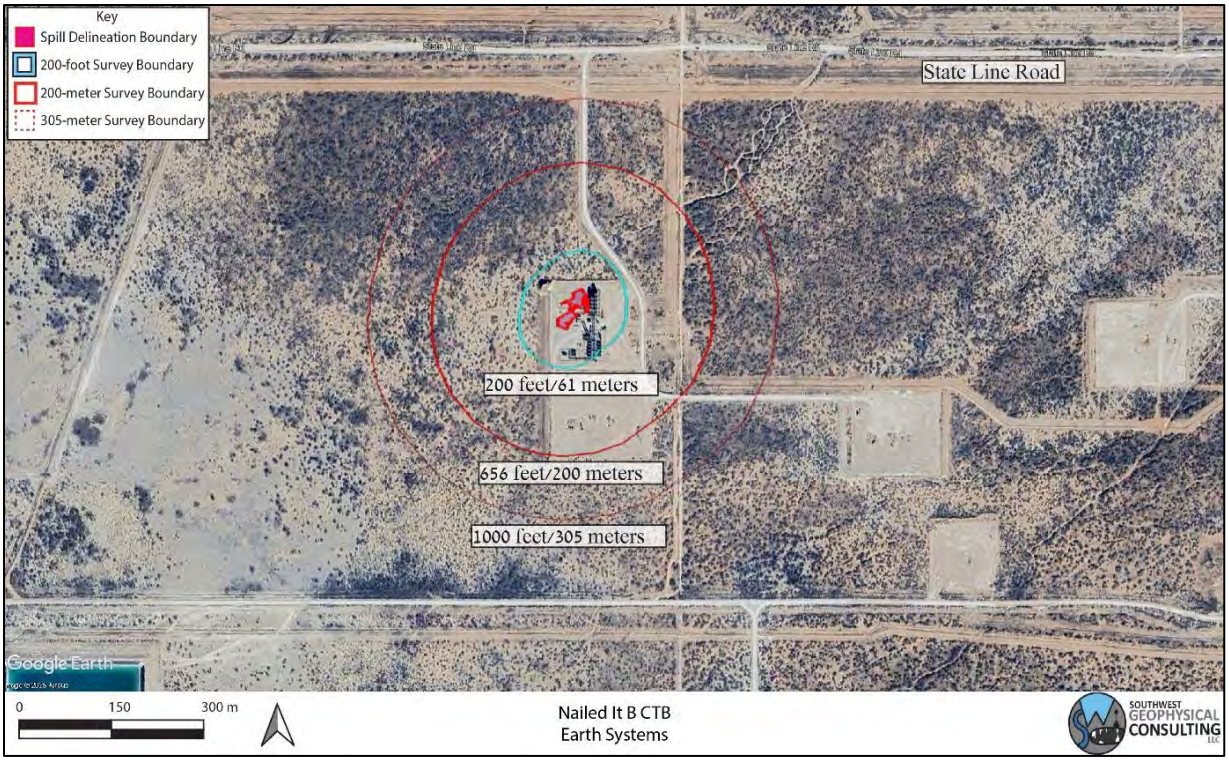
Surface karst surveys are conducted by sUAS at low elevation within 200 meters of the spill delineation boundary[4] (**Figure 4**) following a preplanned raster pattern flightpath designed for the purpose of generating at least 75% imagery overlap. The collected high-resolution, georeferenced imagery is stitched together to develop orthomosaic imagery which is further developed into a digital elevation model (DEM); the DEM is then processed into a local relief model (LRM) (**Figure 6**). This LRM is color coded to enhance differences in elevation of as little as five centimeters. The orthoimagery, DEM, and LRM are uploaded to a server where they are analyzed by an experienced karst geologist. Finally, the data is reviewed by a senior karst geologist for quality assurance and downloaded into a table for inclusion in a written report[17].

Figure 4: Surface survey overview. Background image credit: Google Earth. Image date: December 31, 2023. Datum: WGS-84.

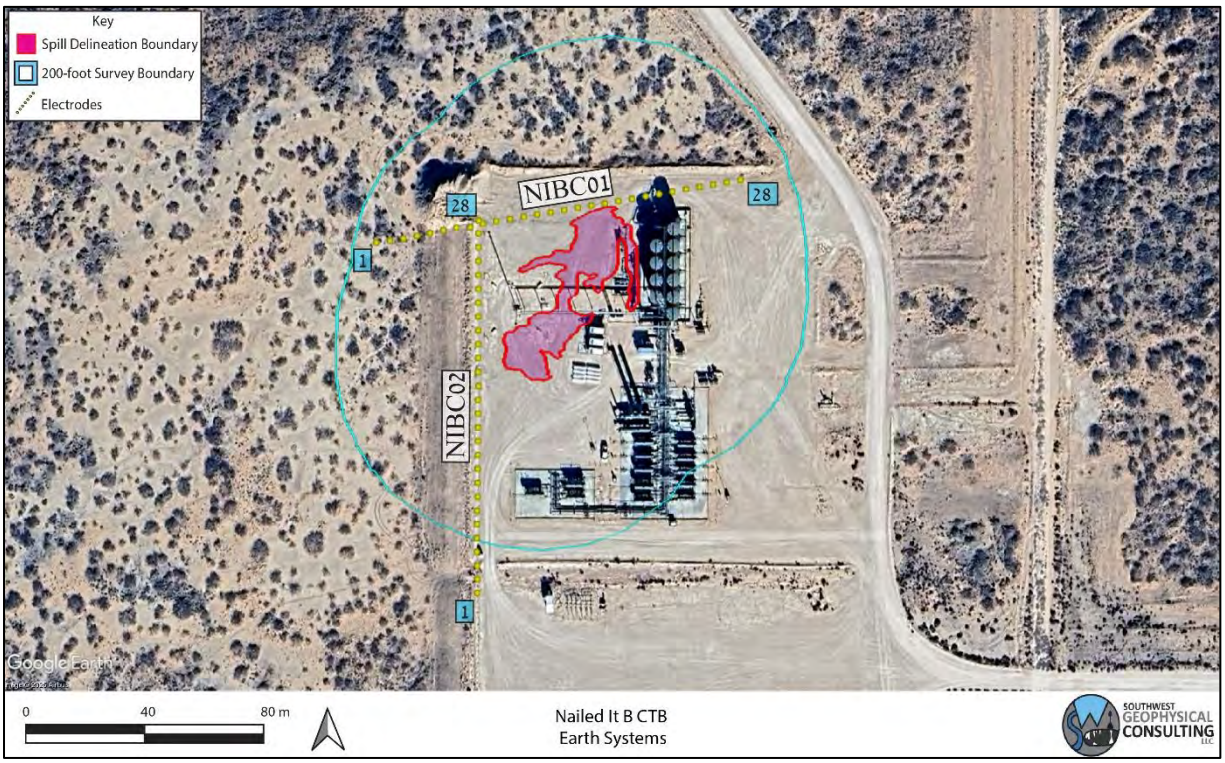
For this survey, a Guideline Geo Terrameter LS 2 and a 28-electrode array of 40-centimeter-long electrodes were used to image the subsurface. This survey consisted of two resistivity lines in a dipole-dipole configuration. Line NIBC01 is laid out west to east while line NIBC02 is laid out south to north. Both lines consisted of 28 electrodes at 5-meter spacing, resulting in 135-meter-long arrays (**Figure 5**, **Table 1**). A preconfigured protocol file was used to run the data collection (DipoleDipole2x14). This electrode configuration provided a depth of investigation of 27 meters (89 feet) and a resolution of 2.5 to 3.0 meters (8.2 to 9.8 feet) within the first 5 to 8 meters (16 to 26 feet) from the surface. A Leica GS18 GPS was used to record electrode locations and elevations.

Figure 5: Geophysical survey overview. Two survey lines were conducted with 28 electrodes each (yellow dots denoted with blue numbers). Background image credit: Google Earth. Image date: December 31, 2023. Image datum: WGS-84.

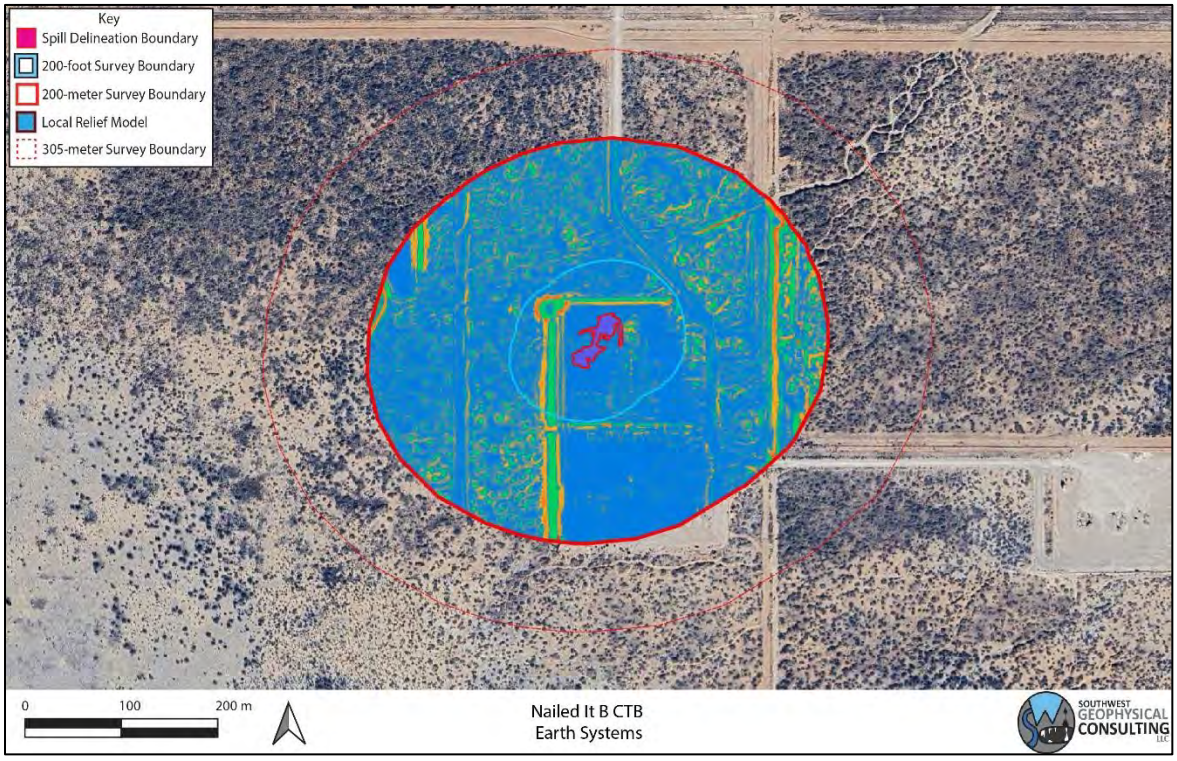
Figure 6: Surface karst survey results. Background image credit: Google Earth. Image date: December 31, 2023. Image datum: WGS-84.

The desk study and surface karst survey showed no surface karst features within the 200-foot (61-meter)[1] karst survey boundary (Figure 6).

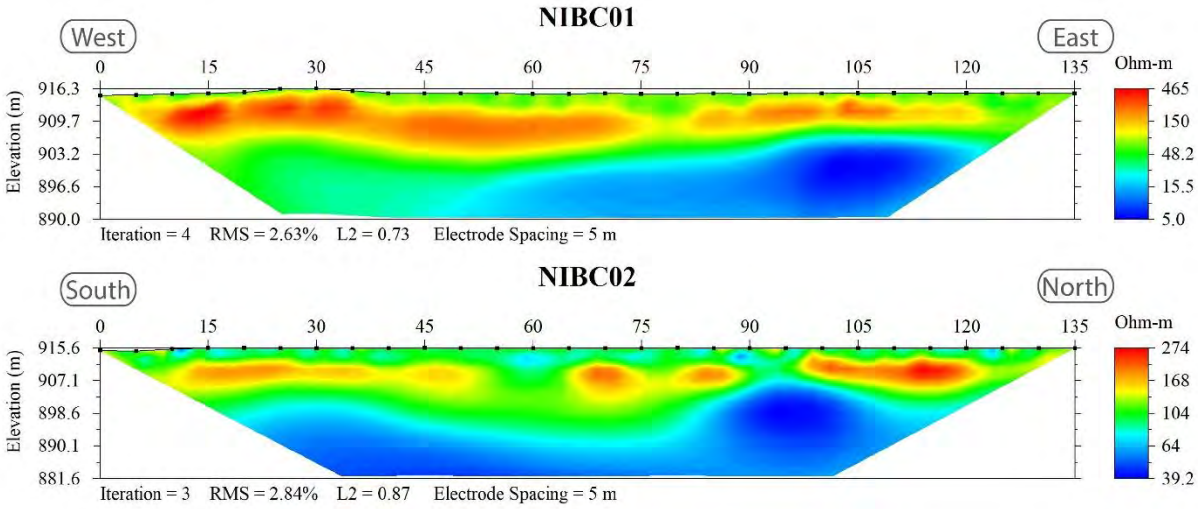
Figure 7: 2D inverted resistivity sections. Reds and oranges indicate higher resistivity values. Yellows and greens are medium-resistivity values. Blues are low-resistivity values. Please note that the color scale is relative.

The results of this study indicate a well-layered geologic system with low resistivities between 5.0 and 465 Ohm-m (**Figure 7**). Please keep in mind when viewing the 2D inverted resistivity sections that color maps can be widely different for each view. Always check the color map located on the right side of the image when viewing the 2D images to ensure you understand the range of resistivities presented. Distances along the top and depths along the left side are in meters. The color map along the right side is in Ohm-m. Due to the nature of the survey, shallower zones have higher resolution between electrodes than deeper zones; therefore, small features at depth will not be visible.

Areas of moderate resistivity (yellows, and greens) near the surface are interpreted as sand, caliche, or sandstone of the Dewey Lake Formation; or dry caliche soils and gypsum or dolomite bedrock Rustler Formation [18] (**Figure 7** and **Figure 8**). The low-resistivity area at a depth of approximately 12 - 15 meters beneath the surface across both lines is likely a layer of either clay and halite lenses or moist or saturated layers within the Dewey Lake or Rustler Formations. (**Figure 7** and **Figure 8**).

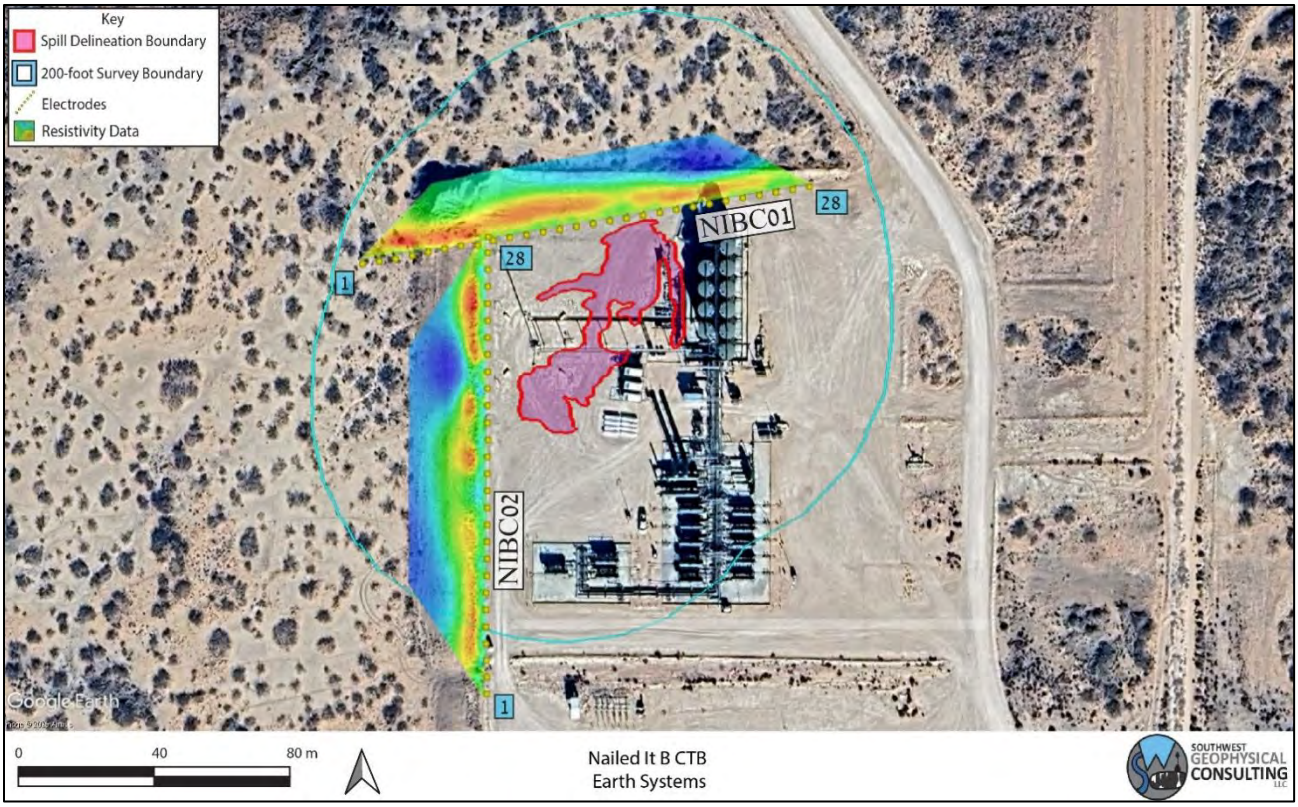
Figure 8: Interpretation. Colored trapezoids are 2D inverted resistivity lines. Background image credit: Google Earth. Image date: December 31, 2023.

No surface karst features and no anomalies consistent with air-filled subsurface voids are found within the NIBC survey area. However, small solutionally enlarged voids or fractures at or near the resolution limit of the survey (2.5 – 3.0 meters) may be present. Slightly higher-than-average resistivity areas less than 10 meters beneath the surface are interpreted as sand, caliche, or gypsite soils. Due to their much lower resistivity values when compared with significant subsurface voids, these features should not be a concern during remediation efforts.

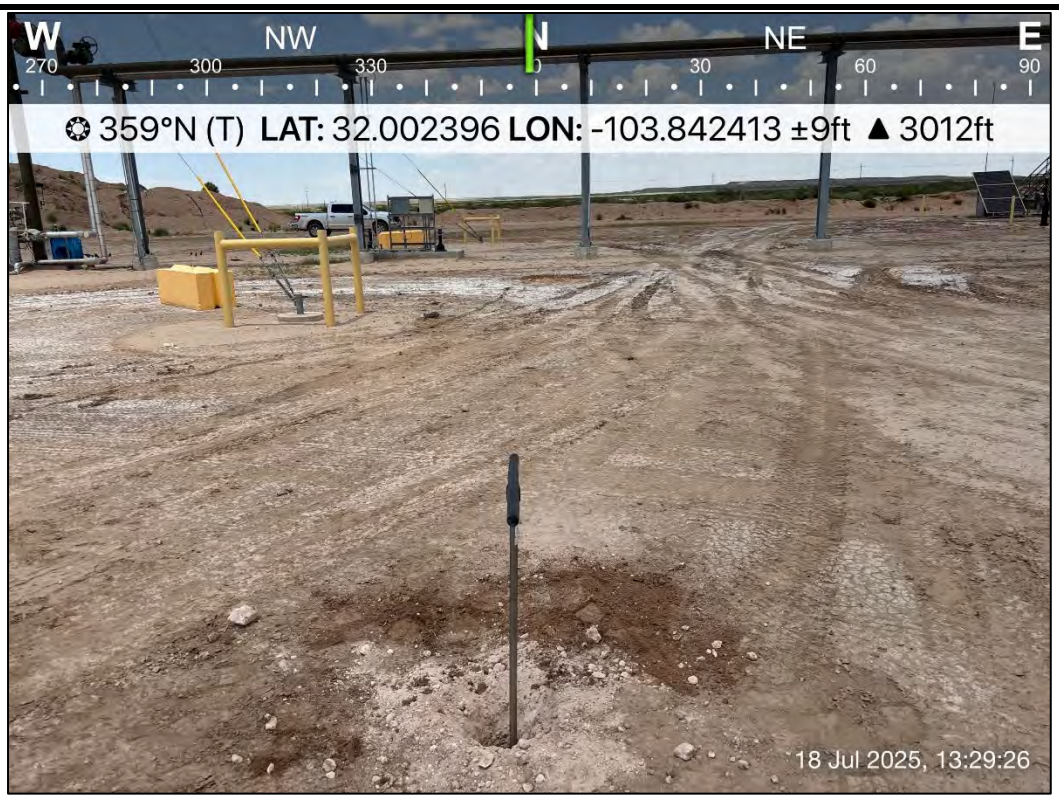
PHOTO 4: Northern view during delineation activities. 7/18/2025

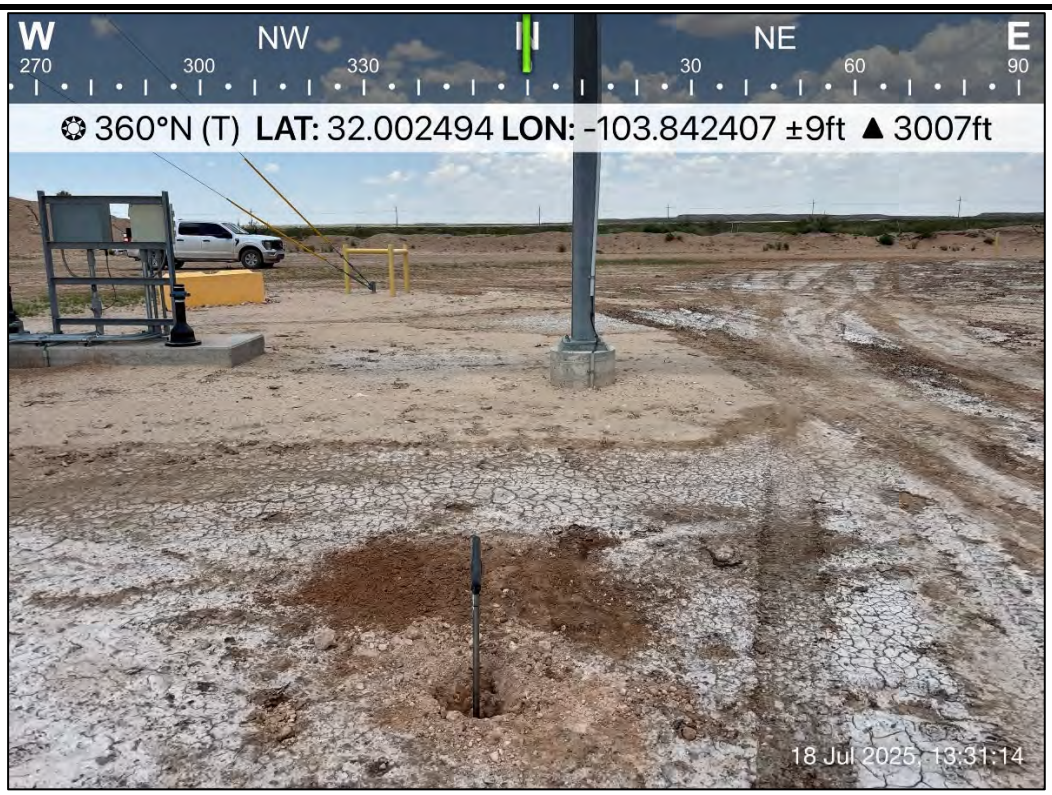
PHOTO 5: Northern view during delineation activities. 7/18/2025

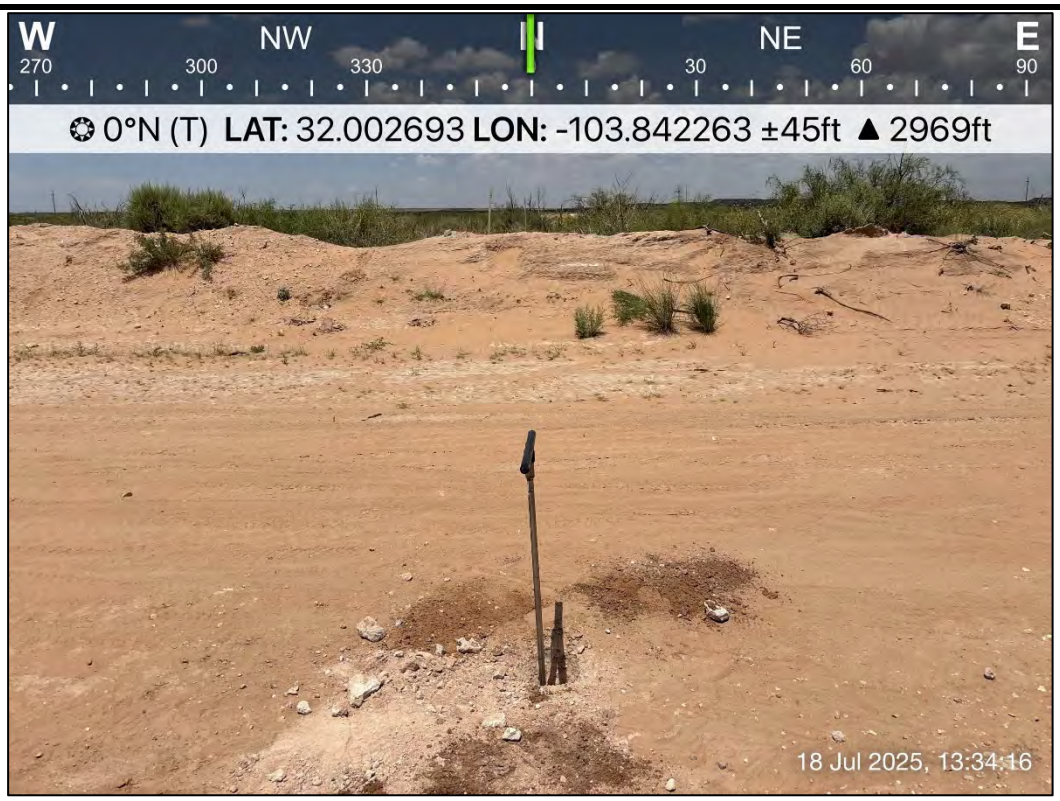
PHOTO 7: Northern view during delineation activities. 7/18/2025
