February 19, 2026

RE: **Nailed It B CTB - Closure Request Report**
Incident Number: nAPP2519532647
GPS: 32.002686°, -103.842251°
Eddy County, New Mexico
ESRR Project No. 422

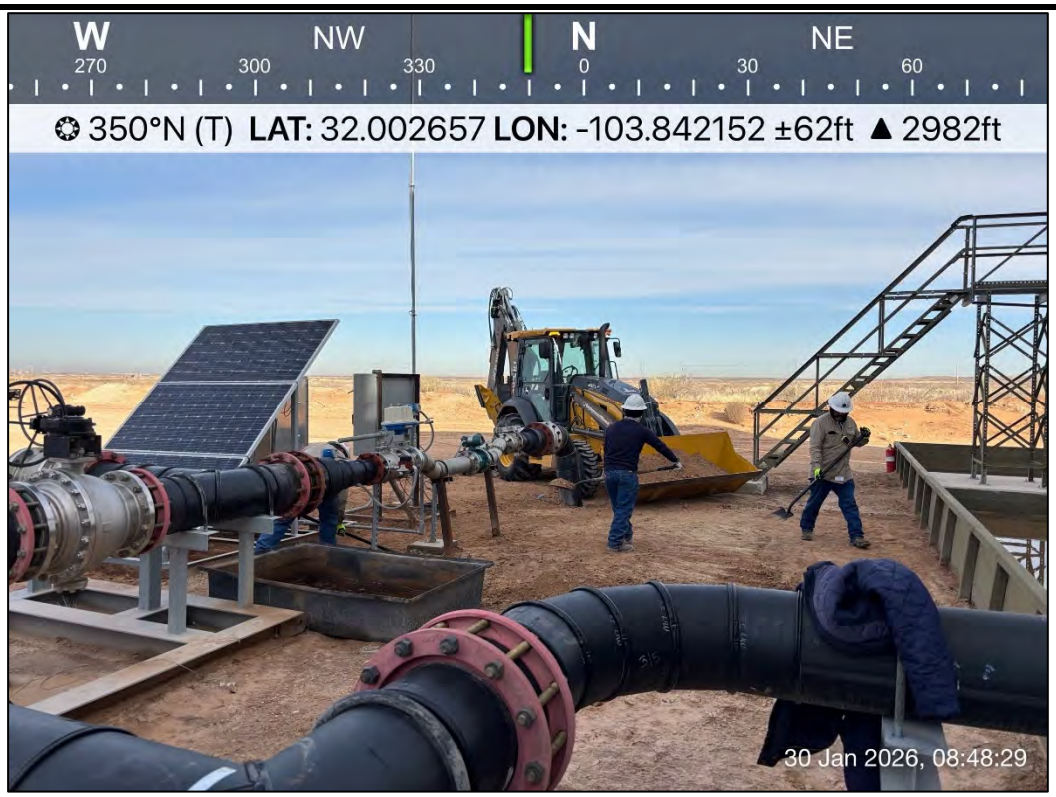
PHOTO 9: Northwestern view during excavation activities. 1/30/2026

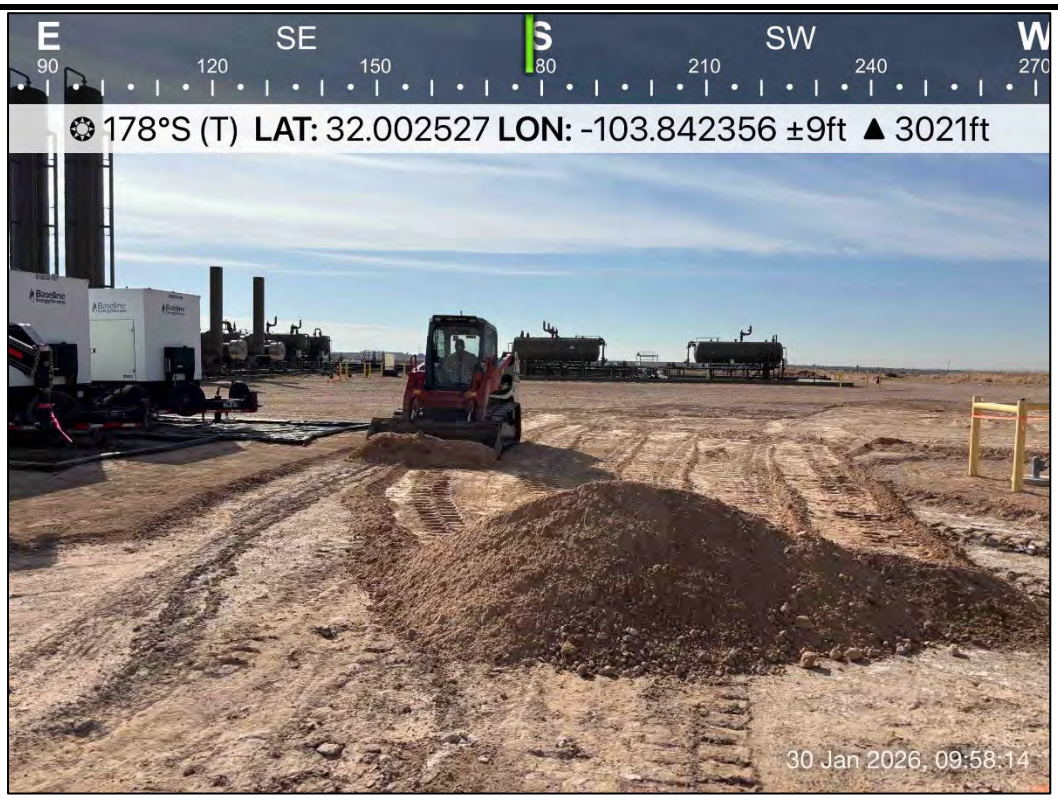
PHOTO 11: Southern view during excavation activities. 1/30/2026

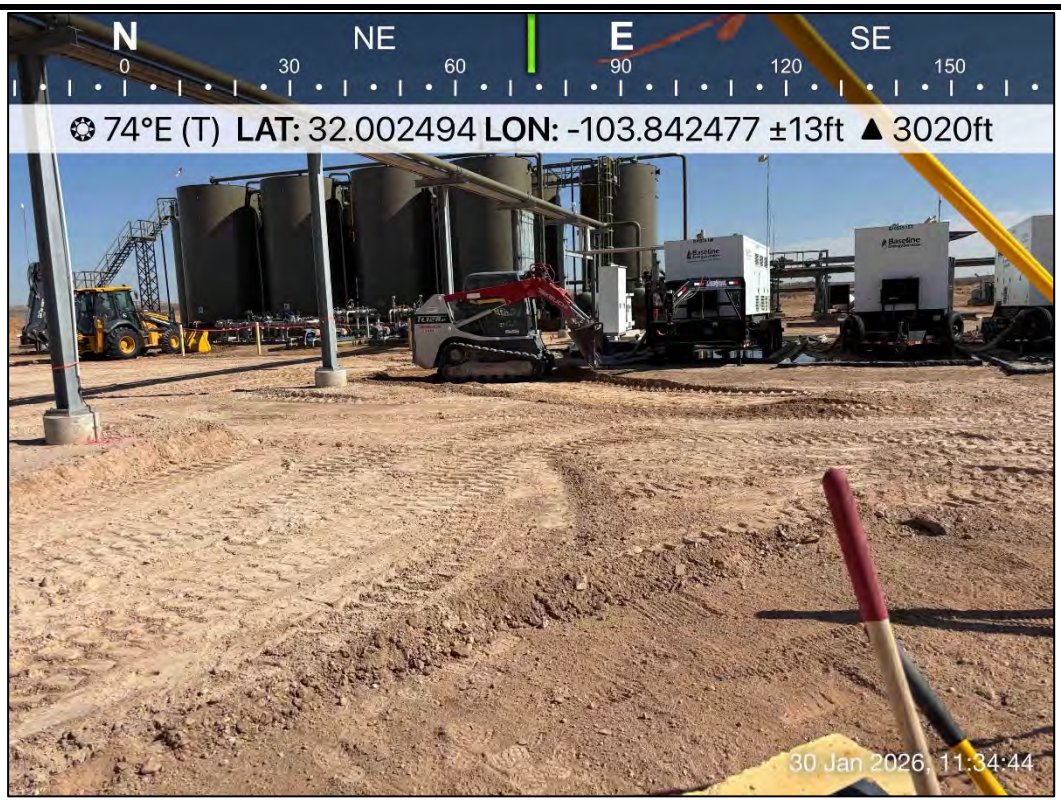
PHOTO 12: Northeastern view during excavation activities. 1/30/2026

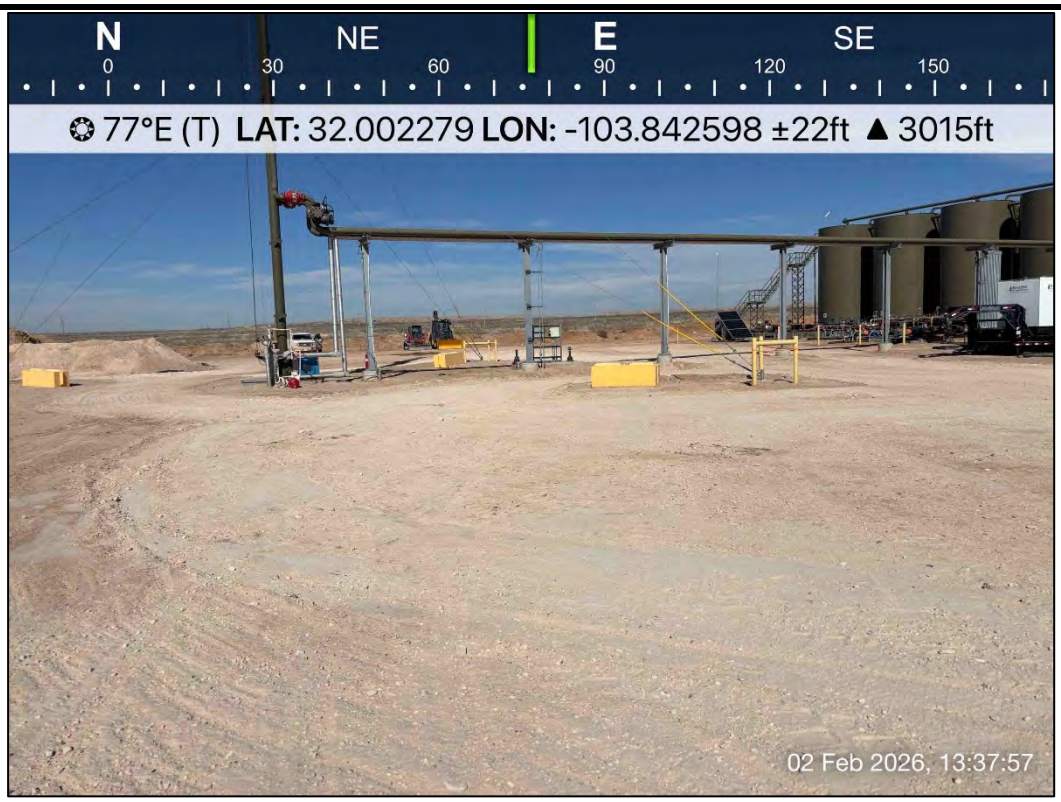
PHOTO 14: Northeastern view of excavation extent. 2/02/2026

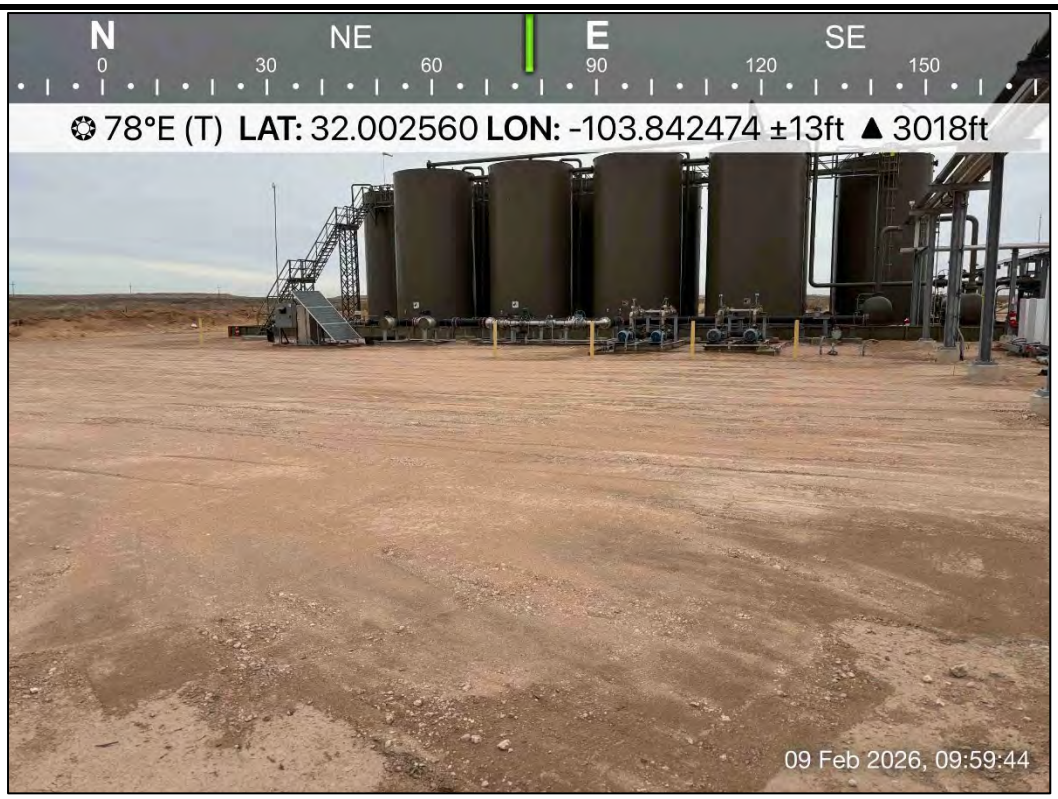
PHOTO 15: Northeastern view following restoration activities. 2/09/2026
