Closure Report
Convoy Booster Release
Lea County, New Mexico
Incident ID: NAPP2415666595
Unit O Sec 28 T24S R33E
32.183611°, -103.576709°

Produced Water Release
Point of Release: Pump-Bearing Failure
Release Date: 03/19/2024
Volume Released: 150 barrels of Produced Water
Volume Recovered: 130 barrels of Produced Water

Re: Closure Report
Convoy Booster Release
EOG Resources, Inc
Incident ID: NAPP2415666595
Site Location: Unit O, S28, T24S, R33E
(Lat 32.183611°, Long -103.576709°)
Lea County, New Mexico

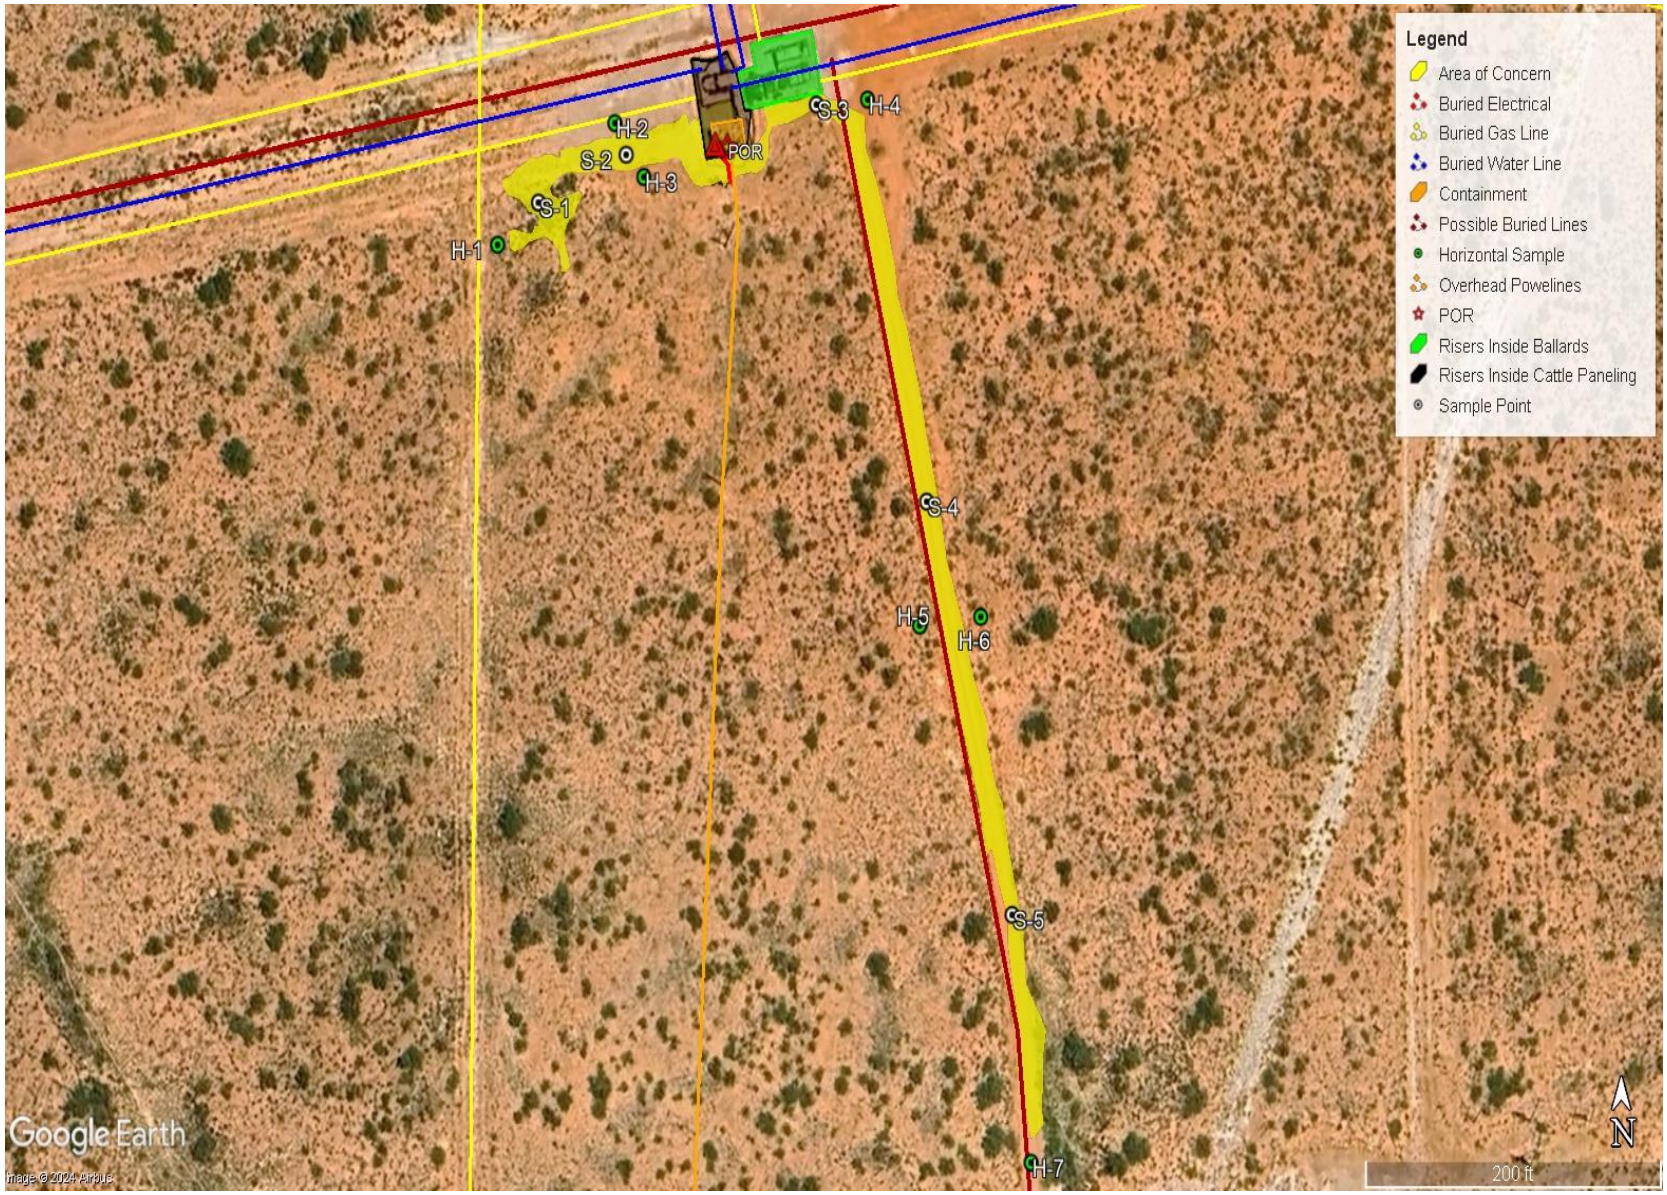
SAMPLE LOCATION MAP EOG RESOURCES CONVOY BOOSTER RELEASE LEA COUNTY, NEW MEXICO 32.183611°, -103.576709°	CARMONA RESOURCES	FIGURE 3

Based on the initial C-141 obtained from the New Mexico Oil Conservation Division (NMOCD), the release was discovered from a pump-bearing failure on March 19, 2024. It released one hundred fifty (150) barrels of produced water, with one hundred thirty (130) barrels recovered. The release occurred on the pipeline right of way and in the pasture. Refer to Figure 3 for the spill area. The Notice of Release form is attached in Appendix C.

On March 21, 2024, Carmona Resources, LLC performed site assessment activities to evaluate soil impacts stemming from the release. Five (5) soil samples (S-1 through S-5) and seven (7) horizontal samples (H-1 through H-7) were advanced to depths ranging from the surface to 3' bgs inside and surrounding the release area to assess the vertical and horizontal extent of the contamination. See Figure 3 for the sample locations. For chemical analysis, the soil samples were collected and placed directly into laboratory-provided sample containers, stored on ice, and transported under the proper chain-of-custody protocol to Cardinal Laboratories in Hobbs, New Mexico. The samples were analyzed for total petroleum hydrocarbons (TPH) by EPA method 8015, modified benzene, toluene, ethylbenzene, and xylenes (BTEX) by EPA Method 8021B, and chloride by EPA method 4500. The laboratory reports, including analytical methods, results, and chain-of-custody documents, are attached in Appendix E.

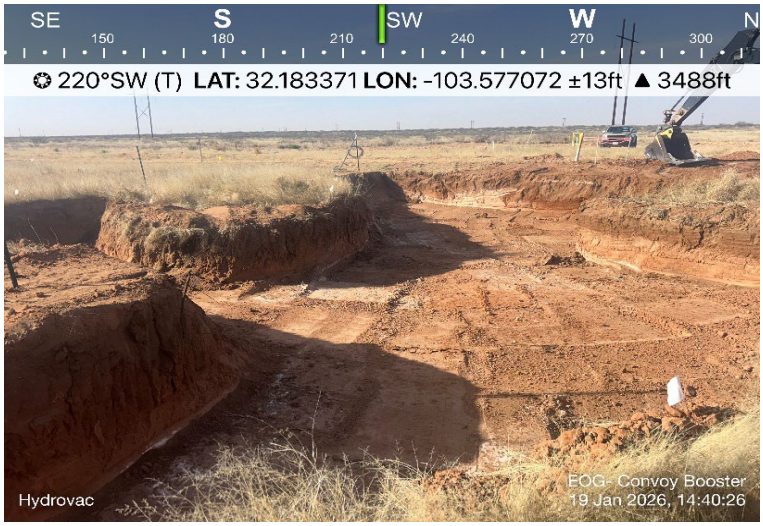
Description:
View Southwest of excavated area.

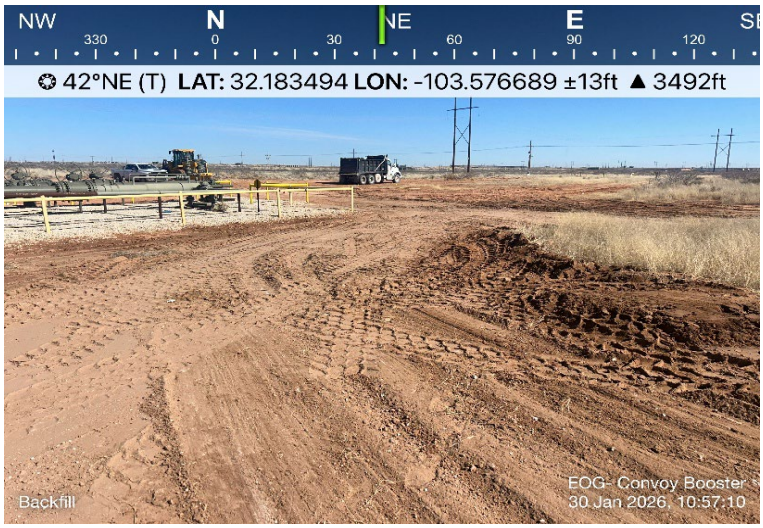
Description:
View Northeast of backfilled area.

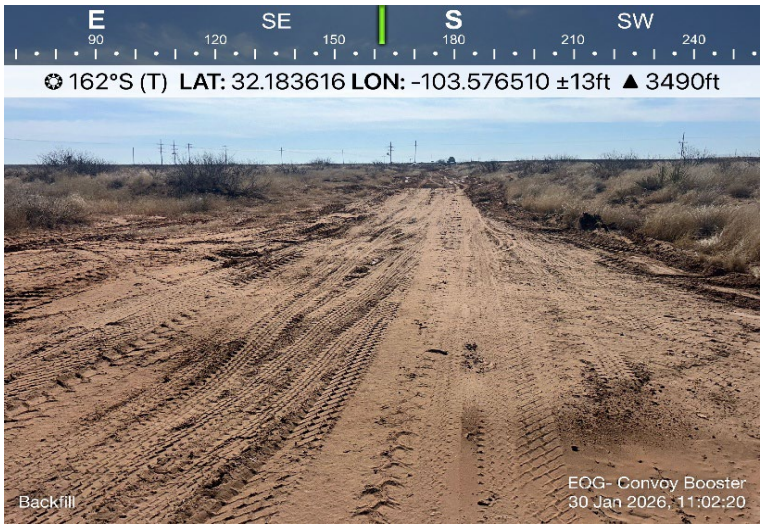
Description:
View South of backfilled area.

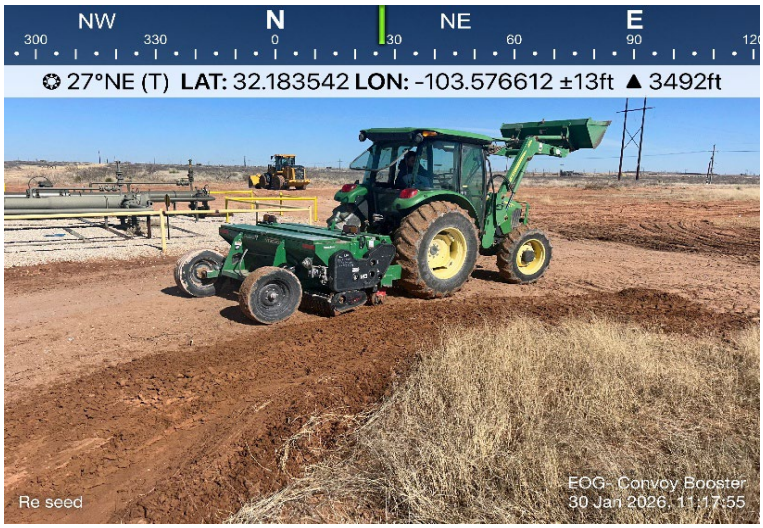
Description:
View Northeast area of reclamation.
