April 9, 2026

RE: **Spud Muffin 31 30 #738H - Closure Request Report**
Incident Number: nAPP2431628896
GPS: 32.2551108°, -104.016727°
Eddy County, New Mexico
ESRR Project No. 2657 / VP-15995

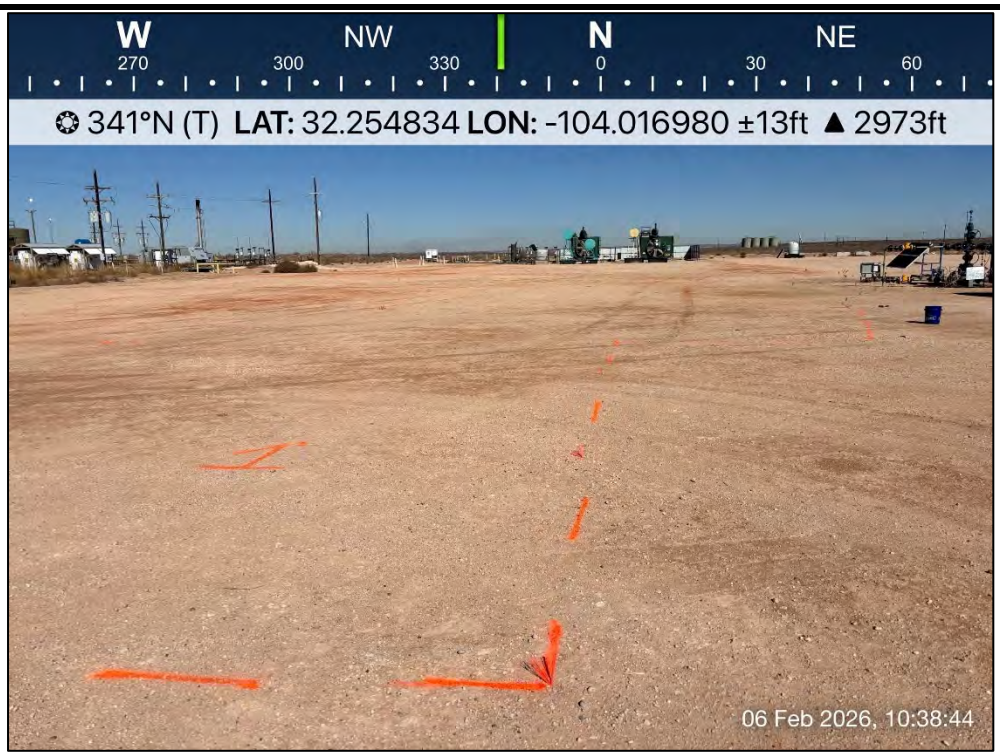
PHOTO 1: Northwestern view during pre-excavation activities. 2/6/2026

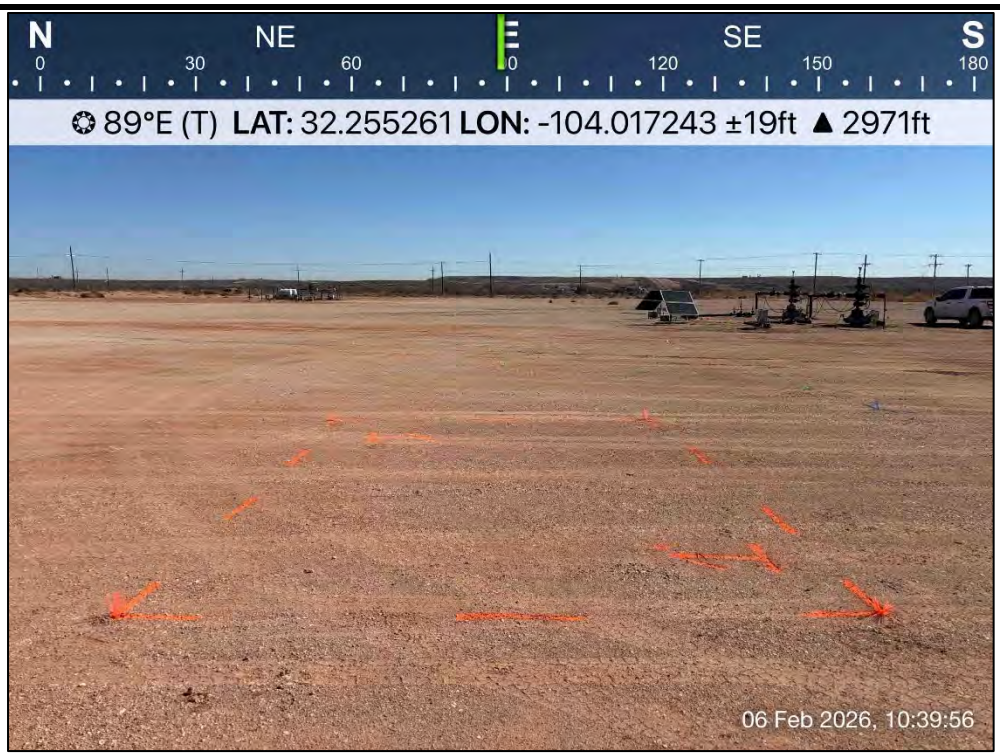
PHOTO 2: Eastern view during pre-excavation activities. 2/6/2026

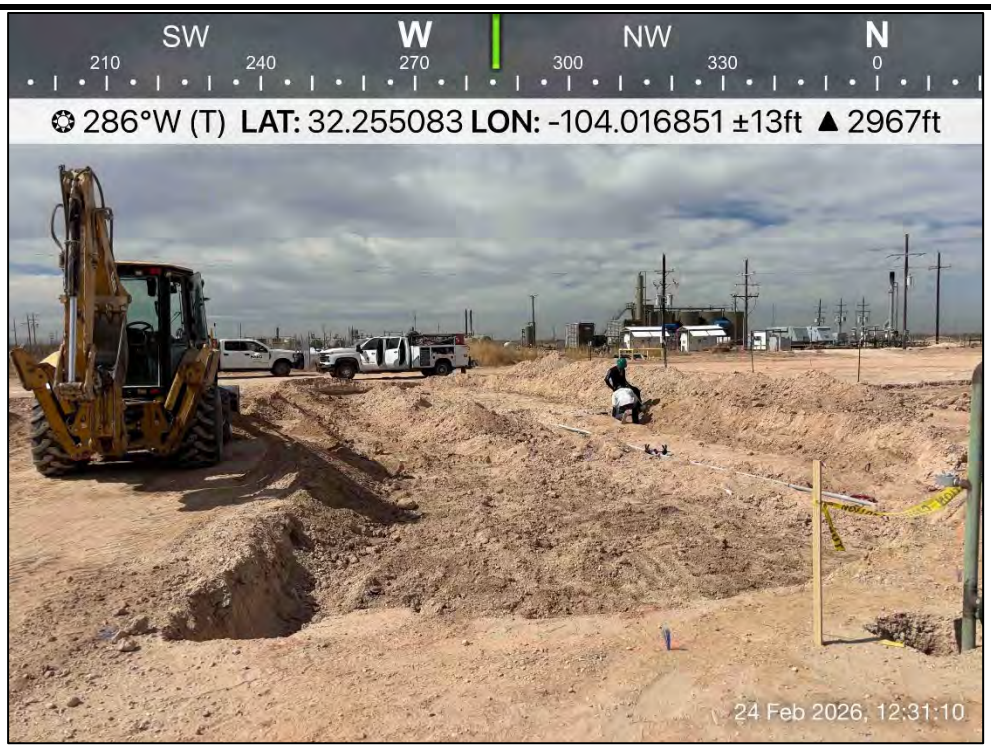
PHOTO 4: Northwestern view during excavation activities. 2/24/2026

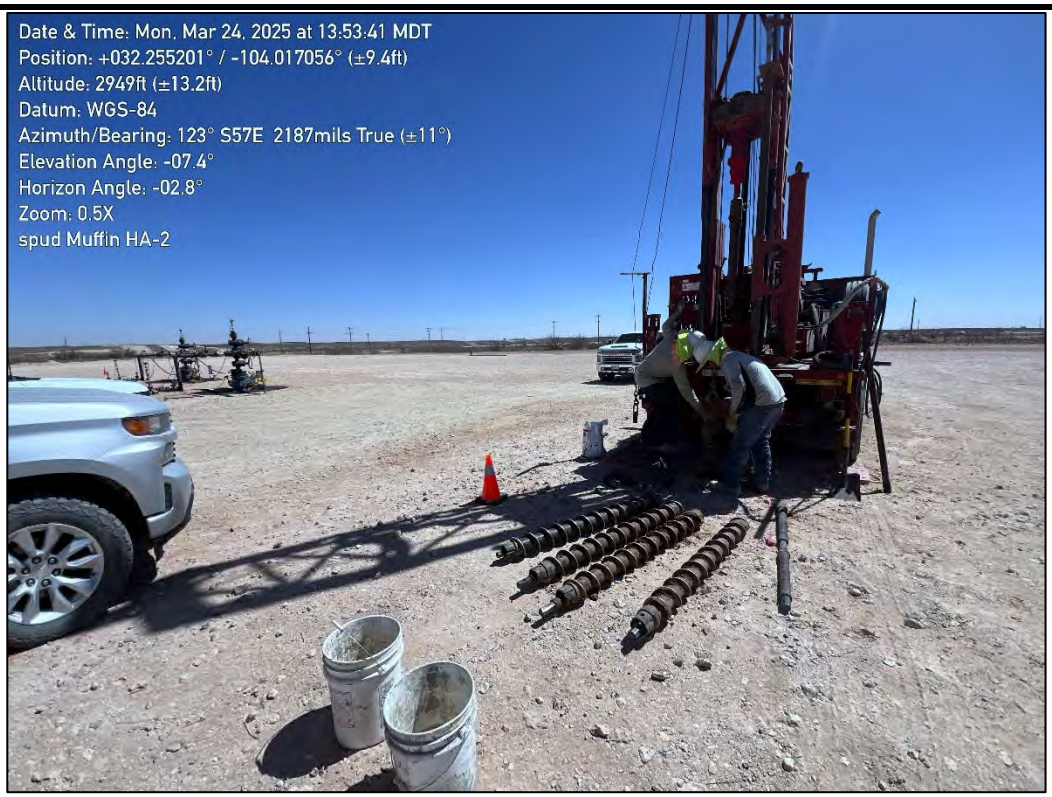
PHOTO 10: Southeastern view during additional delineation activities. 3/24/2025

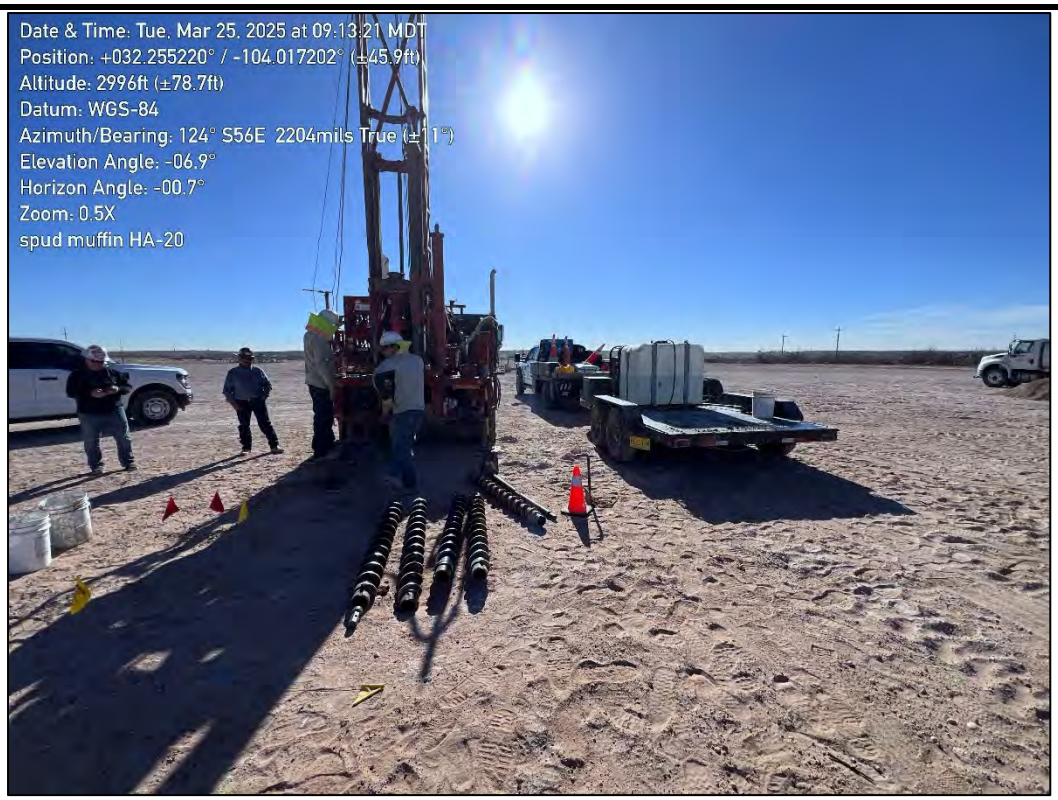
PHOTO 11: Southeastern view during additional delineation activities. 3/25/2025

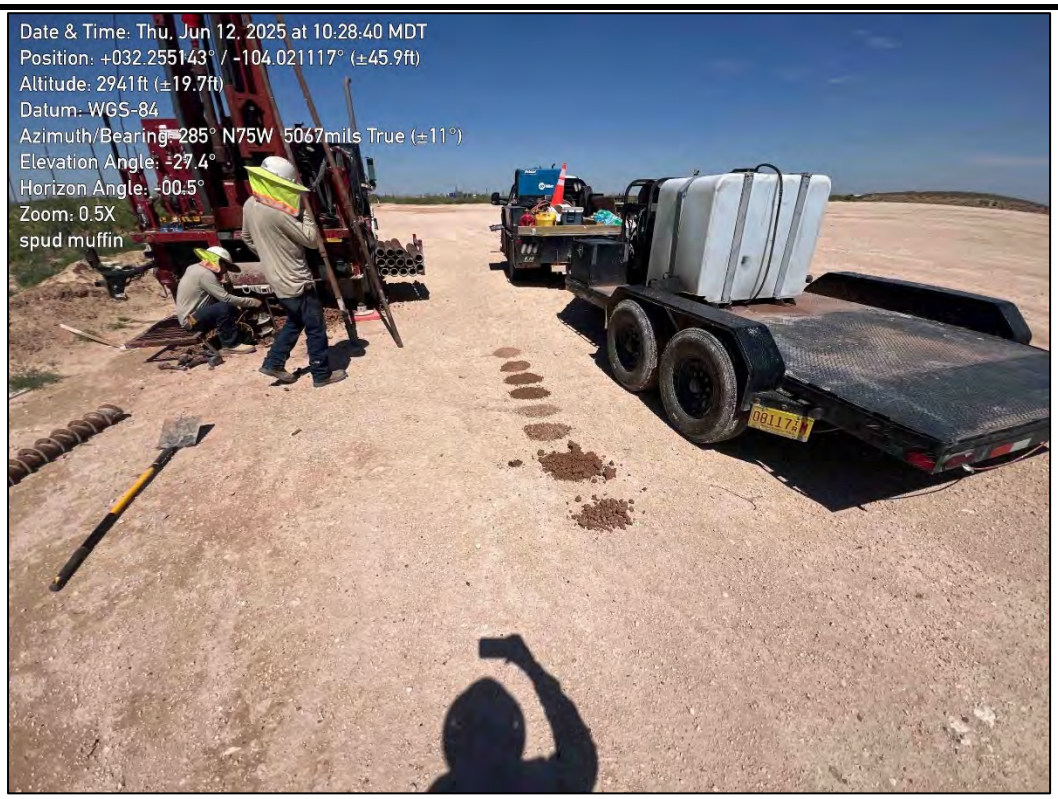
PHOTO 13: Northwestern view during DTW drilling. 6/12/2025

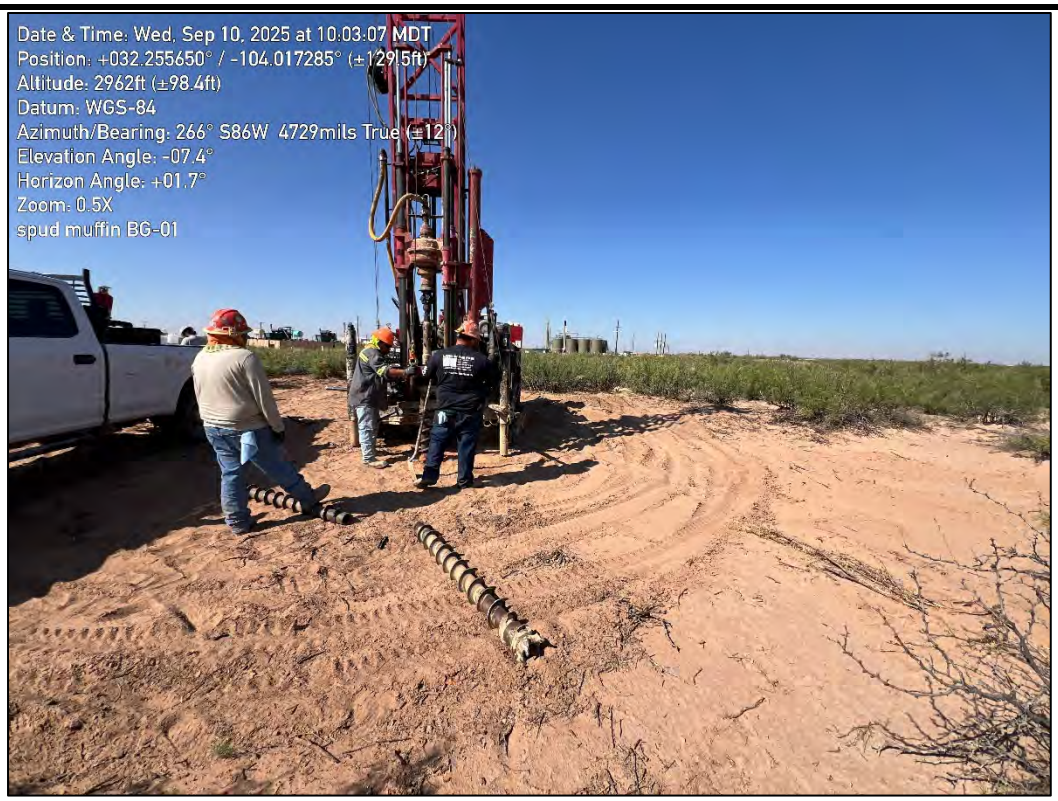
PHOTO 14: Southwestern view during background sampling activities. 9/10/2025

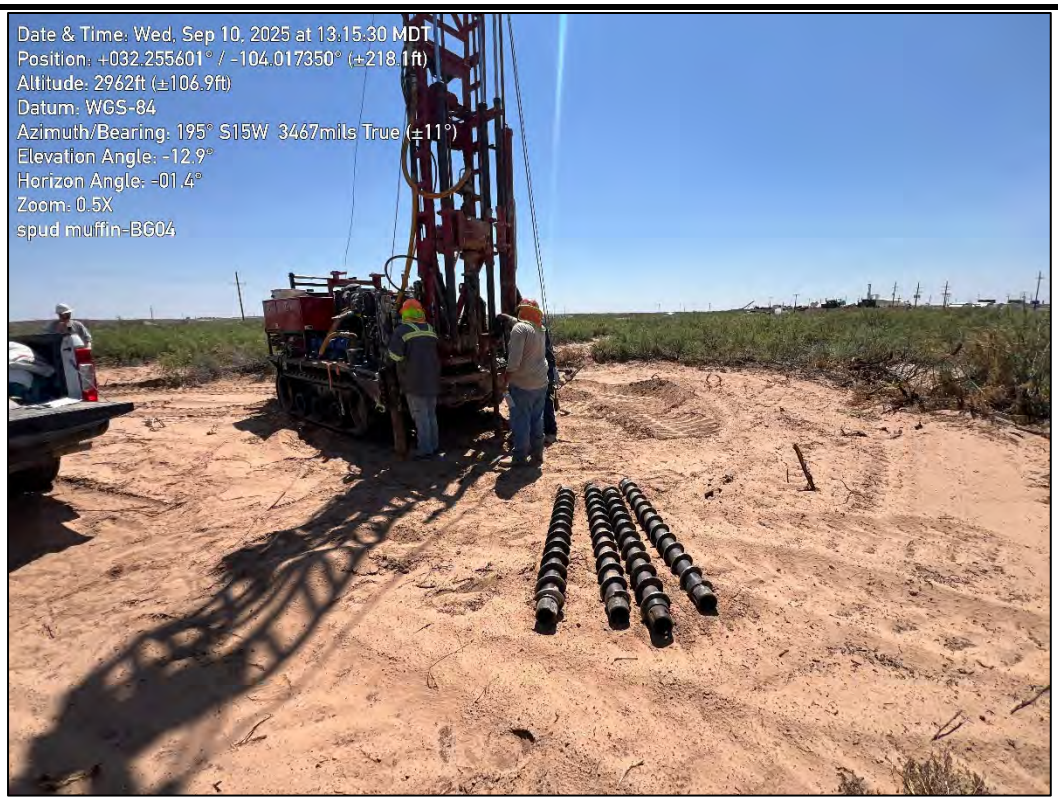
PHOTO 16: Southwestern view during background sampling activities. 9/10/2025
