Pit, Below-Grade Tank, or Proposed Alternative Method Permit or Closure Plan Application

Hilcorp Energy Company
San Juan Basin
Below Grade Tank Closure Report

Lease Name: Burroughs Com 1
API No.: 30-045-06149

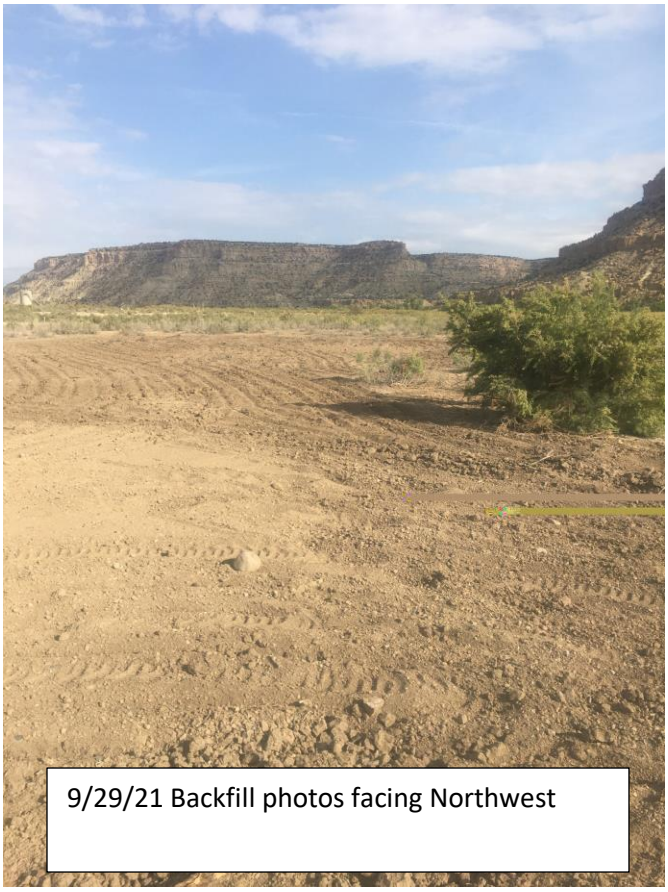
9/29/21 Backfill photos facing Northwest

9/24/21 Backfill photos facing West
