Pit, Below-Grade Tank, or Proposed Alternative Method Permit or Closure Plan Application

Hilcorp Energy Company
San Juan Basin
Below Grade Tank Closure Report

Lease Name: Valencia Canyon Unit 13
API No.: 30-039-21469

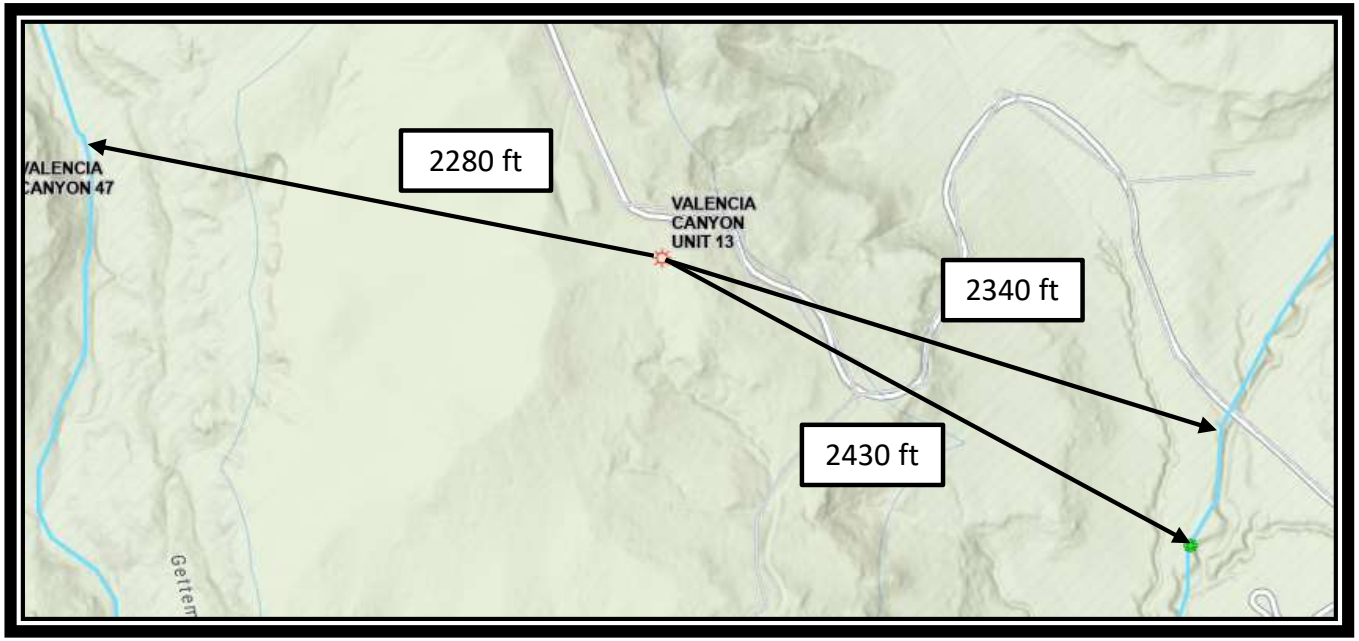
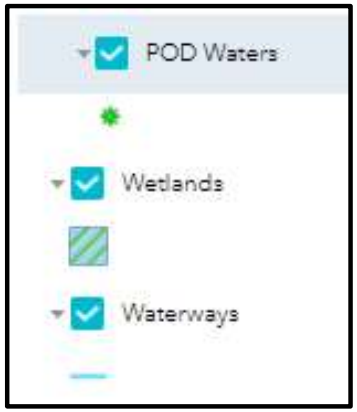
NMAC 19.15.29 Siting Criteria for Closure Standards

BGT is not shown to be within:

- 300 ft of any continuously flowing watercourse or any other significant water course.
- 200 feet of any lakebed, sinkhole or playa lake
- 300 feet of any occupied permanent residence
- 500 feet of a spring or private, domestic fresh water well.
- 1000 feet of any fresh water well
- 300 feet of a wetland
- Incorporated municipal boundaries
- Overlying a subsurface mine
- An unstable area
- A 100-year floodplain
