Pit, Below-Grade Tank, or Proposed Alternative Method Permit or Closure Plan Application

1.
Operator: Hilcorp Energy Company OGRID #: 372171
Address: 382 Road 3100 Aztec NM 87410
Facility or well name: McDaniel B 1E
API Number: 30-045-24435 OCD Permit Number
U/L or Qtr/Qtr D Section 17 Township 29N Range 11W County: San Juan
Center of Proposed Design: Latitude 36.730088 °N Longitude -108.019825 °W NAD83
Surface Owner: ☐ Federal ☐ State ☒ Private ☐ Tribal Trust or Indian Allotment

Hilcorp Energy Company
San Juan Basin: New Mexico Assets
Below Grade Tank Closure Report

Lease Name: McDaniel B 1E
API No.: 30-045-24435

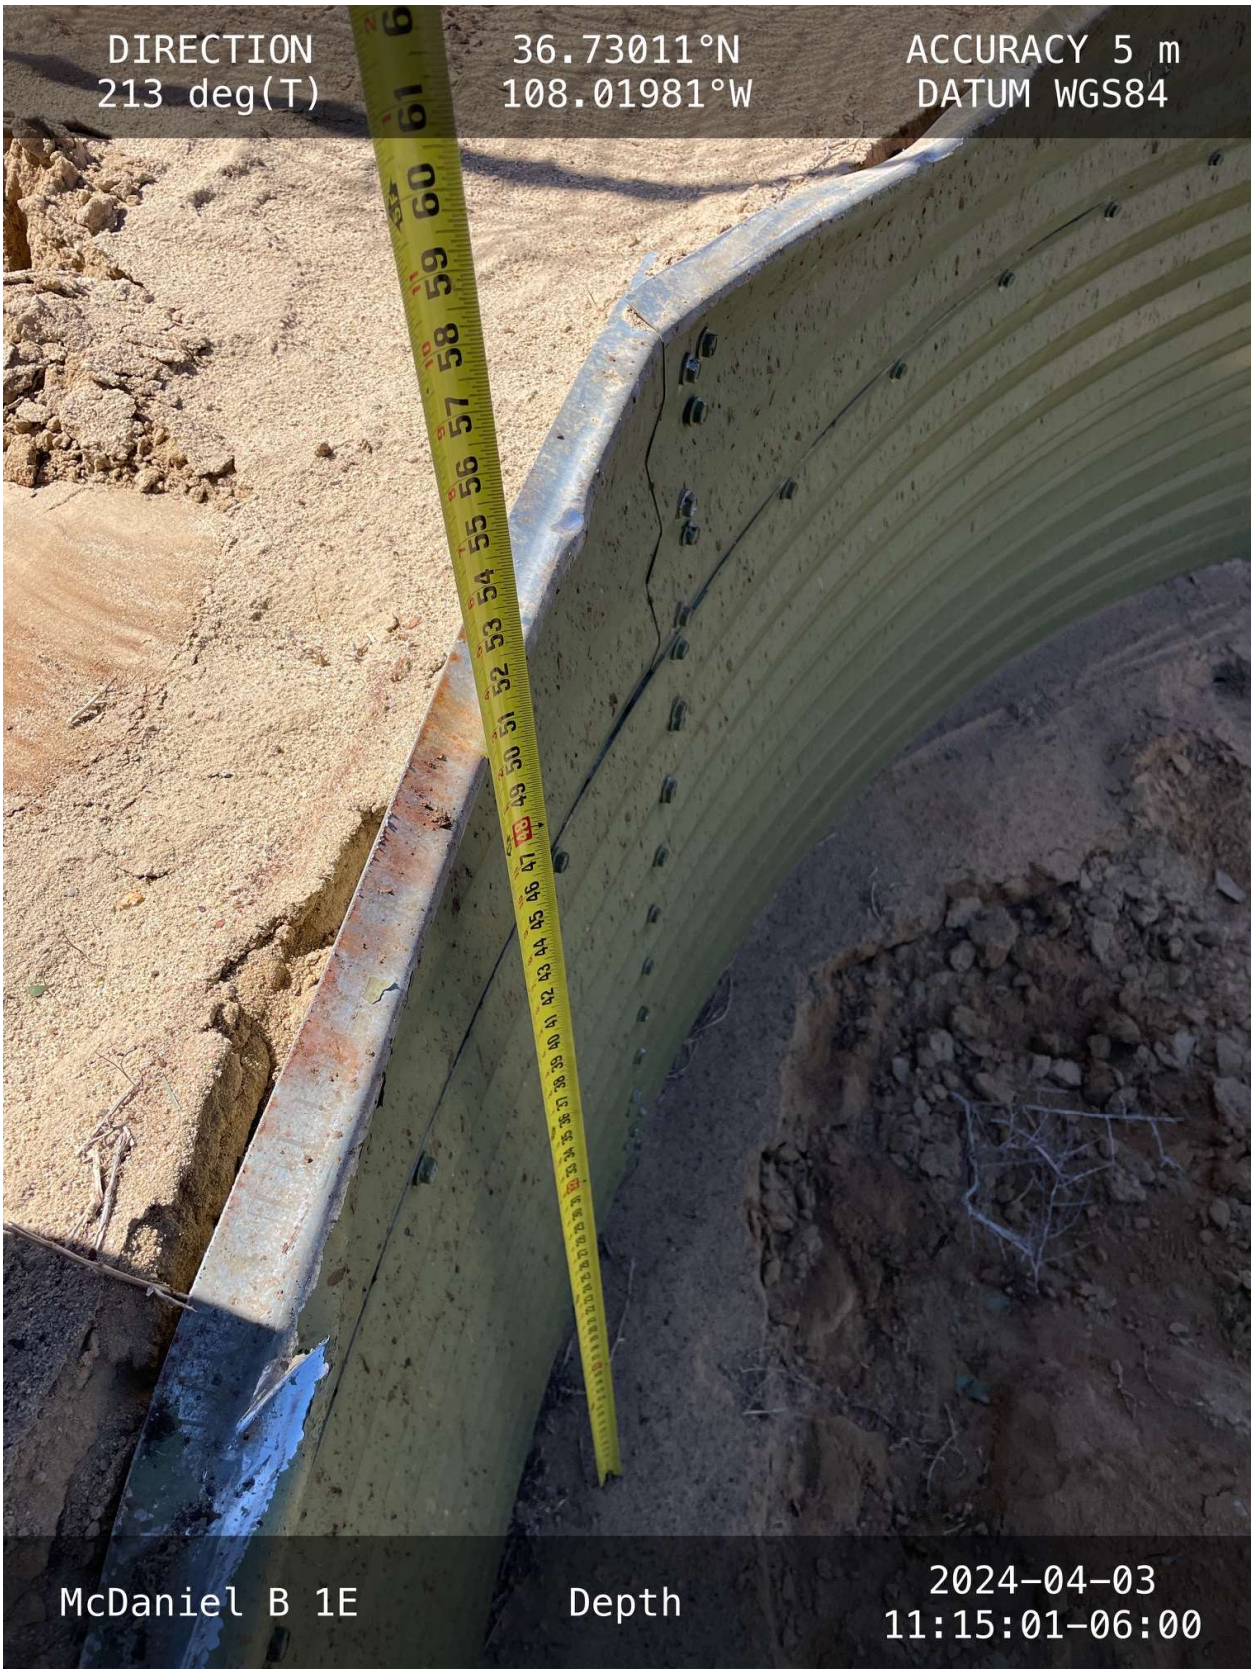
DIRECTION
19 deg(T)
36.73011°N
108.01985°W
ACCURACY 4 m
DATUM WGS84
McDaniel B 1E
Sampling
2024-04-03
11:08:14-06:00

DIRECTION
213 deg(T)
36.73011°N
108.01981°W
ACCURACY 5 m
DATUM WGS84
McDaniel B 1E
Depth
2024-04-03
11:15:01-06:00

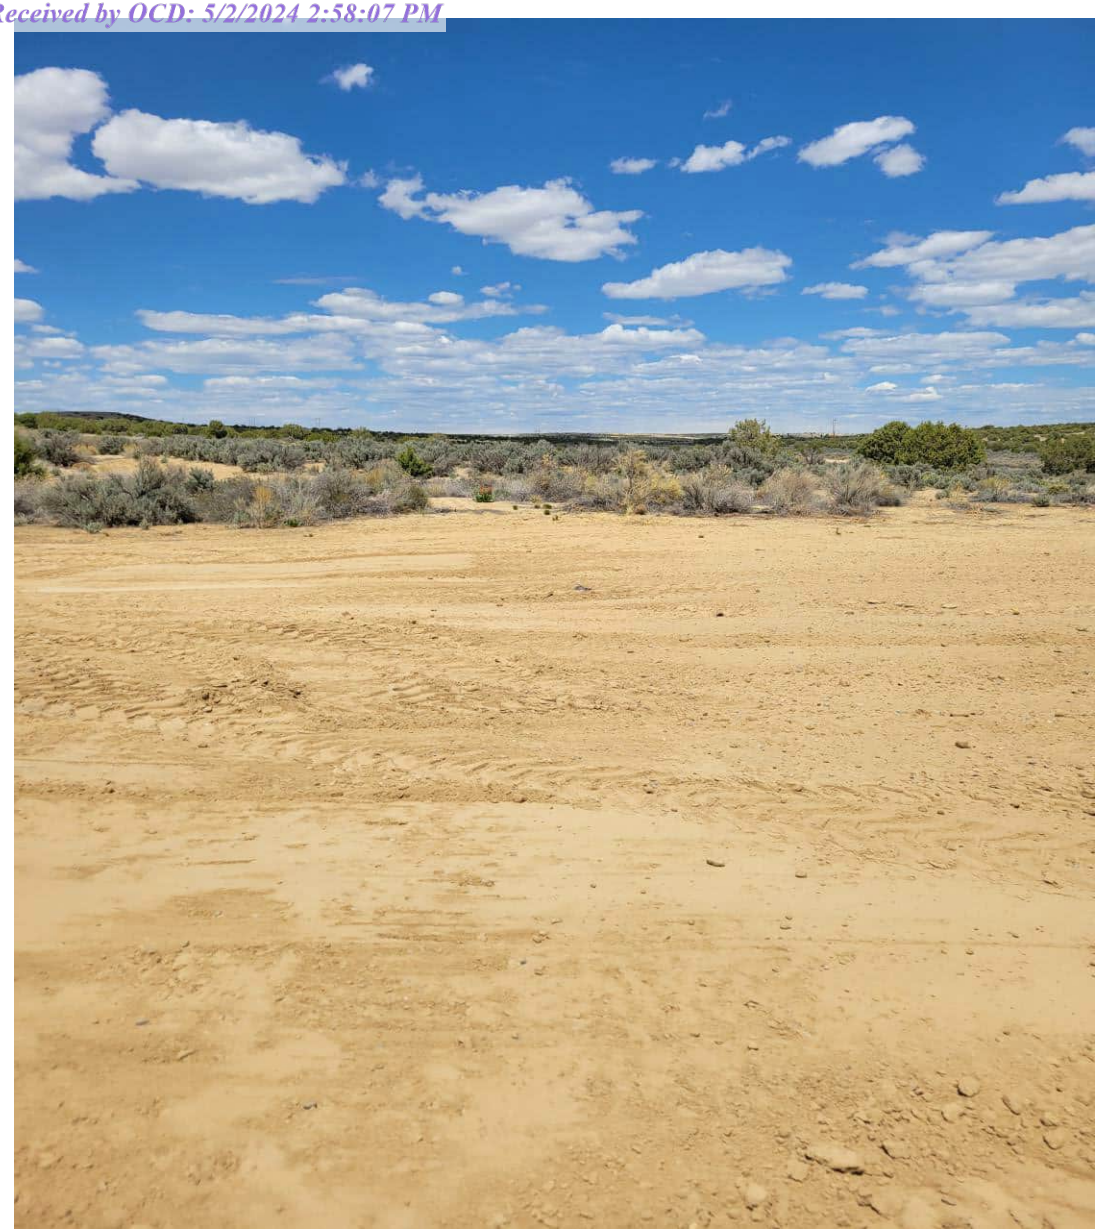
McDaniel #1E
04/22/24

Pit Closure Pictures.

View Looking North

View Looking South

The tank removal area passed all requirements of Table I of 19.15.17.13 NMAC and was backfilled with compacted, non-waste containing, earthen material which included at least one foot of suitable material to establish vegetation at the site.
