Pit, Below-Grade Tank, or Proposed Alternative Method Permit or Closure Plan Application

Hilcorp Energy Company
San Juan Basin
Below Grade Tank Closure Report

Lease Name: HUERFANO UNIT 156E
API No.: 30-045-26391

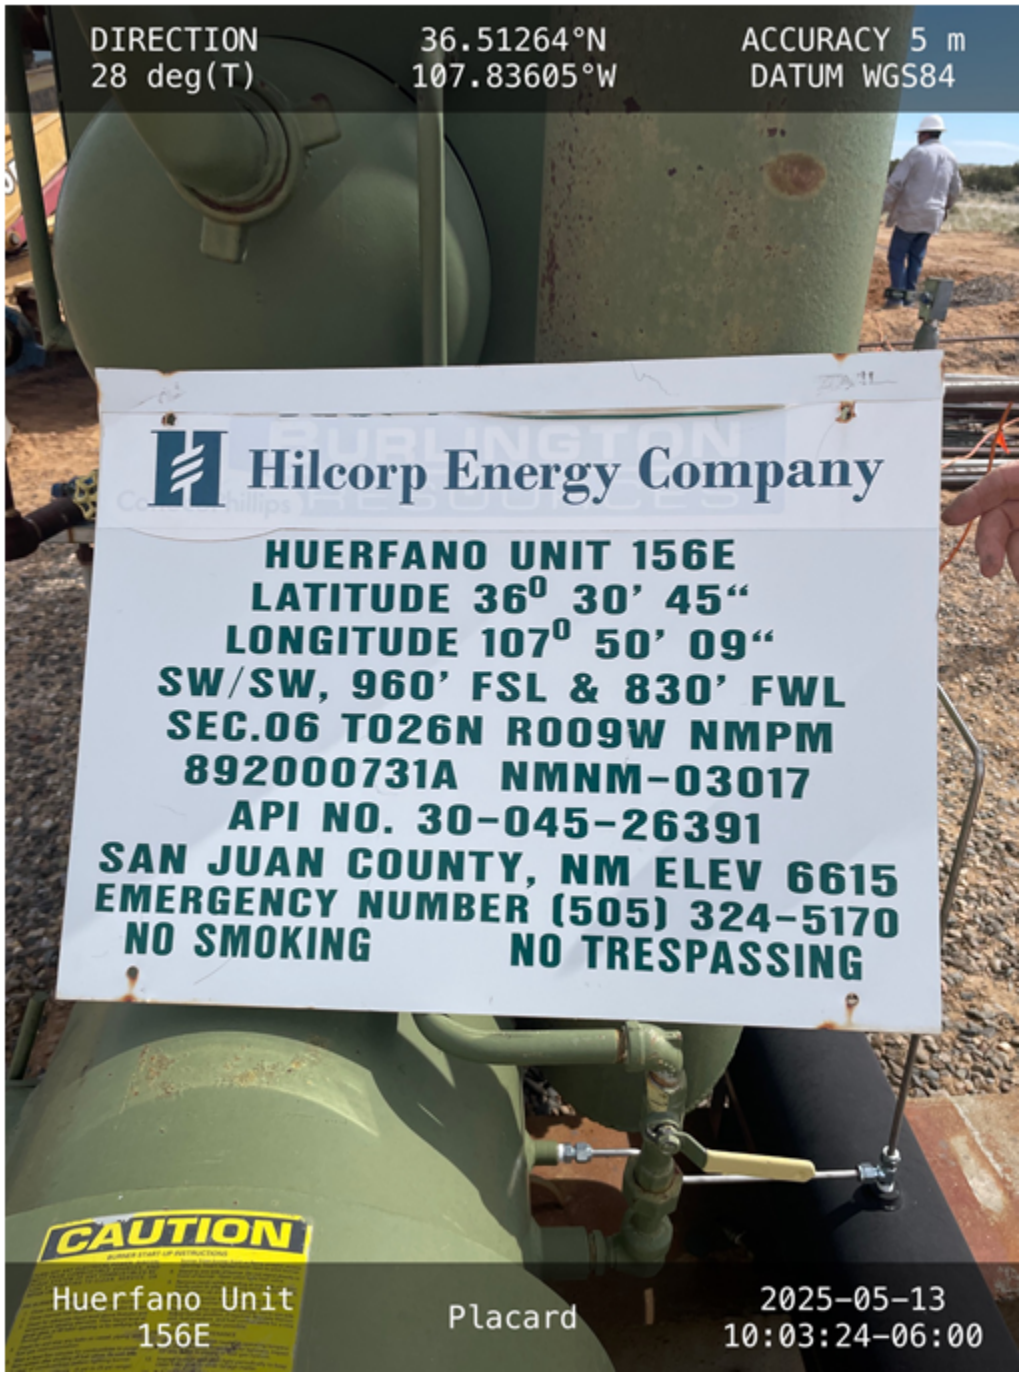
DIRECTION
28 deg(T)
36.51264°N
107.83605°W
ACCURACY 5 m
DATUM WGS84
Hilcorp Energy Company
HUERFANO UNIT 156E
LATITUDE 36° 30' 45"
LONGITUDE 107° 50' 09"
SW/SW, 960' FSL & 830' FWL
SEC.06 T026N R009W NMPM
892000731A NMNM-03017
API NO. 30-045-26391
SAN JUAN COUNTY, NM ELEV 6615
EMERGENCY NUMBER (505) 324-5170
NO SMOKING
NO TRESPASSING
CAUTION
Huerfano Unit 156E
Placard
2025-05-13 10:03:24-06:00

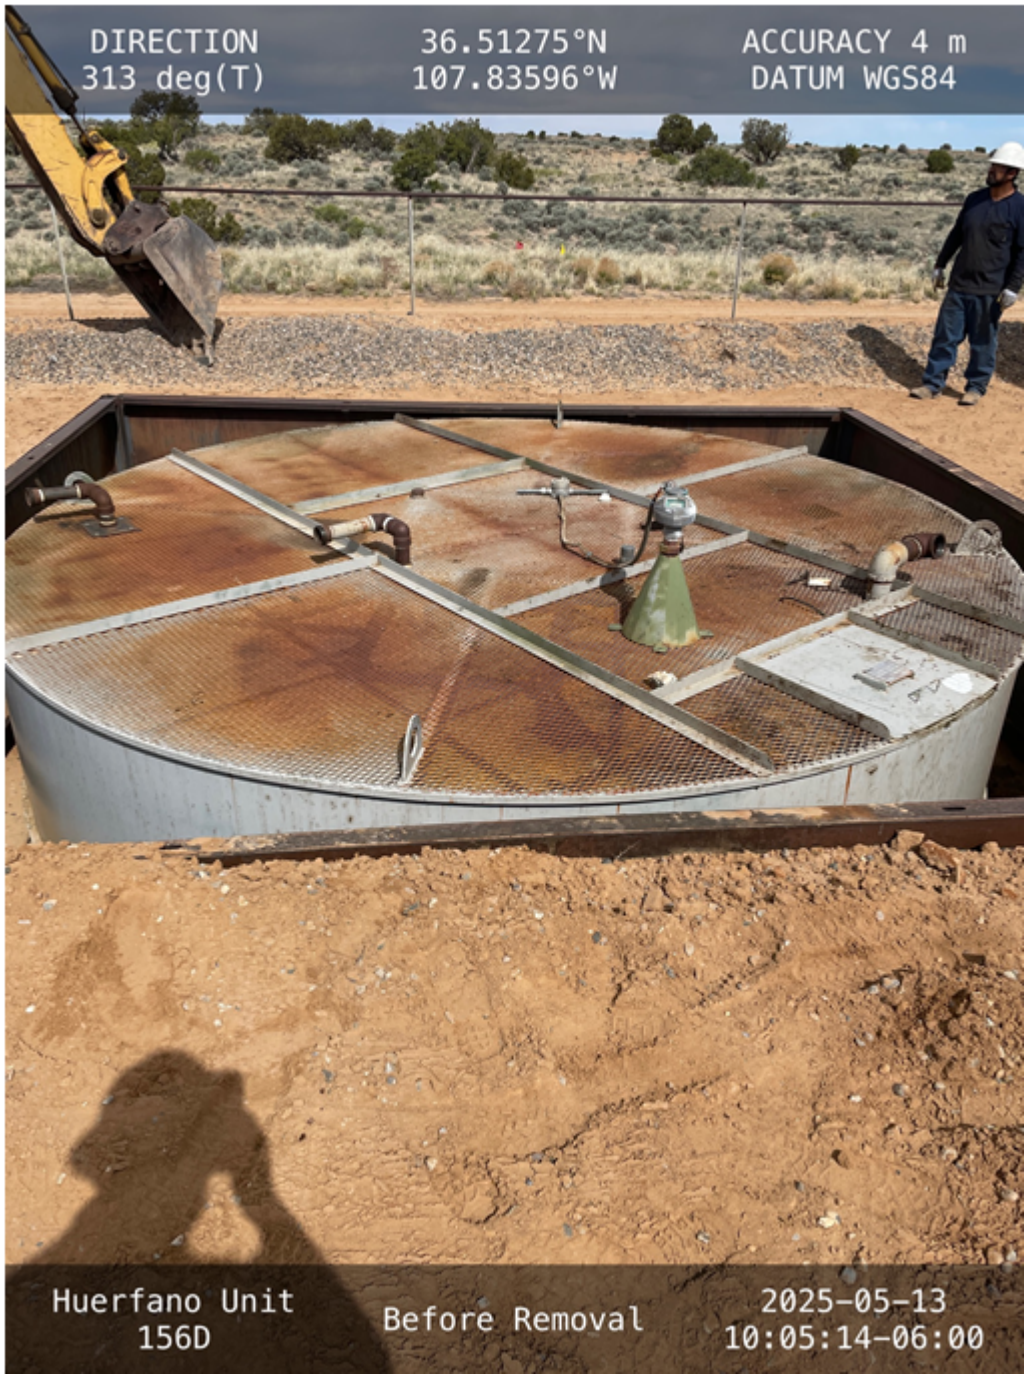
DIRECTION
313 deg(T)
36.51275°N
107.83596°W
ACCURACY 4 m
DATUM WGS84
Huerfano Unit
156D
Before Removal
2025-05-13
10:05:14-06:00

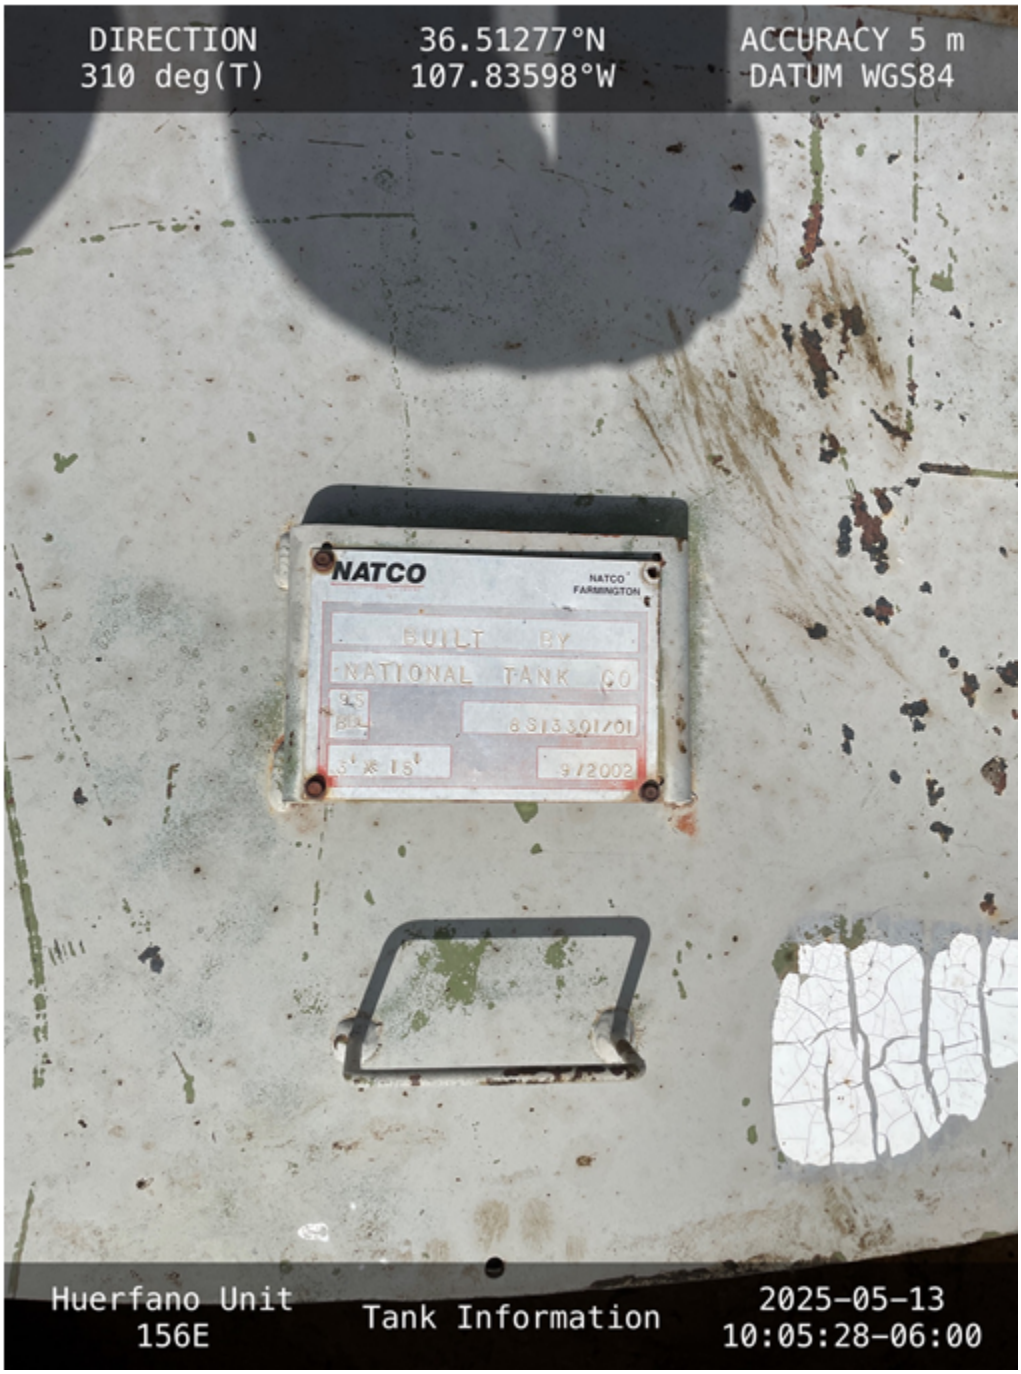
DIRECTION
310 deg(T)
36.51277°N
107.83598°W
ACCURACY 5 m
DATUM WGS84
NATCO
NATCO
FARMINGTON
BUILT BY
NATIONAL TANK CO
9/2002
Huerfano Unit
156E
Tank Information
2025-05-13
10:05:28-06:00

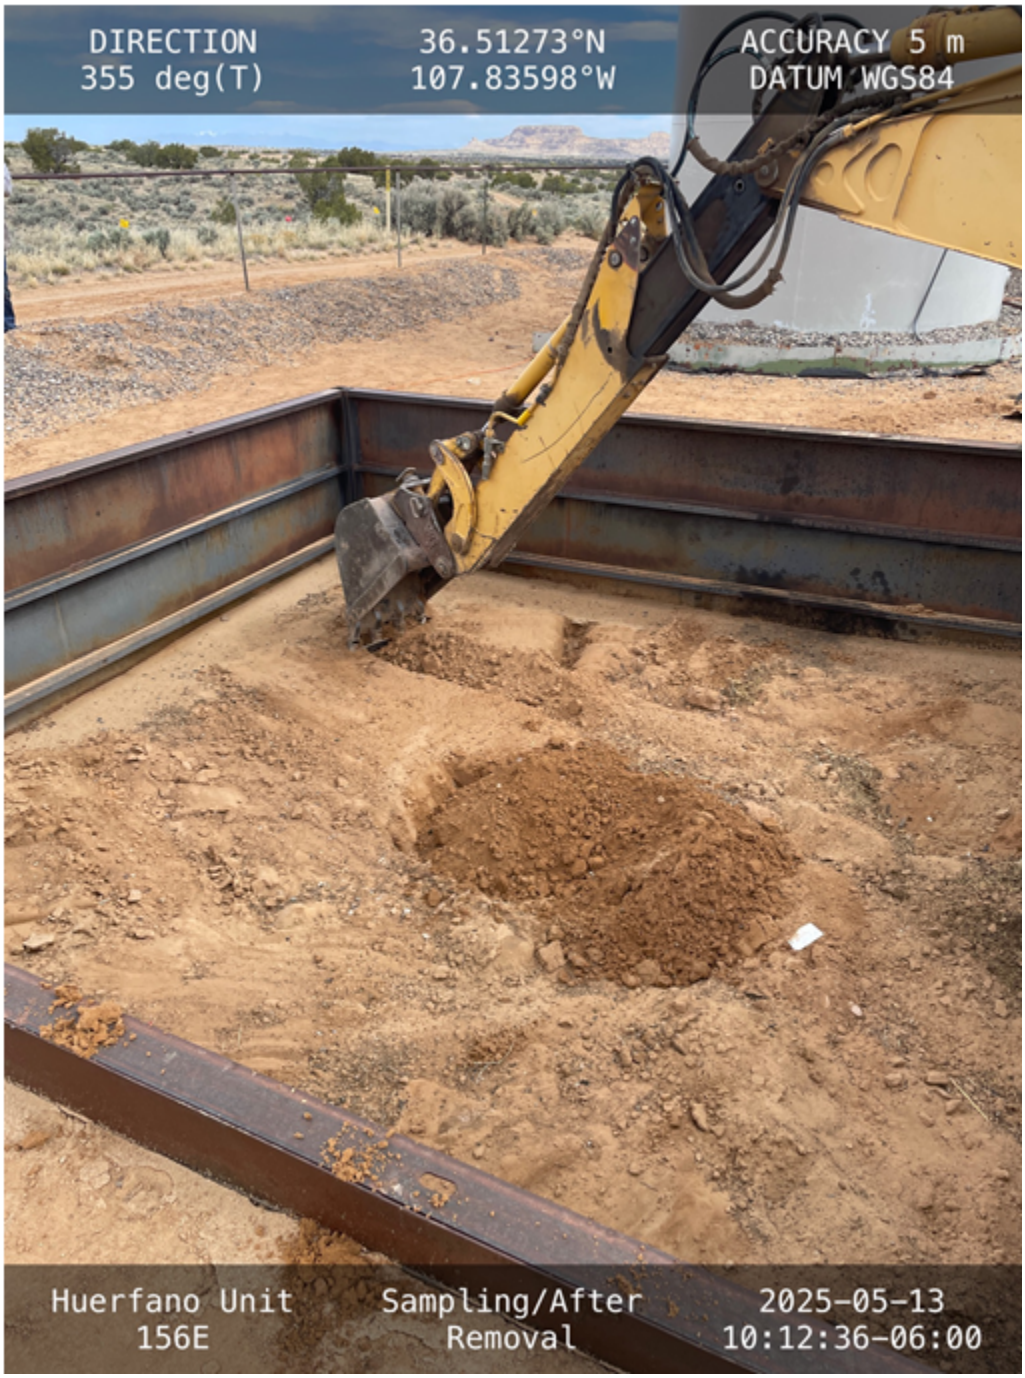
DIRECTION
355 deg(T)
36.51273°N
107.83598°W
ACCURACY 5 m
DATUM WGS84
Huerfano Unit
156E
Sampling/After
Removal
2025-05-13
10:12:36-06:00
