LT Environmental, Inc.
3300 North "A" Street
Building 1, Unit 222
Midland, Texas 79705
432.704.5178

October 21, 2020

RE: Closure Request Addendum
WPX Energy Permian, LLC
Longview Federal 1 #021H
Incident Number NRM2000356004
Eddy County, New Mexico

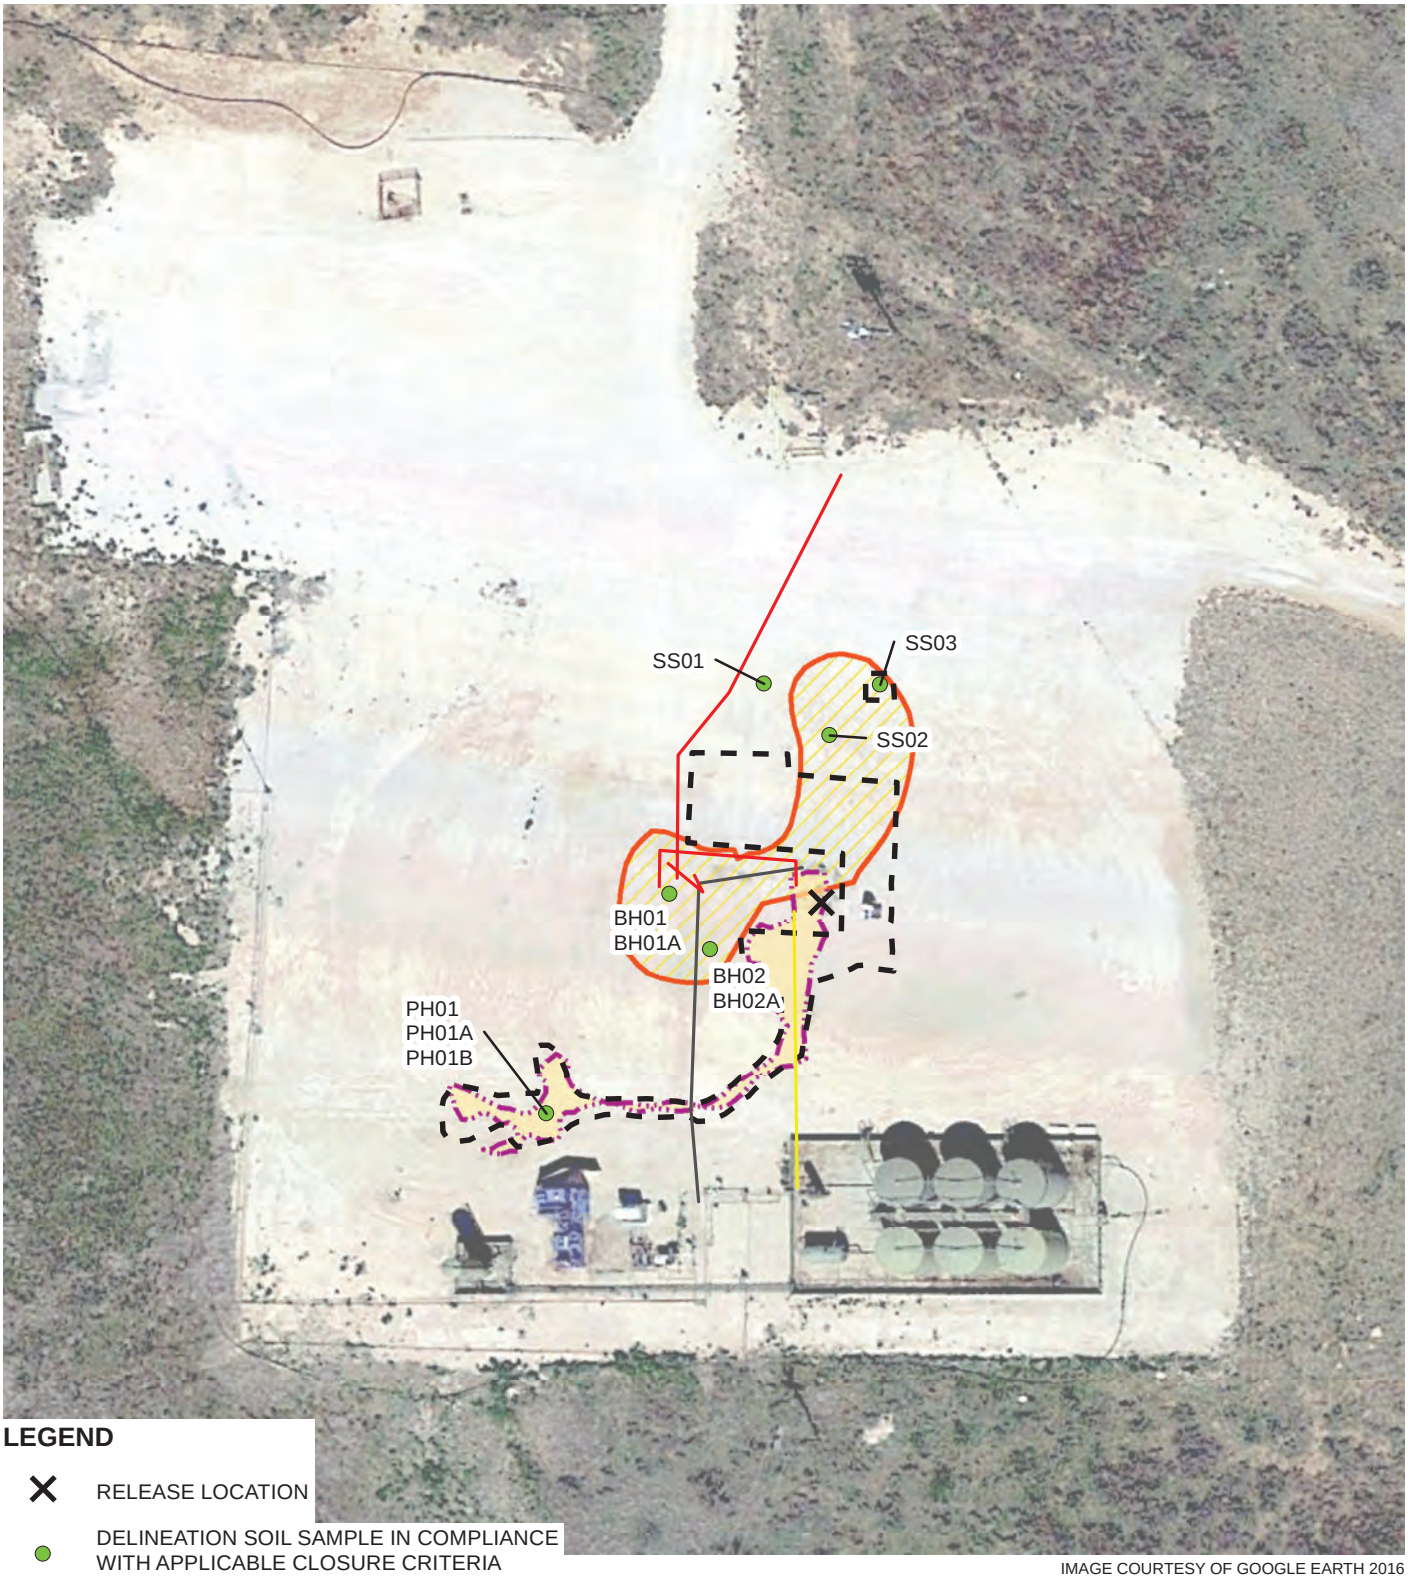
FIGURE 2
DELINEATION SOIL SAMPLE LOCATIONS
LONGVIEW FEDERAL 1 #021H
LOT 4 SEC 1 T23S R28E
EDDY COUNTY, NEW MEXICO
WPX ENERGY PERMIAN, LLC

On October 7, 2020, LTE was onsite to investigate horizontal delineation of sidewall soil samples SW07 and SW08 to meet the NMOCD conditions provided on August 19, 2020. LTE utilized a hand auger to advance two boreholes, BH01 and BH02. Two soil samples were collected at depth intervals 0.2 to 0.5 feet bgs and 0.75 to 1 foot bgs at each borehole location. Delineation activities were directed by field screening soil samples for volatile aromatic hydrocarbons using a photoionization detector (PID) and chloride using Hach® chloride QuanTab® test strips. The borehole locations were mapped utilizing a handheld Global Positioning System (GPS) unit and have been added to Figure 2.

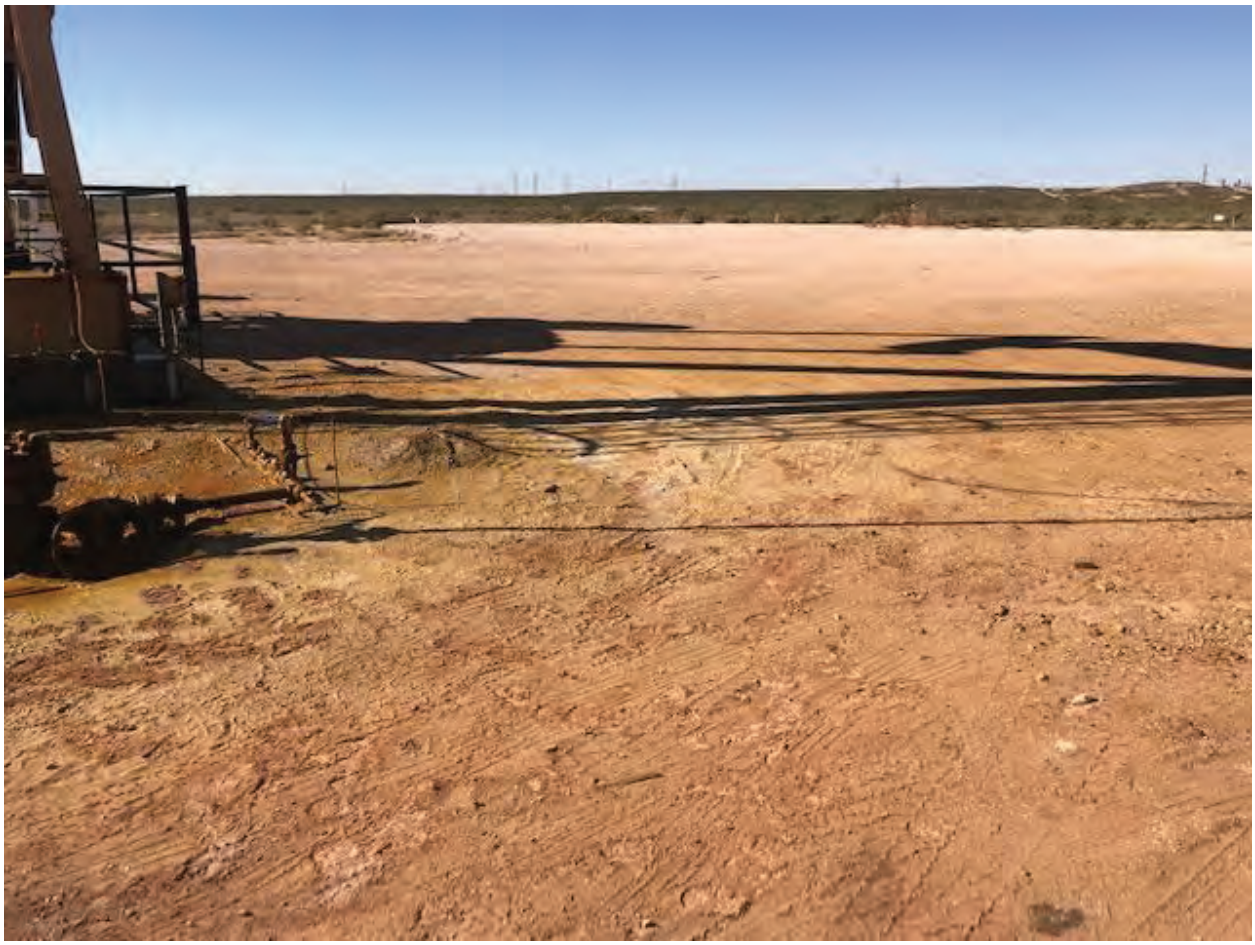
Western view of overspray north of pumpjack.
