April 26, 2021

Subject: **Quarter 1 2021 - Quarterly SVE System Update**
Hilcorp Energy Company
OH Randel #5
San Juan County, New Mexico
API # 30-045-05964
Incident # NVF1602039091

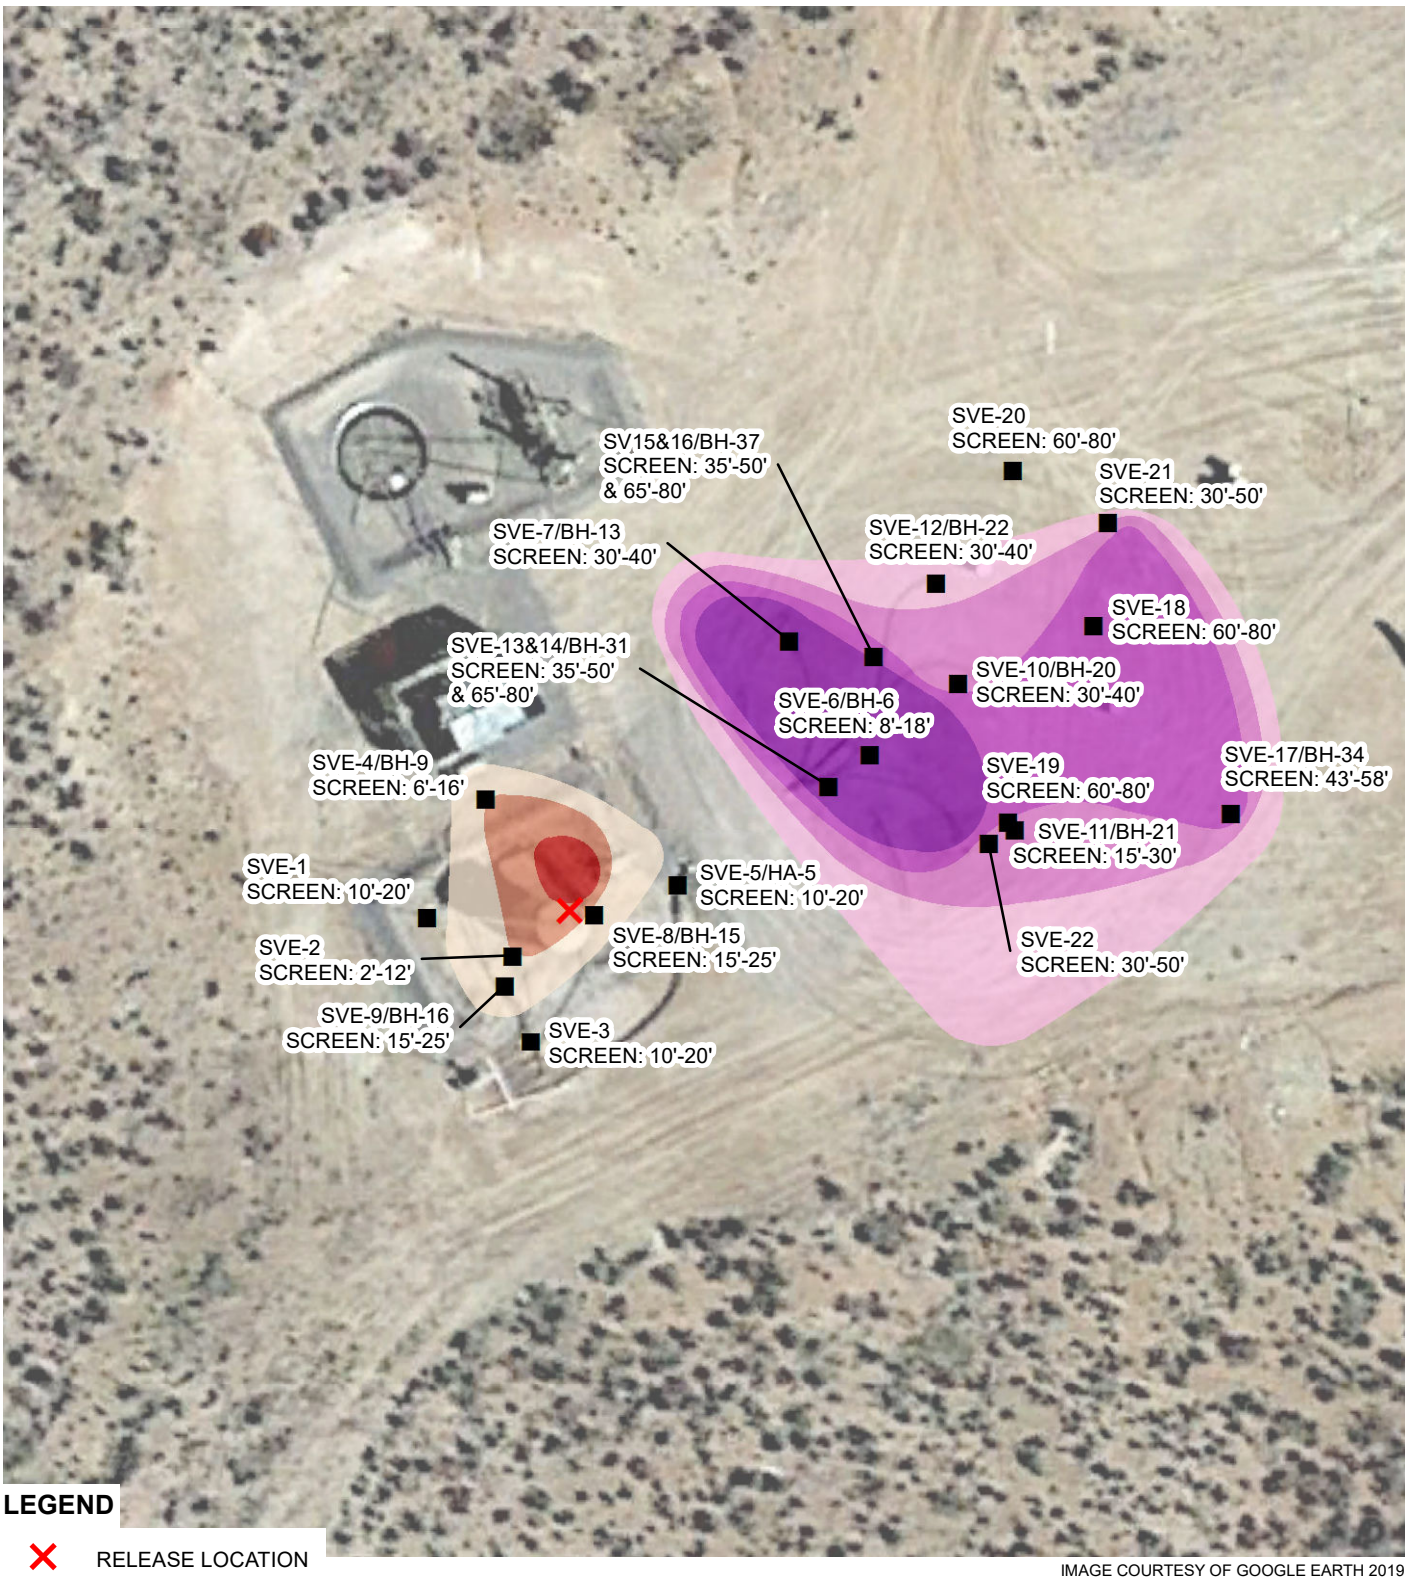
FIGURE 1
SVE SYSTEM LAYOUT
OH RANDEL #5
NWNW SEC 10 T26N R11W
SAN JUAN COUNTY, NEW MEXICO
HILCORP ENERGY COMPANY

An SVE system was originally installed by XTO Energy in 2016. Based on prior delineation events and the pilot test, an additional five SVE wells were installed on August 23, 2019 by Hilcorp. SVE well configuration and screen intervals are presented in Figure 1. In total, the SVE system consists of a two-horsepower Atlantic AB-301 regenerative blower capable of producing 110 cubic feet per minute (cfm) at 72 inches of water column vacuum. The blower is connected to an adjustable manifold that allows control over which SVE wells are currently active.
