Report Type: Deferment Report 1RP-4727

General Site Information:						
Site:	New Mexico DL State #1					
Company:	COG Operating LLC					
Section, Township and Range	Unit I	Sec. 18	T 23S	R 33E		
Lease Number:	API No. 30-025-28223					
County:	Lea County					
GPS:	32.302948° N			103.6050491° W		
Surface Owner:	State					
Mineral Owner:						
Directions:	From the intersection HWY 128 and Red Rd, travel southeast on 128 for 1.2 mi, turn northeast onto lease road and continue for 7.8 miles, turn southeast for 0.9 miles, turn east for 0.75 miles, turn north for 0.30 miles to location.

June 14, 2018

Re: Work Plan for the COG Operating LLC., New Mexico DL State #1, Unit I, Section 18, Township 23 South, Range 33 East, Lea County, New Mexico. 1RP-4727.

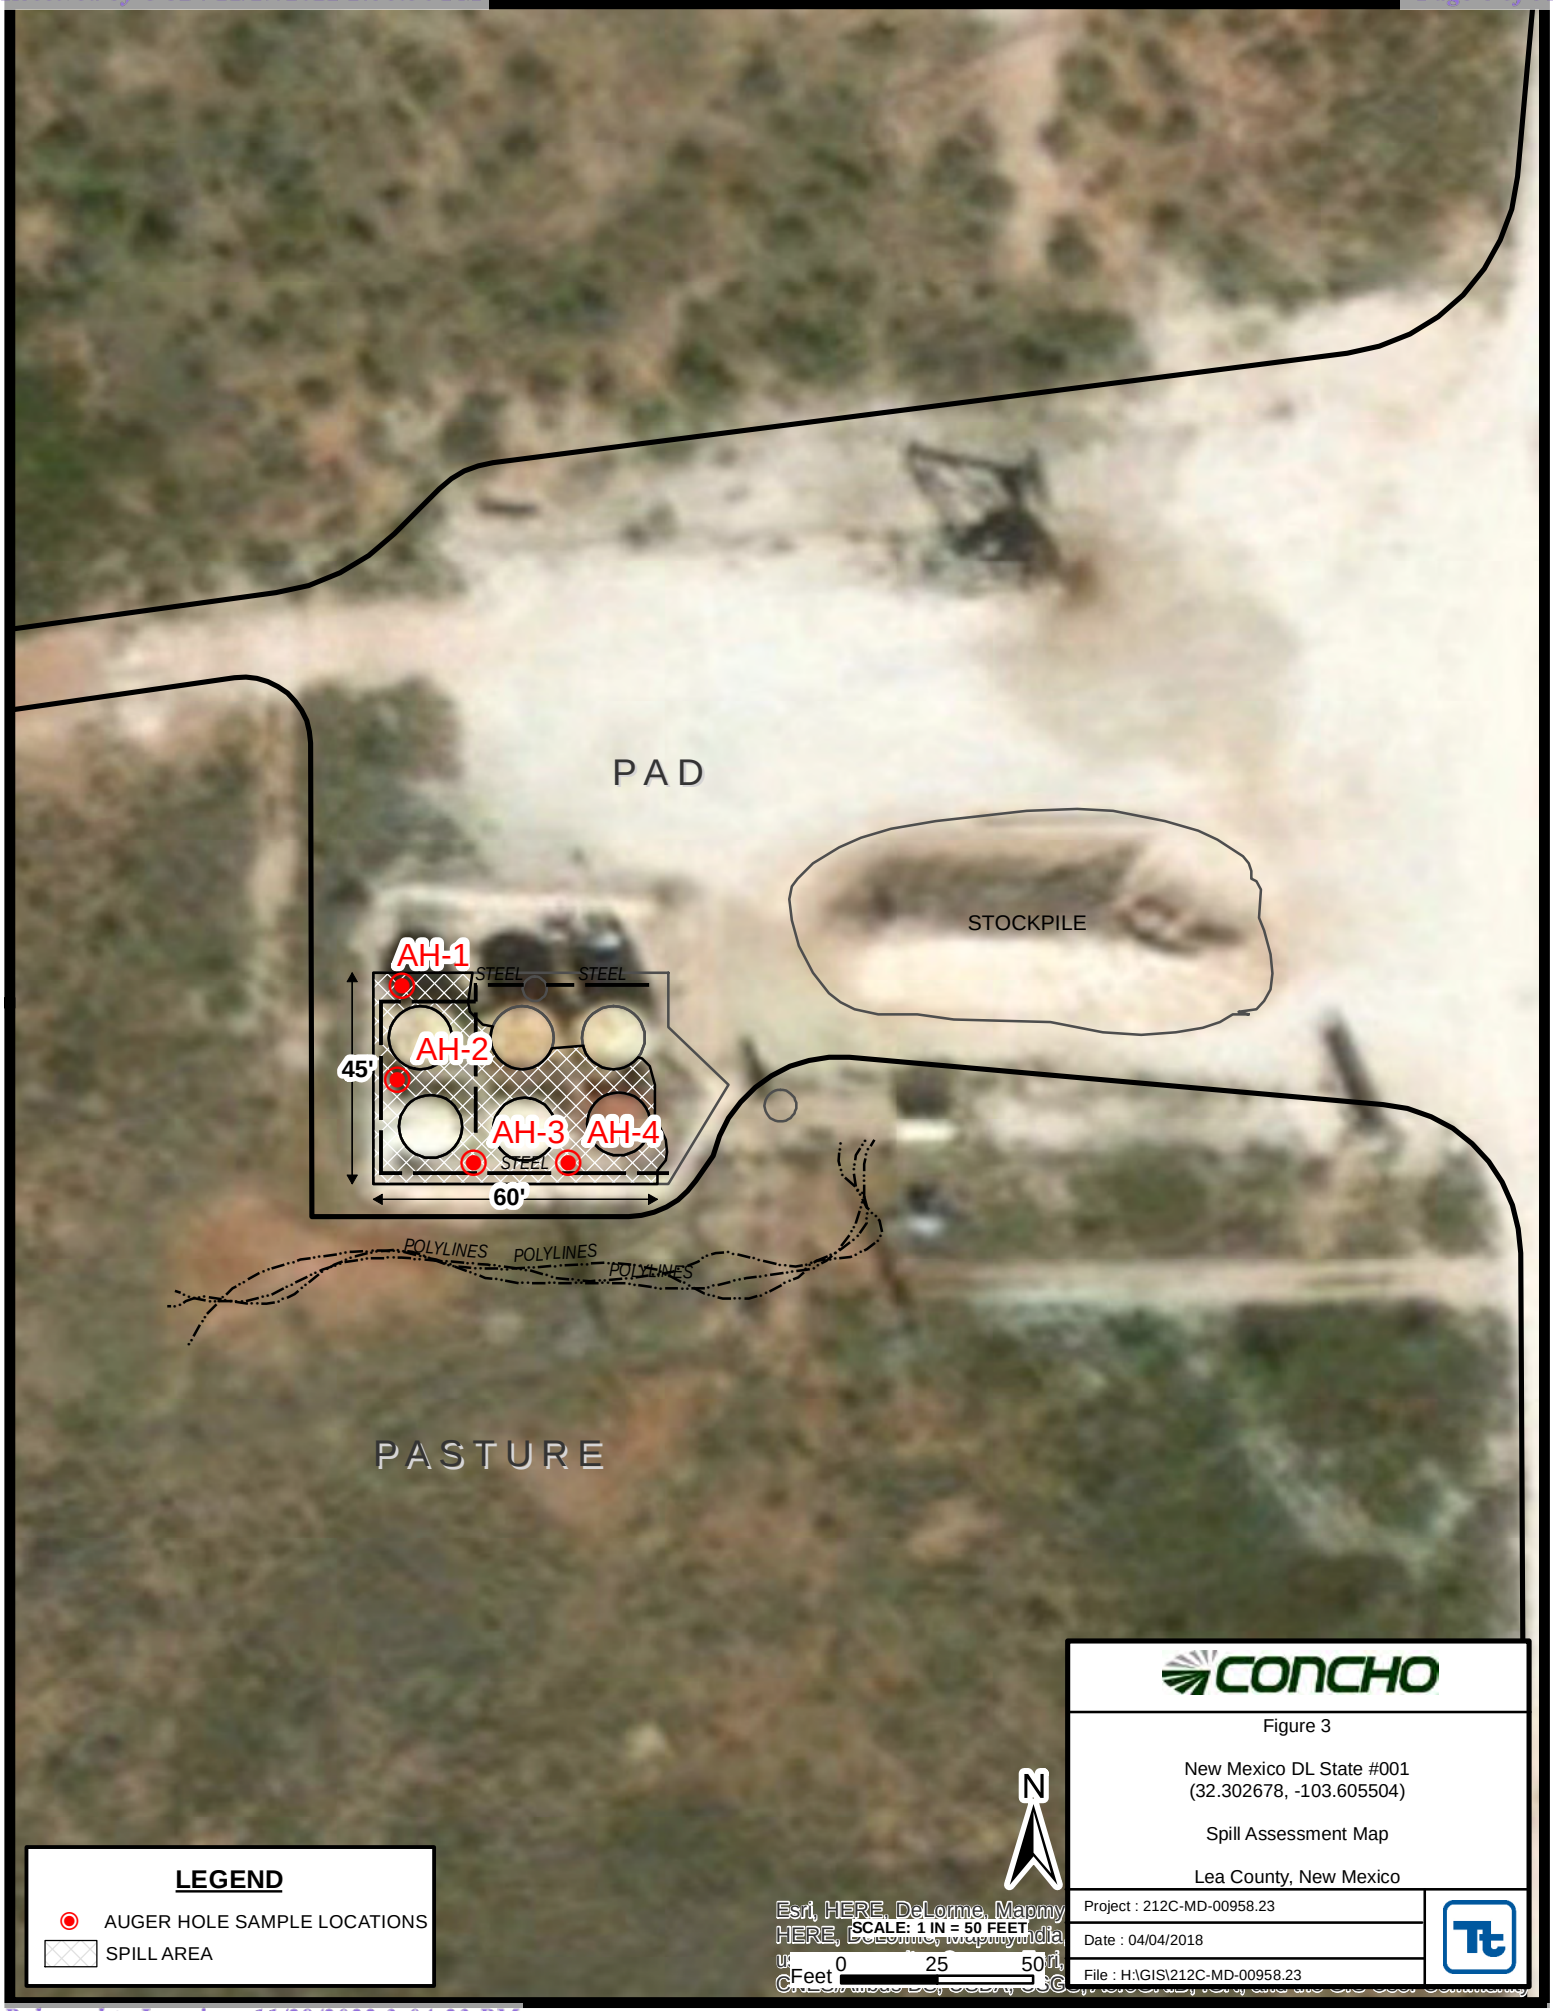
Figure 3

On February 15, 2018, Tetra Tech personnel were onsite to evaluate and inspect the release area. A total of four (4) auger holes (AH-1, AH-2, AH-3, and AH-4) were installed in the release area to total depths ranging from 1-1.5' to 3-3.5' below surface. Deeper samples could not be collected due to a dense formation in the area. Selected samples were analyzed for TPH analysis by EPA method 8015 modified, BTEX by EPA Method 8021B and chloride by EPA method 300.0. Copies of laboratory analysis and chain-of-custody documentation are included in Appendix C. The results of the sampling are summarized in Table 1. The auger hole locations are shown on Figure 3.

Referring to Table 1, the areas of auger holes (AH-1, AH-2, and AH-3) showed benzene and total BTEX concentrations below the RRALs at 0-1' below surface. However, the area of auger hole (AH-4) showed a benzene concentration of 3.79 mg/kg and a total BTEX concentration of 126 mg/kg at 0-1' below surface.

Elevated TPH concentrations were detected at all of the auger hole locations. The areas of auger holes (AH-2 and AH-3) showed a shallow hydrocarbon impact to the soil, with TPH concentrations of 5,970 mg/kg and 7,900 mg/kg at 0-1' below surface, respectively. The TPH concentrations then declined with depth at 1-1.5' below the RRAL to 1,620 mg/kg (AH-2) and 3,270 mg/kg (AH-3). The area of auger hole (AH-1) showed deeper impact to the soils, declining below the RRAL at 3-3.5' below surface to 1,900 mg/kg. The area of auger hole (AH-4) showed TPH concentrations of 11,000 mg/kg (0-1') and 6,660 mg/kg (1.0'-1.5') and the area was not vertically defined.

The areas of auger holes (AH-1 and AH-2) did not detect any significant chloride concentrations in the soils. However, chloride highs of 763 mg/kg (0-1') and 831 mg/kg (1.0'-1.5') were detected in the areas of auger holes (AH-3 and AH-4), respectively.

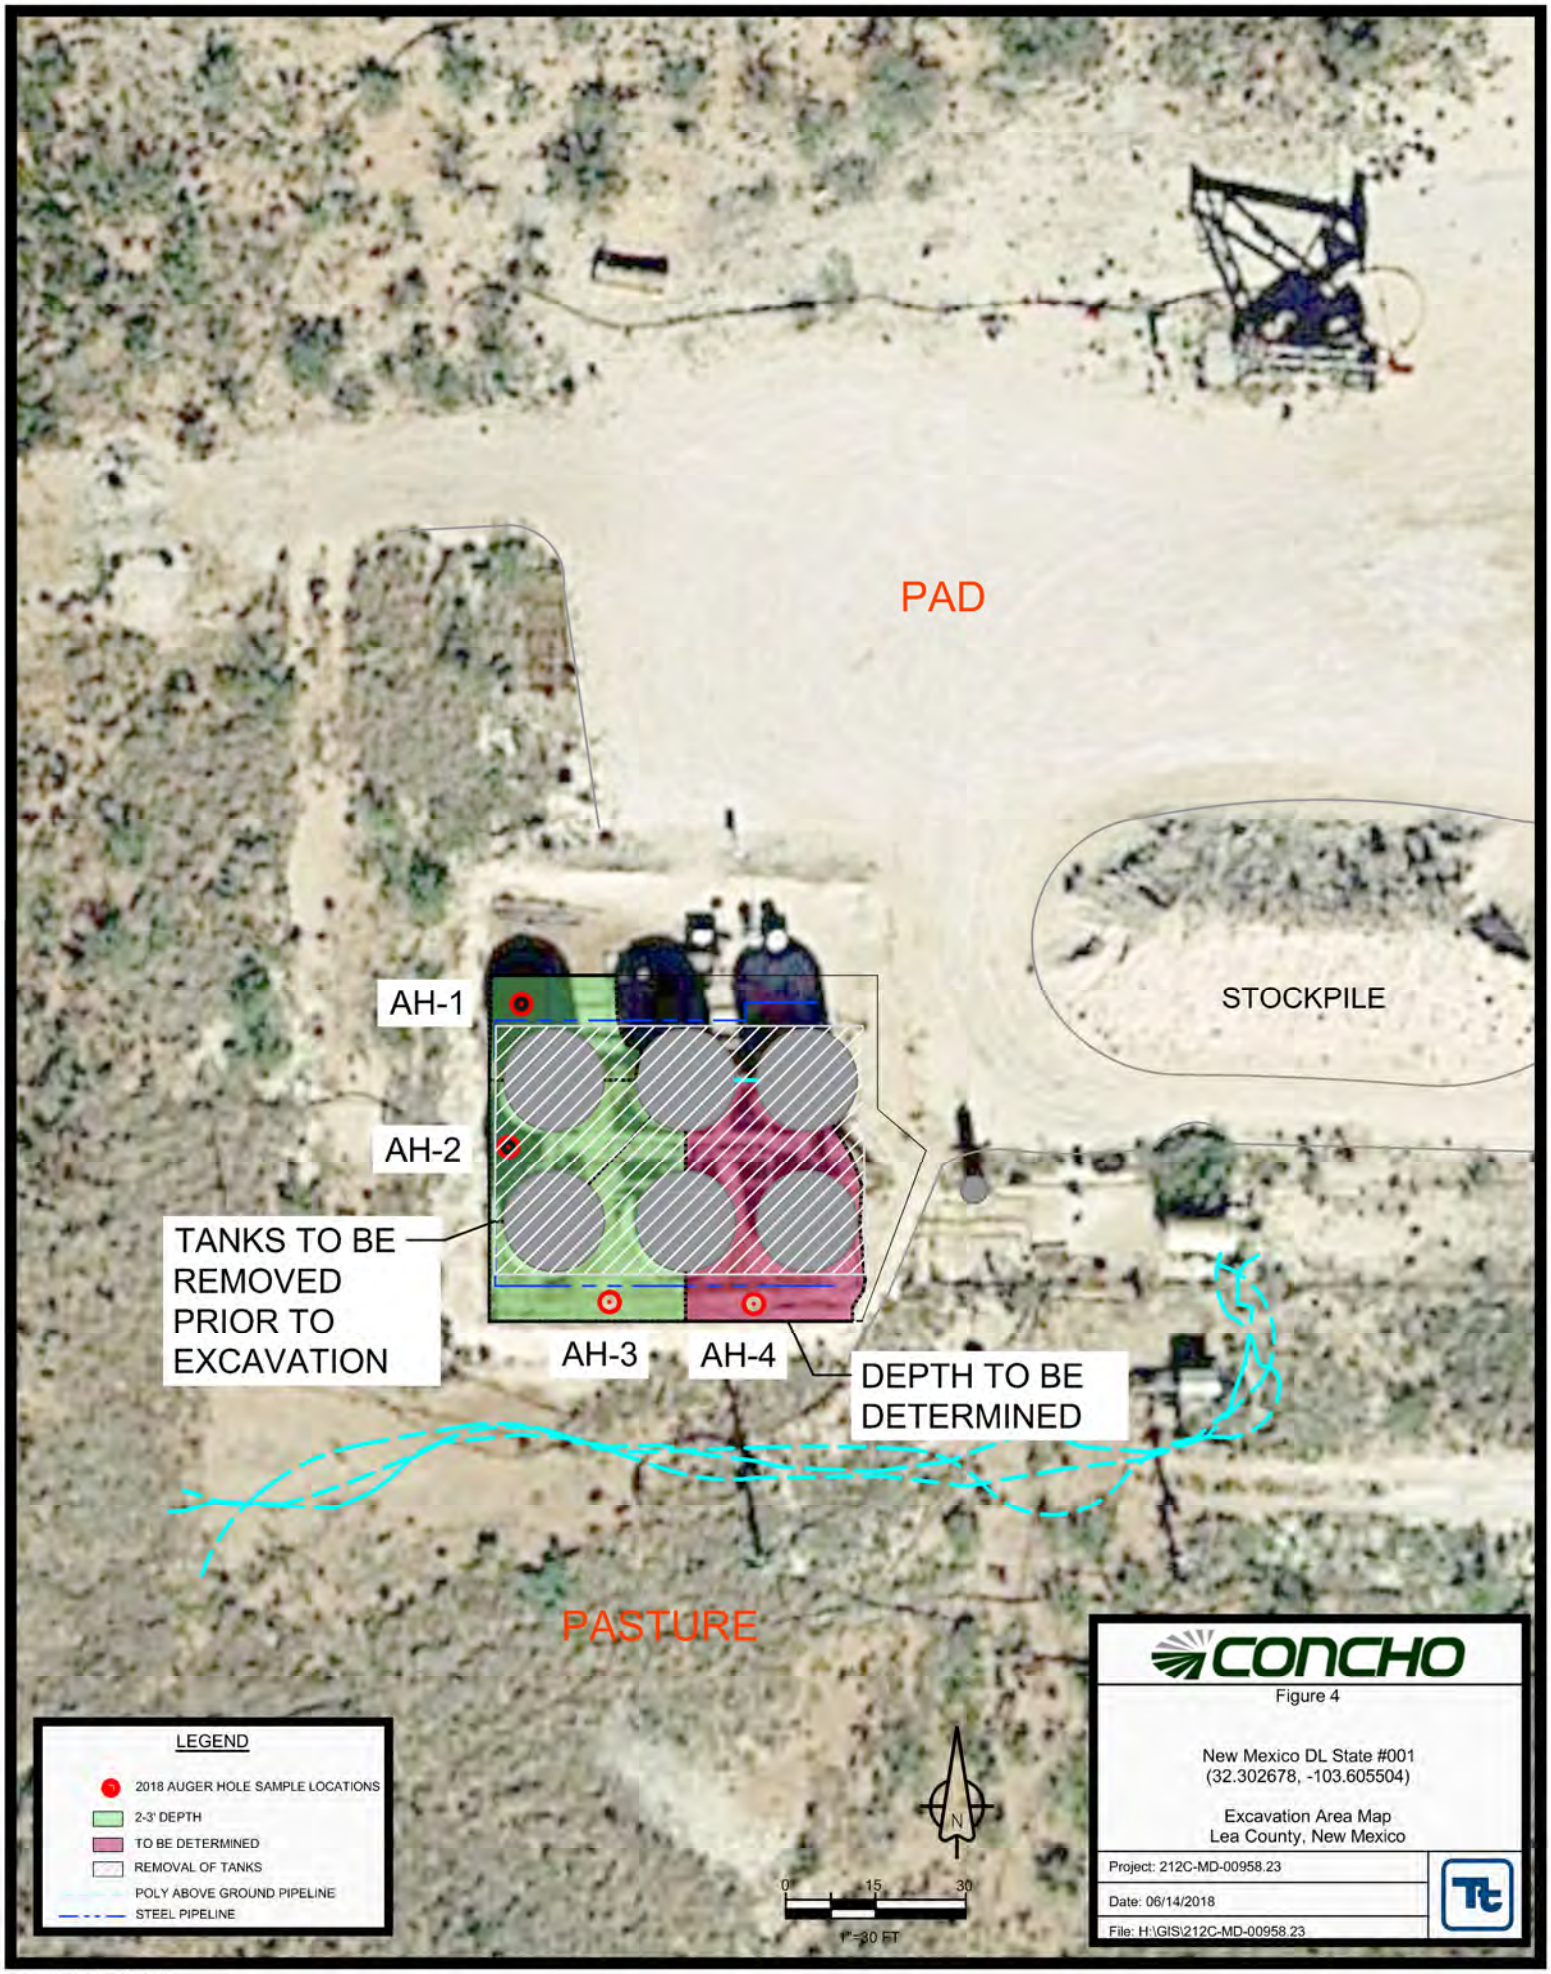
PAD
STOCKPILE
AH-1
AH-2
AH-3
AH-4
TANKS TO BE REMOVED PRIOR TO EXCAVATION
DEPTH TO BE DETERMINED
PASTURE
LEGEND
2018 AUGER HOLE SAMPLE LOCATIONS
2-3' DEPTH
TO BE DETERMINED
REMOVAL OF TANKS
POLY ABOVE GROUND PIPELINE
STEEL PIPELINE
N
0'
15
30
1" = 30 FT
CONCHO
Figure 4
New Mexico DL State #001
(32.302678, -103.605504)
Excavation Area Map
Lea County, New Mexico
Project: 212C-MD-00958.23
Date: 06/14/2018
File: H:\GIS\212C-MD-00958.23
Drawn By: MISTI MORGAN

Based on the laboratory results, COG proposes to remove the impacted material as highlighted (green) in Table 1 and shown on Figure 4. The area of auger hole (AH-1) will be excavated to approximately 2.0'-3.0' below surface and the areas of auger holes (AH-2 and AH-3) will be excavated to approximately 1.0' below surface. In the area of auger hole (AH-4) Tetra Tech will use a backhoe to define the vertical extents and properly remove the impacted soils to the appropriate depth.

Once the areas are excavated to the appropriate depths, the areas will be backfilled with clean material to surface grade. All of the excavated material will be transported offsite for proper disposal.

The proposed excavation depths may not be reached due to wall cave ins and safety concerns for onsite personnel. In addition, impacted soil around oil and gas equipment, structures or lines may not be feasible or practicable to be removed due to safely concerns for onsite personnel. As such, COG will excavate the impacted soils to the maximum extent practicable.
