Site Assessment/Characterization

Closure

Re: Site Assessment and Closure Report
Gaucho 21 Federal 3H
API No. 30-025-42136
GPS: Latitude 32.370490 Longitude -103.478813
UL N, Sec. 21, T22S, R34E
Lea County, NM
NMOCD Ref. No. NAPP2130049855

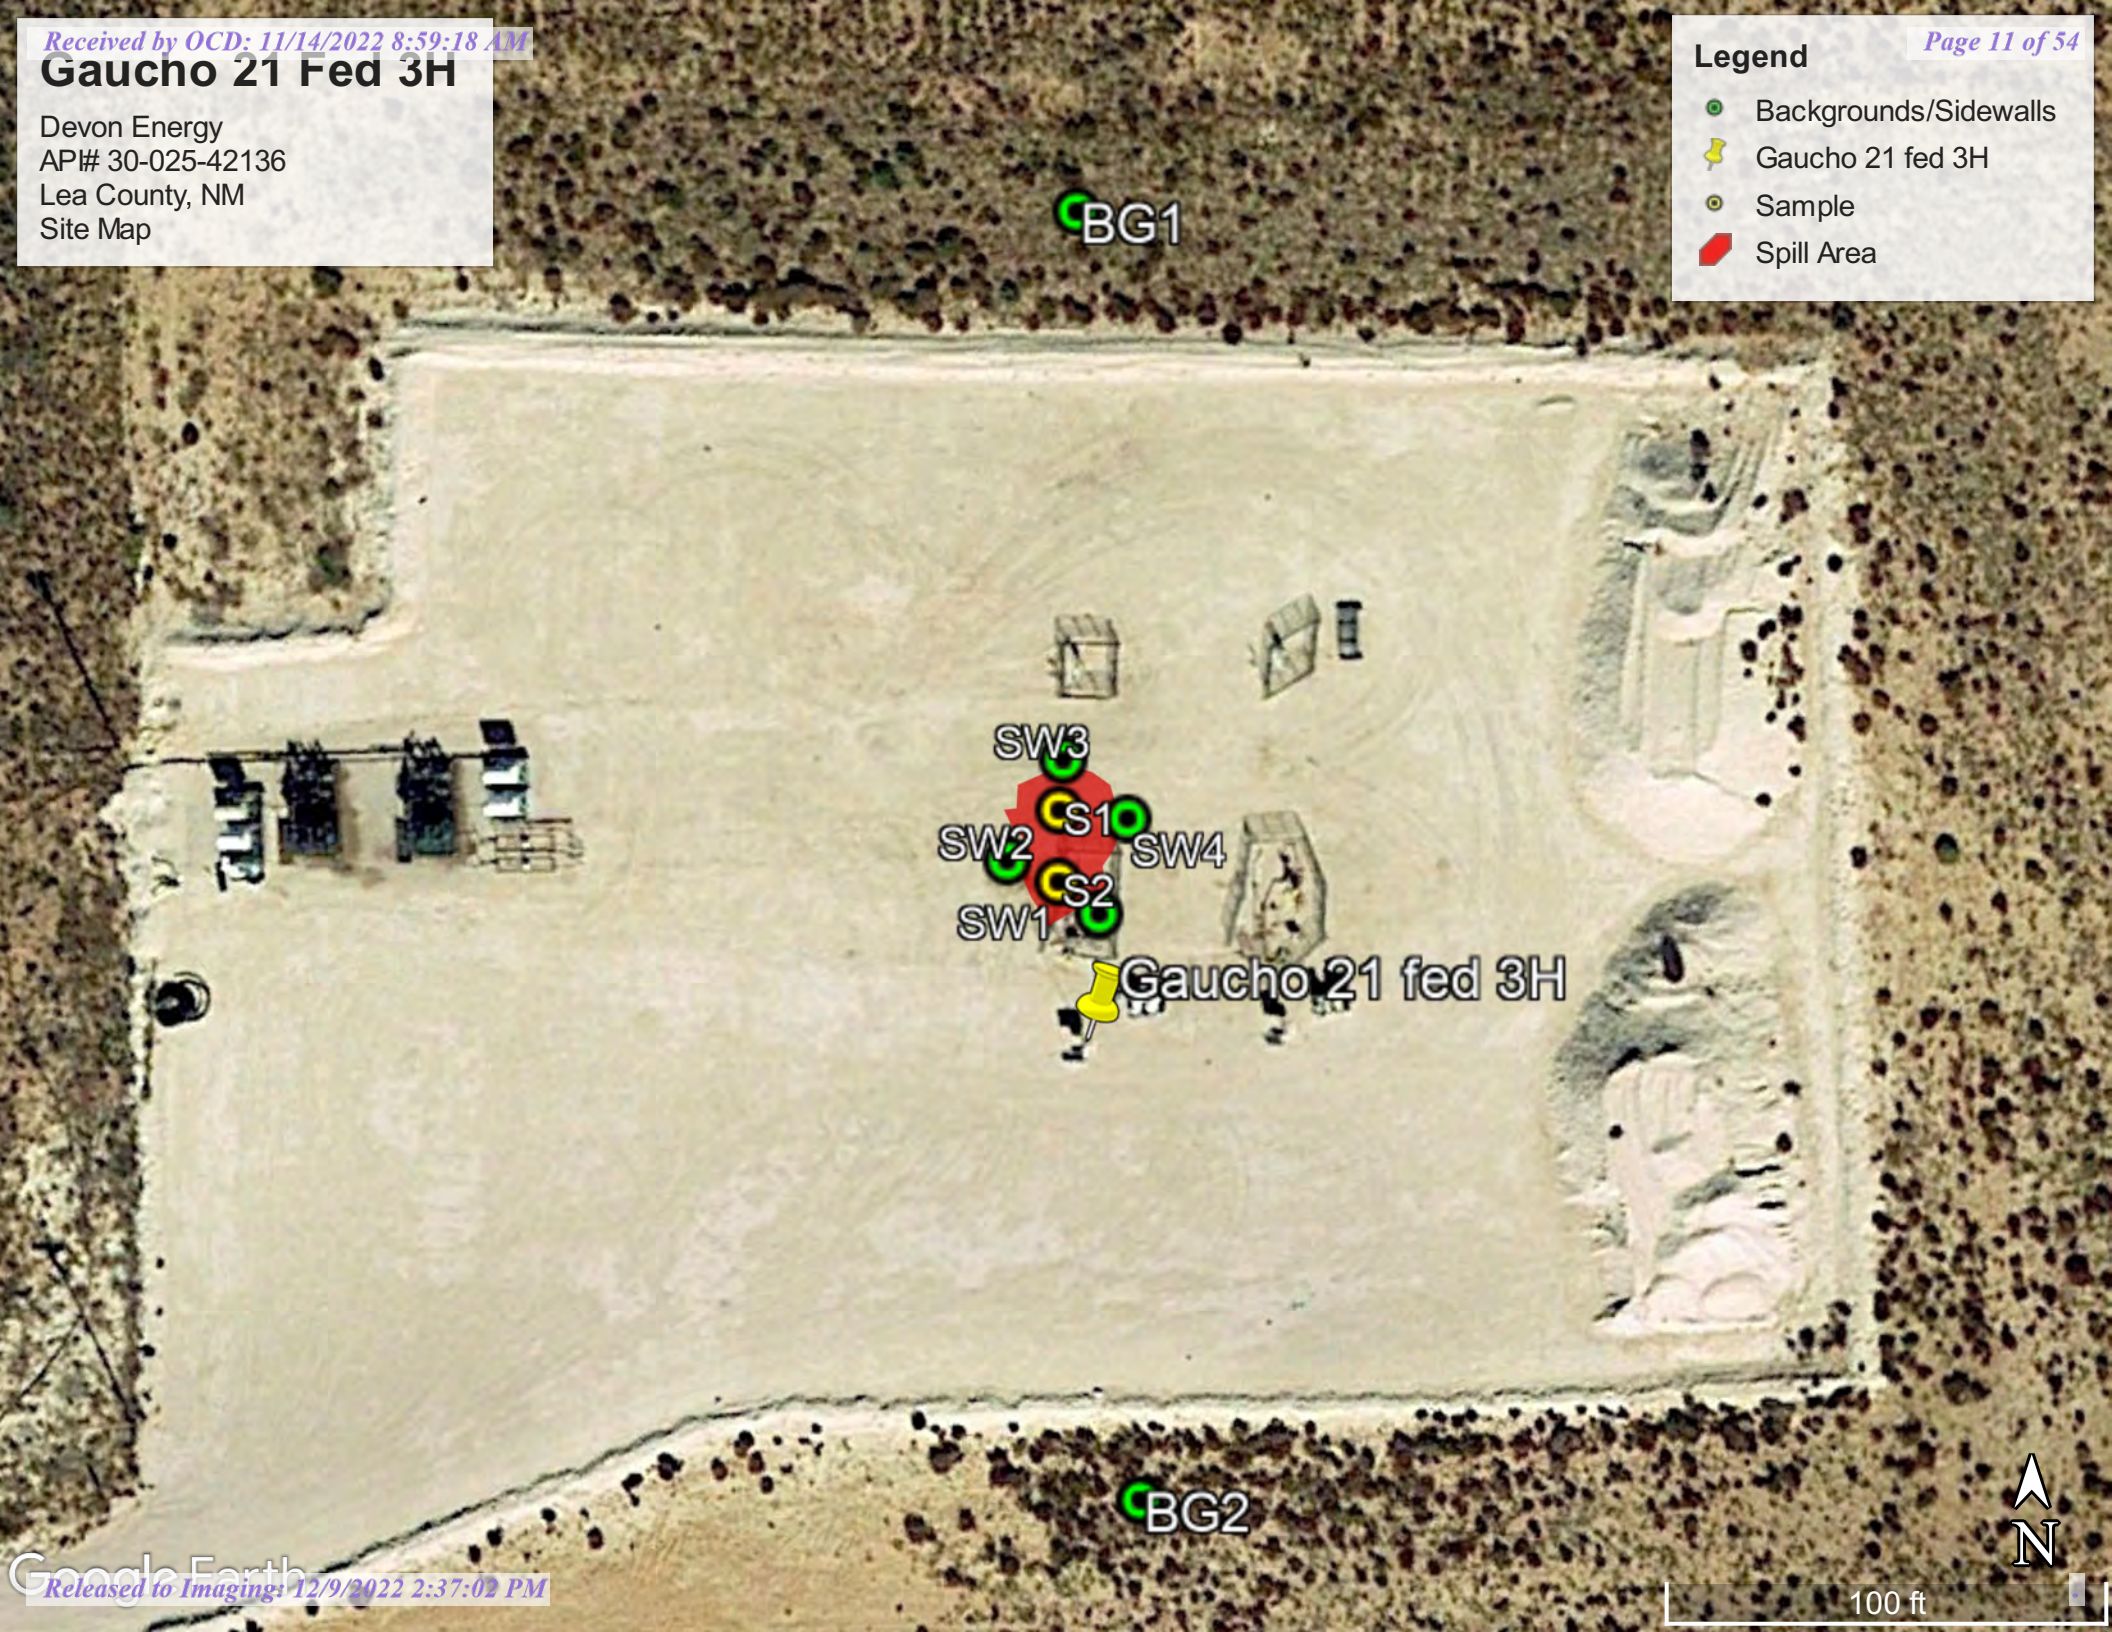
Devon Energy
API# 30-025-42136
Lea County, NM
Site Map

On June 23, 2022, Pima mobilized personnel to the site to assess the area. We sampled the impacted area. Laboratory results of this sampling event can be found in the following data table. A Site Map can be found in Figure 4.

Based on the soil sample results, the contamination levels are already less than the regulatory limits of the most stringent criteria in Table 1 of NMAC 19.15.29.1.
