Remediation Summary & Soil Closure Request

Mewbourne Oil Company
Jennings 27 W0AP Fed Com #3H
Lea County, New Mexico
Unit Letter "A", Section 27, Township 25 South, Range 32 East
Latitude 32.1078820 North, Longitude 103.656499 West
NMOCD Reference No. nAPP2236429003

Etech Environmental & Safety Solutions, Inc.
6309 Indiana Ave, Ste. D
Lubbock, Texas 79413

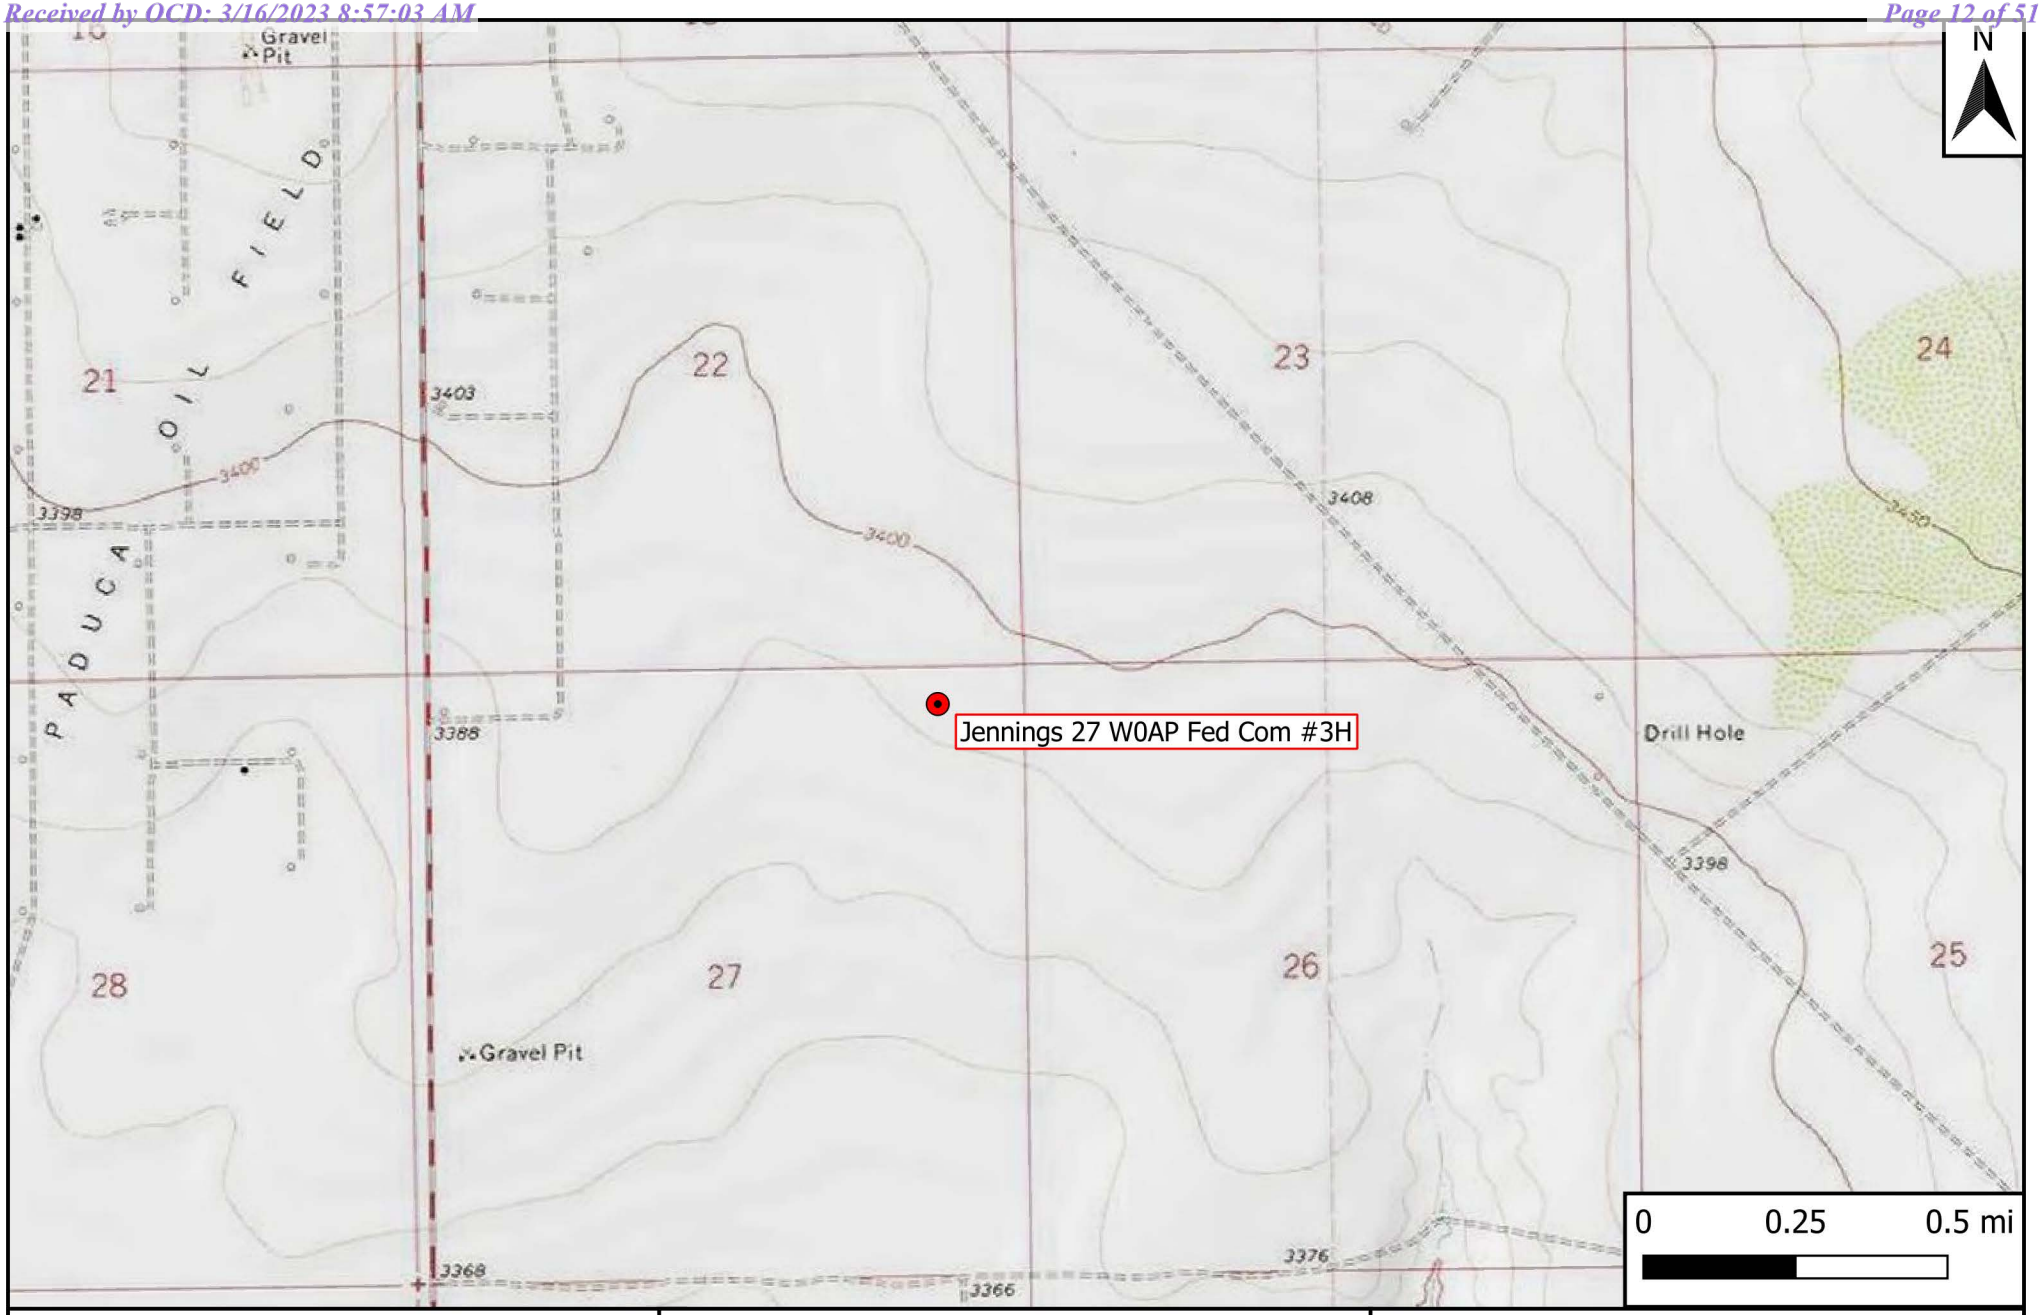
Figure 1

NMOCD Siting Criteria data was gathered from available resources including Bureau of Land Management (BLM) and Fish & Wildlife Services (FWS) shapefiles, topographic maps, NMOSE and USGS databases, and aerial imagery. The results are depicted in Figures 1, 2, 4, and 5.

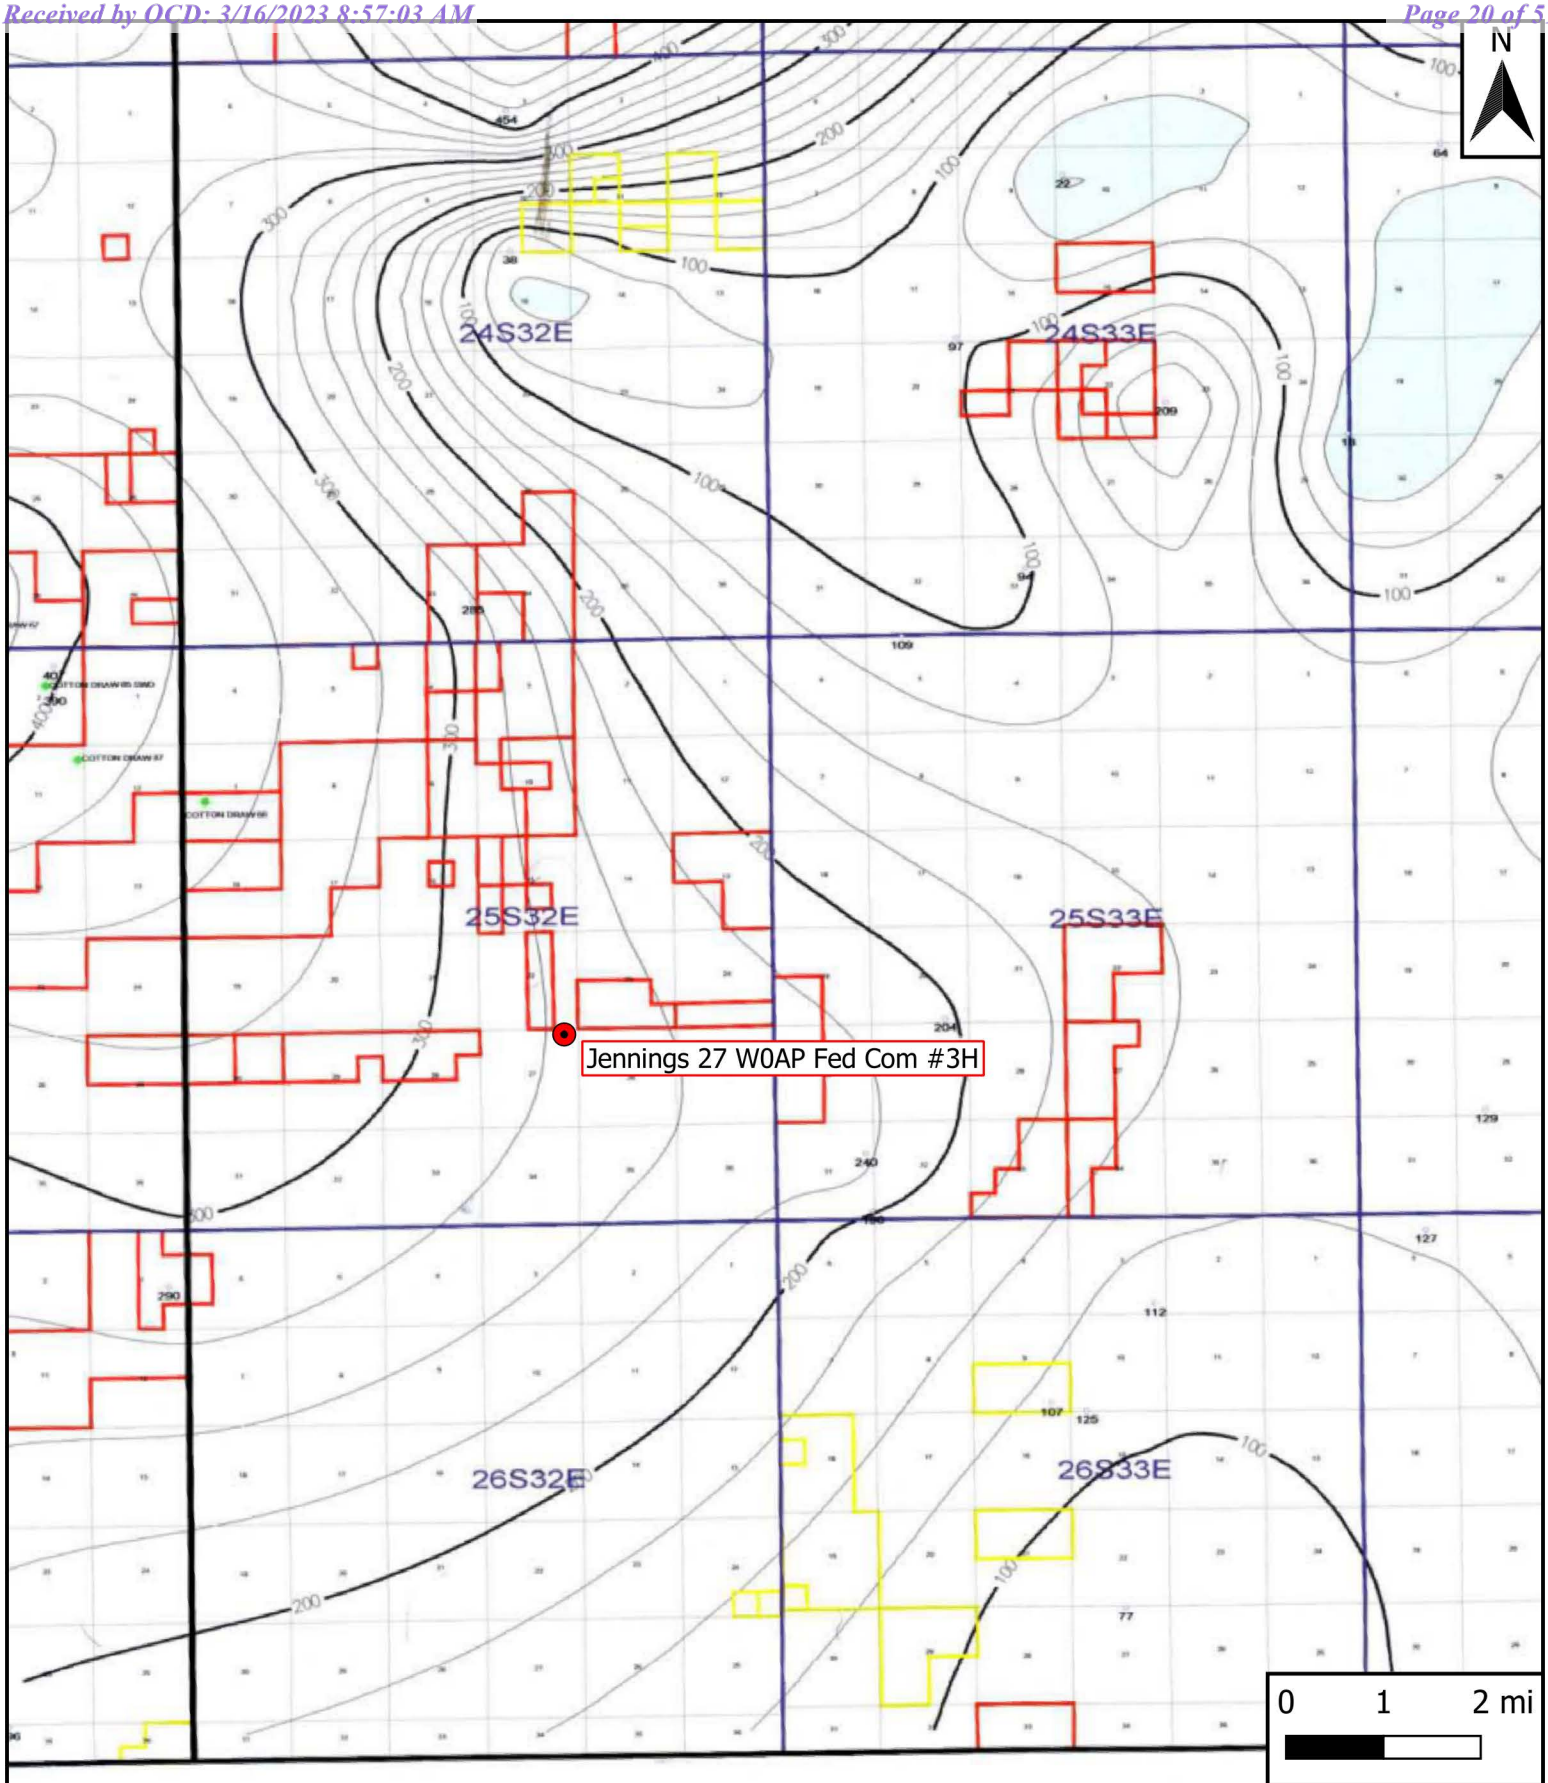
Figure 4

A search of groundwater databases maintained by the New Mexico Office of the State Engineer (NMOSE) and United States Geological Survey (USGS) was conducted in an effort to determine the horizontal distance to known water sources within a half-mile radius of the Jennings 27 release site. Probable groundwater depth was determined using data generated by numeric models based on available water well data and published information. Depth to groundwater information is provided as Appendix A.
