Closure Report
Myox 5 State Com 022H (01.07.23)
Eddy County, New Mexico
Incident ID: NAPP2301934442
Unit O Sec 05 T26S R28E
32.0647°, -104.1083°

Crude Oil & Produced Water Release
Point of Release: Separator Malfunction
Release Date: 01.07.23
Volume Released: 0.709 barrels of Crude Oil & 11.336 barrels of Produced Water
Volume Recovered: 0.709 barrels of Crude Oil & 10 barrels of Produced Water

Re: Closure Report
Myox 5 State Com 022H (01.07.23)
Concho Operating, LLC
Incident ID NAPP2301934442
Site Location: Unit O, S05, T26S, R28E
(Lat 32.0647º, Long -104.1083º)
Eddy County, New Mexico

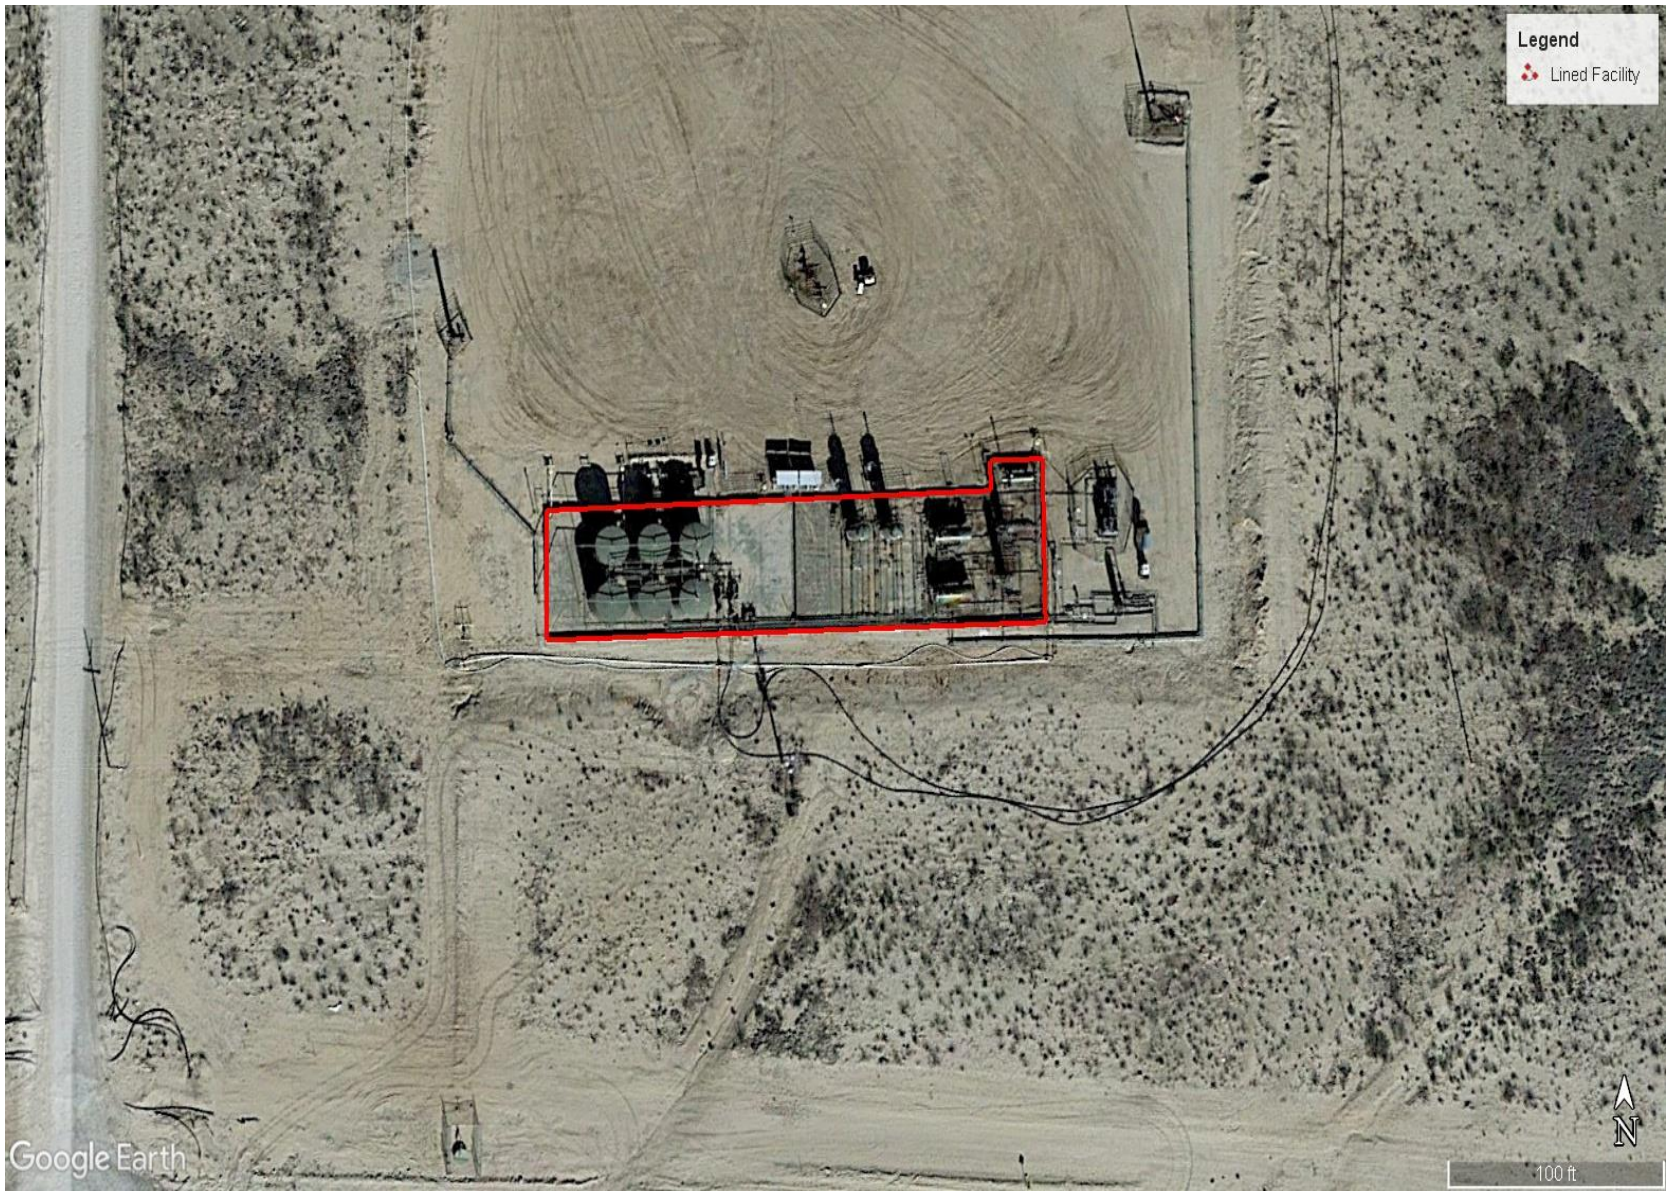
SECONDARY CONTAINMENT MAP COG OPERATING, LLC MYOX 5 STATE COM 022H (1.7.23) EDDY COUNTY, NEW MEXICO 32.0647°, -104.1083°	CARMONA RESOURCES	FIGURE 3

Based on the initial C-141 obtained from the New Mexico Oil Conservation Division (NMOCD), the release was discovered on January 7, 2023, due to a separator malfunction. It resulted in approximately 11.336 barrels of produced water and approximately 0.709 barrels of crude oil released. Approximately 10 barrels of produced water and approximately 0.709 barrels of crude oil were recovered. See figure 3. The initial C-141 form is attached in Appendix B.

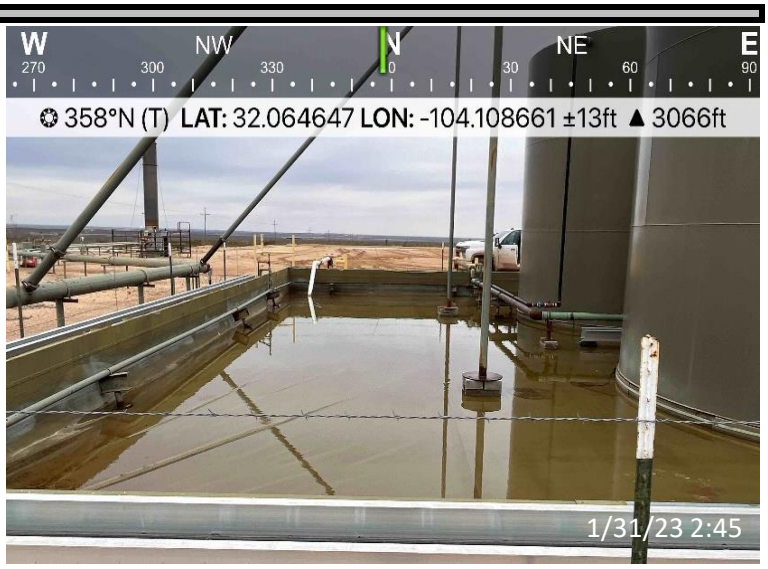
Photograph No. 5

On January 31, 2023, Carmona Resources, LLC conducted liner inspection activities to assess the liner's integrity within the facility. Before performing the liner inspection, the NMOCD division office was notified via email on January 27, 2023, per Subsection D of 19.15.29.12 NMAC. See Appendix B. Carmona Resources, LLC personnel inspected the liner visually and determined it to be intact with no integrity issues. Refer to the Photolog.

Description:
View North of the lined facility.

Based on the liner inspection throughout the facility, no further actions are required at the site. The final C-141 is attached, and COG formally requests the closure of the spill. If you have any questions regarding this report or need additional information, don't hesitate to contact us at 432-813-1992.
