Incident ID	NAPP2317925175
District RP	
Facility ID	
Application ID

Re: Site Assessment, and Closure Report
Fighting Okra 18 CTB 3
API No. N/A
GPS: Latitude 32.049378 Longitude -103.516575
UL –D Section 18, T26S, R34E
Lea County, NM
NMOCD Ref. No. NAPP2317925175

Fighting Okra 18 CTB 3

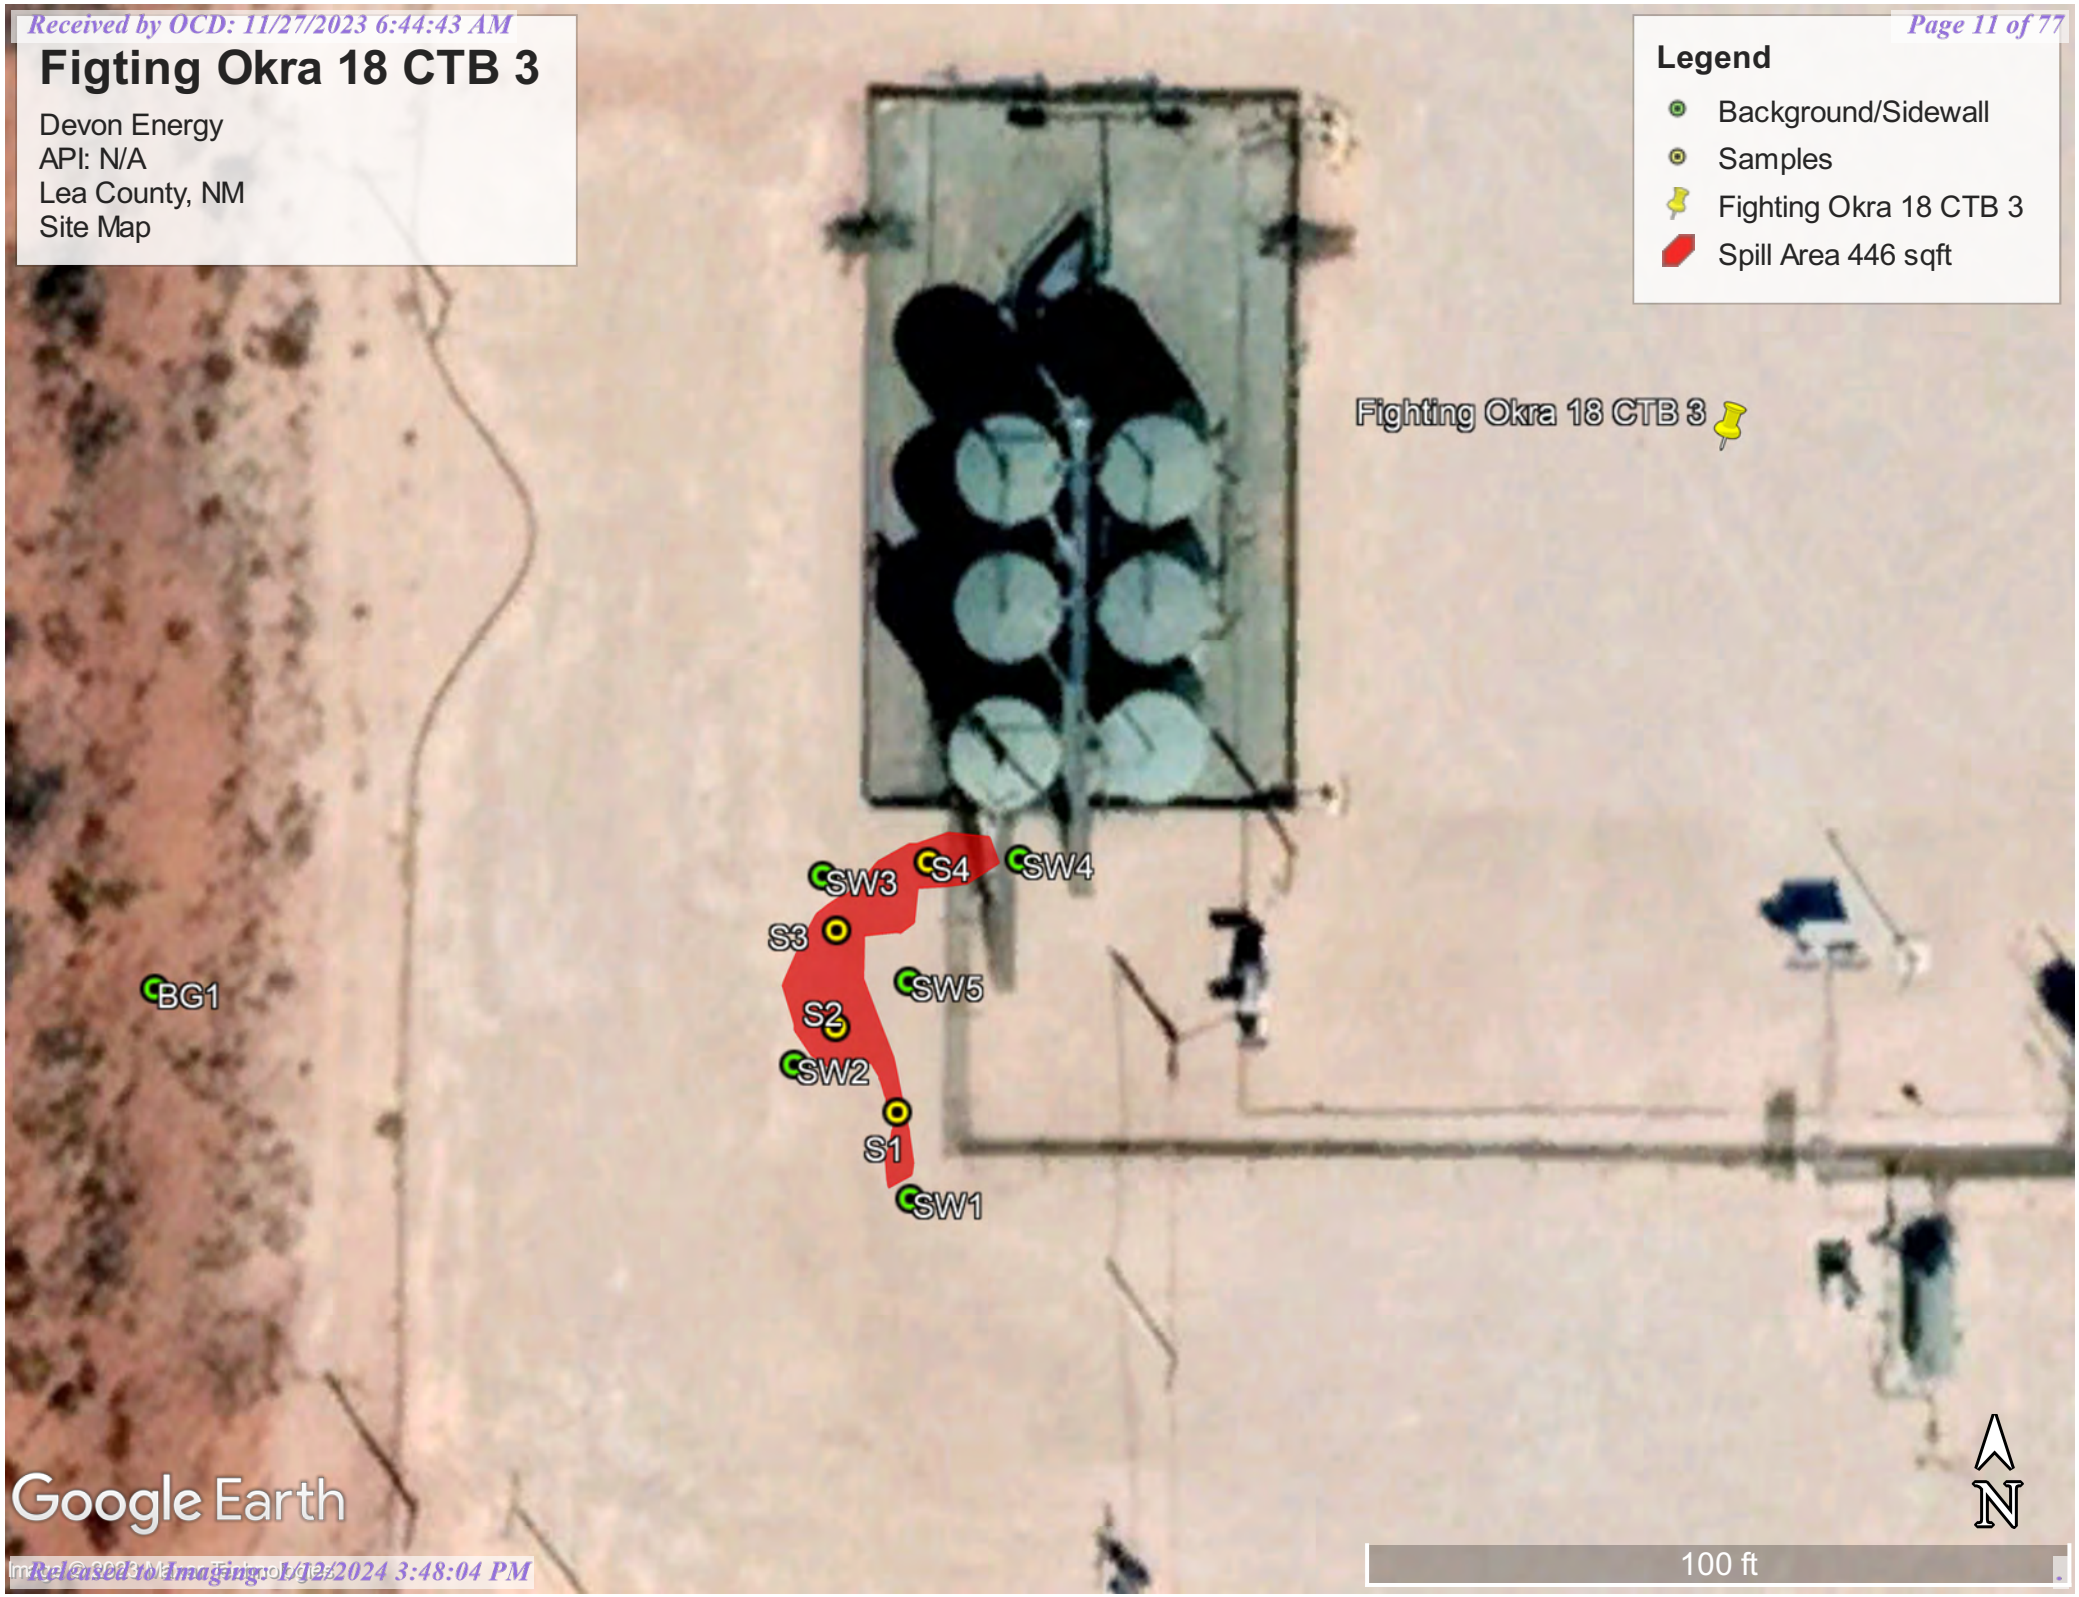
Devon Energy
API: N/A
Lea County, NM
Site Map

On November 8, 2023, Pima mobilized personnel to the site to begin collecting soil samples from the spill area. The laboratory results of this sampling event can be found in the following data table. A Site Map can be found in Figure 4.

Based on the sample results, the bottoms and sidewalls were below NMOCD Closure Criteria 19.15.29 NMAC. See Appendix D for Photographic Documentation.
