****** LIQUID SPILLS - VOLUME CALCULATIONS ******

Location of spill: CHEVRON CVU 106-136 (32.7773247, -103.5020981) **Date of Spill:** 10/30/2010

On 08/05/2010 and 11/05/2010, Chevron Environmental Management Company (Chevron) reported a release at the CVU-106 and CVU-136, respectively. The releases comingled and are referred to as Chevron CVU 106-136. The releases were caused by injection line leaks.

Through delineation activities, this site has been found to meet the standards of Table I of 19.15.29.12 NMAC; therefore, does not require further remediation activities. Trinity Oilfield Services respectfully requests that the New Mexico Oil Conservation Division grant remediation closure approval for the referenced release.

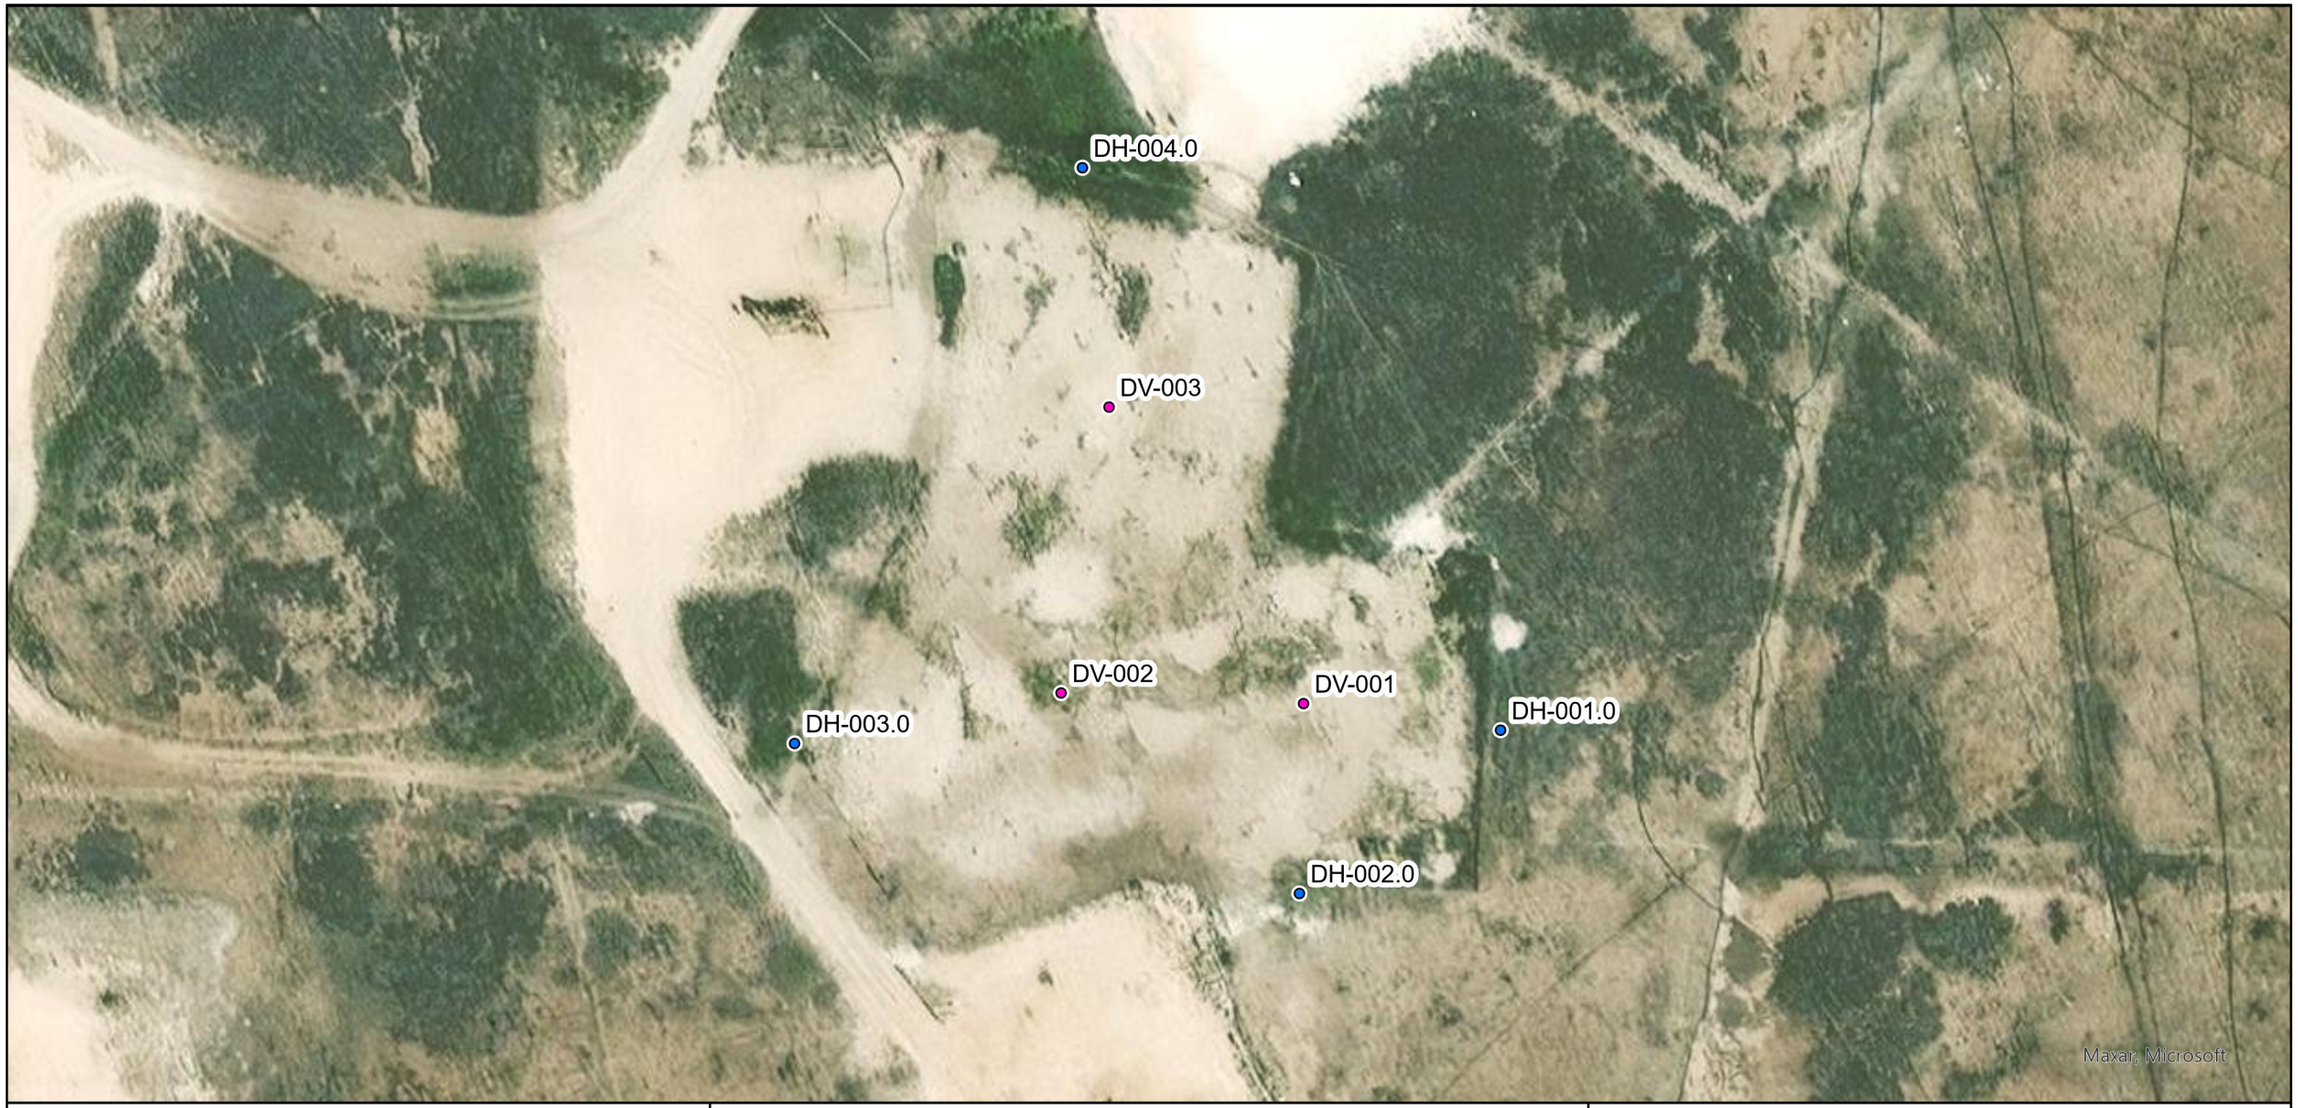
SAMPLE LOCATION	SAMPLE DEPTH (BGS)	SAMPLE DATE	VERTICAL/ HORIZONTAL	OFF-SITE/ ON-SITE	SAMPLE TYPE	SOIL STATUS	CHLORIDE (mg/Kg)	TPH C6-C36 (mg/Kg)	GRO+ DRO (mg/kg)	GRO C6-C10 (mg/Kg)	DRO C10-C28 (mg/Kg)	MRO C28-C36 (mg/Kg)	TOTAL BTEX (mg/Kg)	BENZENE (mg/Kg)
On-Site, & Deeper than 4' Pasture							**600**	**100**	**NE**	**NE**	**NE**	**NE**	**50**	**10**
Delineation Special Circumstance, NMOCD Delineation Limits Pasture to 4'							**600**	**100**	**NE**	**NE**	**NE**	**NE**	**50**	**10**
Vertical Delineation														
DV-001.0-00.0-P	0	1/23/2024	Vertical	Off-Site	Grab	In-Situ	<16.0	<10.0	<10.0	<10.0	<10.0	<10.0	<10.0	<10.0
DV-001.0-01.0-P	1	1/23/2024	Vertical	Off-Site	Grab	In-Situ	<16.0	<10.0	<10.0	<10.0	<10.0	<10.0	<10.0	<10.0
DV-002.0-00.0-P	0	1/23/2024	Vertical	Off-Site	Grab	In-Situ	<16.0	<10.0	<10.0	<10.0	<10.0	<10.0	<10.0	<10.0
DV-002.0-01.0-P	1	1/23/2024	Vertical	Off-Site	Grab	In-Situ	32.0	<10.0	<10.0	<10.0	<10.0	<10.0	<10.0	<10.0

DV-003.0-00.0-P	0	1/23/2024	Vertical	Off-Site	Grab	In-Situ	16.0	<10.0	<10.0	<10.0	<10.0	<10.0	<10.0	<10.0
DV-003.0-01.0-P	1	1/23/2024	Vertical	Off-Site	Grab	In-Situ	32.0	<10.0	<10.0	<10.0	<10.0	<10.0	<10.0	<10.0
Horizontal Delineation														
DH-001.0-01.0-P	1	1/23/2024	Horizontal	Off-Site	Grab	In-Situ	16.0	<10.0	<10.0	<10.0	<10.0	<10.0	<10.0	<10.0
DH-002.0-01.0-P	1	1/23/2024	Horizontal	Off-Site	Grab	In-Situ	<16.0	<10.0	<10.0	<10.0	<10.0	<10.0	<10.0	<10.0
DH-003.0-01.0-P	1	1/23/2024	Horizontal	Off-Site	Grab	In-Situ	<16.0	<10.0	<10.0	<10.0	<10.0	<10.0	<10.0	<10.0
DH-004.0-01.0-P	1	1/23/2024	Horizontal	Off-Site	Grab	In-Situ	<16.0	<10.0	<10.0	<10.0	<10.0	<10.0	<10.0	<10.0

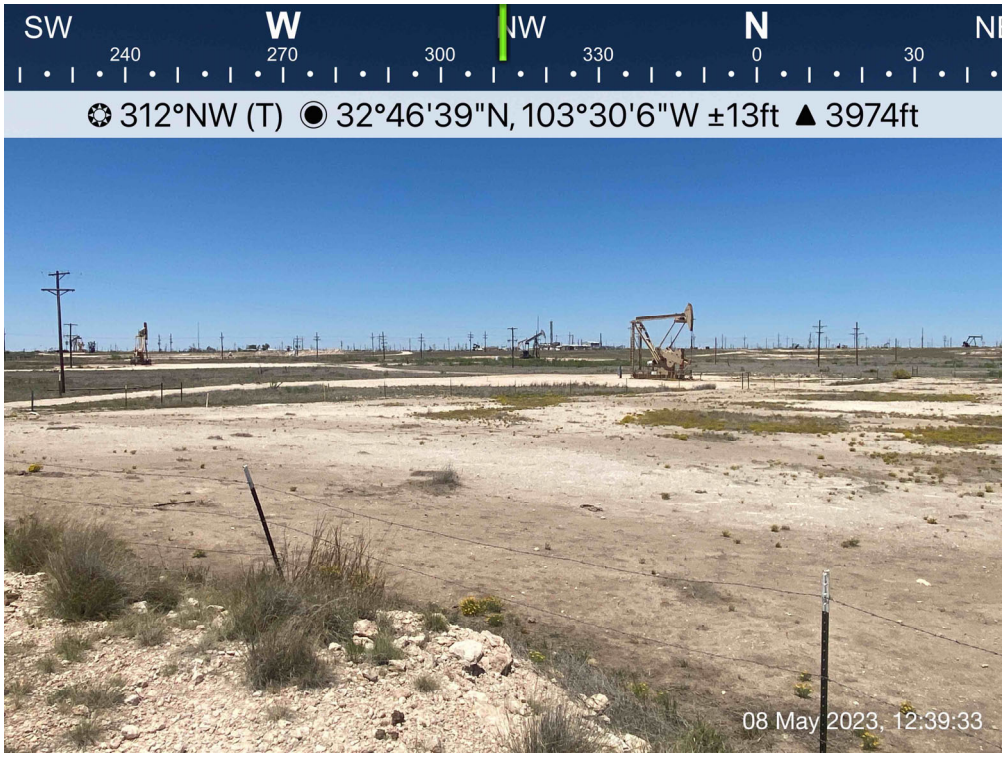
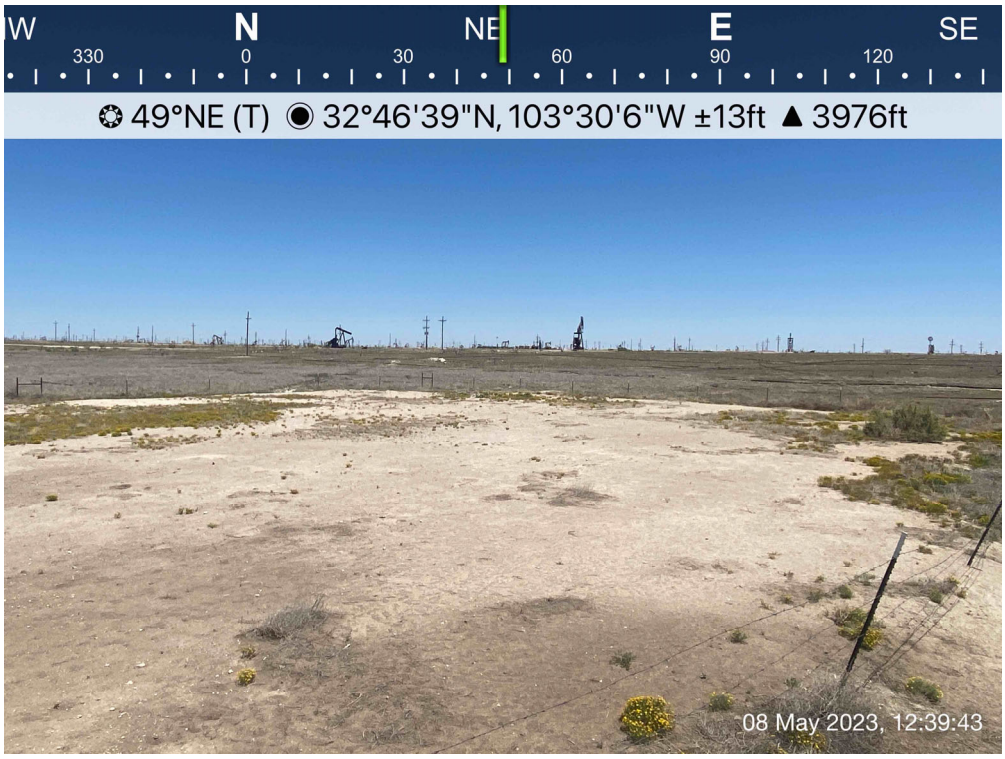
On 10/03/17 and 10/04/2017, the site was seeded with BLM No. 2 without lovegrass. While vegetation emerged over the release area, slow growth over the previous years is attributed to regional drought conditions observed and confirmed with USGS Vegetation Drought Response Index (VegDRI) maps.
