Remediation Closure

PLU 29 Big Sinks West CTB

XTO Energy, Inc.

Vertex Resource Services Inc.

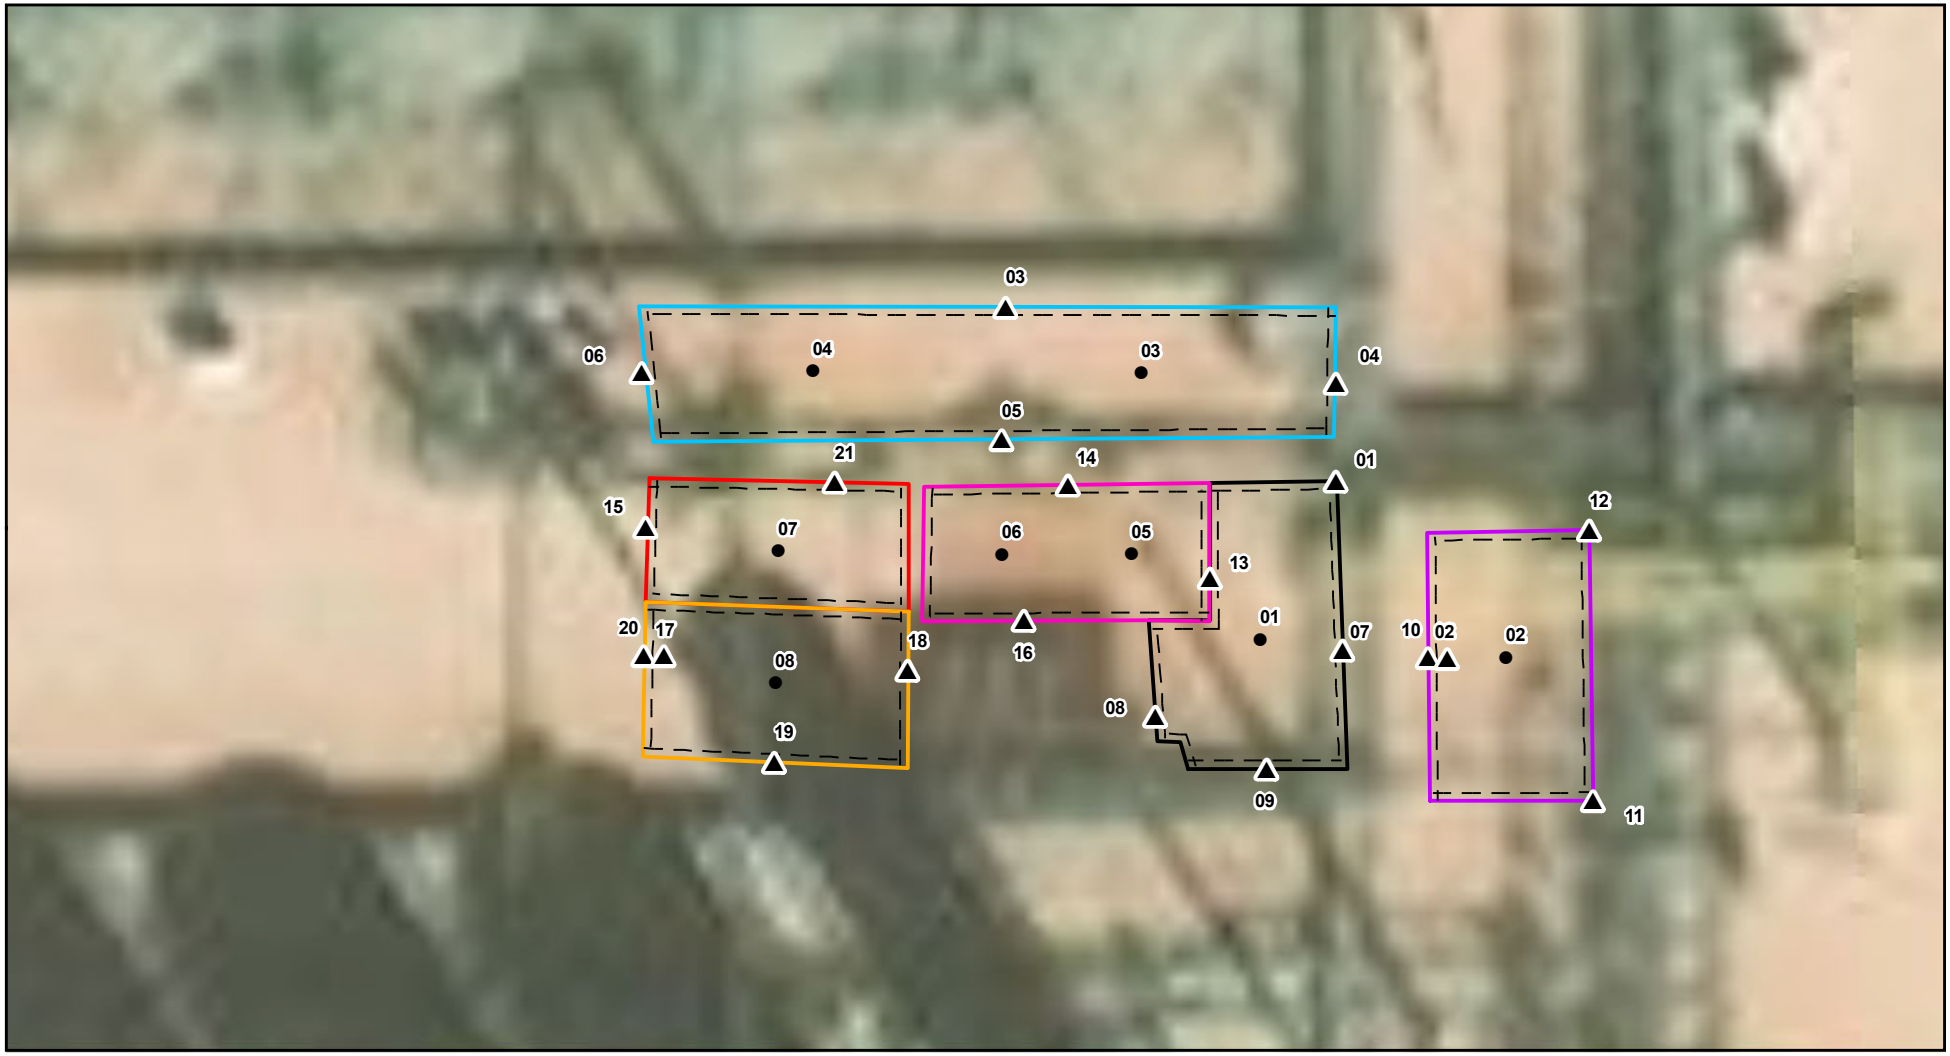
I am reviewing the reports for NAPP2401043023 PLU 29 BIG SINKS WEST TB and the following reason for rejection was not addressed: In addition, WS24-02 and WS24-17 are missing both from Figure 2 and Table 4. Can you update the table and figure to address these?

- Base Sample (Prefixed by "BS24-")
- Wall Sample (Prefixed by "WS24-")
- Center Excavation to 1 ft. bgs (~ 193 sq. ft. | 62 ft.)
- East Excavation to 1 ft. bgs (~ 186 sq. ft. | 56 ft.)
- Excavation to 2 ft. bgs (~ 165 sq. ft. | 55 ft.)
- Excavation to 4 ft. bgs (~ 175 sq. ft. | 55 ft.)
- North Excavation to 1 ft. bgs (~ 387 sq. ft. | 107 ft.)
- West Excavation to 1 ft. bgs (~ 139 sq. ft. | 50 ft.)
- Area of Excavation Walls to 1 ft. bgs (~ 250 sq. ft.)
- Area of Excavation Walls to 2 ft. bgs (~ 98 sq. ft.)
- Area of Excavation Walls to 4 ft. bgs (~ 204 sq. ft.)
