January 9, 2025

Re: Fourth Quarter 2024 – SVE System Update
Sullivan GC D #1E
San Juan County, New Mexico
Hilcorp Energy Company
NMOCD Incident Number: NCS1518952648

PROJECT PHOTOGRAPHS
Sullivan GC D #1E
San Juan County, New Mexico
Hilcorp Energy Company

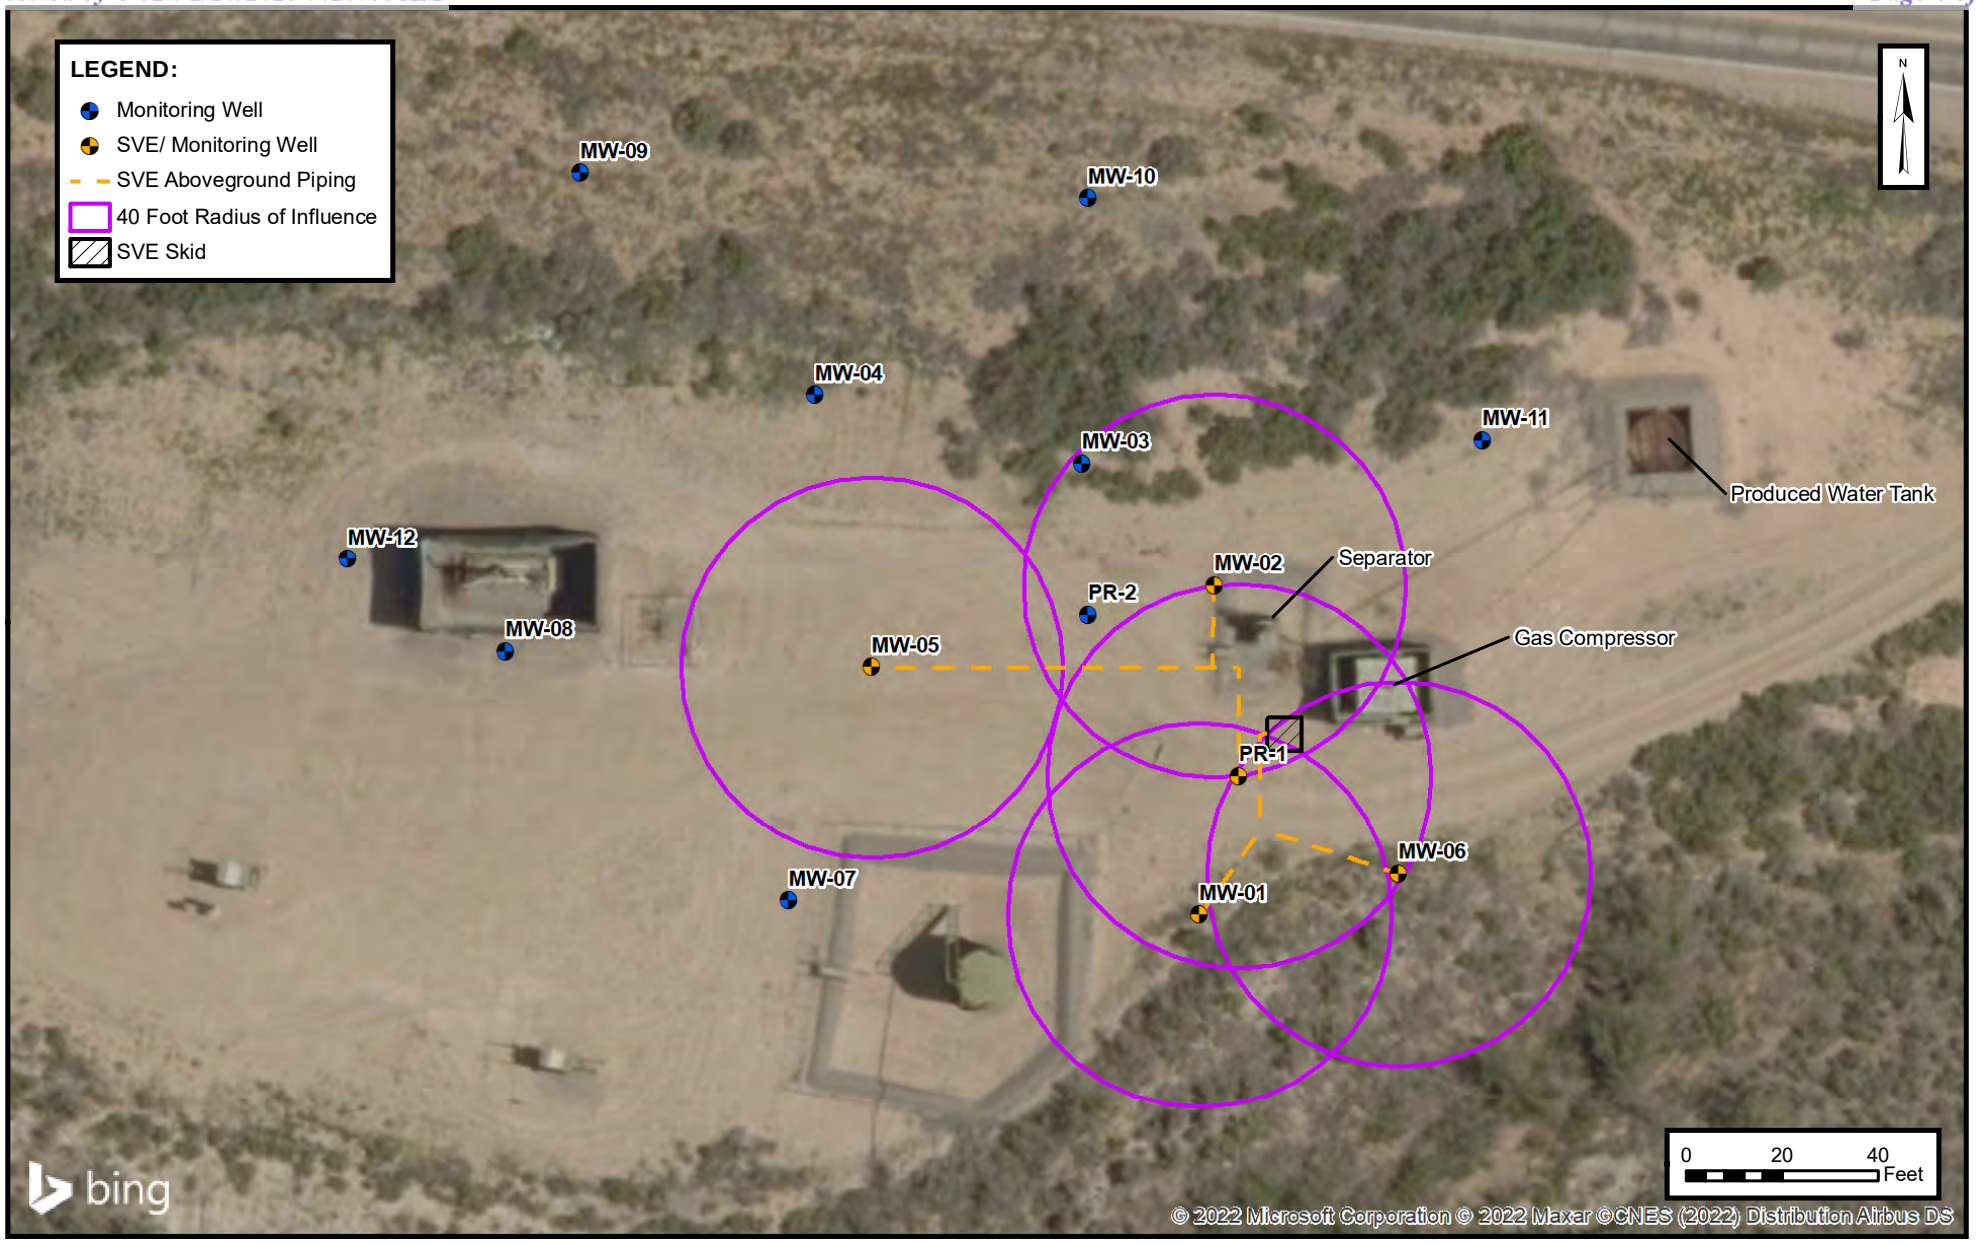
FIGURE

The current Geotech SVE system is configured with vacuum applied to wells PR-1, MW-01, MW-02, MW-05, and MW-06 (shown on Figure 2). The SVE system consists of a 3 horsepower Rotron Model EN656 regenerative blower capable of producing 212 standard cubic feet per minute (scfm) of flow and 73 inches of water column (IWC) vacuum. The layout of the SVE system and piping is shown on Figure 2.

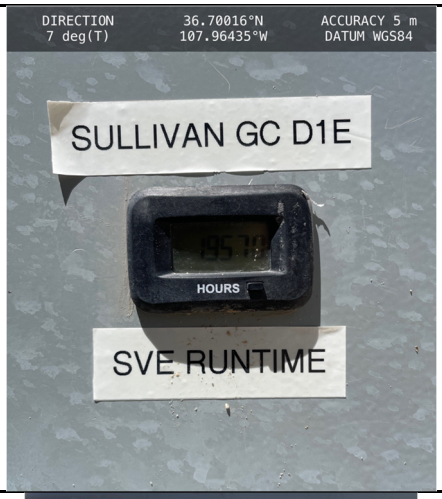
the hour meter was no longer functioning properly and was in need of replacement. A replacement hour meter was installed on December 3, 2024, but was installed in a different location than the broken meter. The broken meter was left in place temporarily and a photo of the old meter was inadvertently collected on December 16, 2024. Photos of the new hour meter will be provided in the next quarterly update report. No alarms were noted on the system telemetry throughout the quarter and the system was in operation during Site visits conducted twice per month during the fourth quarter of 2024. Based on this information, we believe that the system was fully operational between September 16 and December 16, 2024 and runtime was likely greater than 90%. Appendix B presents photographs of the runtime meter for calculating the runtime efficiency. A screenshot of the telemetry screen showing the system status throughout the quarter is also included in Appendix B. Table 1 presents the SVE system operational hours and percent runtime based on the field notes collected during the quarter.

Photograph 1 Runtime meter taken on September 16, 2024 at 2:36 PM Hours = 21,519

Photograph 2 Runtime meter taken on December 2, 2024 at 2:55 PM Hours = 23,262	
Photograph 3 Runtime meter taken on December 16, 2024 at 3:30 PM Hours = 23,269

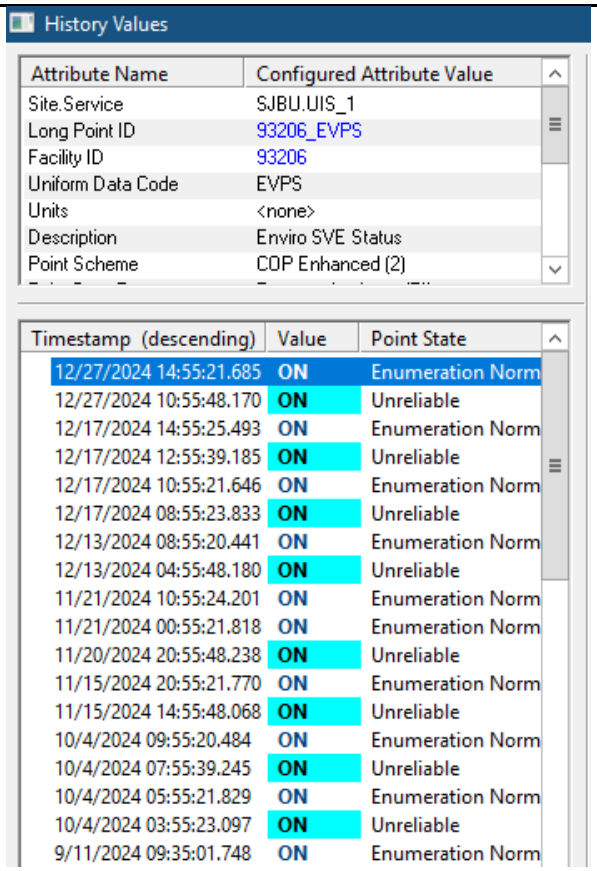
Photograph 4 Fourth Quarter 2024 Telemetry System Status Report
