OCD Photos and notes from witnessed sampling on 5/13/2025

MOORE LS 6B

API NO. 30-045-33564

nAPP2206058318 Moore LS 6B (30-045-30564)

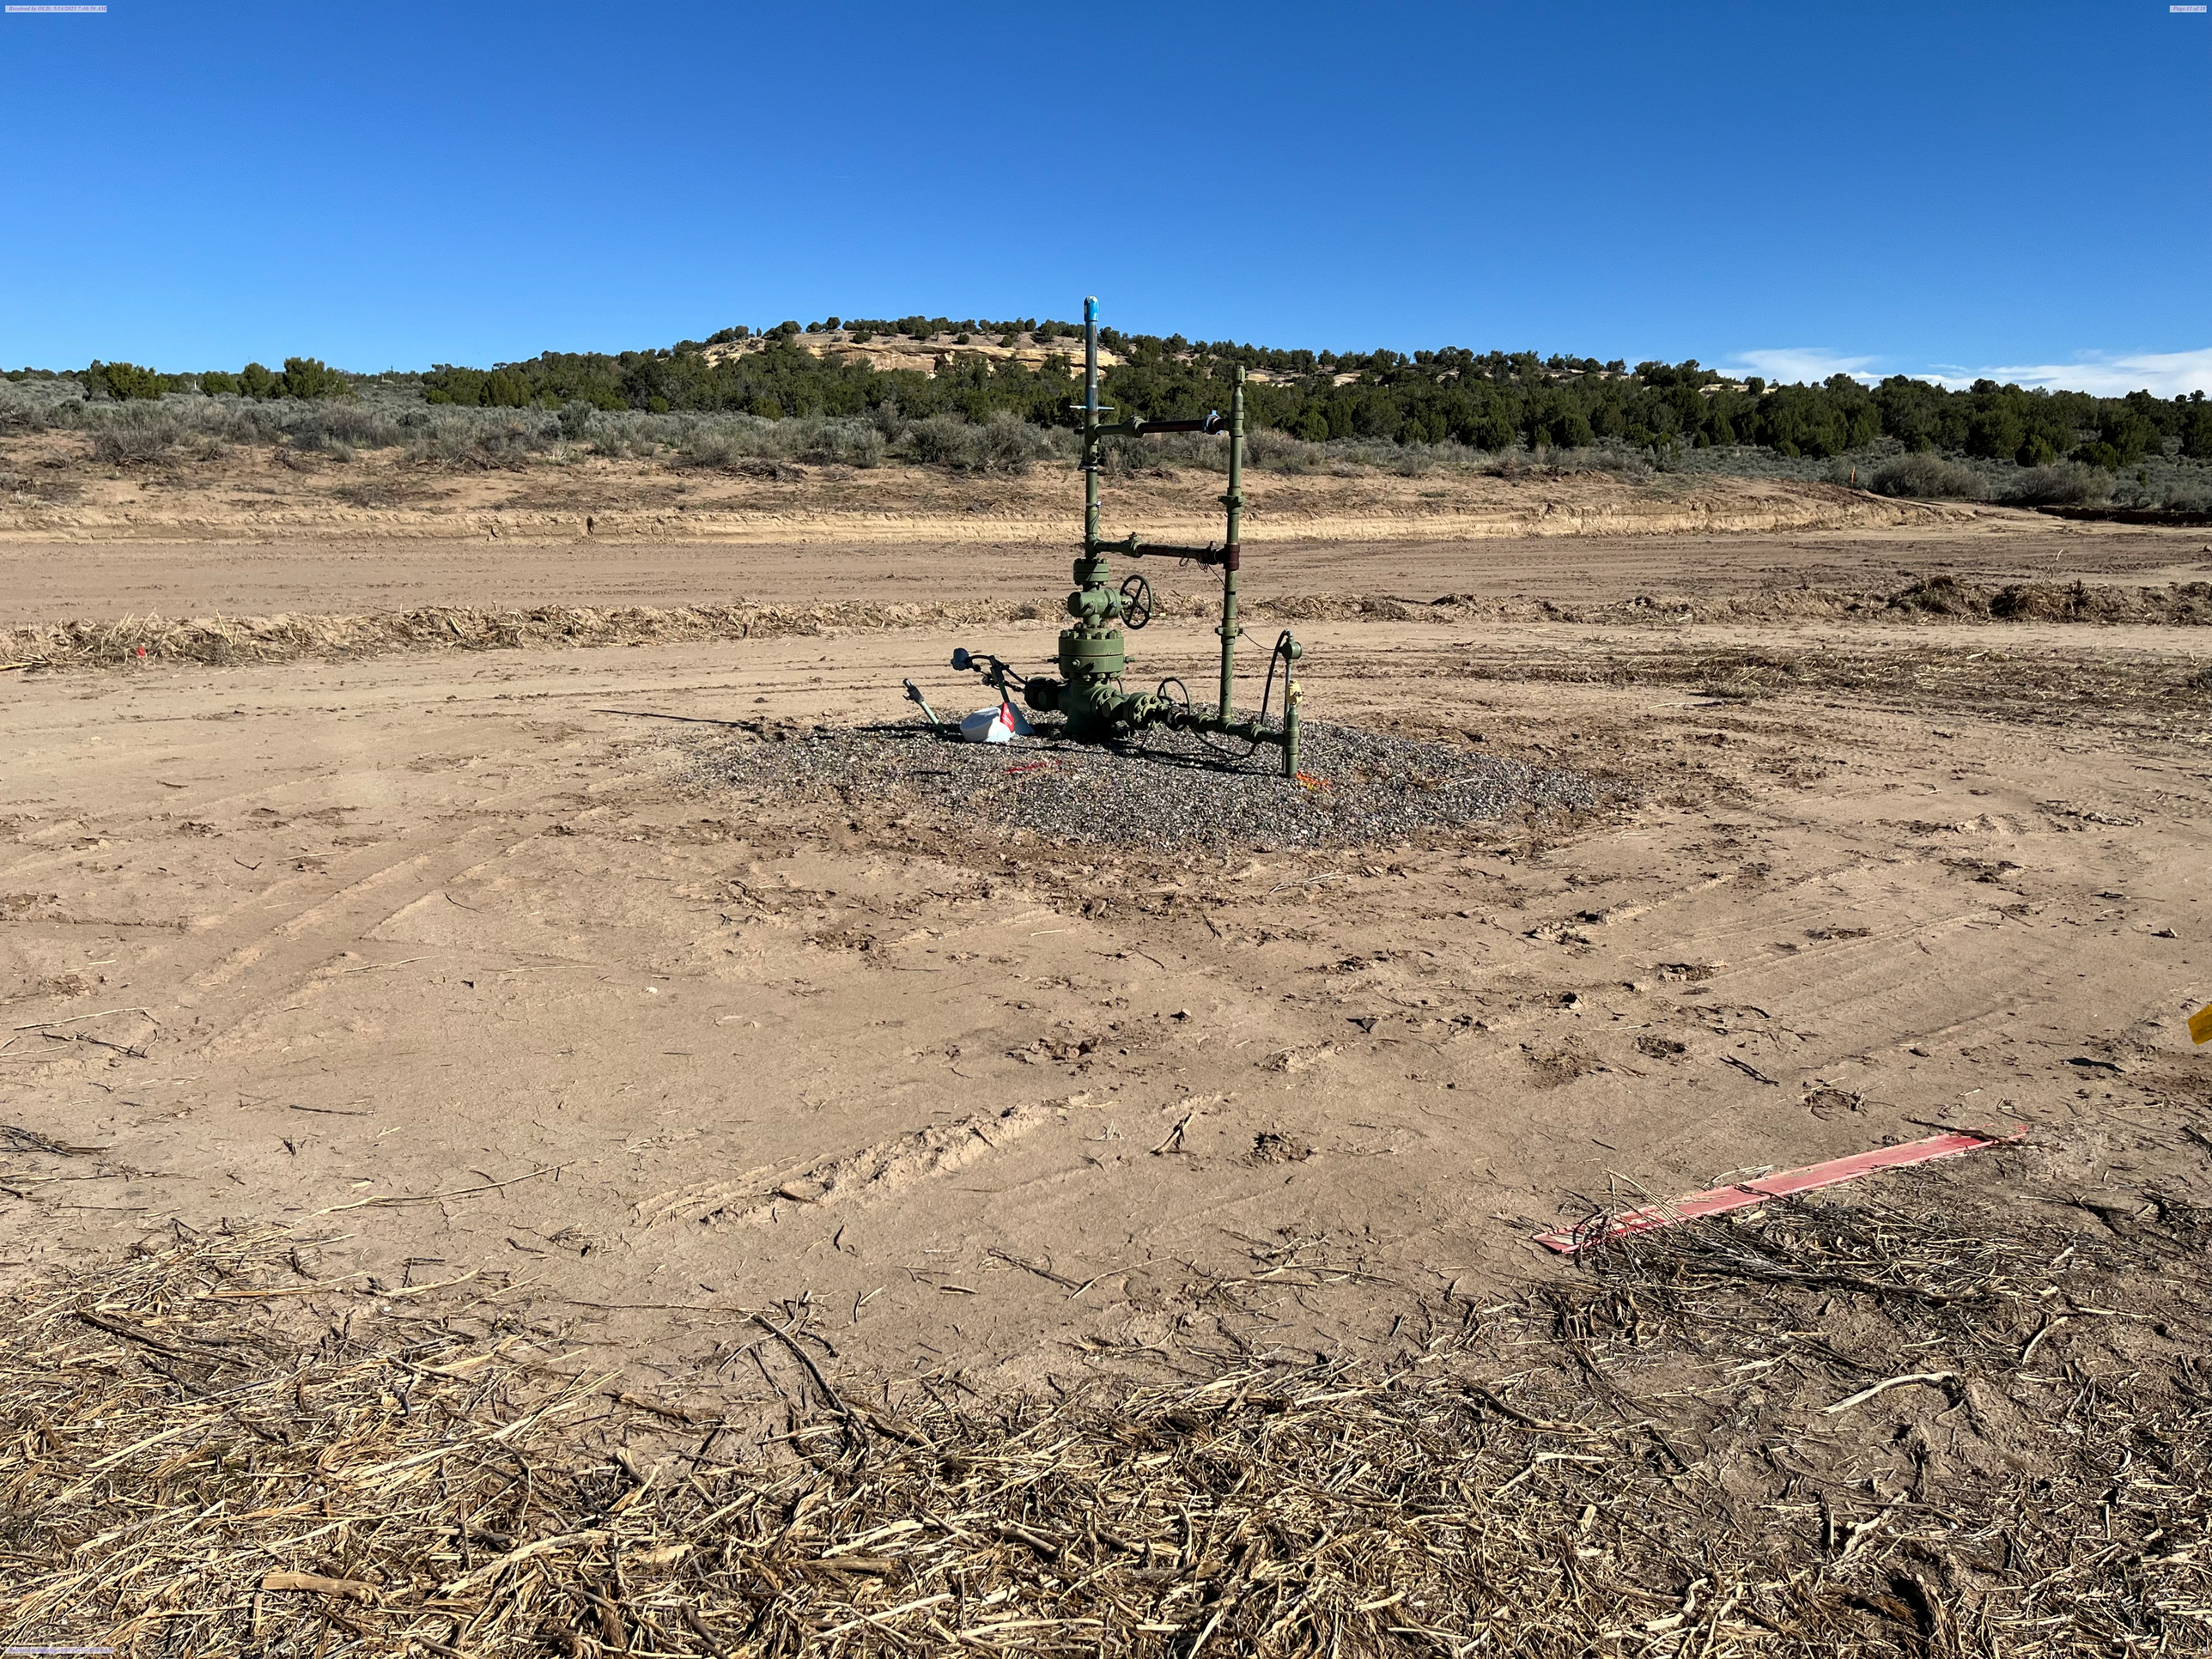
took photos of site. - Enterprise encroachment monitor on-site

LF does not have any contaminated soil in cells yet - does have LF sign (photographed)

excavation of former battery is approximately 24' deep. still failing on E-SE corner per earth work contractor
