Closure Report
Tar Heel 19-18-7 Federal Com 5H
Incident ID: nAPP2424334807
Eddy County, New Mexico
Unit N Sec 29 T26S R30E
32.006178°, -103.907038°

Drilling Mud/Fluid Release
Point of Release: Dump trailer seal failed while driving
Release Date: 08.30.2024
Volume Released: 72 Barrels of Drilling Mud/Fluid
Volume Recovered: 72 Barrels of Drilling Mud/Fluid

Re: Closure Report
Tar Heel 19-18-7 Federal Com 5H (8.30.2024)
Incident ID: nAPP2424334807
Cimarex Energy Co.
Site Location: Unit N, S29, T26S, R30E
(Lat 32.006178º, Long -103.907038º)
Eddy County, New Mexico

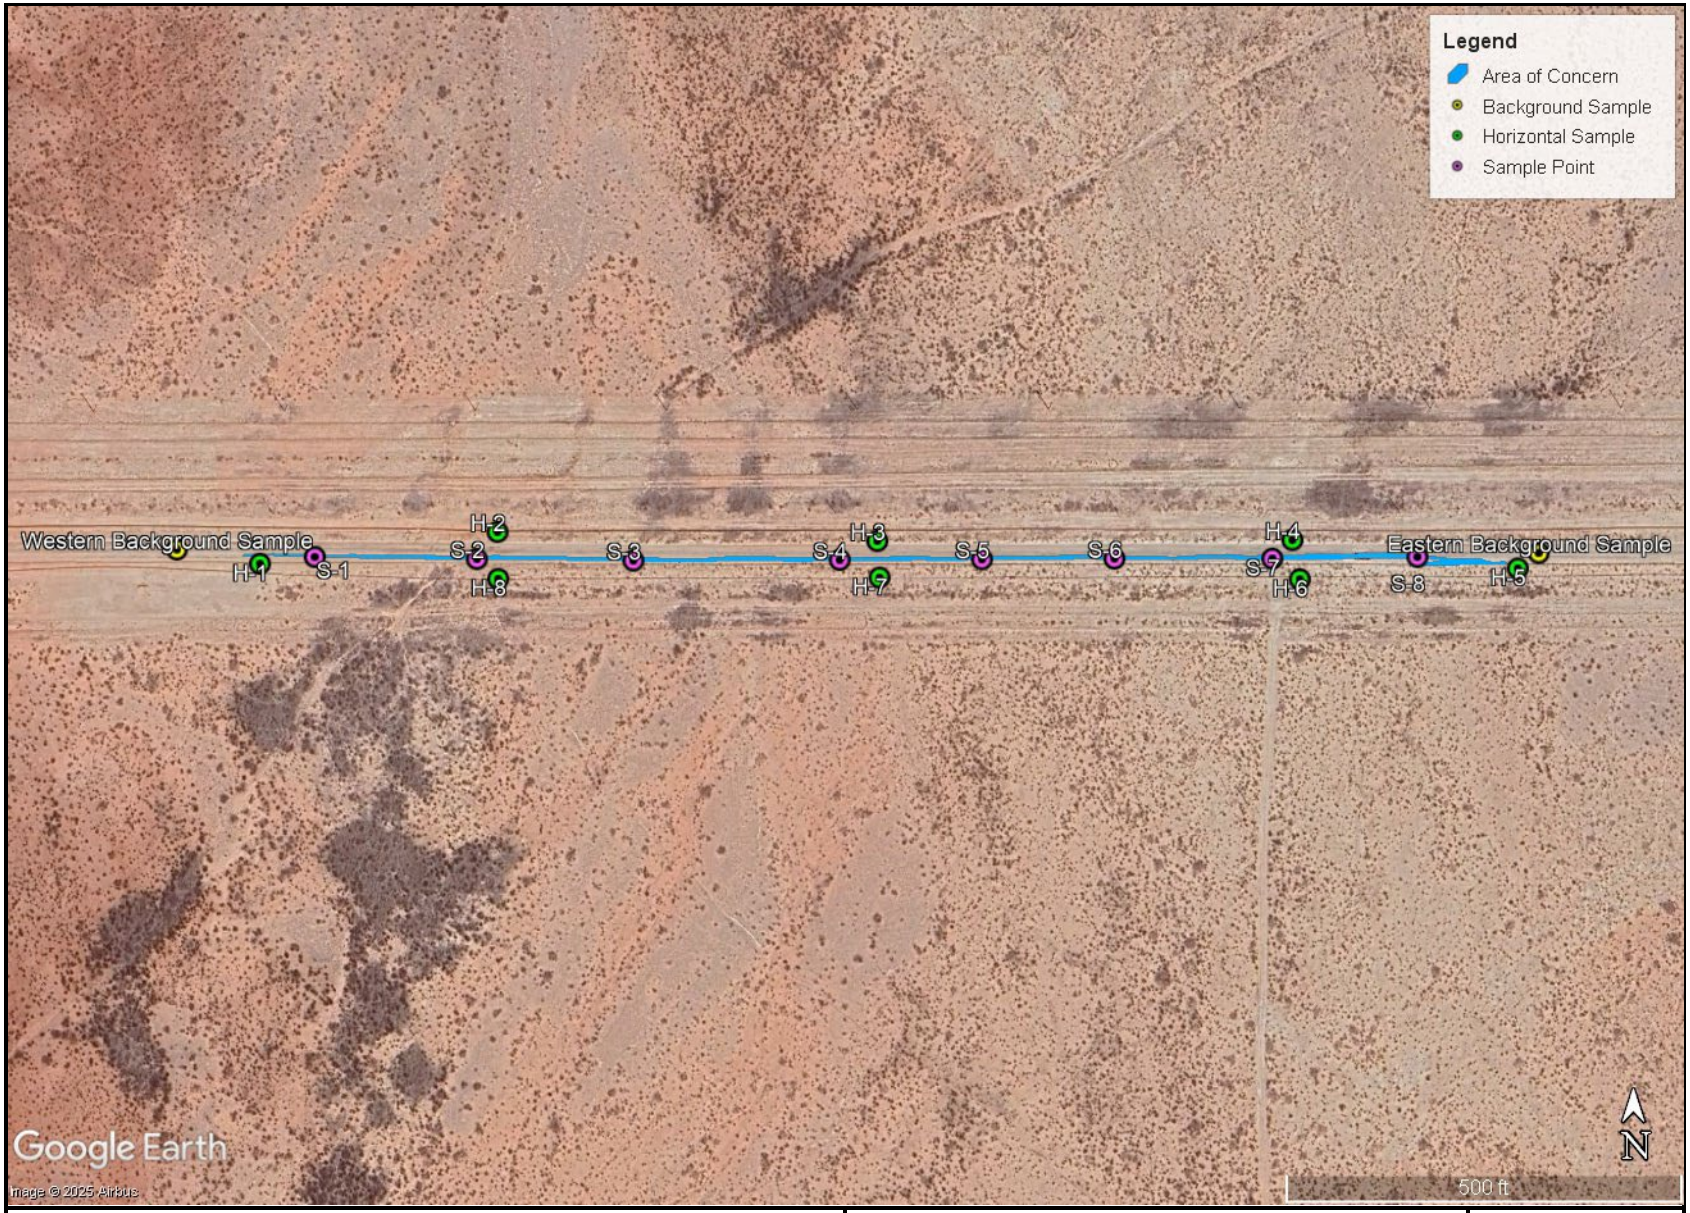
SAMPLE LOCATION MAP CIMAREX ENERGY CO. TAR HEEL 19-18-7 FEDERAL COM 5H (8.30.2024) EDDY COUNTY, NEW MEXICO 32.006178°, -103.907038 °	CARMONA RESOURCES	FIGURE 3

Background samples collected from the East and West ends of the spill area confirmed a naturally high presence of chlorides along the roadway. Based on these findings, it was concluded that the excavation would be solely focused within the areas of S-6 and S-8 until TPH concentrations are below 100 mg/kg. The email correspondence requesting the variance can be found in Appendix C. Copies of laboratory analysis and chain-of-custody documentation are included in Appendix E. Refer to Table 1 for the Background Sample results. See Figure 3 for the sample locations.

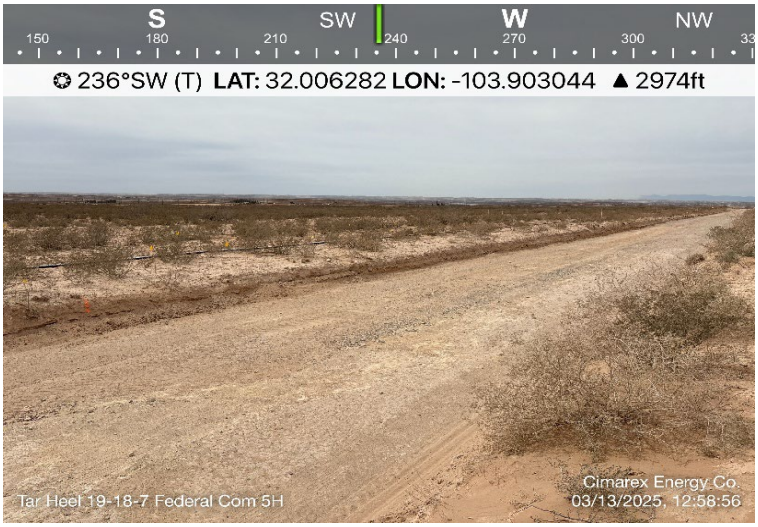
Description:
View Southwest, area of CS-1 through CS-8.

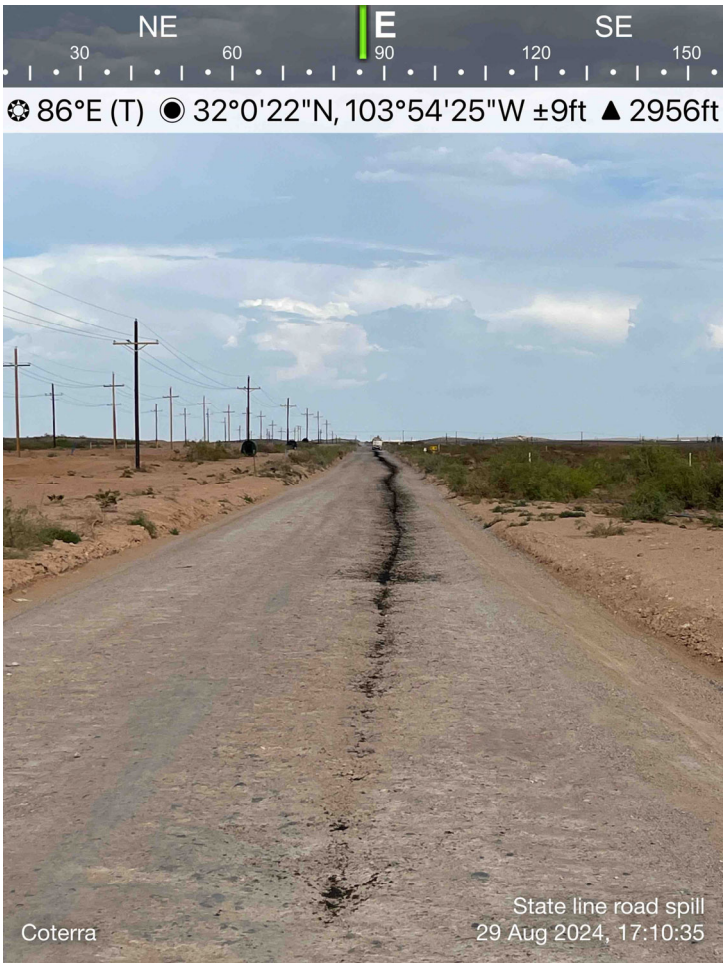
INITIAL RELEASE

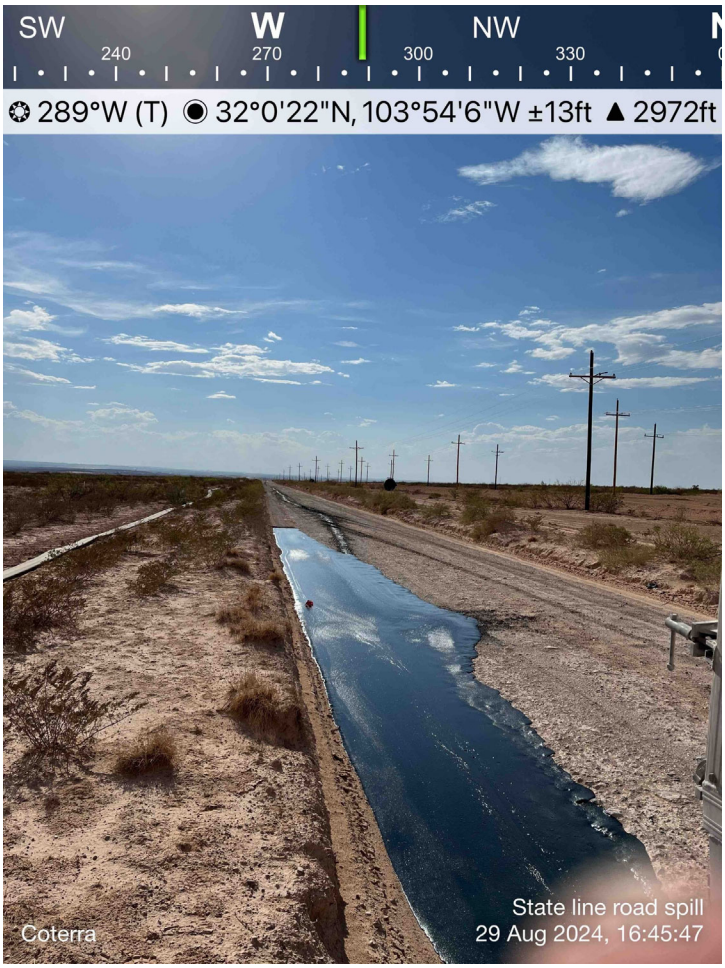
INITIAL RELEASE
