RECLAMATION CLOSURE REPORT

PREPARED FOR:
DEVON ENERGY PRODUCTION, LP.

PREPARED BY:
PIMA ENVIRONMENTAL SERIVCES, LLC.

RE: RECLAMATION CLOSURE REPORT
LOCATION: Green Wave 20 CTB 3
FACILITY ID: fAPP2130250168
GPS: 32.03175646, -103.4937875
INCIDENT LOCATION: UL- K. Section 28, T27N, R13W
COUNTY: Lea
NMOCD REF. NO. NAPP2331731081

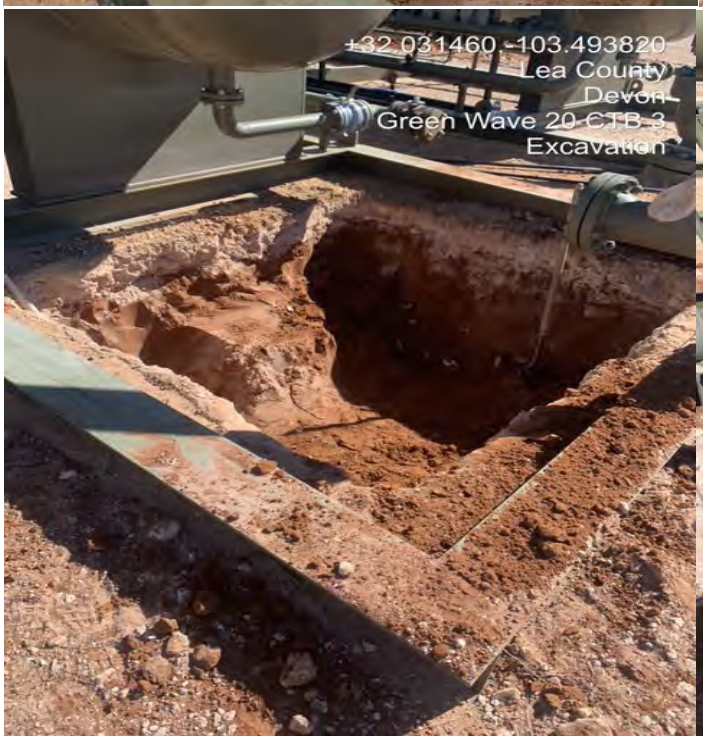
+32.027201,-103.487478
Devon
Green Wave 20 CTB 3
Excavation
CAUTION

On February 5, 2024, the Devon Construction Department mobilized personnel and equipment to begin immediate remediation activities. They began by excavating the area to a depth of 3' BGS. The contaminated soil (8 cubic yards) was hauled to an approved, lined disposal facility and clean backfill material was brought in.
