April 14, 2026

Re: First Quarter 2026 – Remediation System Operation and Monitoring Report
Standard #1
San Juan County, New Mexico
Hilcorp Energy Company
NMOCD Incident Number: NCS1735235018
Abatement Plan Number: AP-126

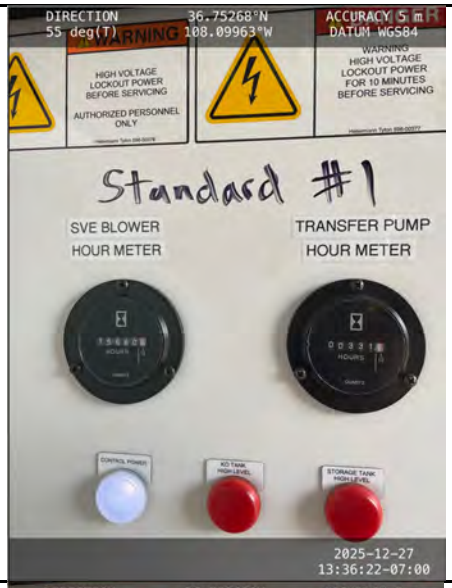
Photograph 1 Runtime meter taken on December 27, 2025 at 1:36 PM Hours = 15,660.8

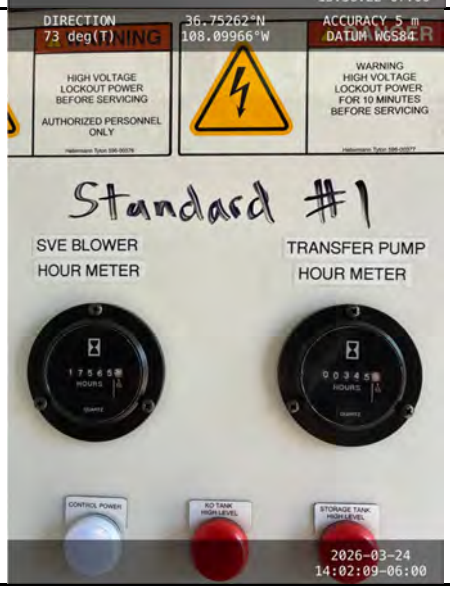
Photograph 2 Runtime meter taken on March 24, 2026 at 2:02 PM Hours = 17,565.8
