BD Jct. N-29

RICE OPERATING COMPANY
JUNCTION BOX DISCLOSURE* REPORT

SWD SYSTEM	JUNCTION	UNIT	SECTION	TOWNSHIP	RANGE	COUNTY	BOX DIMENSIONS - FEET		
							Length	Width	Depth
Blinebry-Drinkard (BD)	Jct. N-29	N	29	22S	38E	Lea	4	4	2
							Eliminated

RE: JUNCTION BOX UPGRADE REPORT for 2013
BD SWD SYSTEM
Lea County, New Mexico

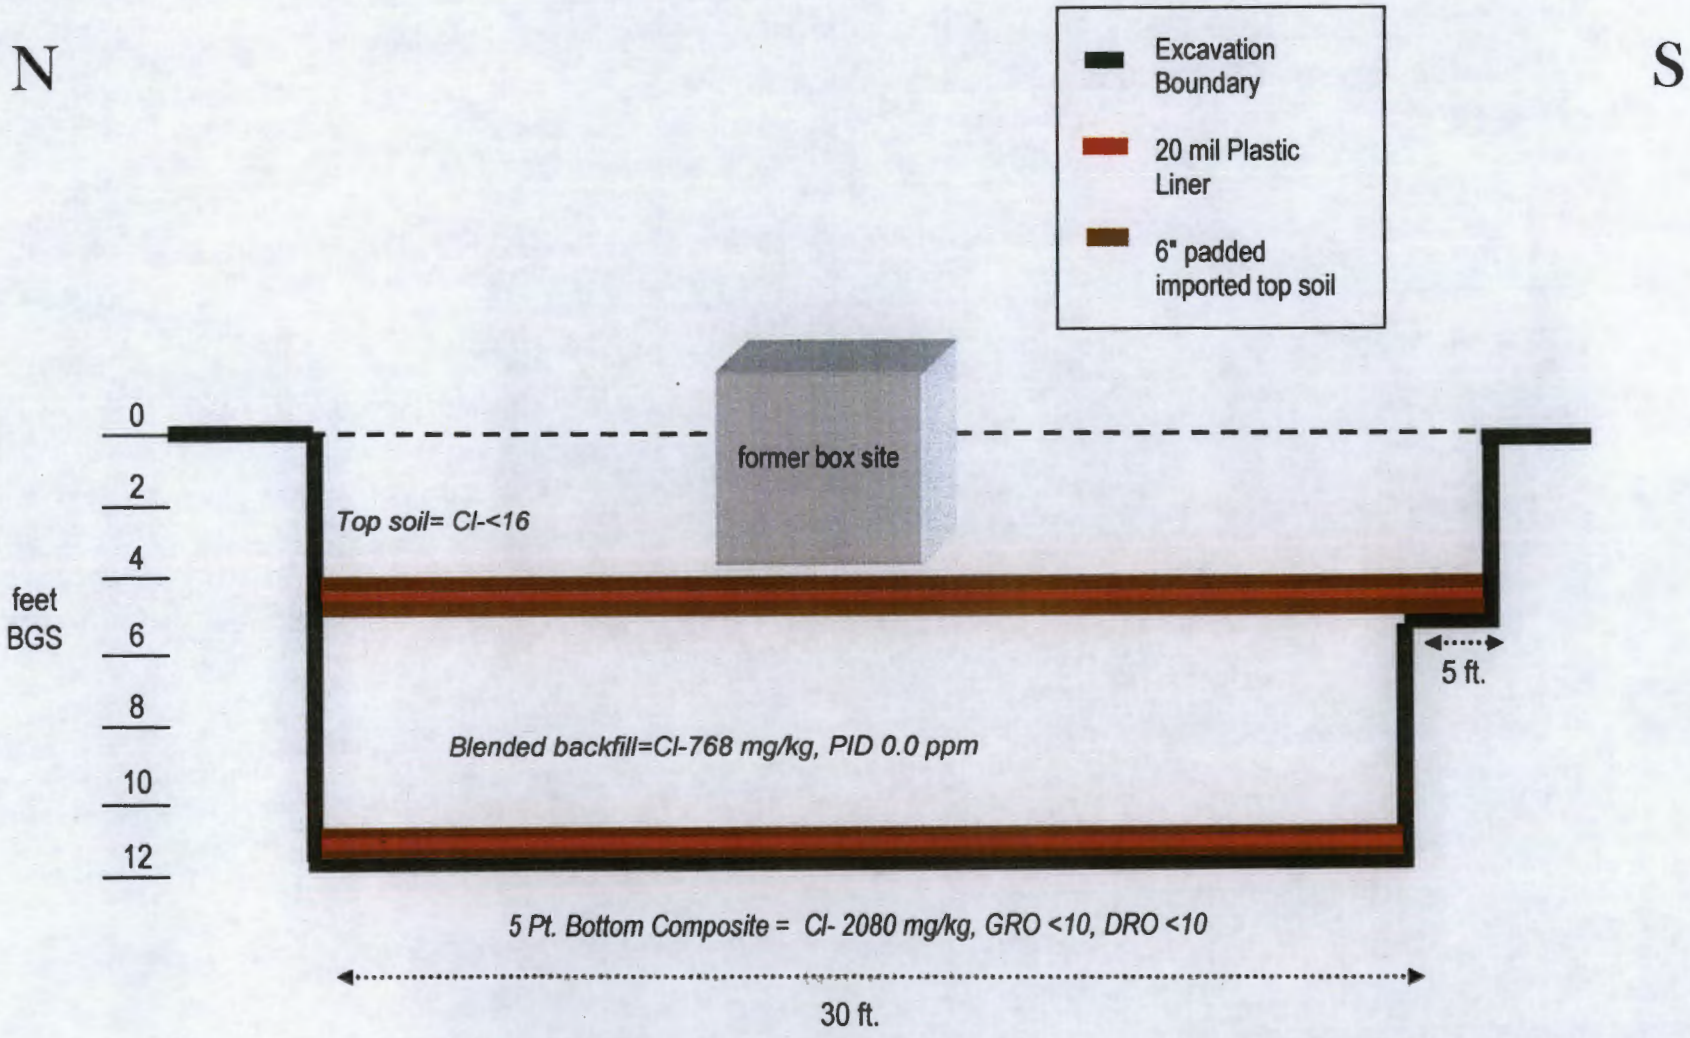
Excavation Cross-Section

Soil Excavated 400 cubic yards Excavation Length 30 Width 30 Depth 12 feet

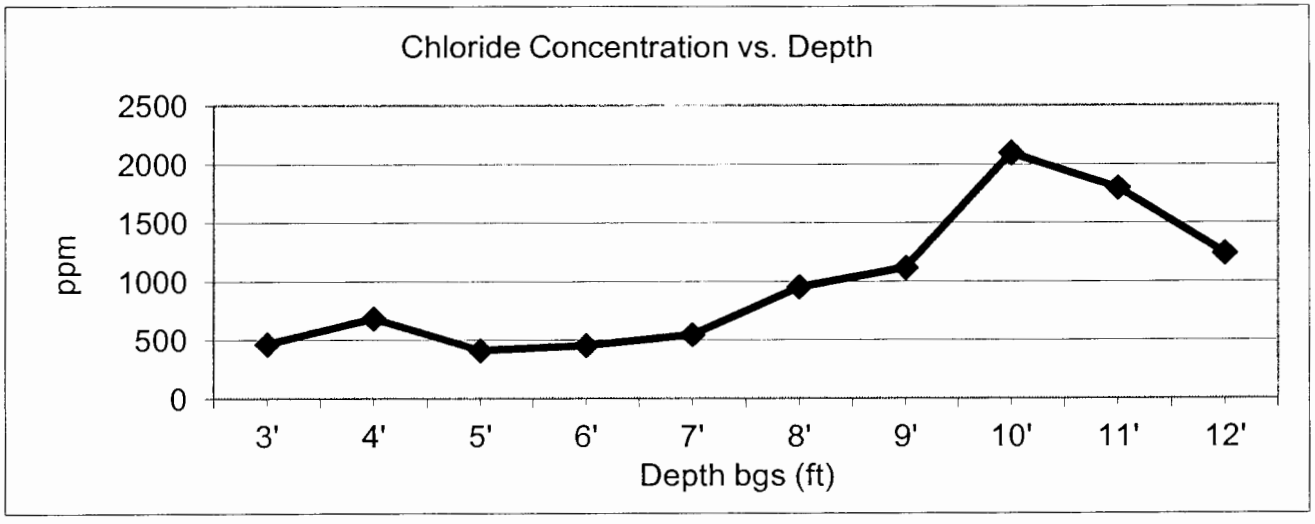
Backhoe samples at the junction (source)

Depth bgs (ft)	[Cl⁻] ppm
3'	464
4'	685
5'	411
6'	453
7'	545
8'	954
9'	1117
10'	2097
11'	1799
12'	1241

Groundwater = 124 ft

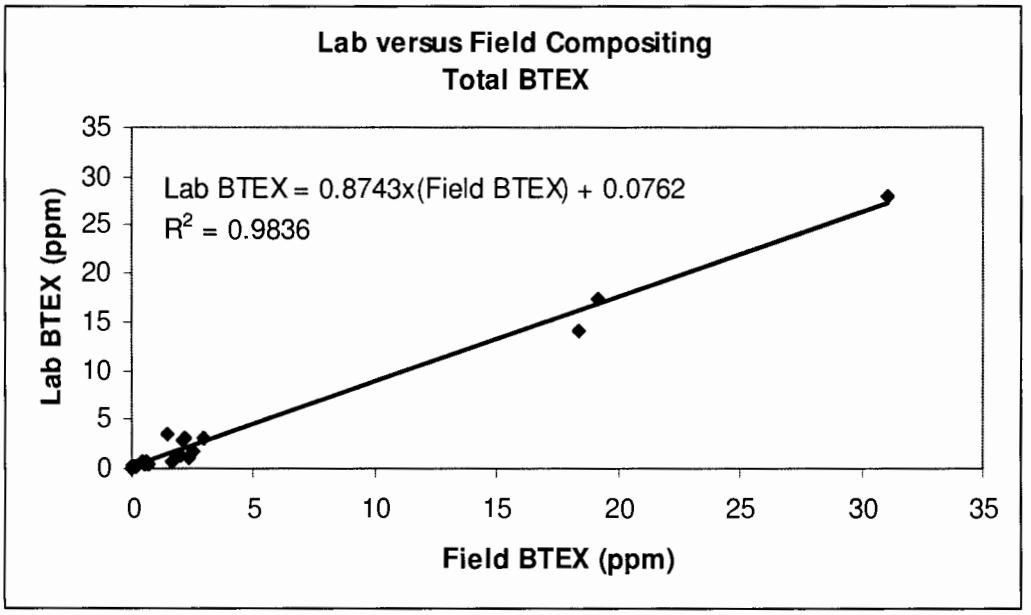
Figure 1 - Laboratory versus field-composited soil samples analyzed for BTEX.

The high R^2 value (0.9836) of the best-fit statistical regression line indicates a high degree of reliability in using the field-compositing method over the range of values observed. Below a "field-composited BTEX" value of 0.61 ppm the "lab-composited BTEX" values are slightly lower. However, above a field-composited BTEX value of 0.61 the lab-composited values run slightly lower. In other words, the field-composited values tended to produce slightly higher BTEX numbers above the point at which BTEX concentrations become significant.

There is a reason for this. BTEX is volatile and quickly biodegradable. The compositing and "packaging" of soil samples in the field minimize the handling and aeration that occur in the laboratory. Thus, field-composited soil samples lose less BTEX to evaporation and/or biodegradation prior to laboratory analysis. In other words, the field compositing and packaging of soil samples better preserves sample integrity, and for this reasons would appear to represent the better method of procuring soil samples for subsequent analysis of BTEX.

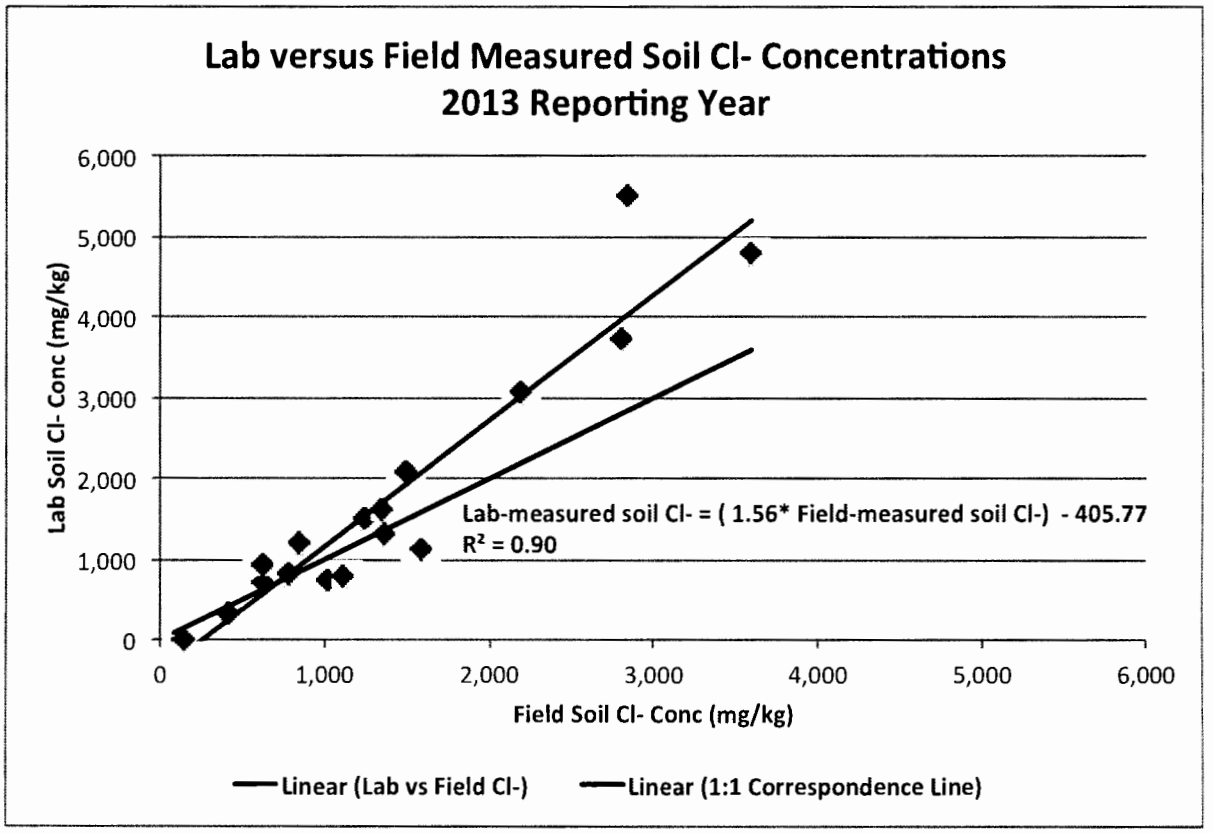
Figure 1 – Laboratory versus field measured soil chloride measurements (n = 29 paired sets).

A straight line fit to the data confirms a general linear trend over a wide range of soil chloride concentrations, and the R^2 value (0.90) indicates that field measurements provide a reliable approximation of laboratory-measured values. Based on the best-fit line of lab vs field measured values, field measured values overestimate lab measure values below a field measured value of 723 mg/kg and above this underestimate the lab-measured values. This is indicated in the graph where the (blue) best-fit line of lab vs field measured chlorides crosses the (black) line which would indicate a 1:1 correspondence.
