EME Jct. D-19

RE: Termination Request
EME Jct. D-19: UL/D, Sec. 19, T19S, R37E
RICE Operating Company – Eunice Monument Eumont SWD System

RICE OPERATING COMPANY
JUNCTION BOX FINAL REPORT

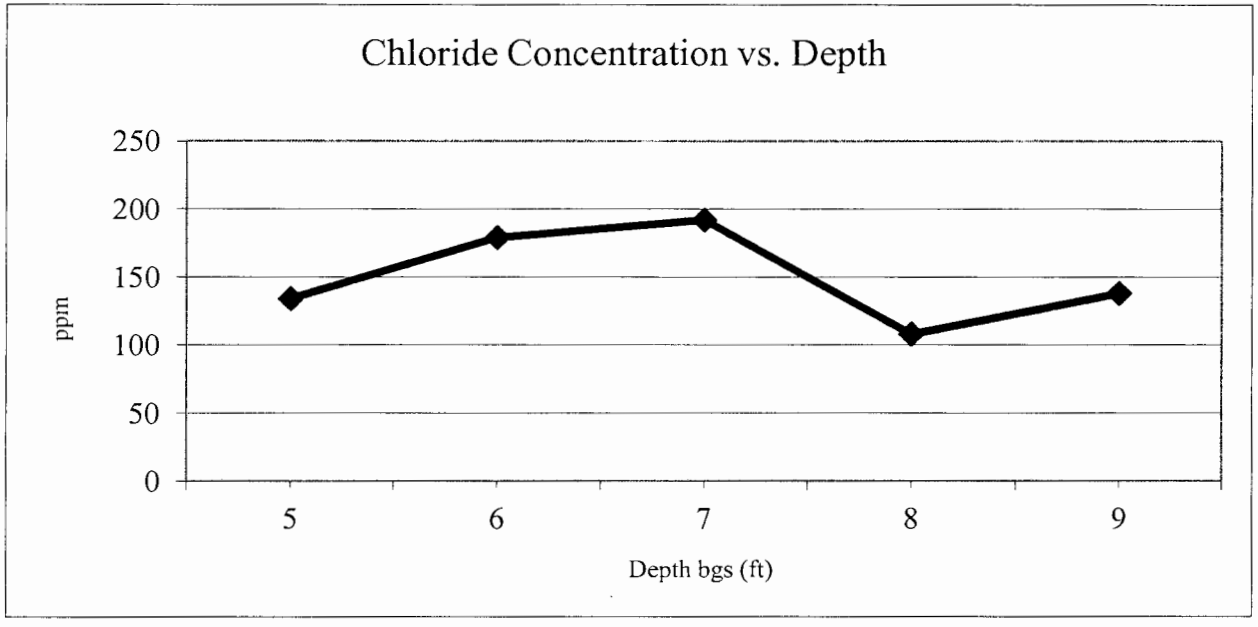
Backhoe samples at junction (source)

Depth bgs (ft)	[Cl⁻] ppm
5	134
6	179
7	192
8	108
9	138

Groundwater = 42 ft

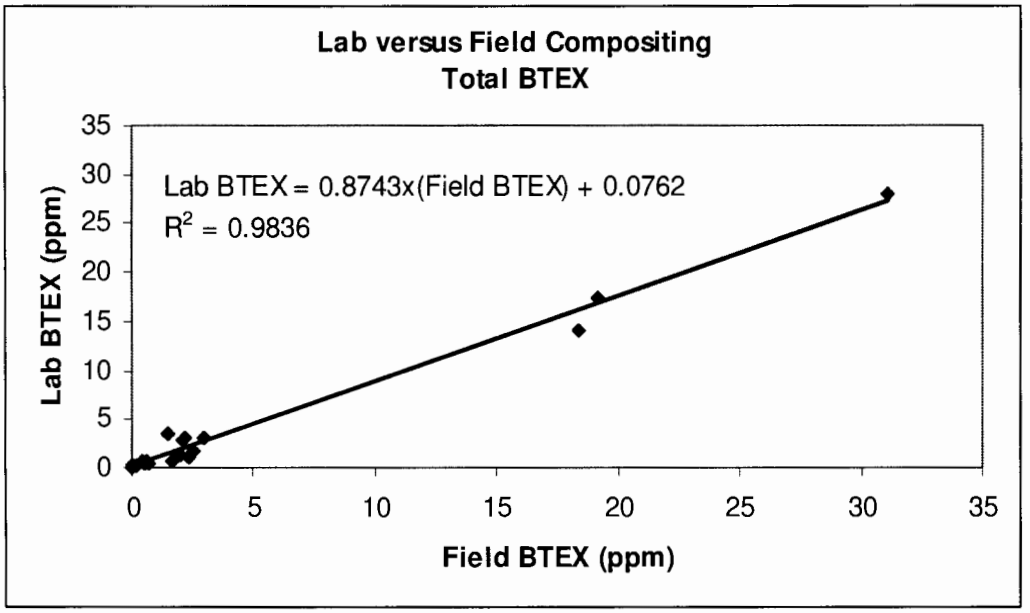
Figure 1 - Laboratory versus field-composited soil samples analyzed for BTEX.

A comparison of lab-composited soil samples versus field-composited soil samples revealed a close correspondence for total BTEX between the two methods (Figure 1).

The high R^2 value (0.9836) of the best-fit statistical regression line indicates a high degree of reliability in using the field-compositing method over the range of values observed. Below a "field-composited BTEX" value of 0.61 ppm the "lab-composited BTEX" values are slightly lower. However, above a field-composited BTEX value of 0.61 the lab-composited values run slightly lower. In other words, the field-composited values tended to produce slightly higher BTEX numbers above the point at which BTEX concentrations become significant.

There is a reason for this. BTEX is volatile and quickly biodegradable. The compositing and "packaging" of soil samples in the field minimize the handling and aeration that occur in the laboratory. Thus, field-composited soil samples lose less BTEX to evaporation and/or biodegradation prior to laboratory analysis. In other words, the field compositing and packaging of soil samples better preserves sample integrity, and for this reasons would appear to represent the better method of procuring soil samples for subsequent analysis of BTEX.

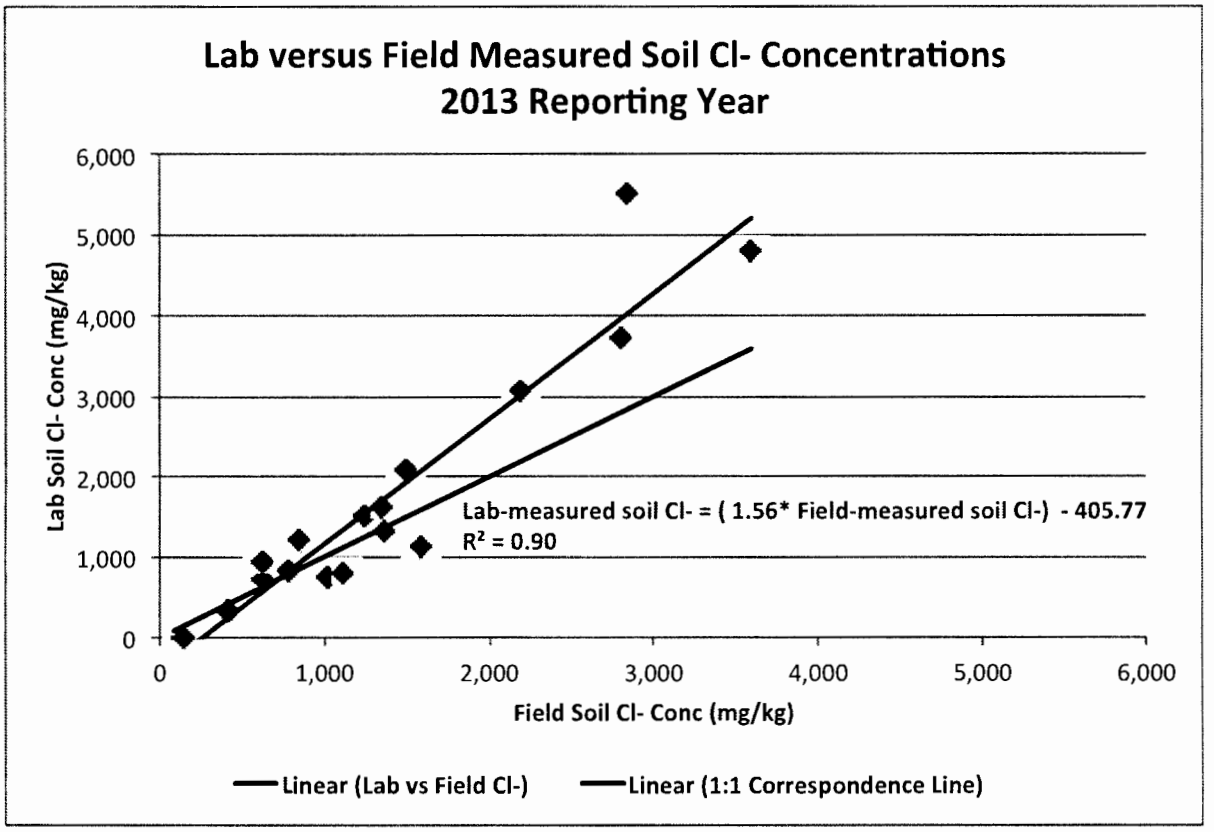
Figure 1 – Laboratory versus field measured soil chloride measurements (n = 29 paired sets).

A representative sample of 29 pairs of laboratory versus field measured soil chloride values was compared to determine how well field measurements matched laboratory measurements. It is assumed that laboratory measurements better represent the "true" values due to the controlled environment that a laboratory provides. A simple plot of the laboratory versus field measured soil chloride values is given below (Figure 1).

A straight line fit to the data confirms a general linear trend over a wide range of soil chloride concentrations, and the R^2 value (0.90) indicates that field measurements provide a reliable approximation of laboratory-measured values. Based on the best-fit line of lab vs field measured values, field measured values overestimate lab measure values below a field measured value of 723 mg/kg and above this underestimate the lab-measured values. This is indicated in the graph where the (blue) best-fit line of lab vs field measured chlorides crosses the (black) line which would indicate a 1:1 correspondence.
