EME M-9 EOL

RE: Termination Request
EME M-9 EOL: UL/M, Sec. 9, T21S, R36E
RICE Operating Company – Eunice Monument Eumont (EME) SWD System

RICE OPERATING COMPANY
JUNCTION BOX FINAL REPORT

RE: JUNCTION BOX UPGRADE REPORT for 2013
EME SWD SYSTEM
Lea County, New Mexico

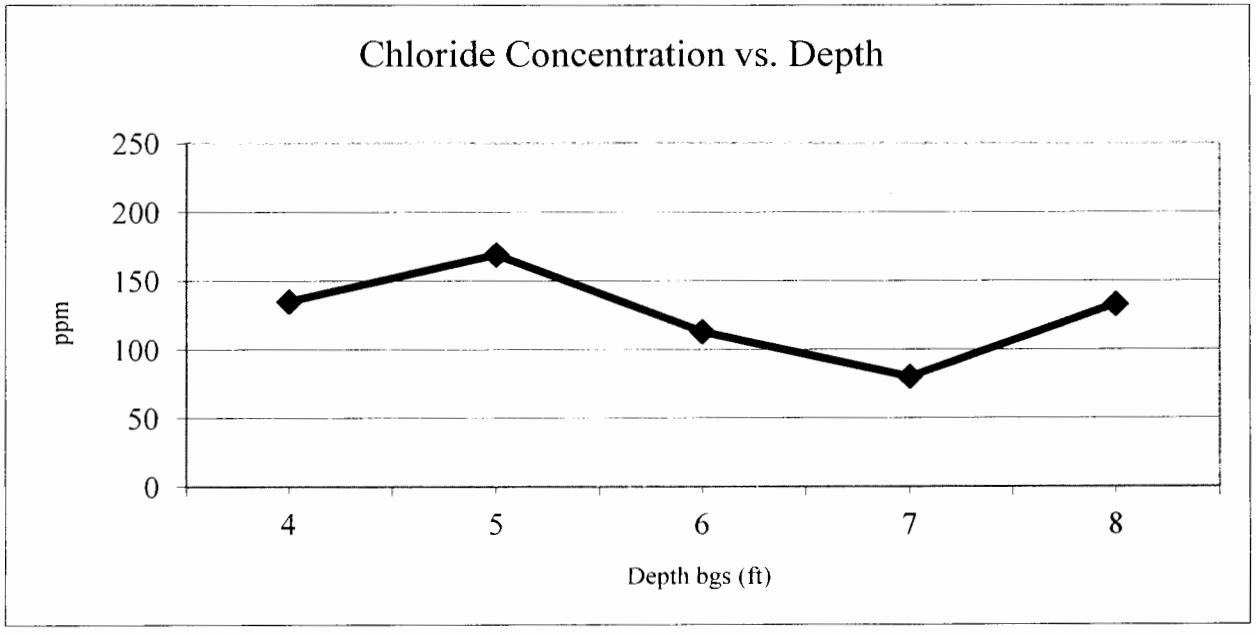
Backhoe samples at junction (source)

Depth bgs (ft)	[Cl^-] ppm
4	135
5	169
6	113
7	80
8	133

Groundwater = 198 ft

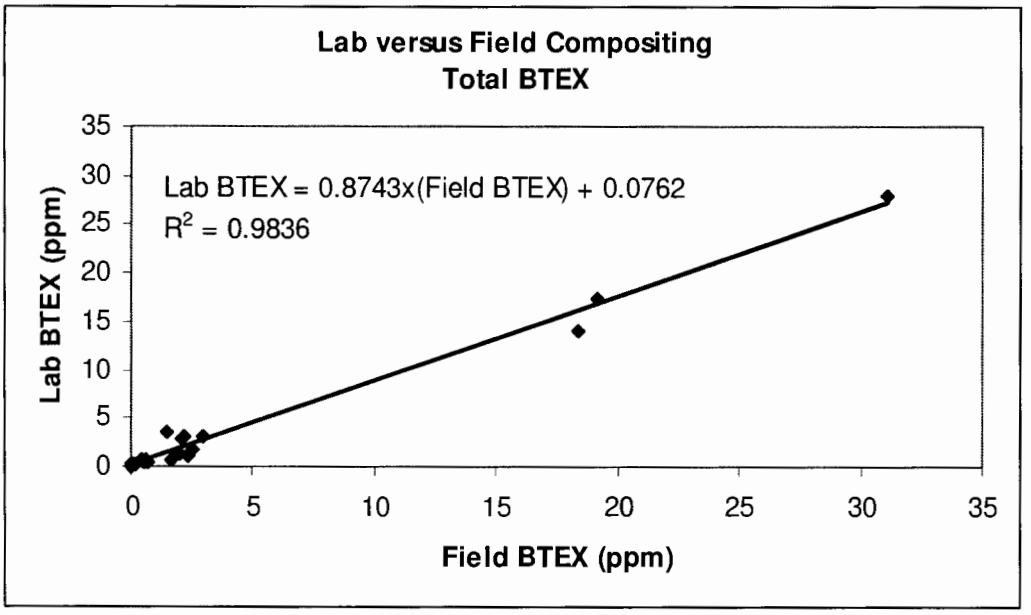
Figure 1 - Laboratory versus field-composited soil samples analyzed for BTEX.

The high R^2 value (0.9836) of the best-fit statistical regression line indicates a high degree of reliability in using the field-compositing method over the range of values observed. Below a "field-composited BTEX" value of 0.61 ppm the "lab-composited BTEX" values are slightly lower. However, above a field-composited BTEX value of 0.61 the lab-composited values run slightly lower. In other words, the field-composited values tended to produce slightly higher BTEX numbers above the point at which BTEX concentrations become significant.

There is a reason for this. BTEX is volatile and quickly biodegradable. The compositing and "packaging" of soil samples in the field minimize the handling and aeration that occur in the laboratory. Thus, field-composited soil samples lose less BTEX to evaporation and/or biodegradation prior to laboratory analysis. In other words, the field compositing and packaging of soil samples better preserves sample integrity, and for this reasons would appear to represent the better method of procuring soil samples for subsequent analysis of BTEX.

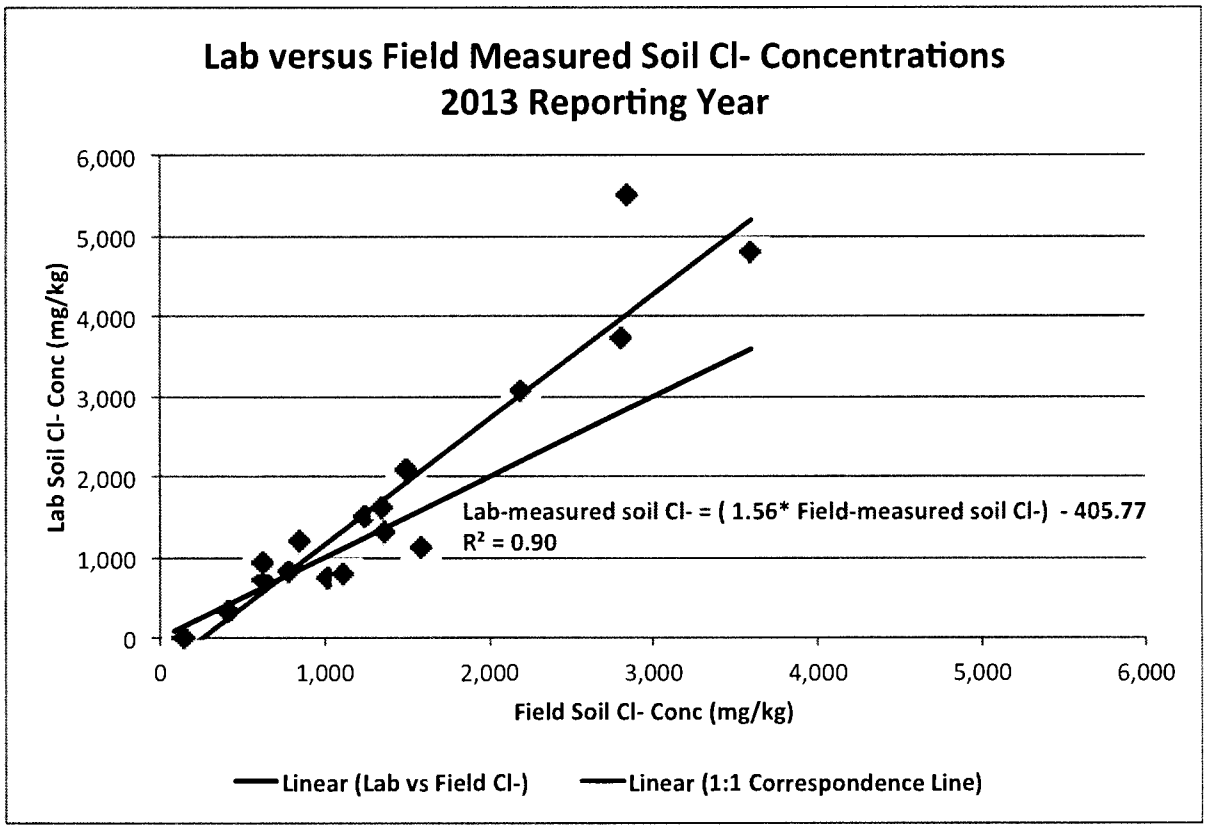
Figure 1 – Laboratory versus field measured soil chloride measurements (n = 29 paired sets).

A straight line fit to the data confirms a general linear trend over a wide range of soil chloride concentrations, and the R^2 value (0.90) indicates that field measurements provide a reliable approximation of laboratory-measured values. Based on the best-fit line of lab vs field measured values, field measured values overestimate lab measure values below a field measured value of 723 mg/kg and above this underestimate the lab-measured values. This is indicated in the graph where the (blue) best-fit line of lab vs field measured chlorides crosses the (black) line which would indicate a 1:1 correspondence.
