BP AMERICA PRODUCTION CO.

GROUNDWATER REMEDIATION REPORT

GCU #153E
(C) SECTION 28, T29N, R12W, NMPM
SAN JUAN COUNTY, NEW MEXICO

PREPARED BY:
BLAGG ENGINEERING, INC.

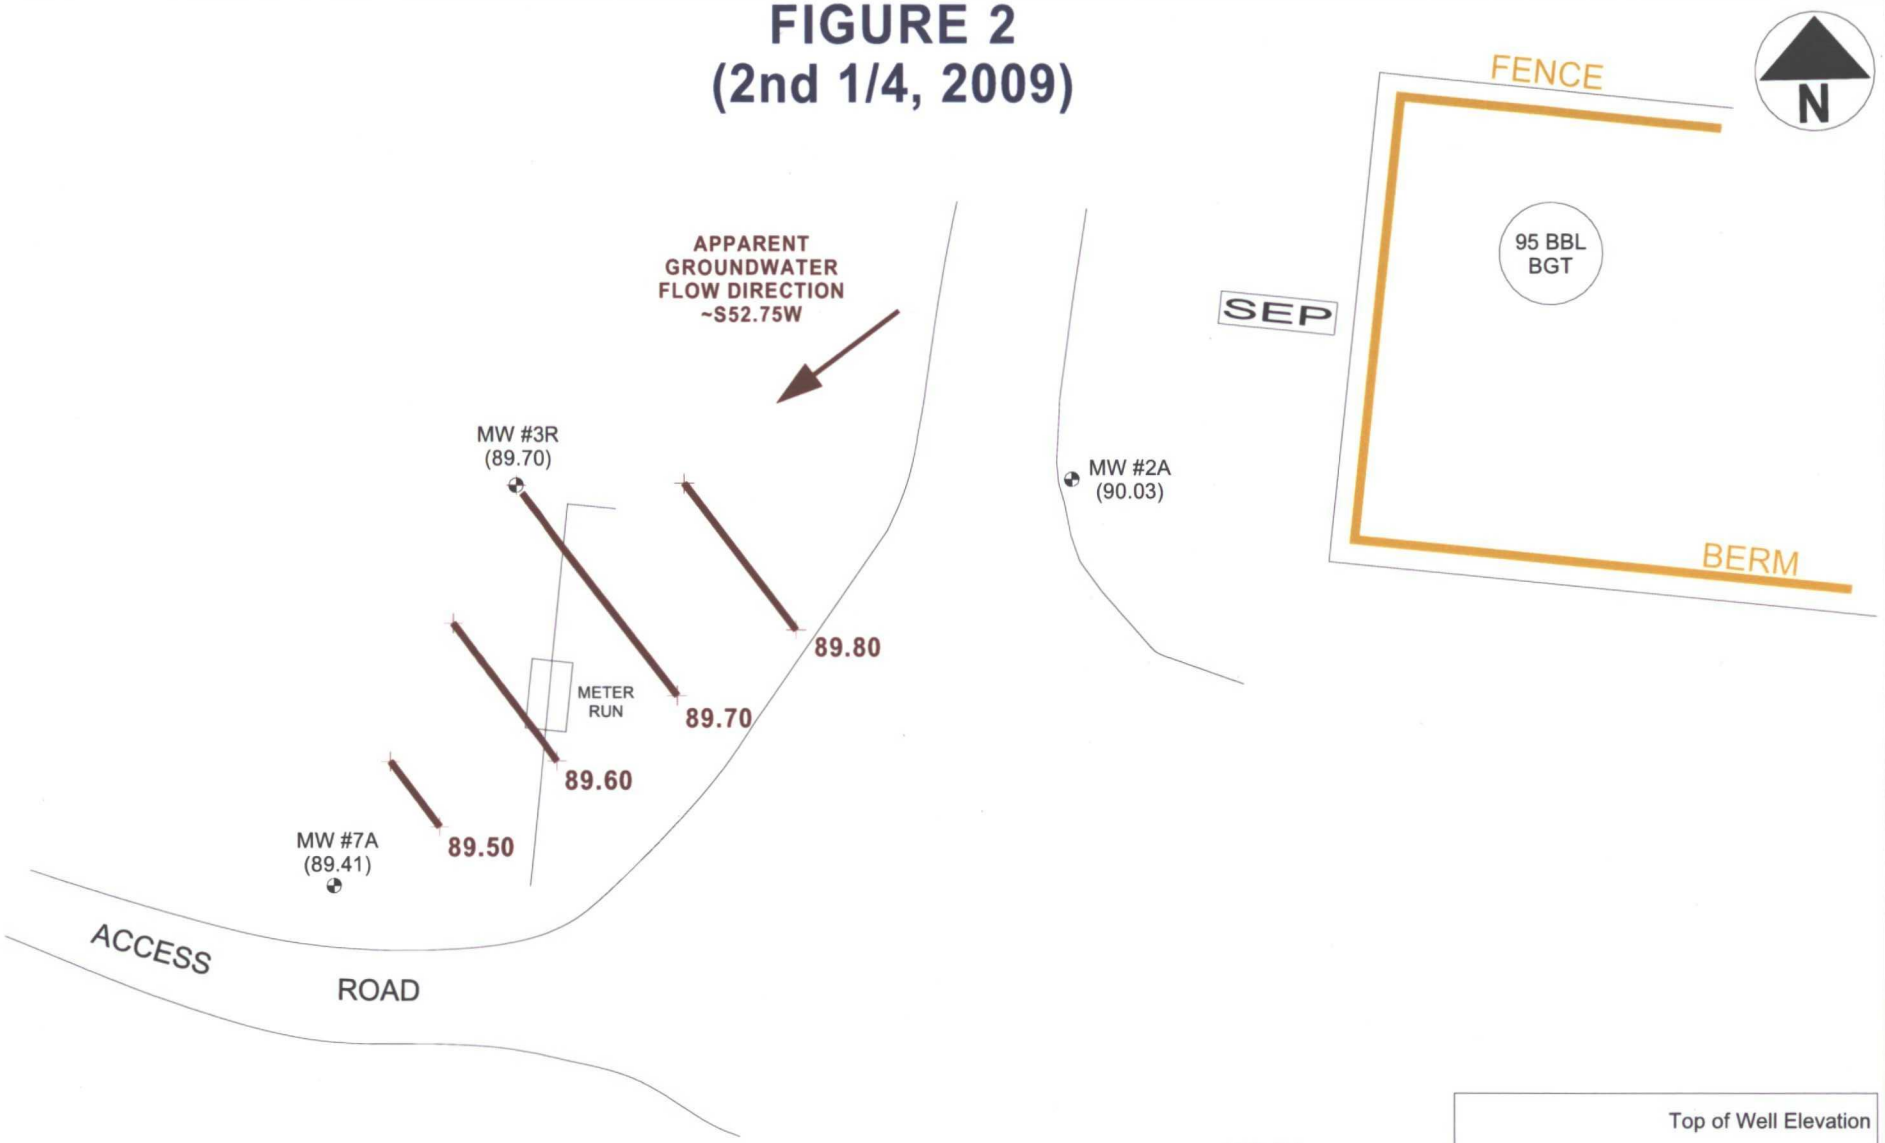
FIGURE 2
(2nd 1/4, 2009)

Groundwater contour maps (Figure 2 through Figure 7) reveal the relative elevations from the site wells have consistently shown an apparent southwest flow direction.

Top of Well Elevation	
MW #2A	(100.40)
MW #3R	(100.80)
MW #7A	(99.72)
MW #2A (90.03)	Groundwater elevation as of 5/26/09.

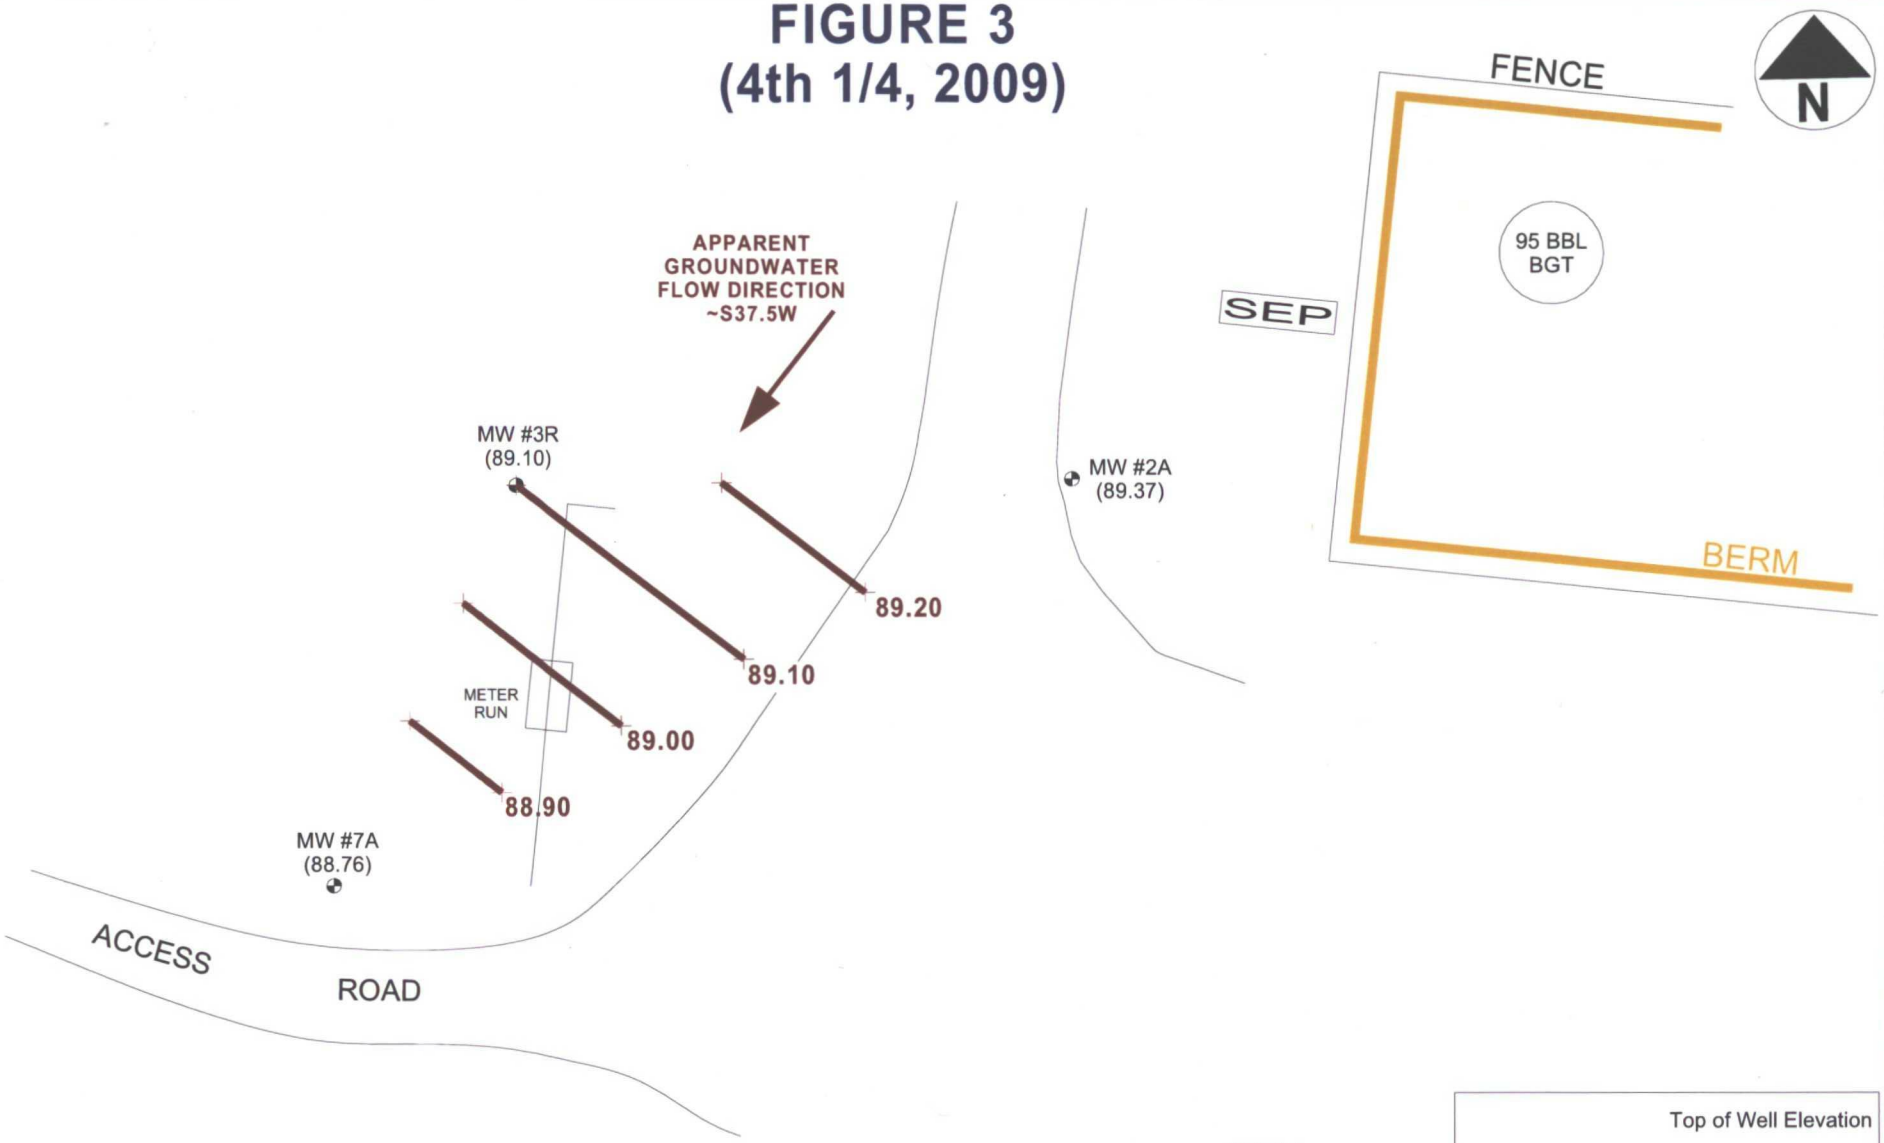
FIGURE 3
(4th 1/4, 2009)

Top of Well Elevation	
MW #2A	(100.40)
MW #3R	(100.80)
MW #7A	(99.72)
MW #2A (89.37)	Groundwater elevation as of 12/28/09.

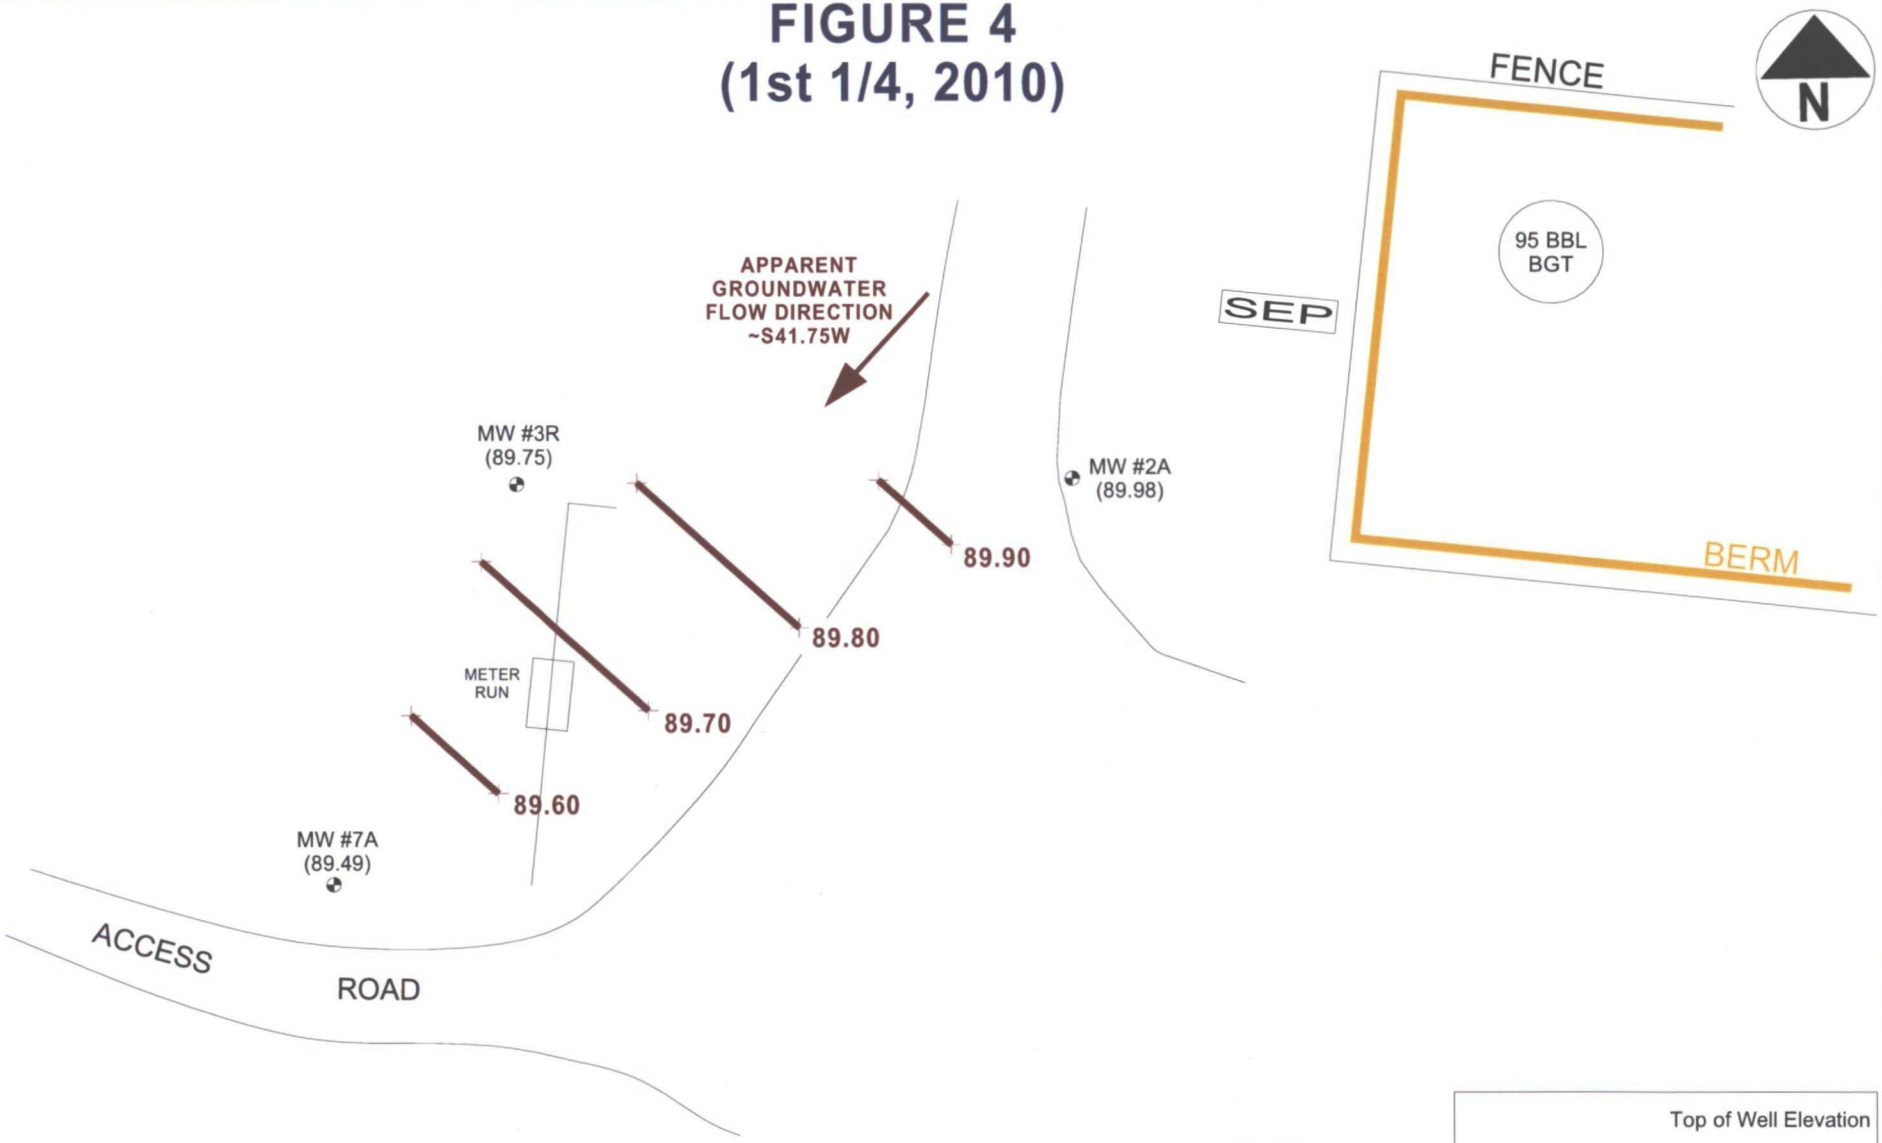
FIGURE 4
(1st 1/4, 2010)

Top of Well Elevation	
MW #2A	(100.40)
MW #3R	(100.80)
MW #7A	(99.72)
MW #2A (89.98)	Groundwater elevation as of 3/2/10.

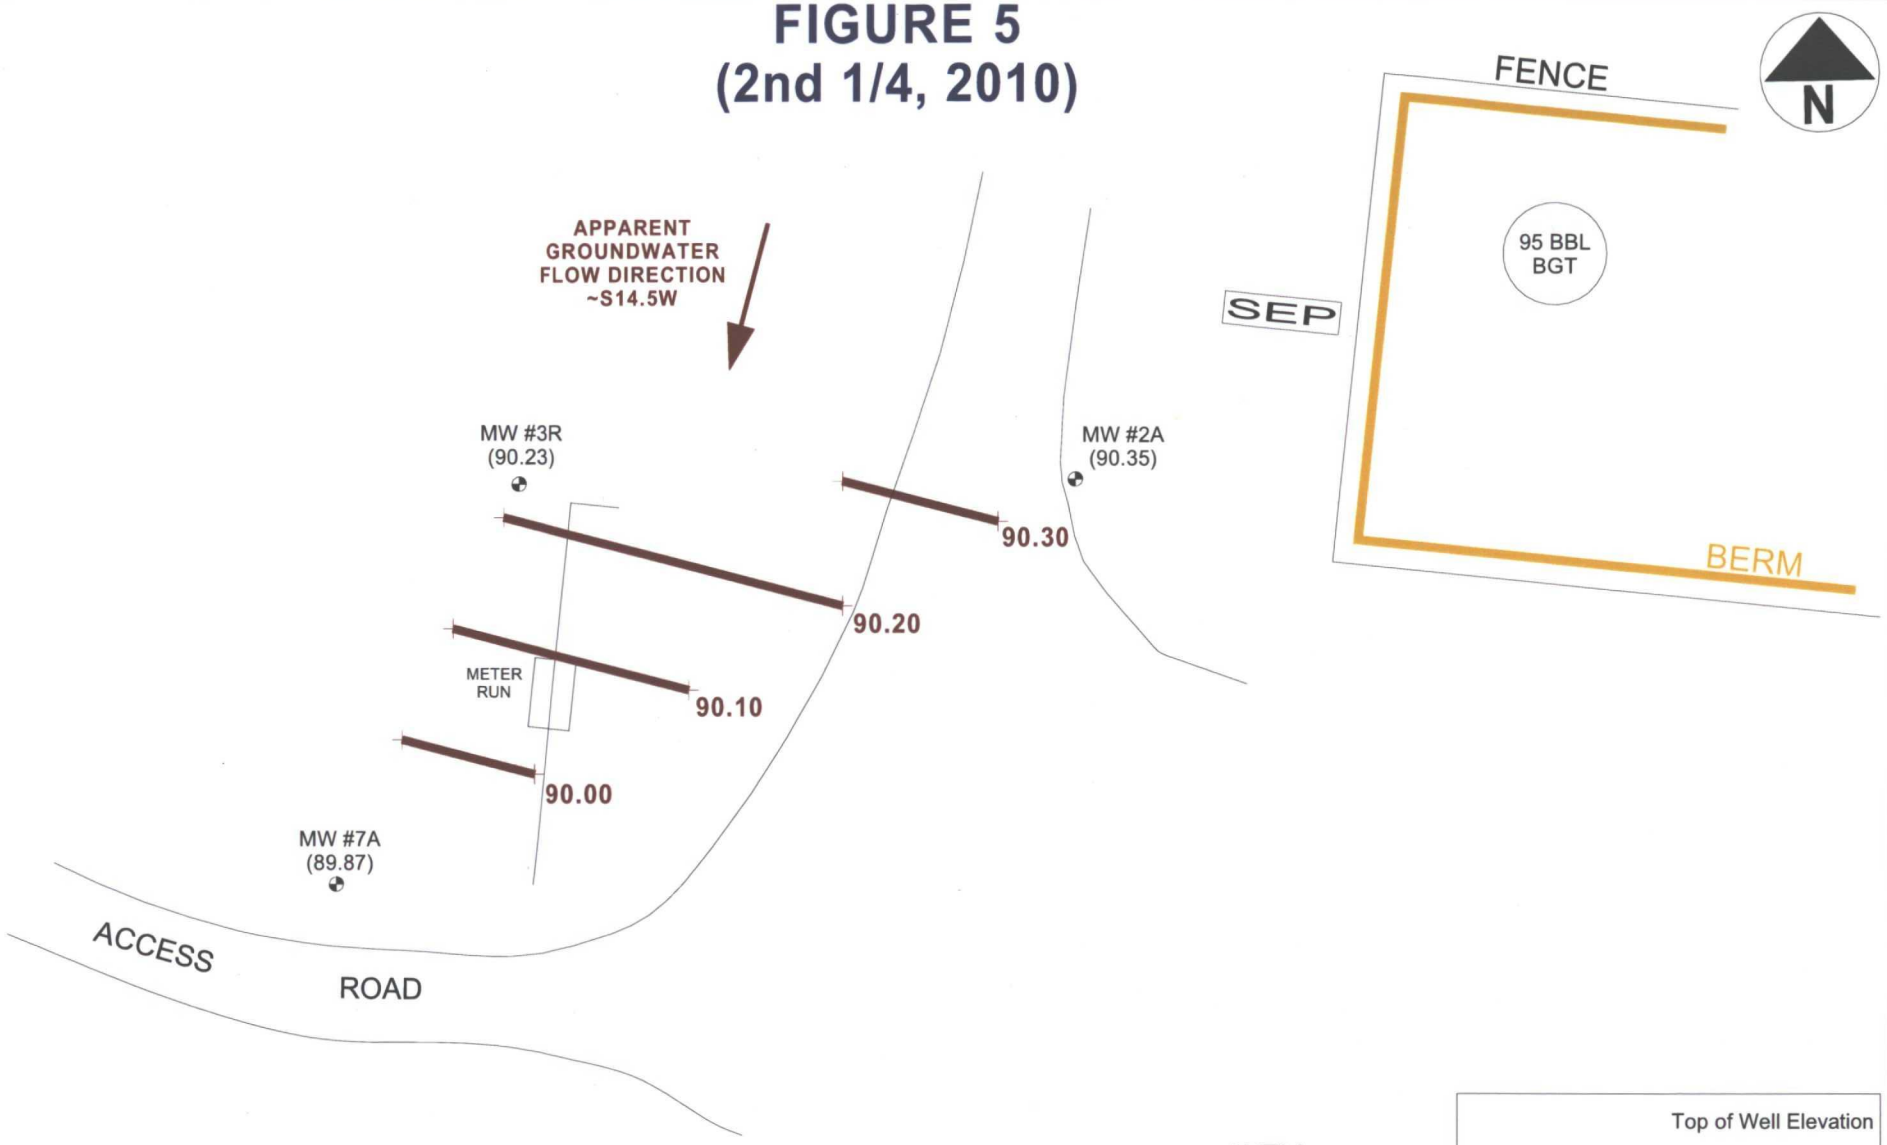
FIGURE 5
(2nd 1/4, 2010)

Top of Well Elevation	
MW #2A	(100.40)
MW #3R	(100.80)
MW #7A	(99.72)
MW #2A (90.35)	Groundwater elevation as of 5/10/10.

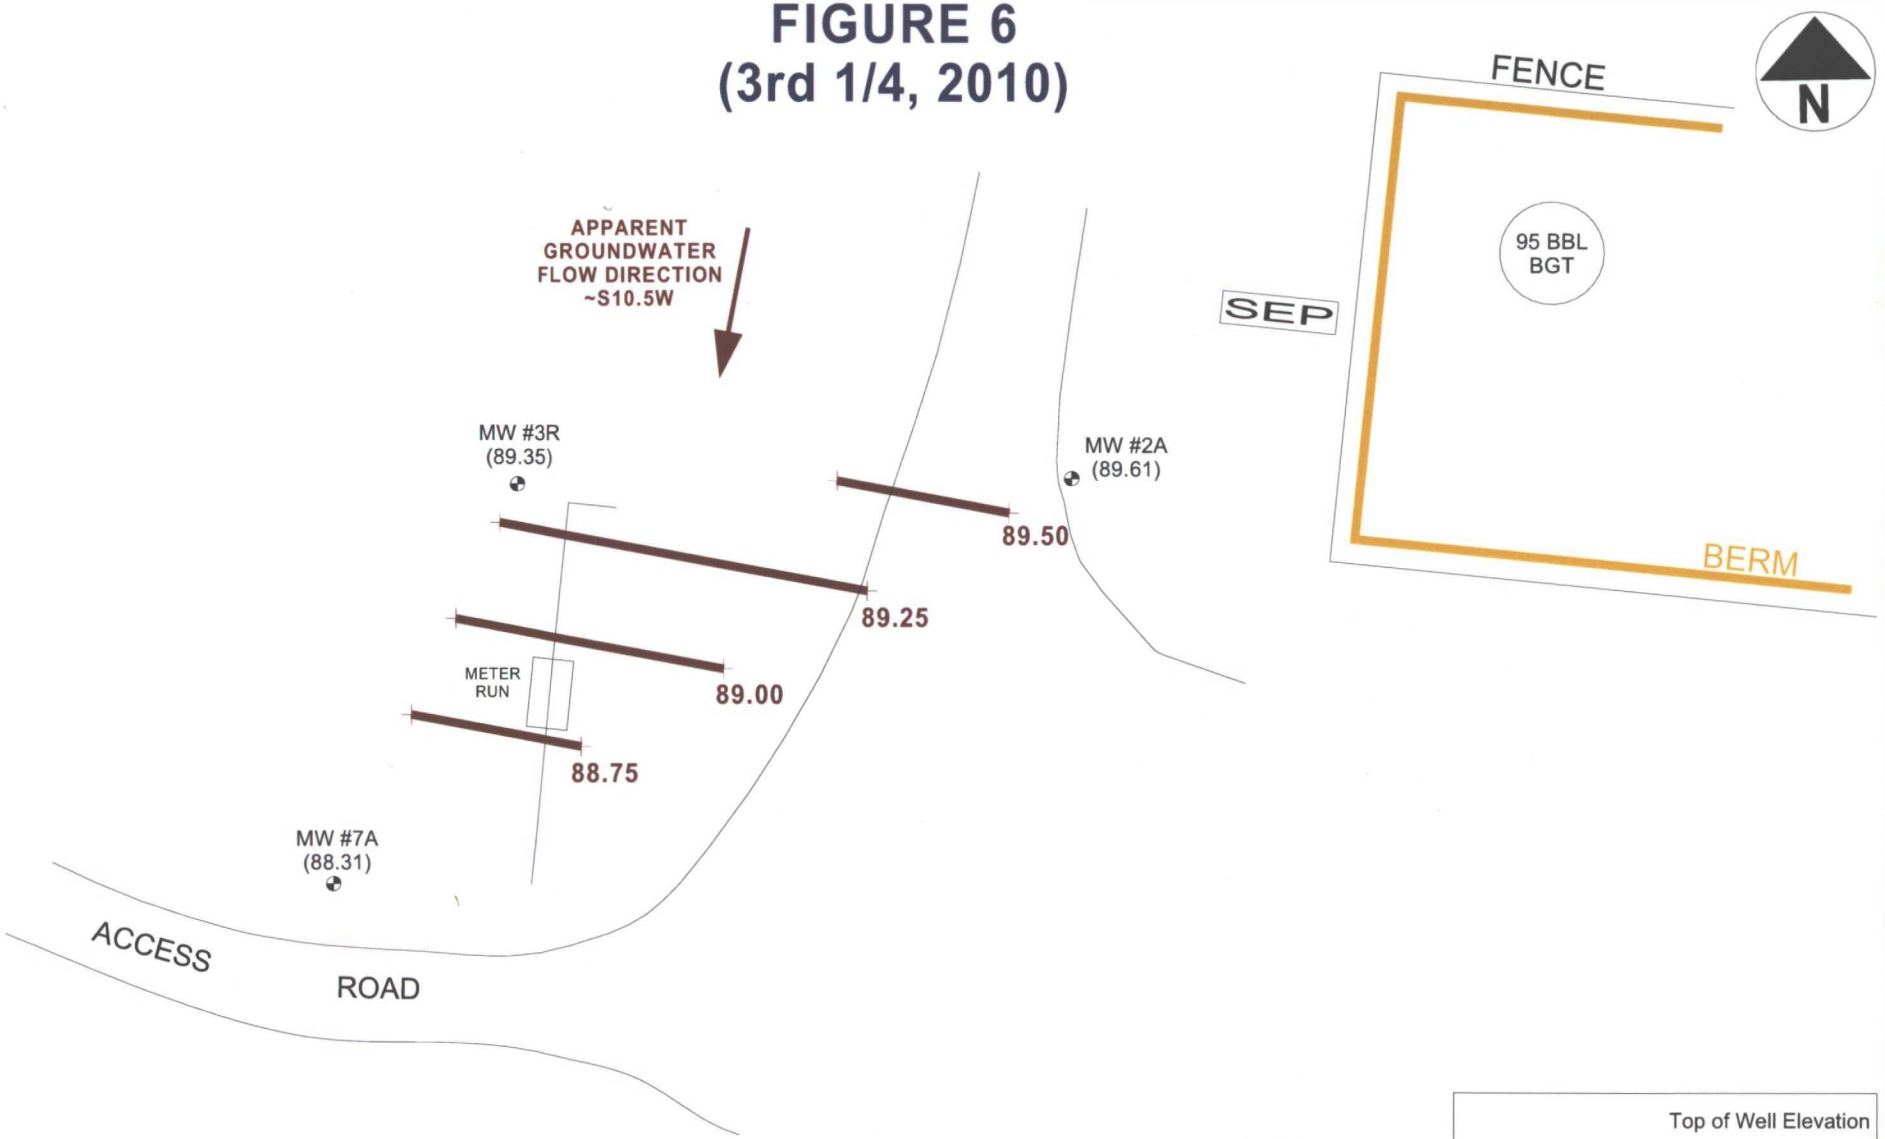
FIGURE 6
(3rd 1/4, 2010)

Top of Well Elevation	
MW #2A	(100.40)
MW #3R	(100.80)
MW #7A	(99.72)
MW #2A (89.61)	Groundwater elevation as of 7/21/10.

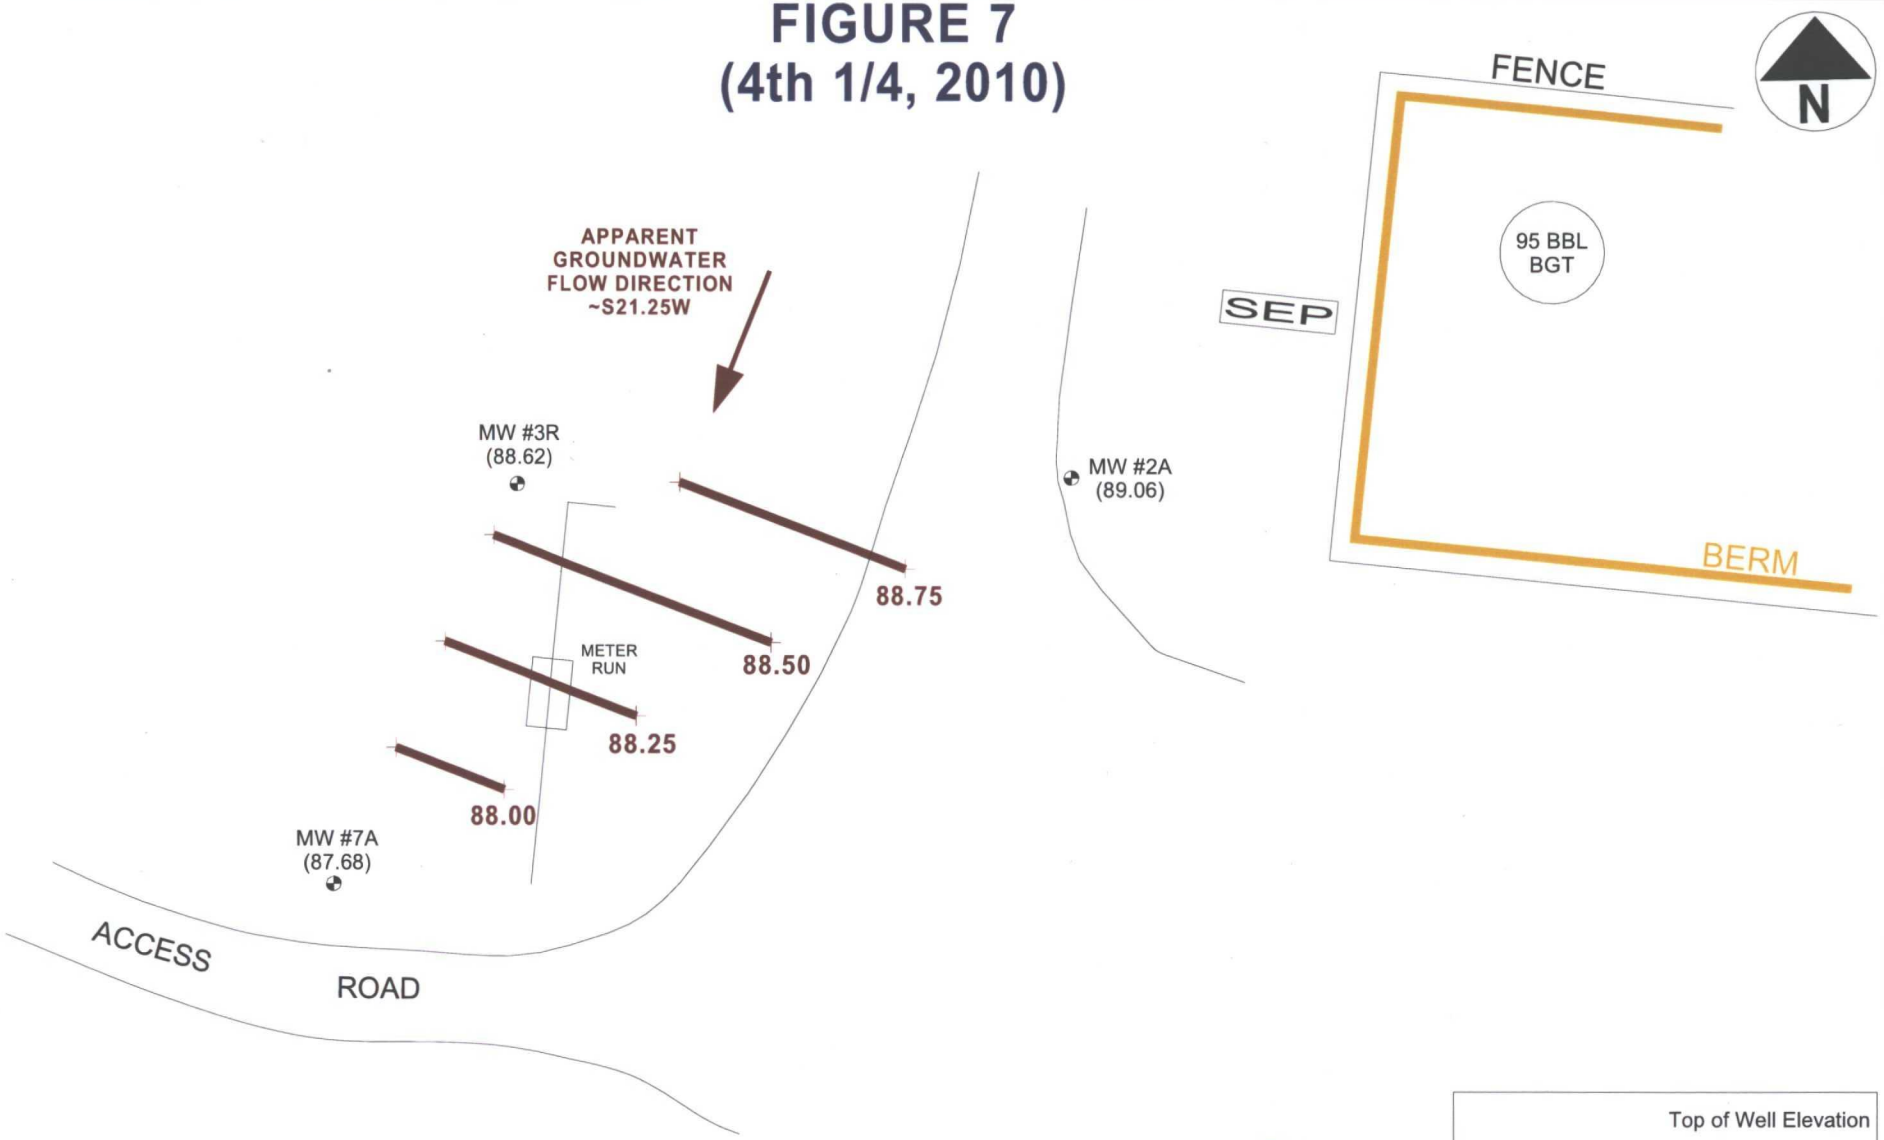
FIGURE 7
(4th 1/4, 2010)

Top of Well Elevation	
MW #2A	(100.40)
MW #3R	(100.80)
MW #7A	(99.72)
MW #2A (89.06)	Groundwater elevation as of 10/21/10.

Continued site monitoring per BP's NMOCD approved Ground Water Management Plan is recommended. Hydrocarbon impacts appear to be in a steady state condition. If warranted, alternative remedial actions will be evaluated.
