SITE INFORMATION 2RP-881 & 891

Report Type: Work Plan

Re: Work Plan for the Alamo Permian Resources LLC., Berry A #33, Unit K, Section 24, Township 17 South, Range 27 East, Eddy County, New Mexico.

Berry A #33

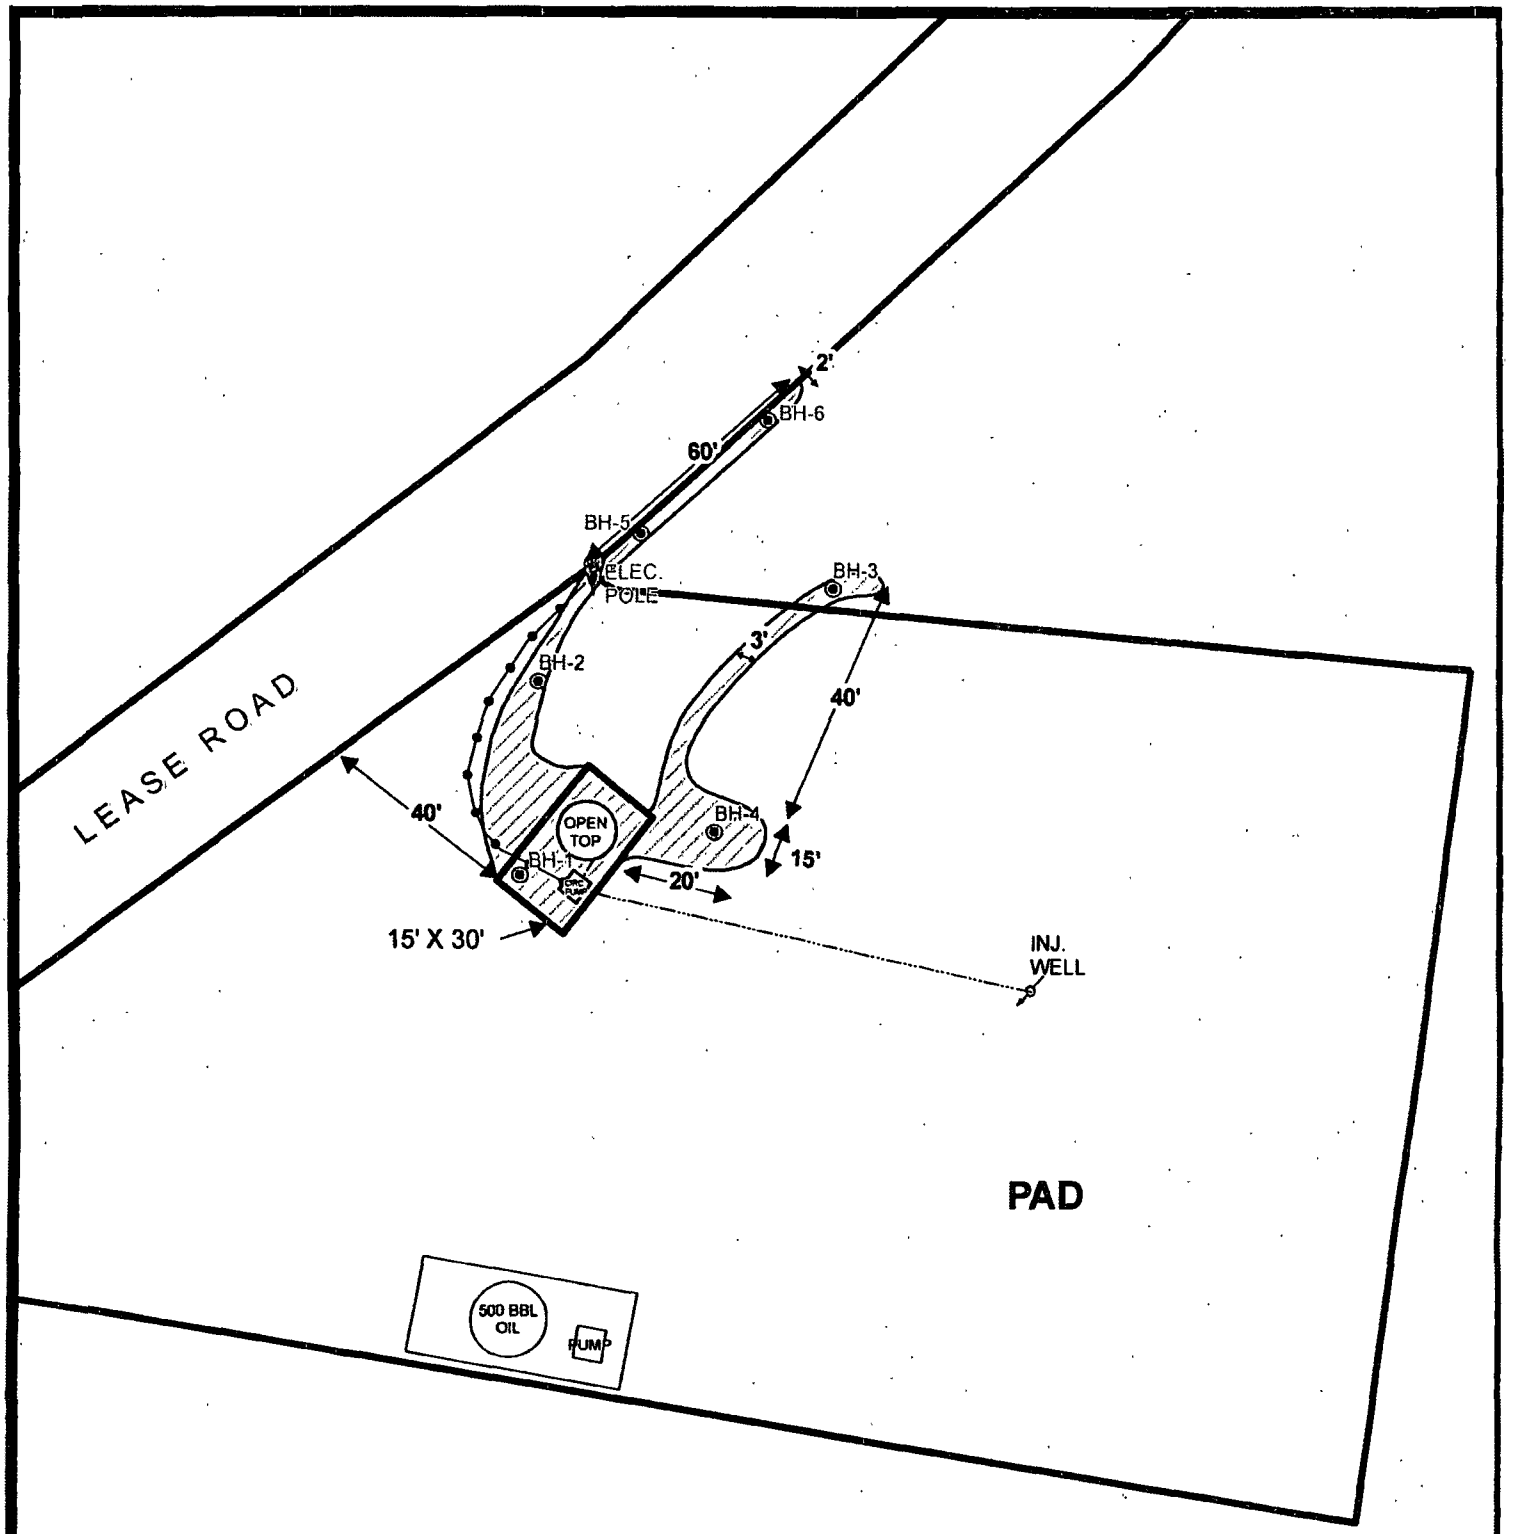
Figure 3

On January 23, 2012, Tetra Tech personnel supervised the installation of boreholes utilizing an air rotary drilling rig. A total of six (6) boreholes (BH-1 through BH-6) were installed and soil samples collected for laboratory analysis. Select samples were analyzed for TPH analysis by EPA method 8015 modified, BTEX by EPA Method 8021B and chloride by EPA method 300.0. Copies of laboratory analysis and chain-of-custody documentation are included in Appendix C. The results of the sampling are summarized in Table 1. The spill footprint and borehole locations are shown on Figure 3.

Spill Assessment Map

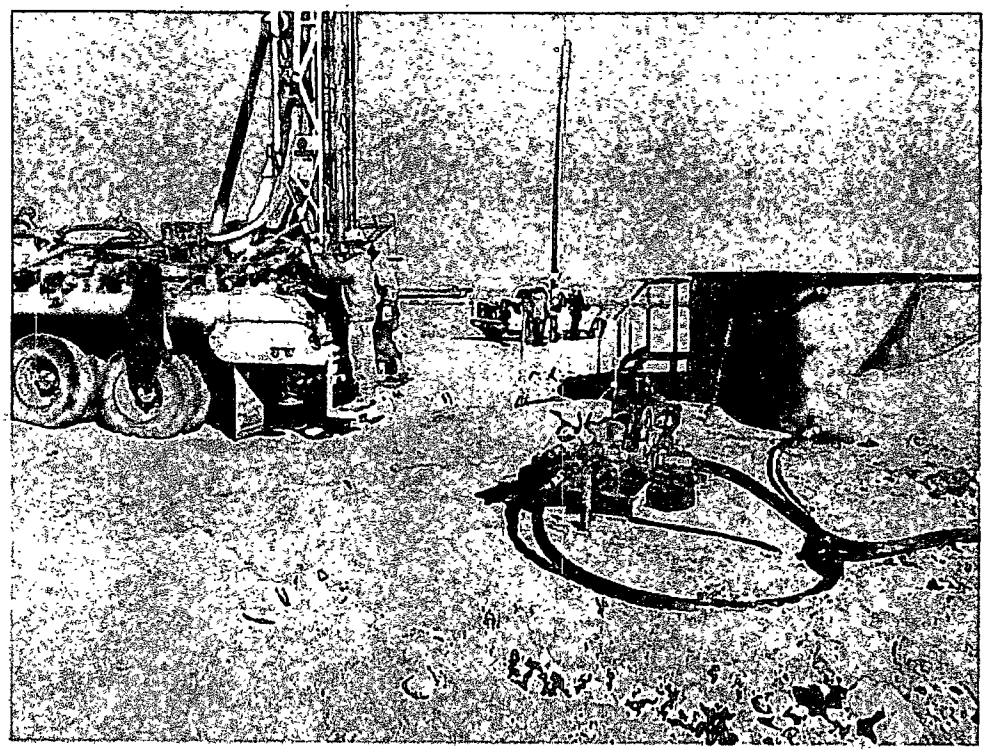
Referring to Table 1, all submitted samples were below the RRAL for TPH and BTEX. Elevated chloride concentrations were detected in BH-1, BH-2, and BH-4. BH-1 located inside the berm area had chloride concentrations ranging from 1,010 mg/kg at 6-7' bgs to 14,200 mg/kg at 14-15' bgs. Chloride concentrations had a significant decrease to 1,480 mg/kg at 29-30' bgs and declined to <200 mg/kg at 39-40' bgs.

View north west – Inside berm area, installation of BH-1

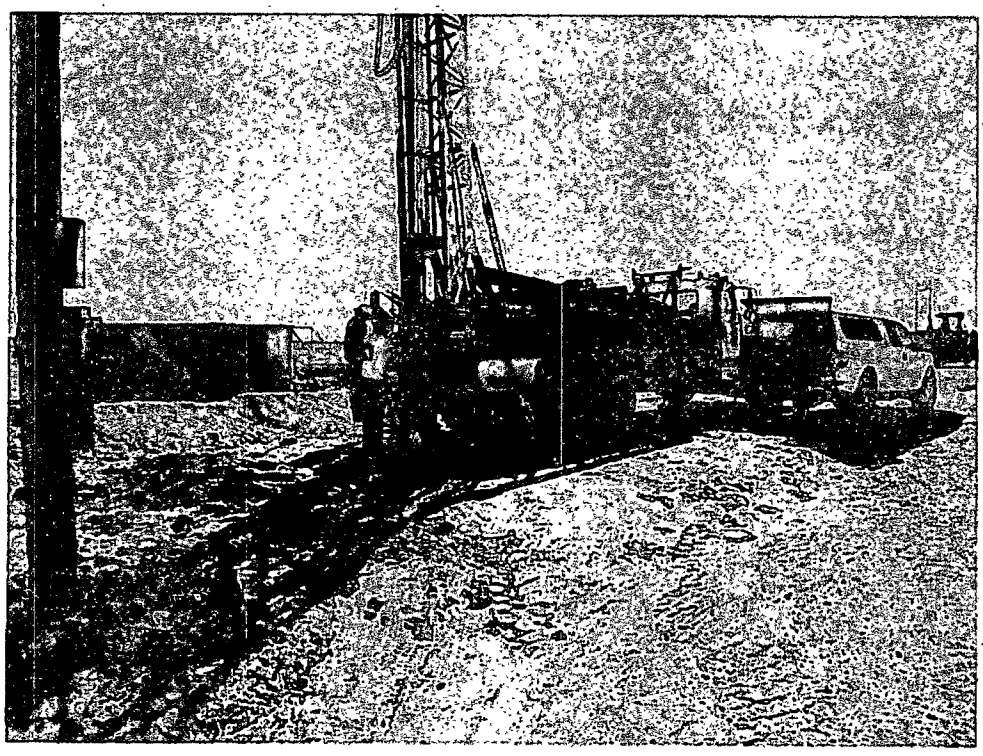
BH-2 and BH-4 were installed outside of the berm area on the east and west side respectively. BH-2, west of berm area had chloride concentrations ranging from 2,800 mg/kg at 9-10' bgs to 15,100 mg/kg at 0-1' bgs. BH-2 was vertically defined with a chloride concentration of 291 mg/kg at 24-25' bgs. BH-4, east of berm had chloride concentrations ranging from 771 mg/kg at 6-7' bgs to 12,200 mg/kg at 14-15' bgs. BH-4 was vertically defined with a chloride concentration of 256 mg/kg at 39-40' bgs.

View east – Installation of BH-2 west of open top

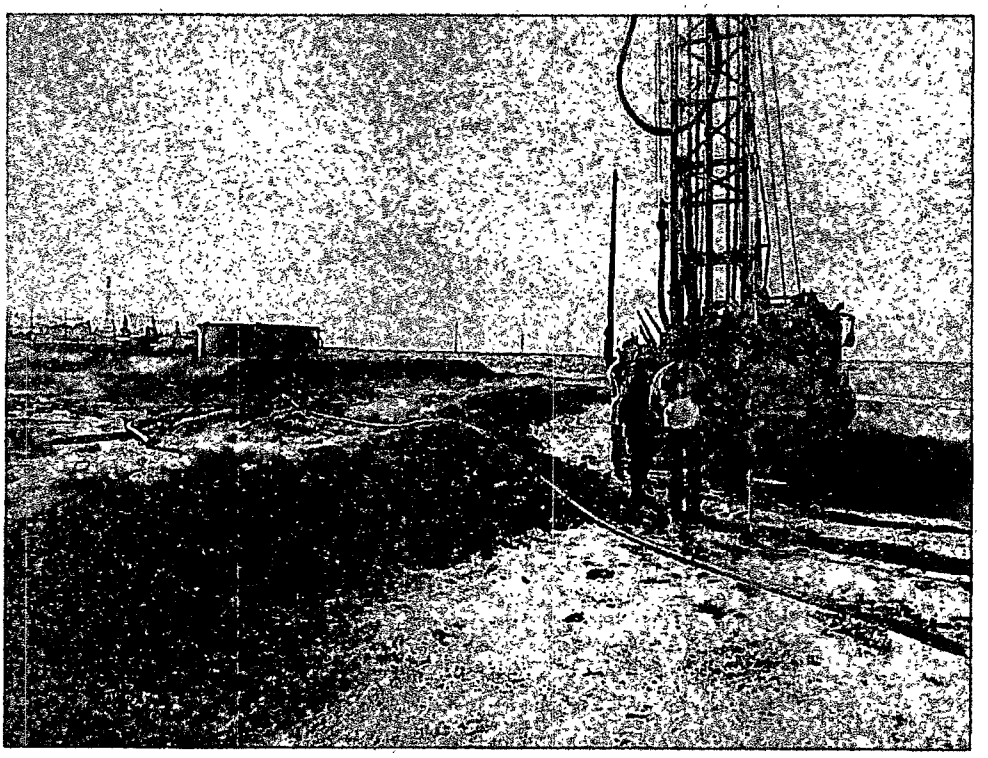
At BH-3 a chloride concentration spike was detected at 6-7' bgs of 3,050 mg/kg. Samples above at 4-5' (482 mg/kg) and below at 9-10' (386 mg/kg) did not show a significant impact. The detected chloride spike does not appear to be an environmental concern.

View west – Installation of BH-3 along north finger of spill path

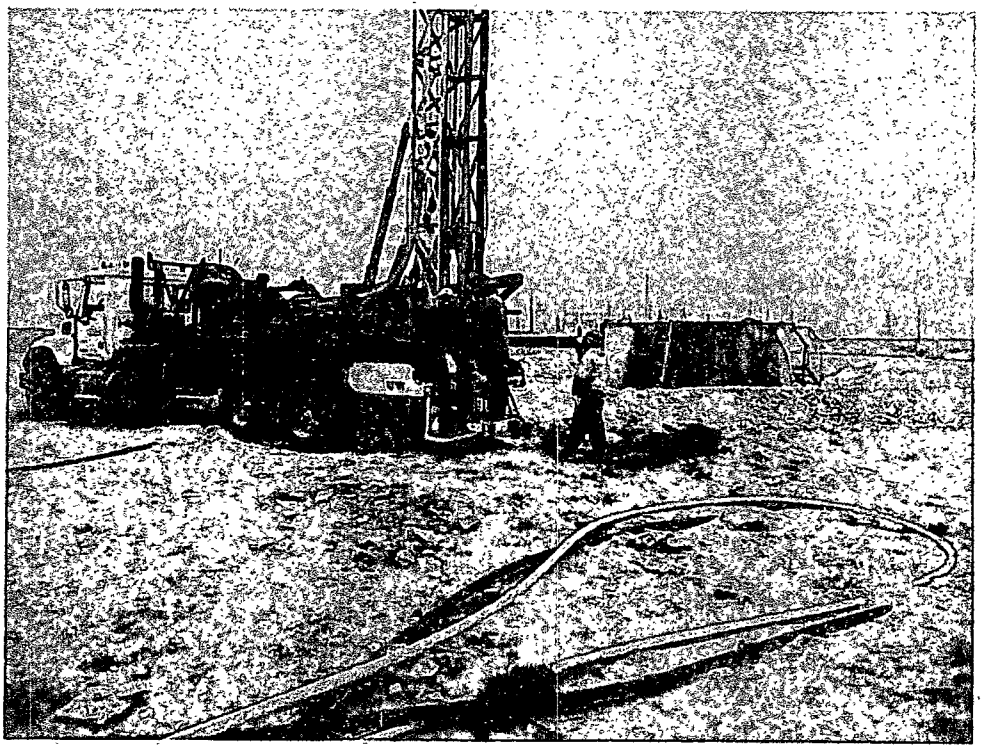
View west – Installation of BH-4, east of open top

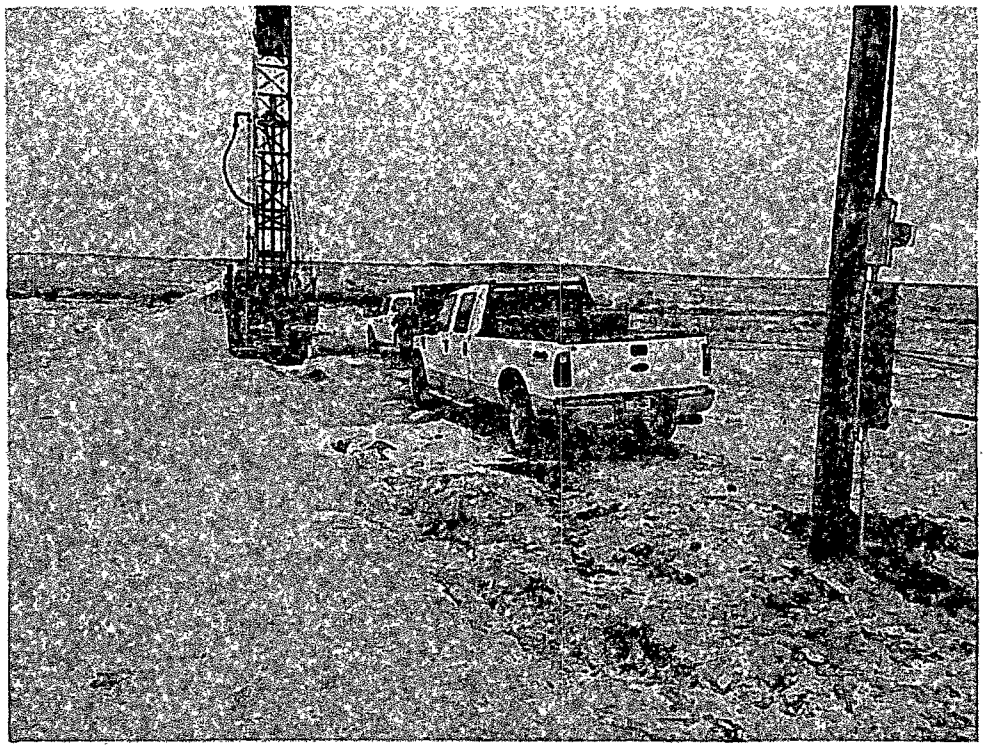
View north – Along lease road near BH-5

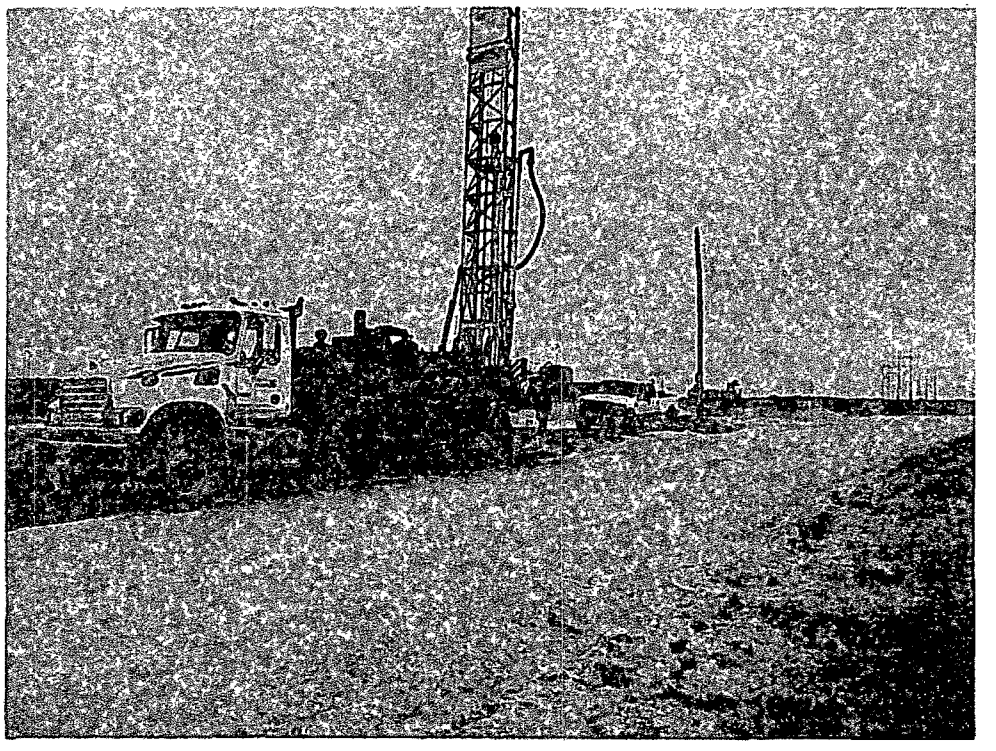
View east – Along lease road, installation of BH-6
