Re: BP America Production Company
Groundwater Monitoring Report
GCU # 153E, Unit C, Sec. 28, T29N, R12W, NMPM
San Juan County, New Mexico

GROUNDWATER REMEDIATION REPORT

GCU #153E
(C) SECTION 28, T29N, R12W, NMPM
SAN JUAN COUNTY, NEW MEXICO

DECEMBER 2010

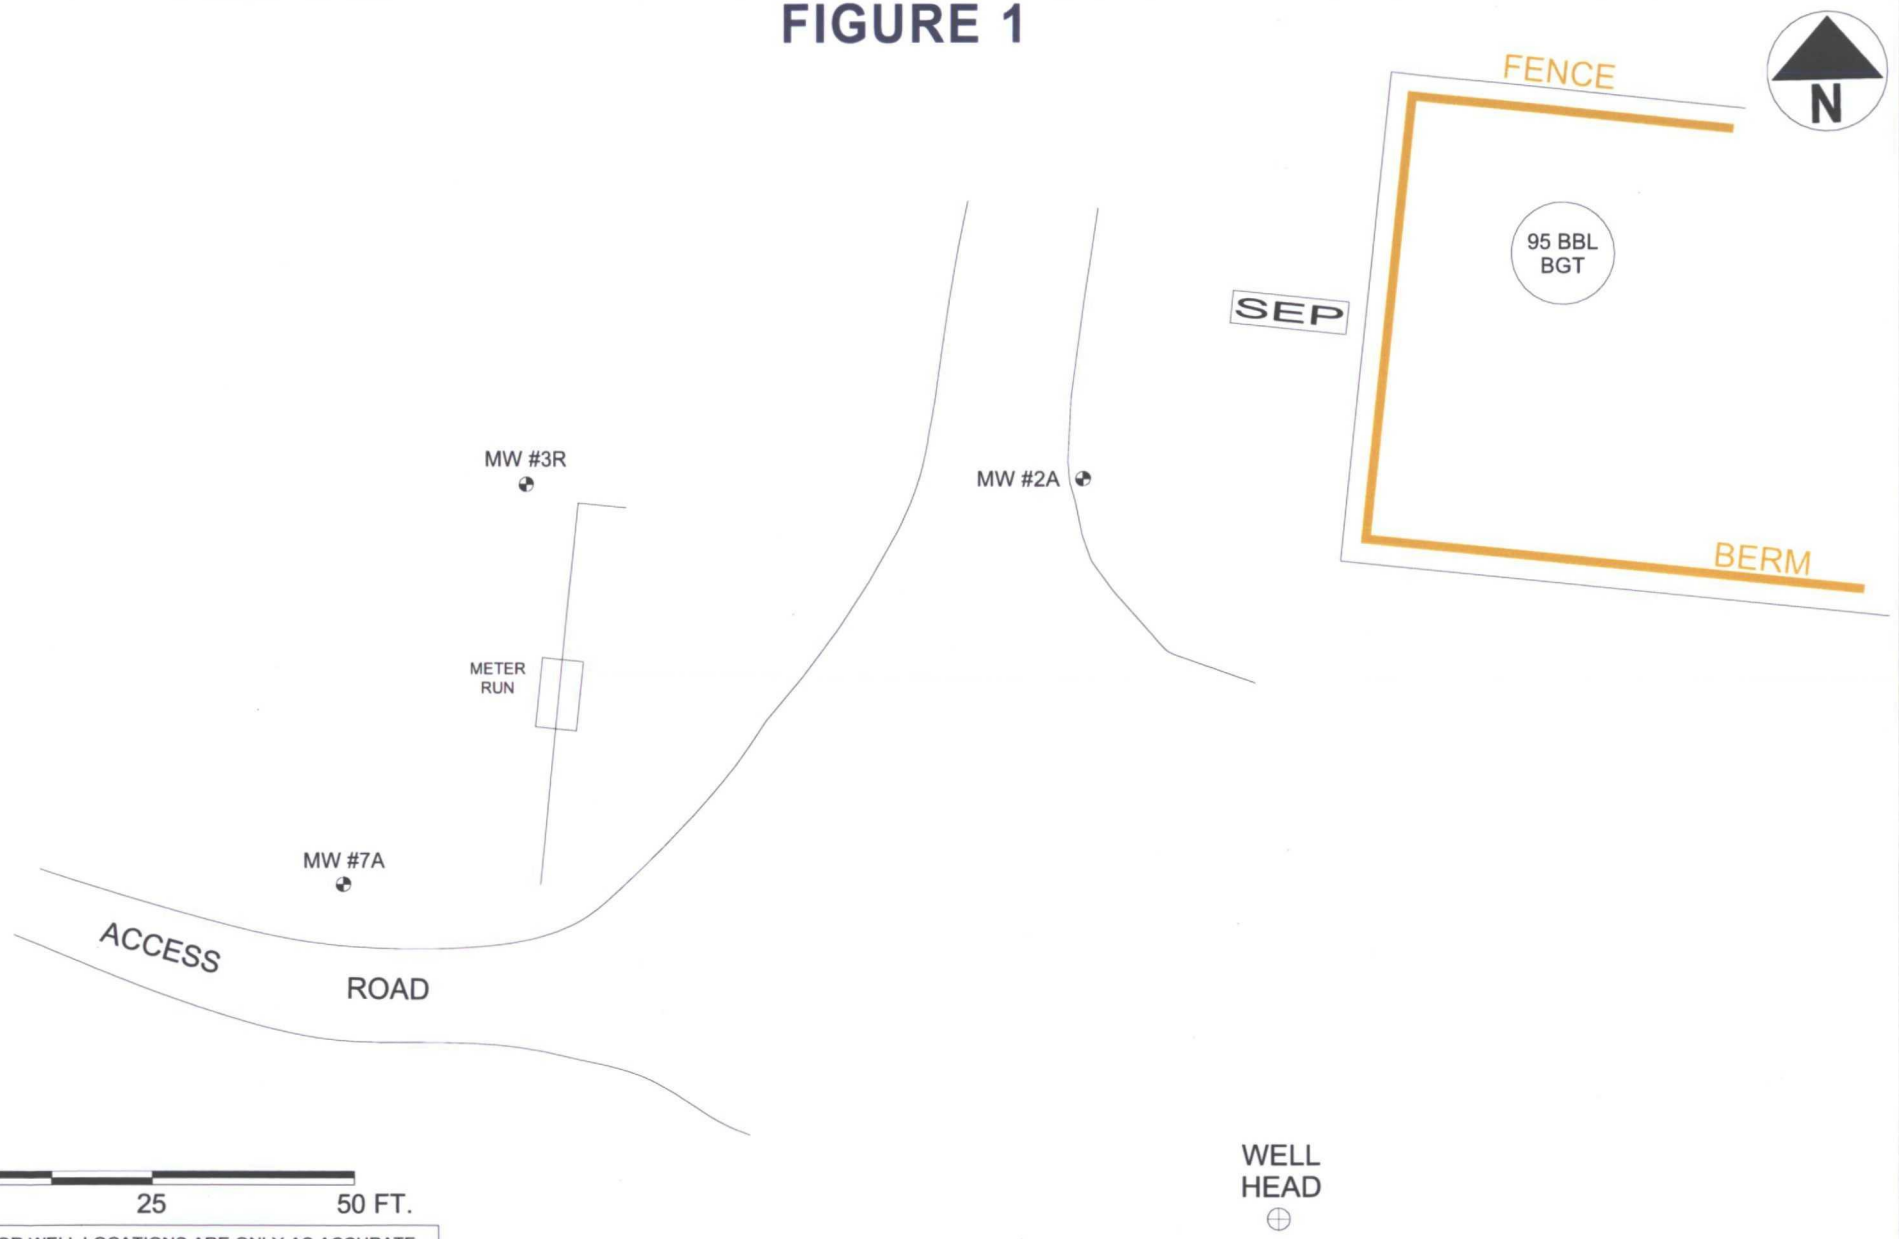
FIGURE 1

BP AMERICA PRODUCTION COMPANY
GCU #153E
NE/4 NW/4 SEC. 28, T29N, R12W
SAN JUAN COUNTY, NEW MEXICO

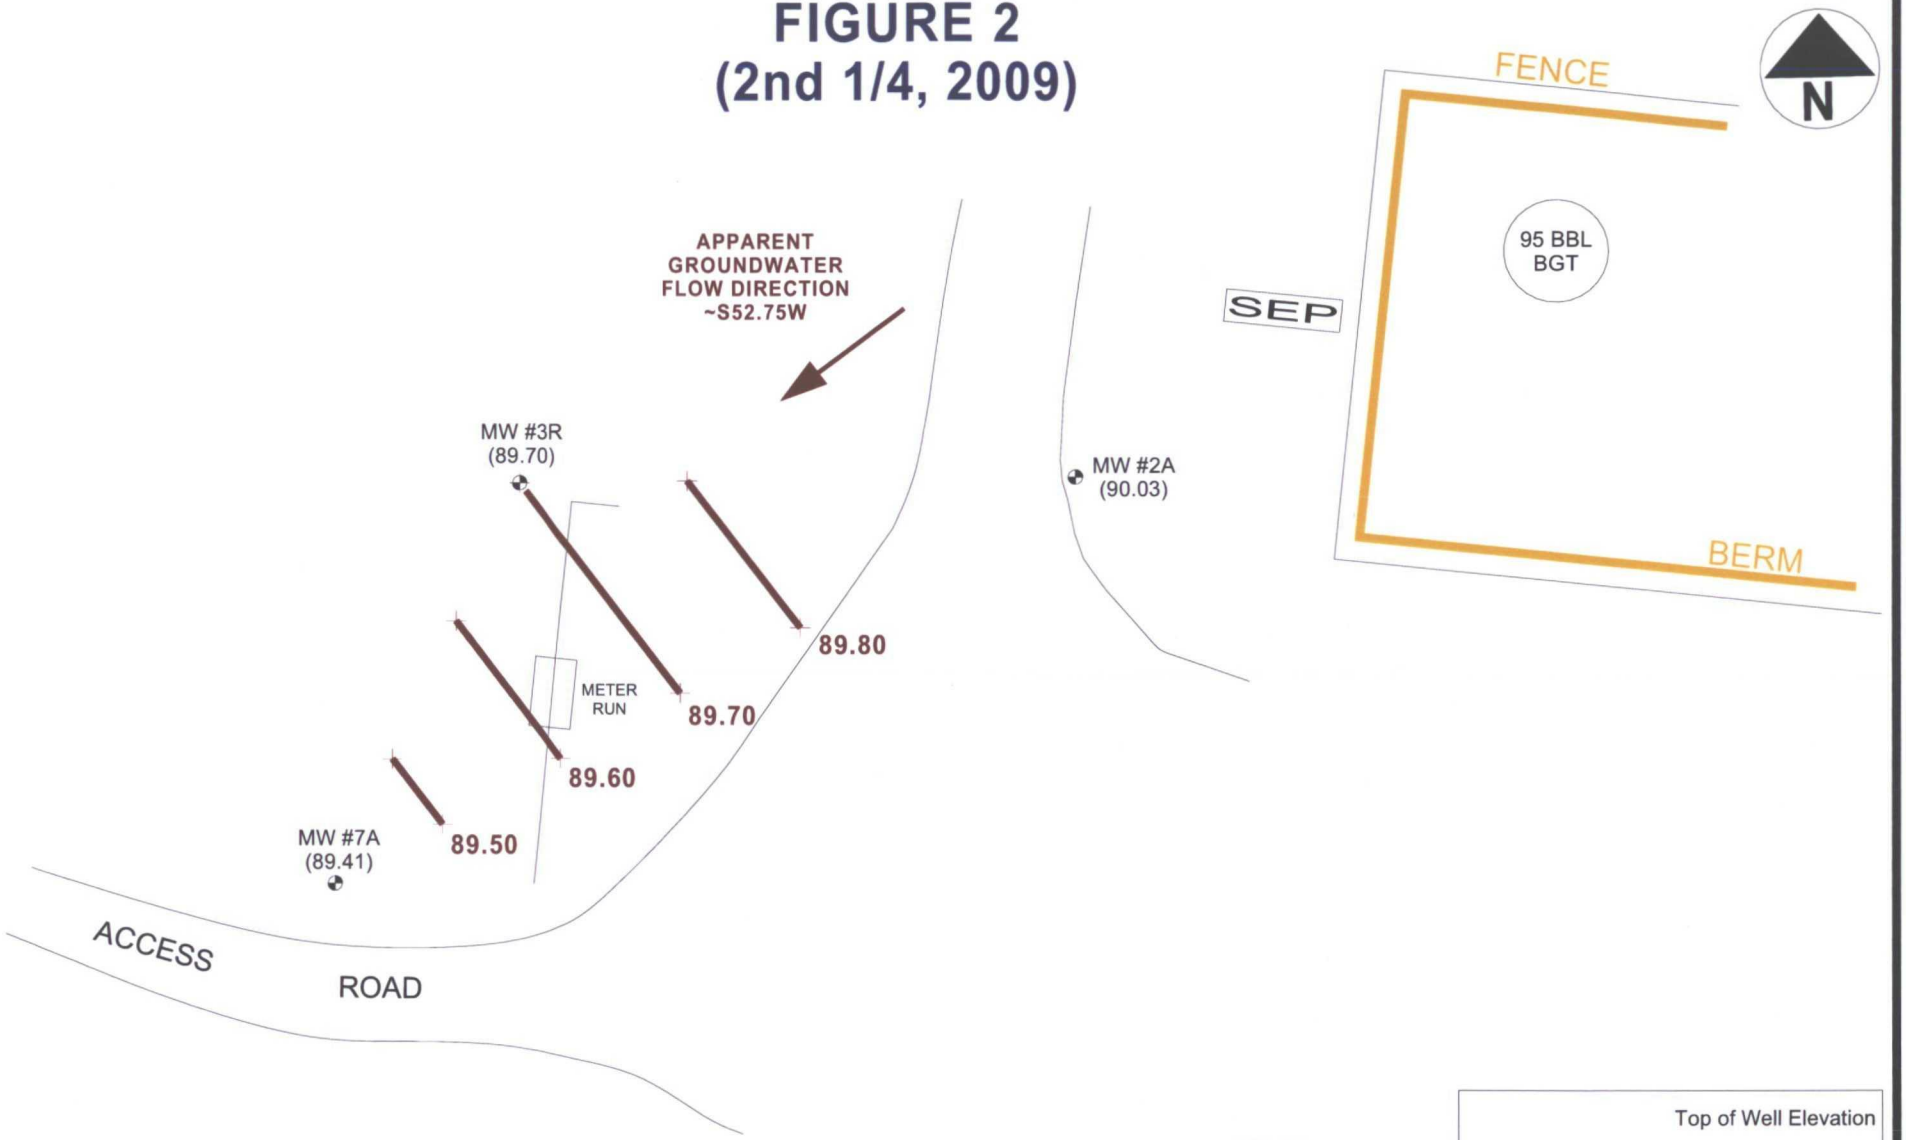
FIGURE 2
(2nd 1/4, 2009)

Groundwater contour maps (Figure 2 through Figure 7) reveal the relative elevations from the site wells have consistently shown an apparent southwest flow direction.

Top of Well Elevation	
MW #2A	(100.40)
MW #3R	(100.80)
MW #7A	(99.72)
MW #2A (90.03)	Groundwater elevation as of 5/26/09.

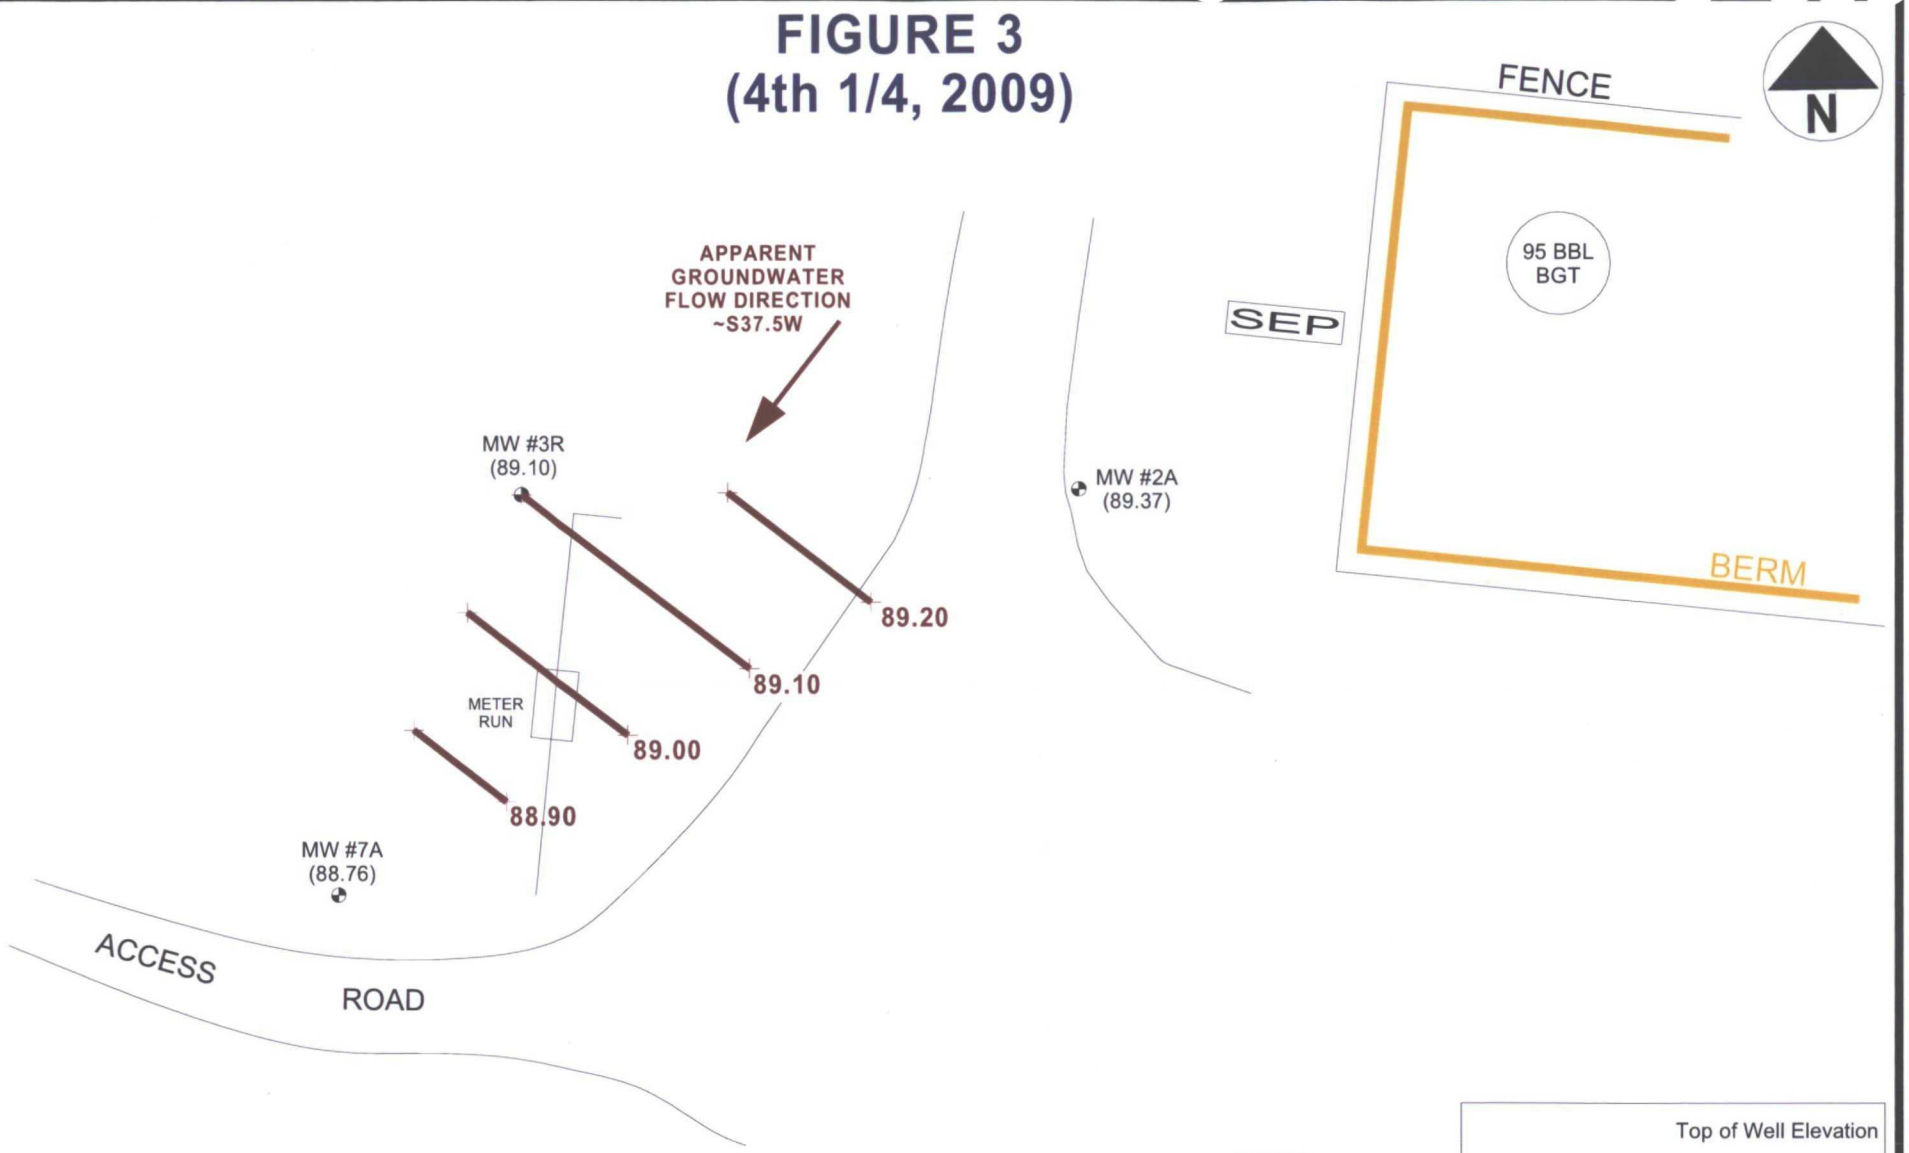
FIGURE 3
(4th 1/4, 2009)

Top of Well Elevation	
MW #2A	(100.40)
MW #3R	(100.80)
MW #7A	(99.72)
MW #2A (89.37)	Groundwater elevation as of 12/28/09.

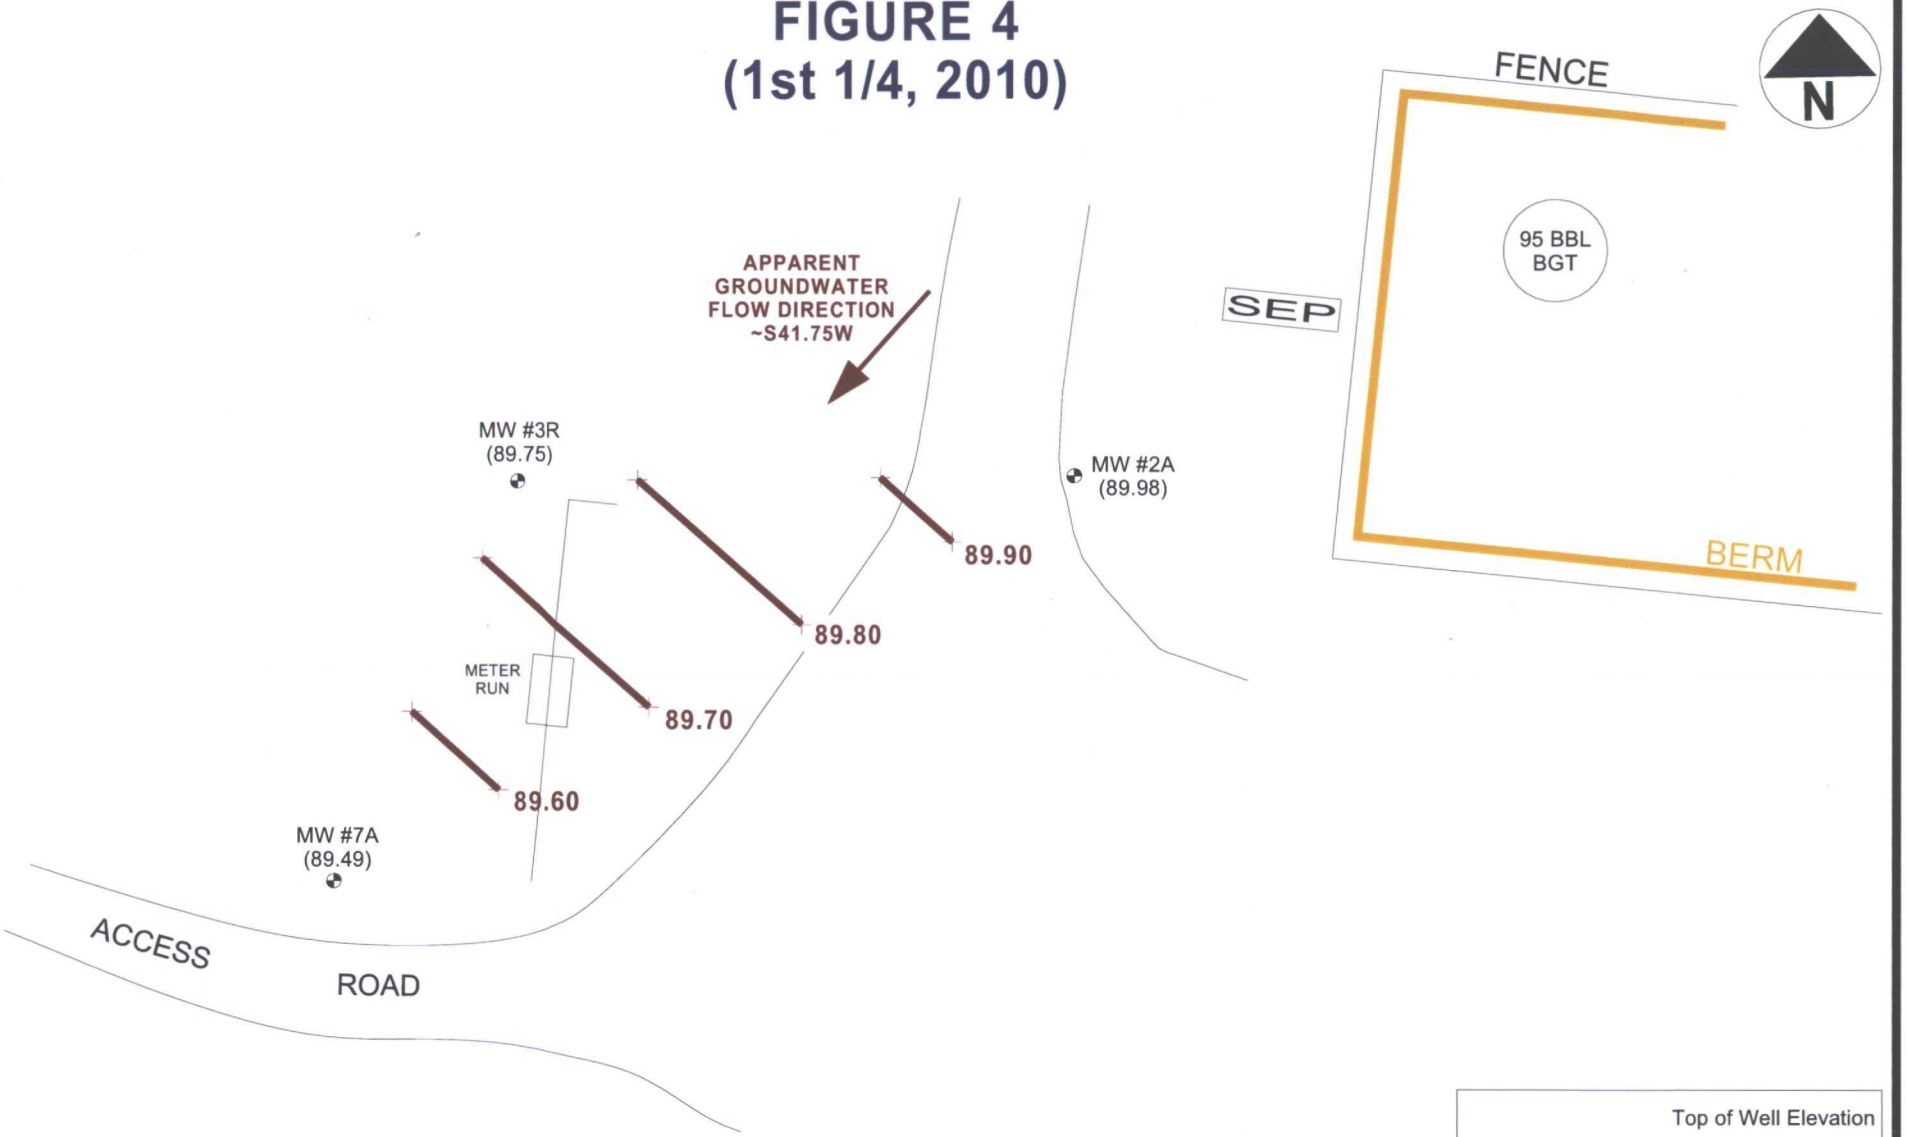
FIGURE 4
(1st 1/4, 2010)

Top of Well Elevation	
MW #2A	(100.40)
MW #3R	(100.80)
MW #7A	(99.72)
MW #2A (89.98)	Groundwater elevation as of 3/2/10.

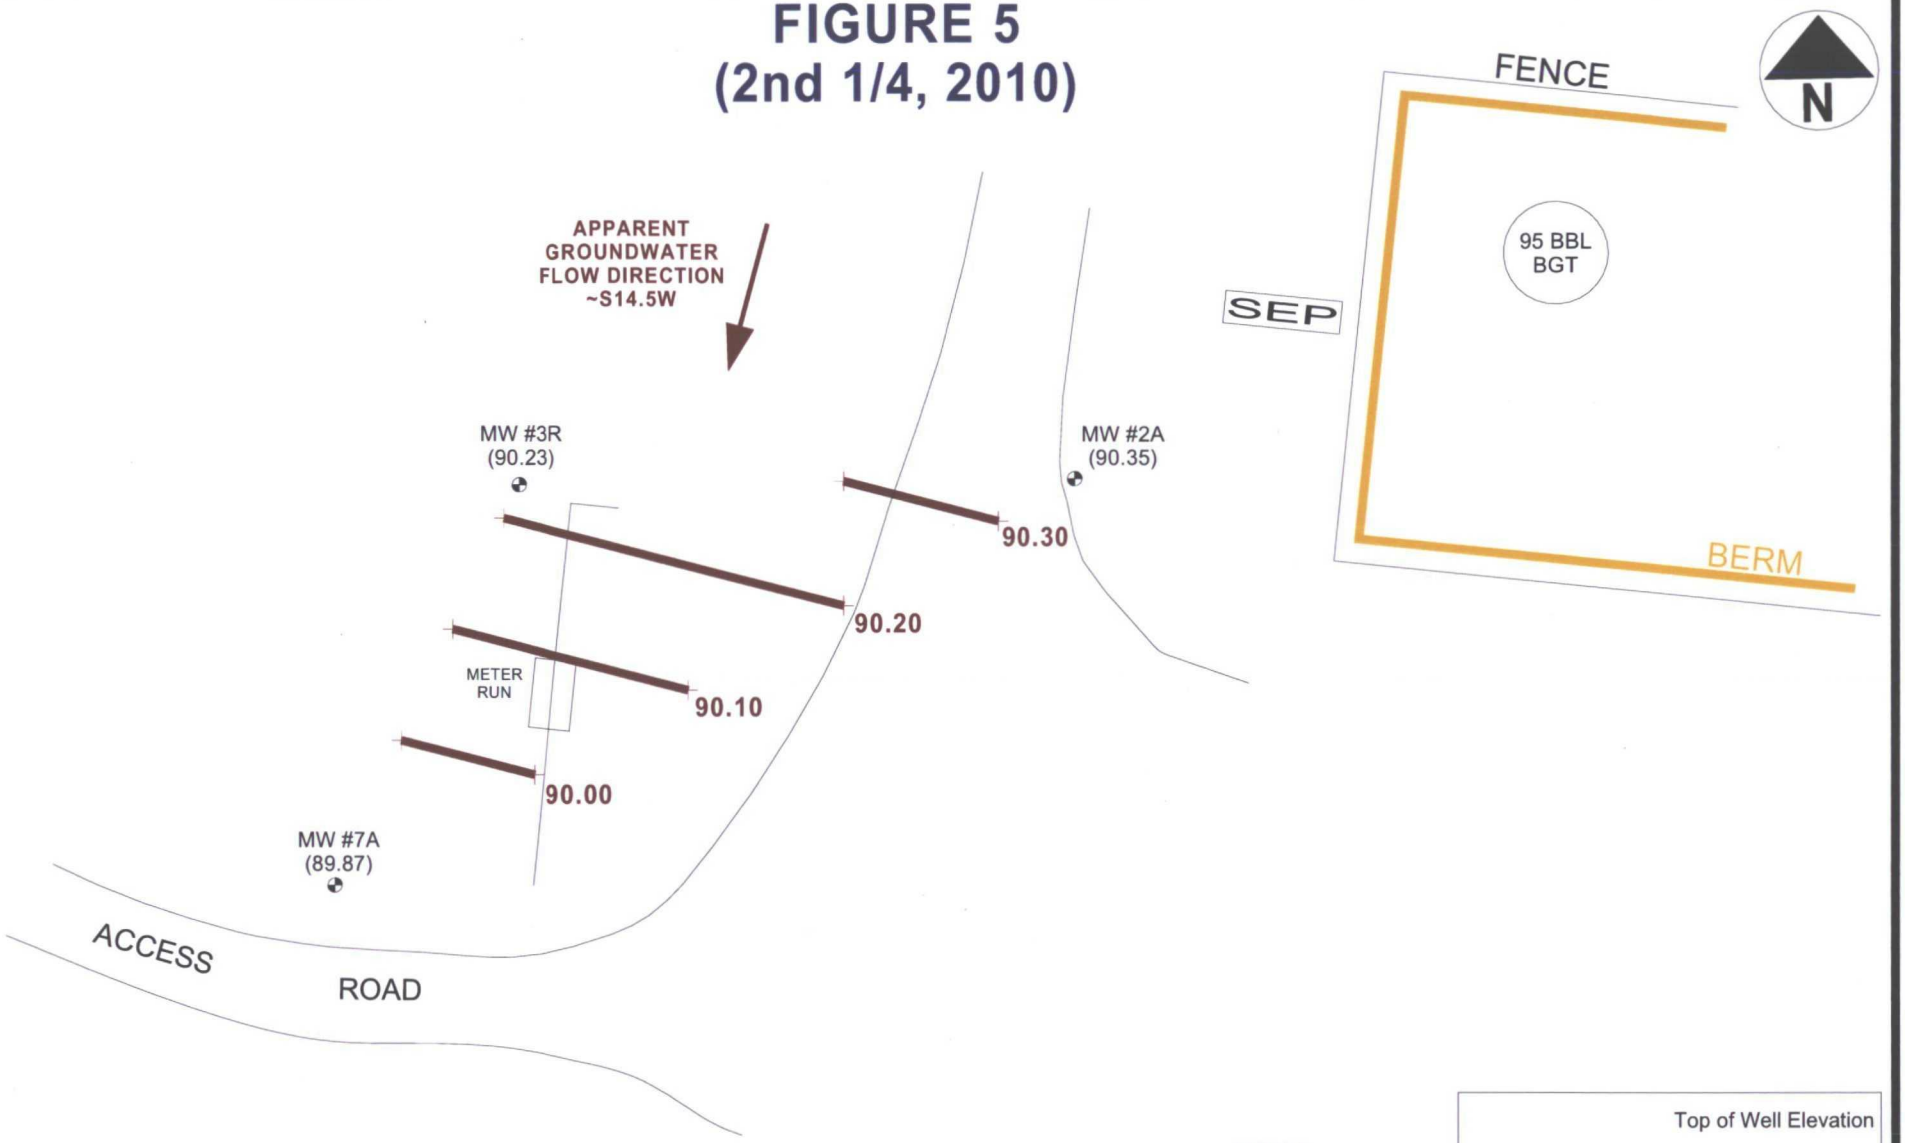
FIGURE 5
(2nd 1/4, 2010)

Top of Well Elevation	
MW #2A	(100.40)
MW #3R	(100.80)
MW #7A	(99.72)
MW #2A (90.35)	Groundwater elevation as of 5/10/10.

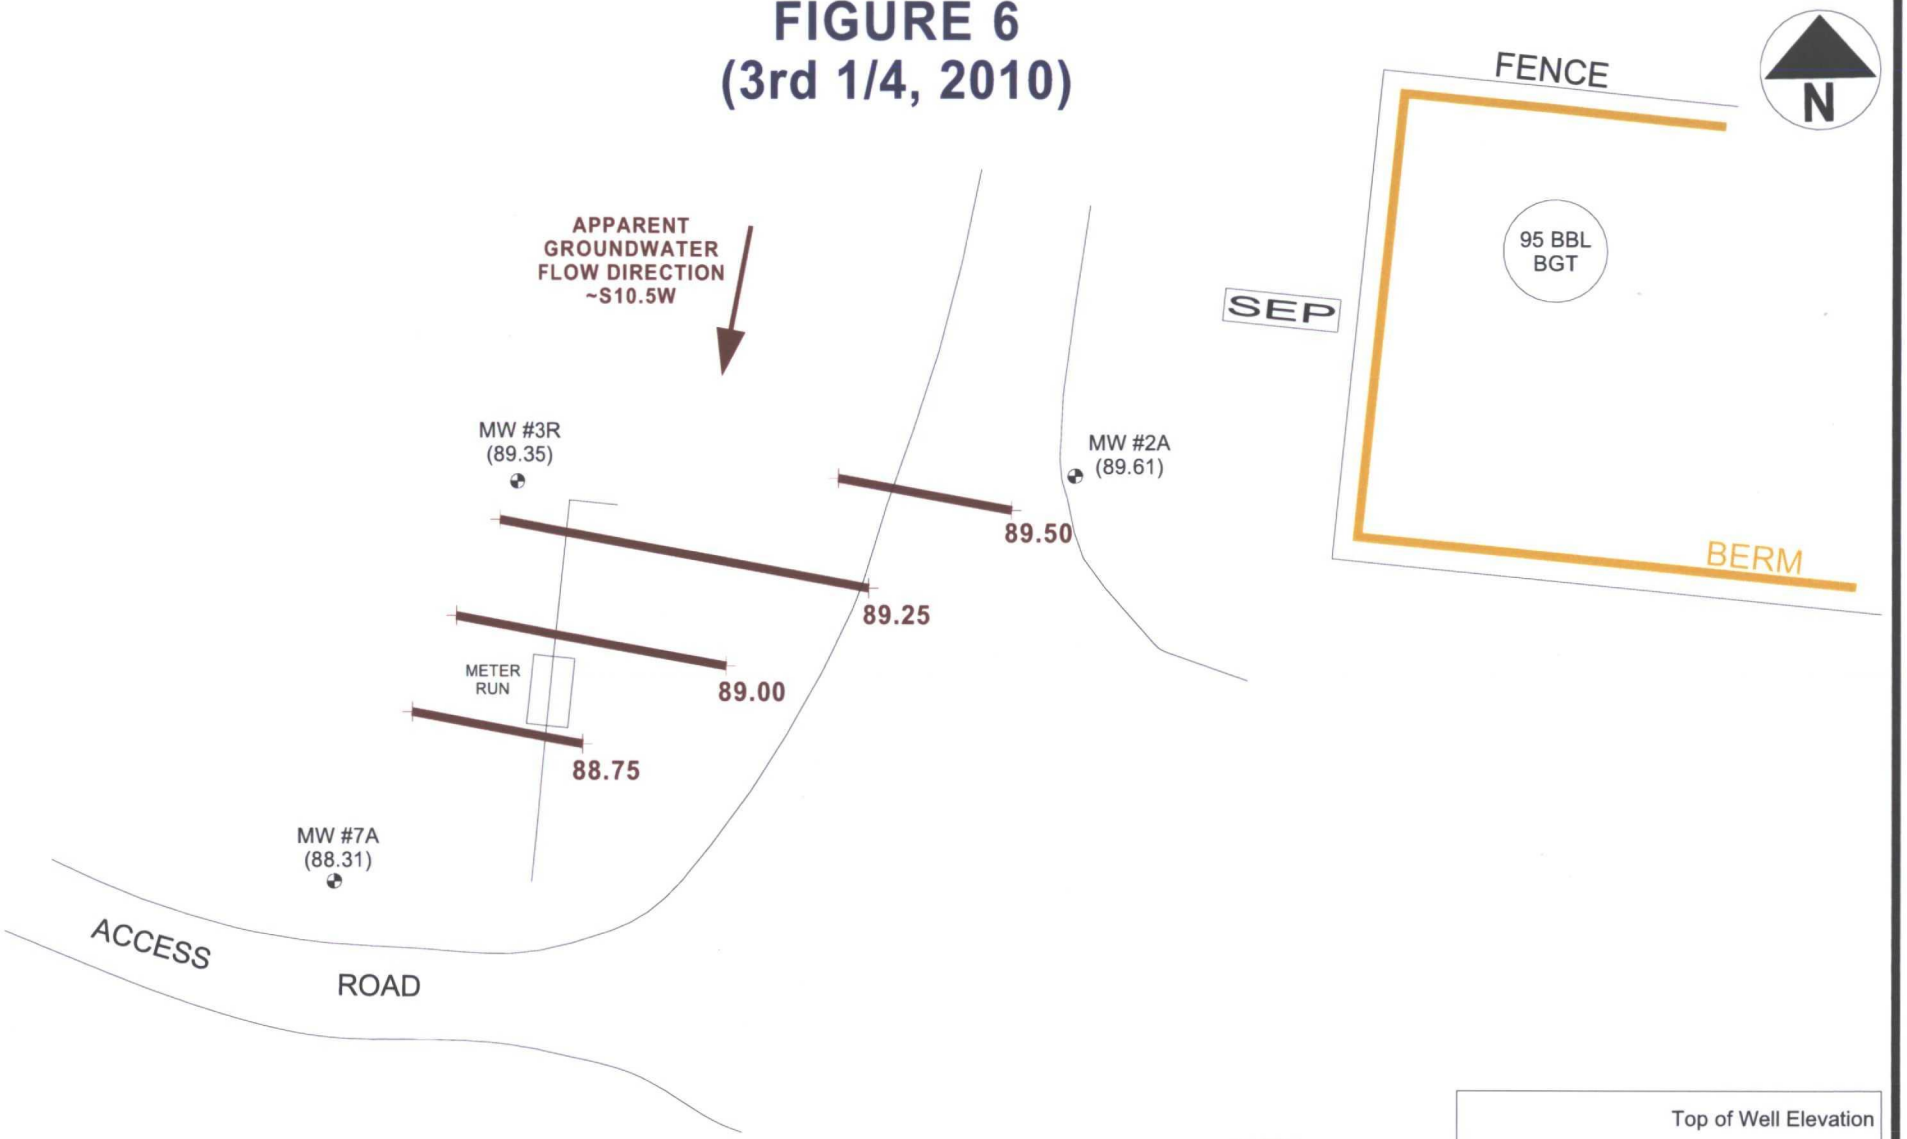
FIGURE 6
(3rd 1/4, 2010)

Top of Well Elevation	
MW #2A	(100.40)
MW #3R	(100.80)
MW #7A	(99.72)
MW #2A (89.61)	Groundwater elevation as of 7/21/10.

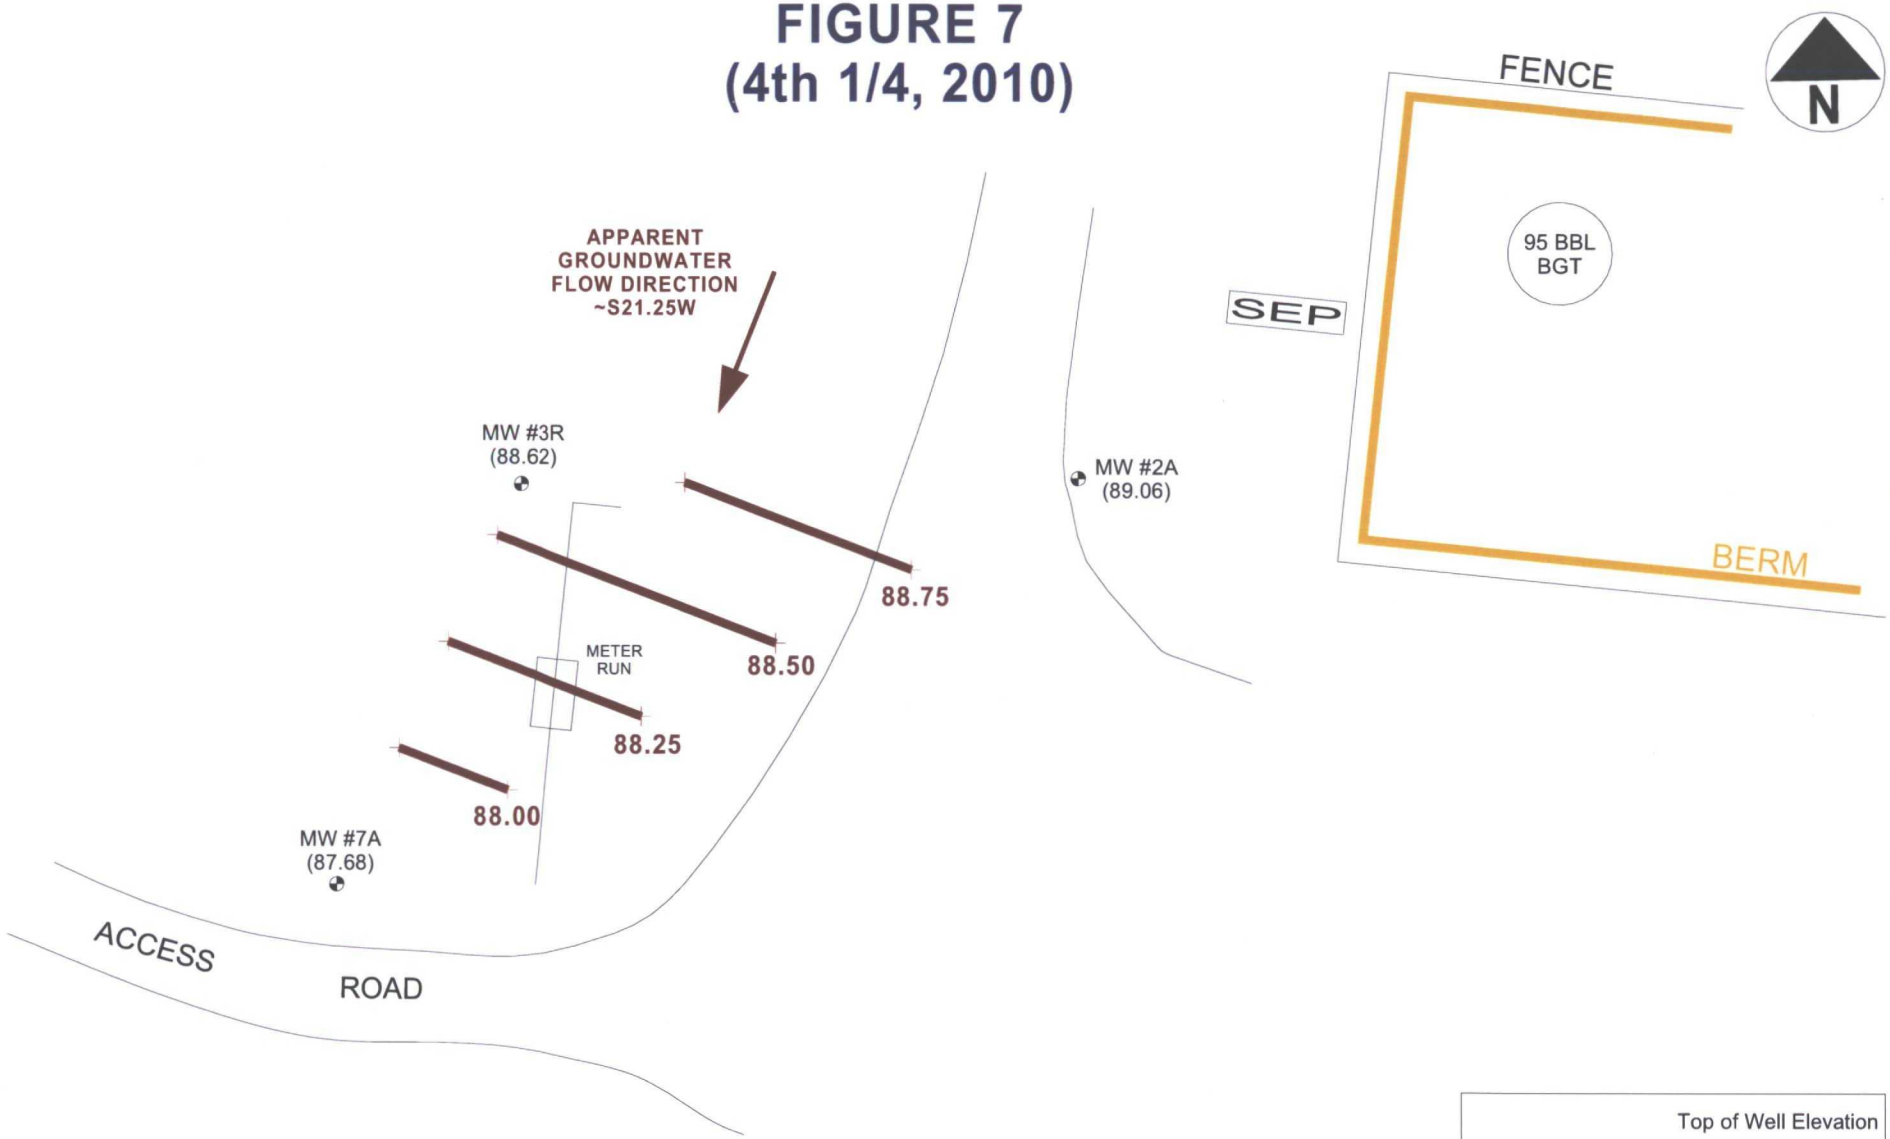
FIGURE 7
(4th 1/4, 2010)

Top of Well Elevation	
MW #2A	(100.40)
MW #3R	(100.80)
MW #7A	(99.72)
MW #2A (89.06)	Groundwater elevation as of 10/21/10.
