SEPTEMBER 2012 QUARTERLY GROUNDWATER MONITORING REPORT

CONOCOPHILLIPS SATEGNA No. 2E
SAN JUAN COUNTY, NEW MEXICO

NMOCD# 3R-428

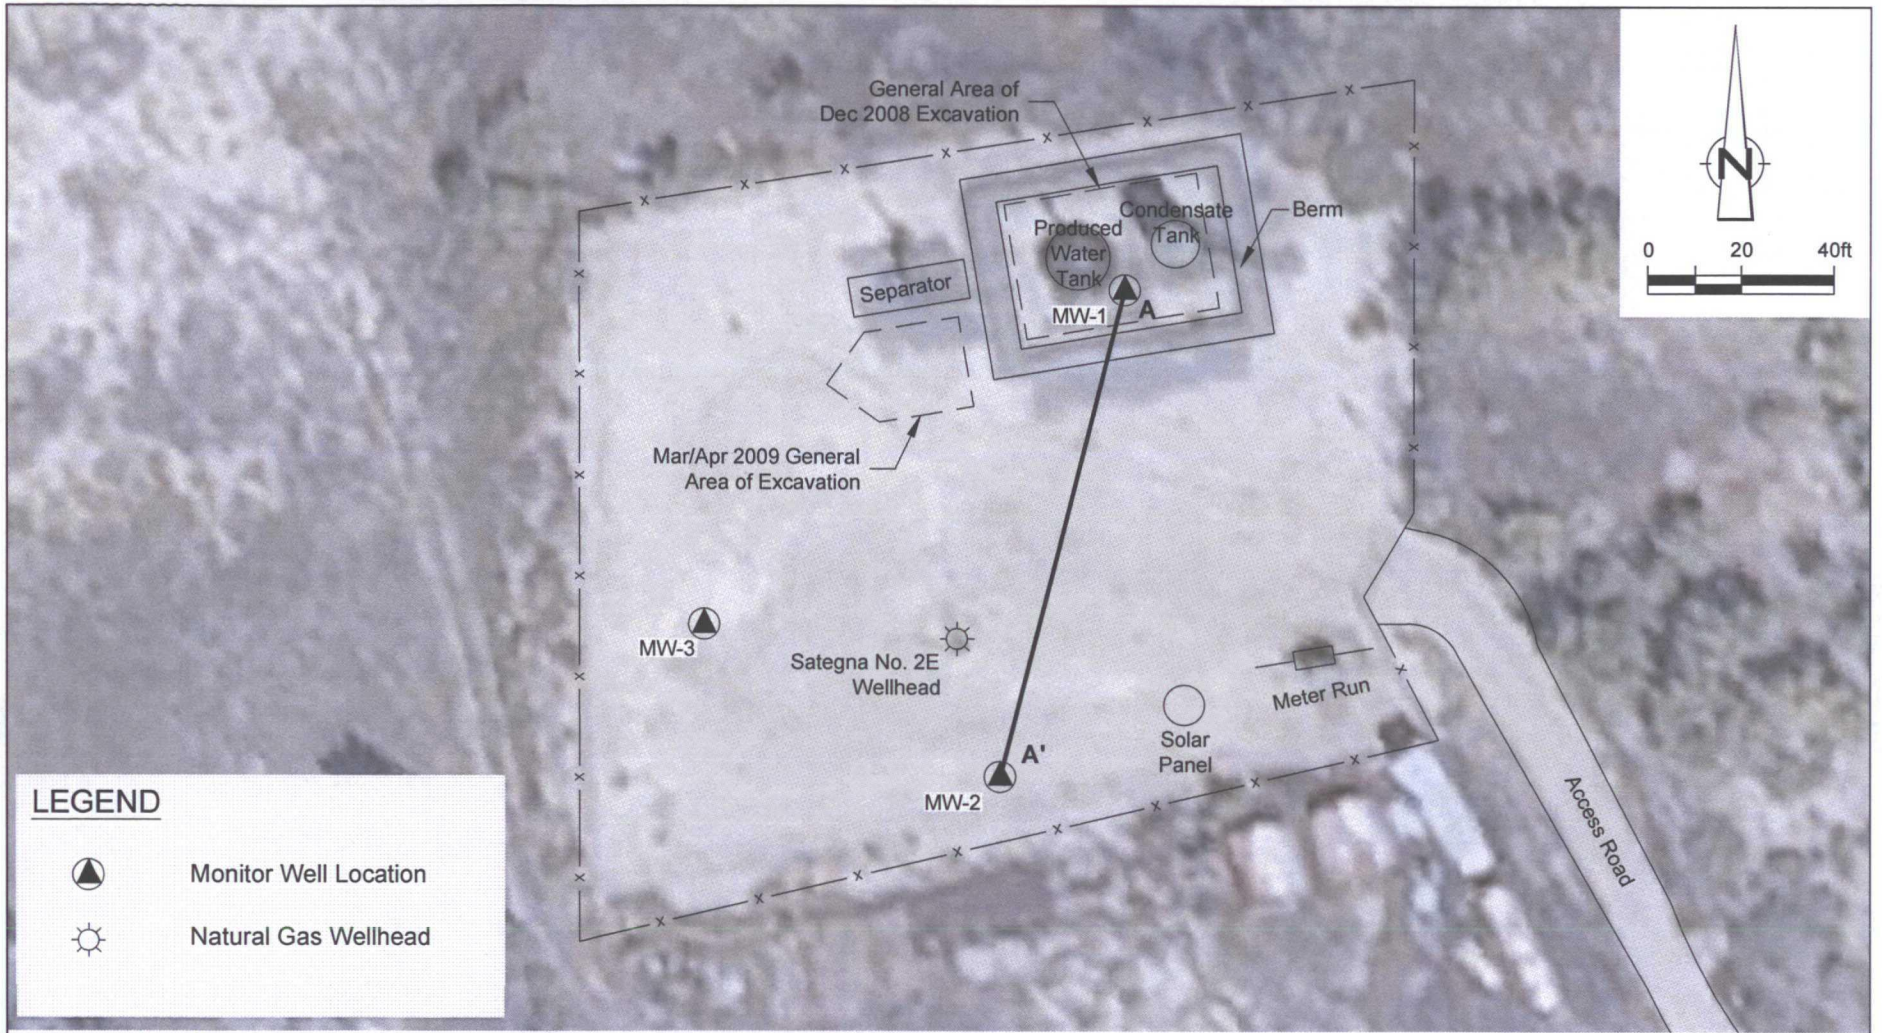
Figure 2

SITE PLAN
SATEGNA No. 2E NATURAL GAS WELL SITE
SECTION 21, T29N-R11W, BLOOMFIELD, NEW MEXICO
ConocoPhillips Company

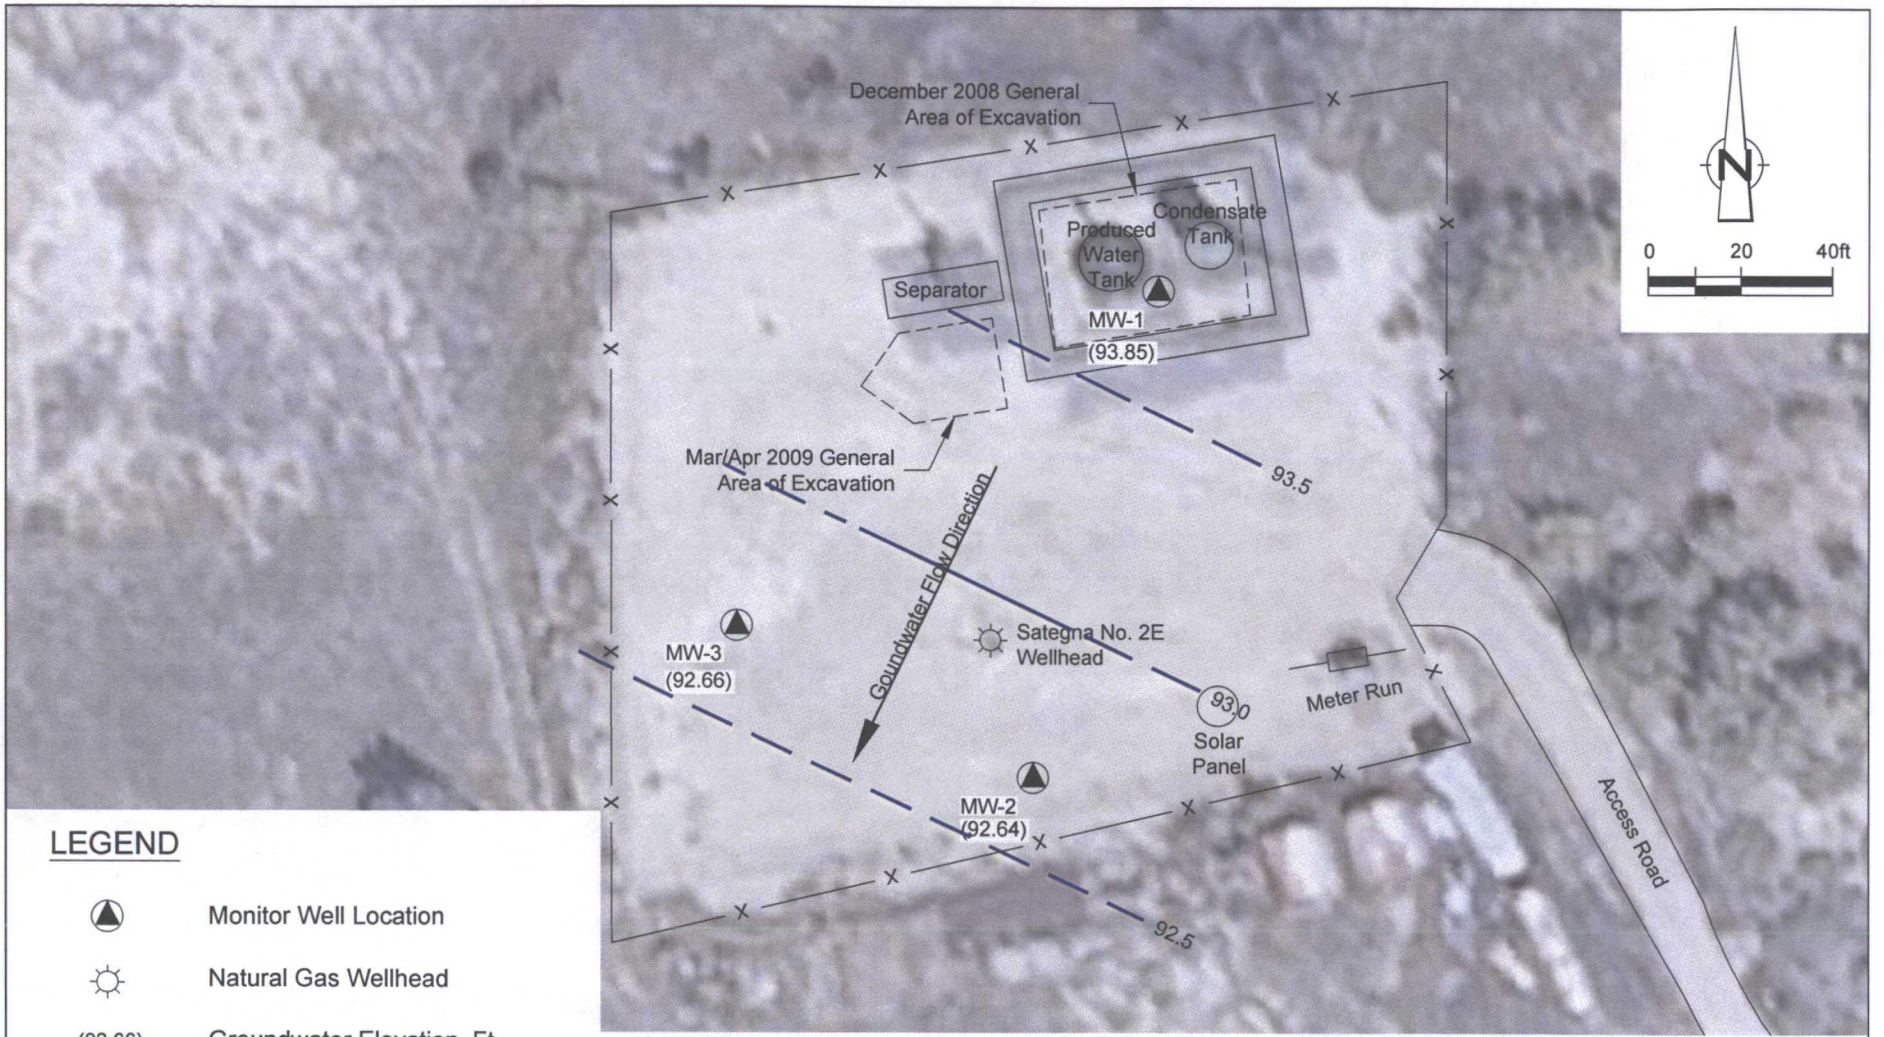
Figure 3

The casings for Monitor Wells MW-1, MW-2, and MW-3 were surveyed in March 2009 using an arbitrary reference-elevation of 100 feet. Groundwater elevation data were obtained during the September 17, 2012 sampling event, but were determined to be anomalous. The wells were gauged again on November 26, 2012. These data were used to create a groundwater potentiometric surface map for the Site (**Figure 3**). Using the November 2012 data, it was determined that the groundwater flow direction at the Site continues to be to the southwest. A generalized geologic cross section for the Site is presented as **Figure 4**.

NOVEMBER 2012 GROUNDWATER POTENTIOMETRIC SURFACE MAP
SATEGNA No. 2E NATURAL GAS WELL SITE
SECTION 21, T29N-R11W, BLOOMFIELD, NEW MEXICO
ConocoPhillips Company

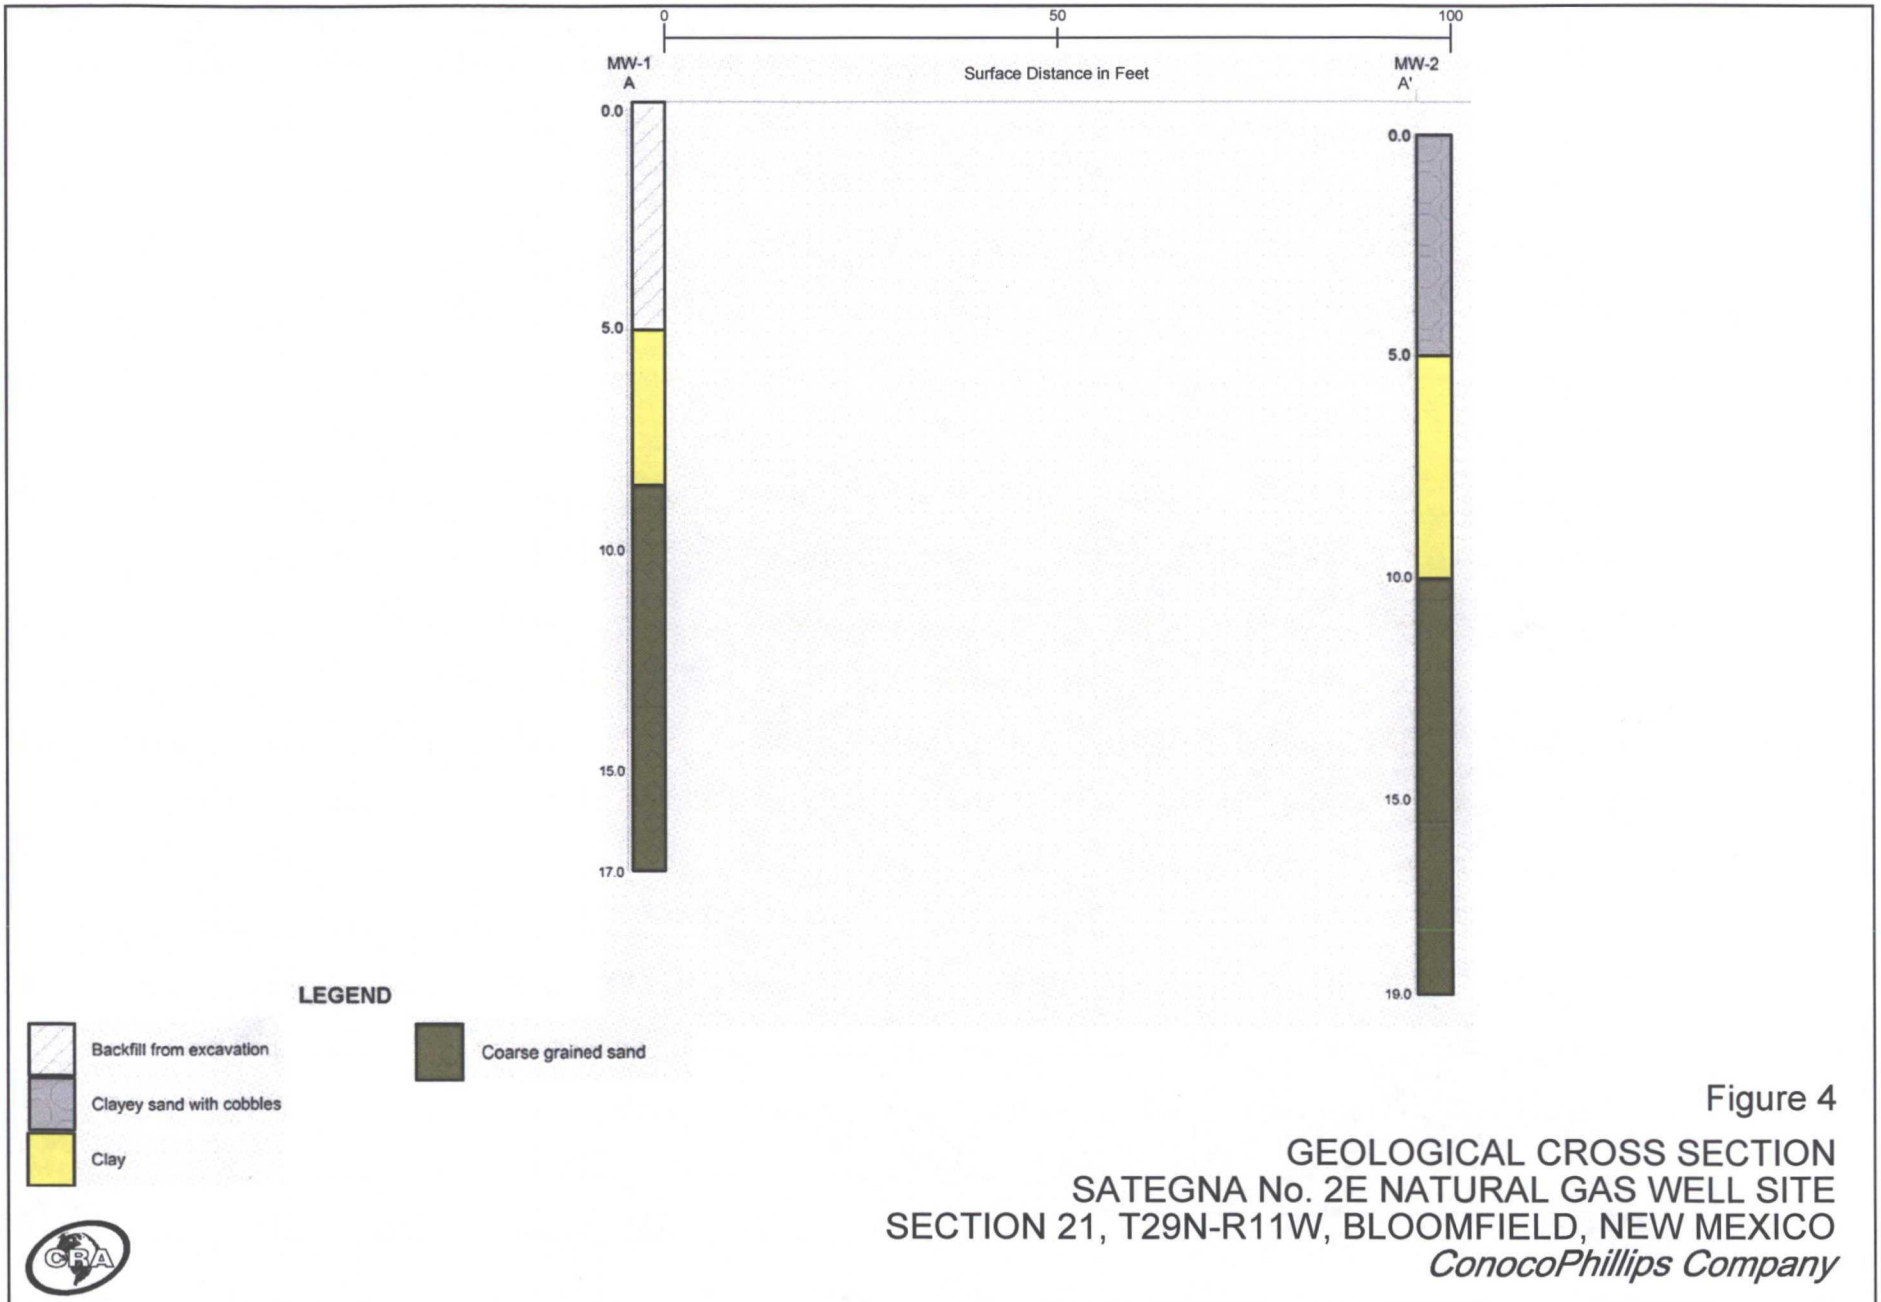
Figure 4

GEOLOGICAL CROSS SECTION
SATEGNA No. 2E NATURAL GAS WELL SITE
SECTION 21, T29N-R11W, BLOOMFIELD, NEW MEXICO
ConocoPhillips Company
