Report Type: Closure Report

June 20, 2013

Re: Closure Report for the COG Operating LLC., Southwest Central Tank Battery, Unit 0, Section 20, Township 17 South, Range 30 East, Eddy County, New Mexico.

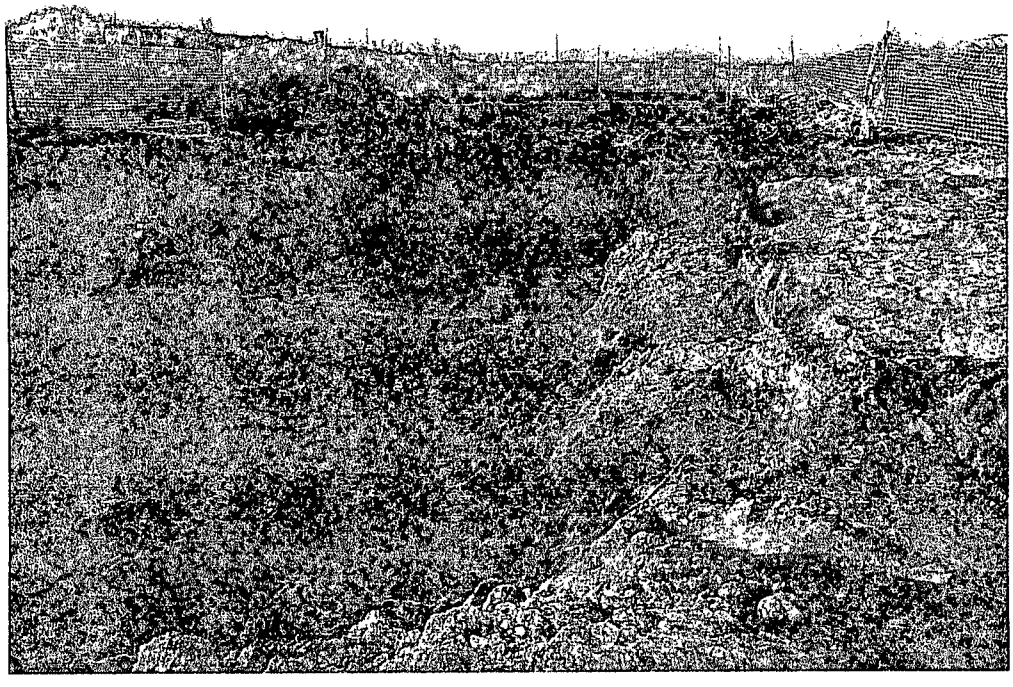
View East – Excavation of AH-2.

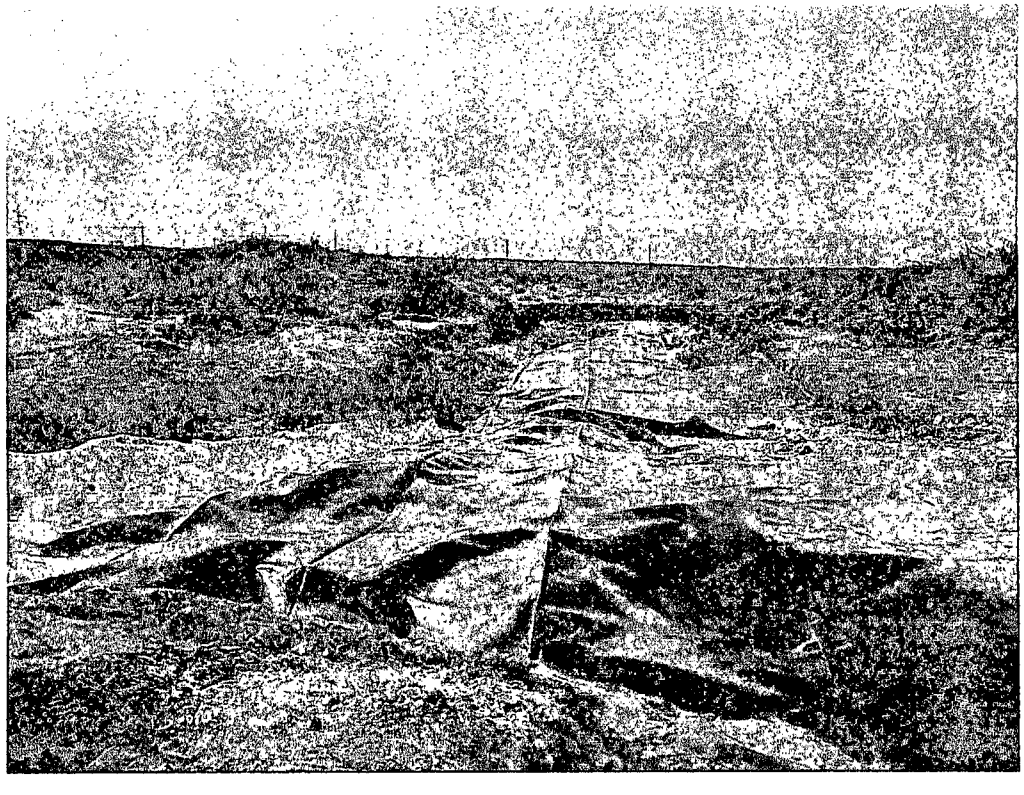
View South – Liner installation in area of AH-1 thru AH-3.

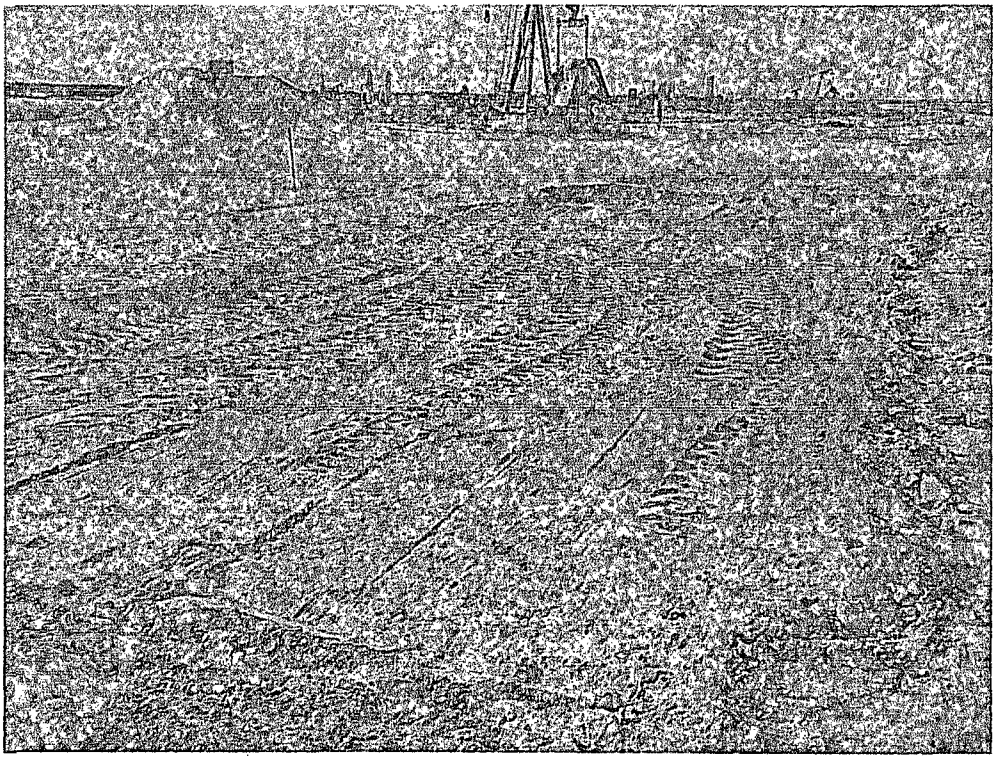
View Northeast – Excavation of AH-5.

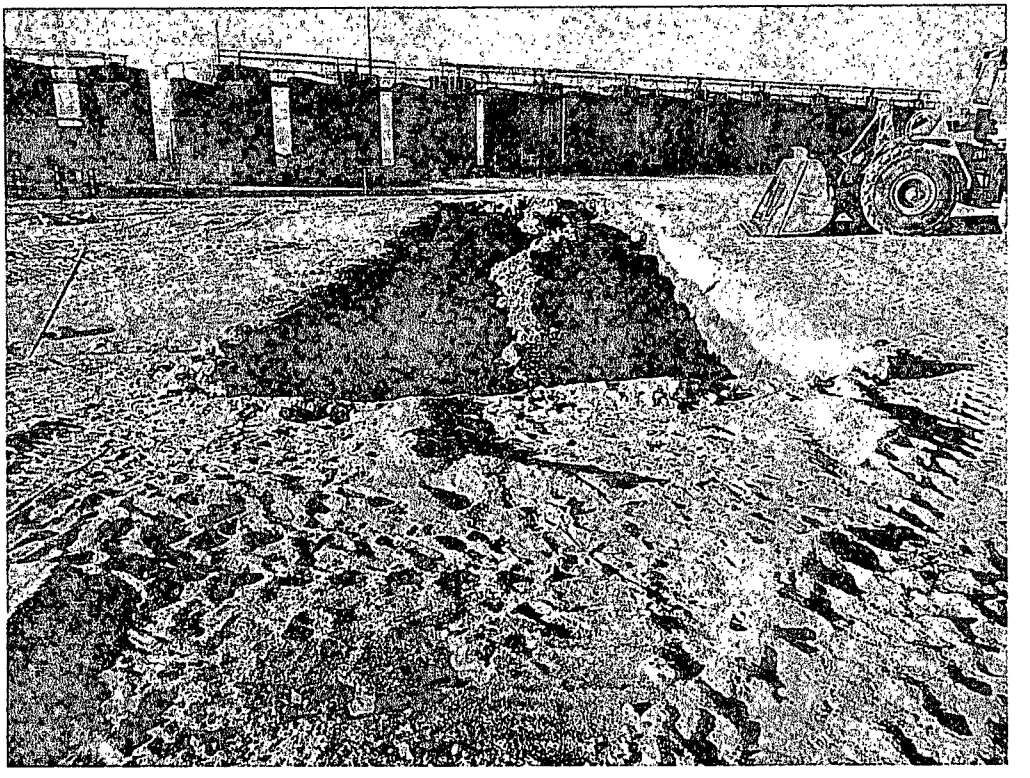
View Southwest – Excavation and clay cap installation in area of AH-7.

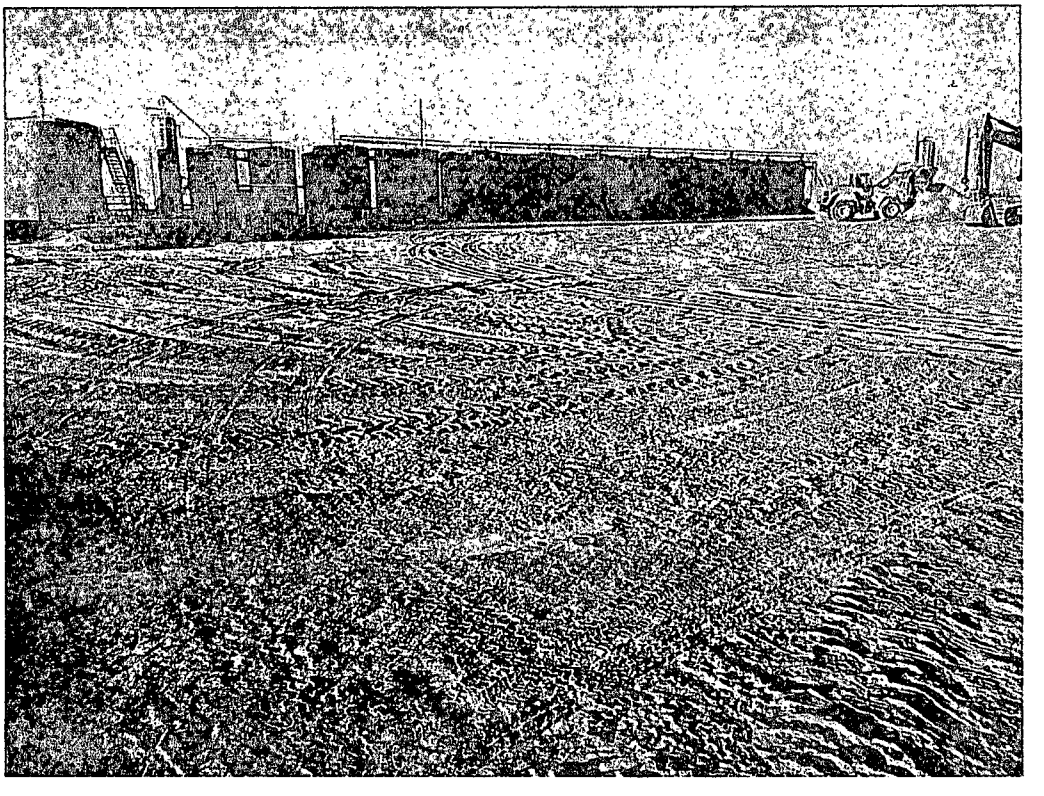
View South – Backfill of areas on pad.
