Report Type: Work Plan

Re: Work Plan for the COG Operating LLC., Folk Federal Tank Battery, located Unit H, Section 17, Township 17 South, Range 29 East, Eddy County, New Mexico.

Table 1
COG Operating LLC.
FOLK FEDERAL TANK BATTERY
Eddy County, New Mexico

Re: Assessment Report and Work Plan for the Spill located at the COG Operating, LLC, Folk Federal #2 Tank Battery, Located in Unit Letter H, Section 17, Township 17 South, Range 29 East, Eddy County, New Mexico.

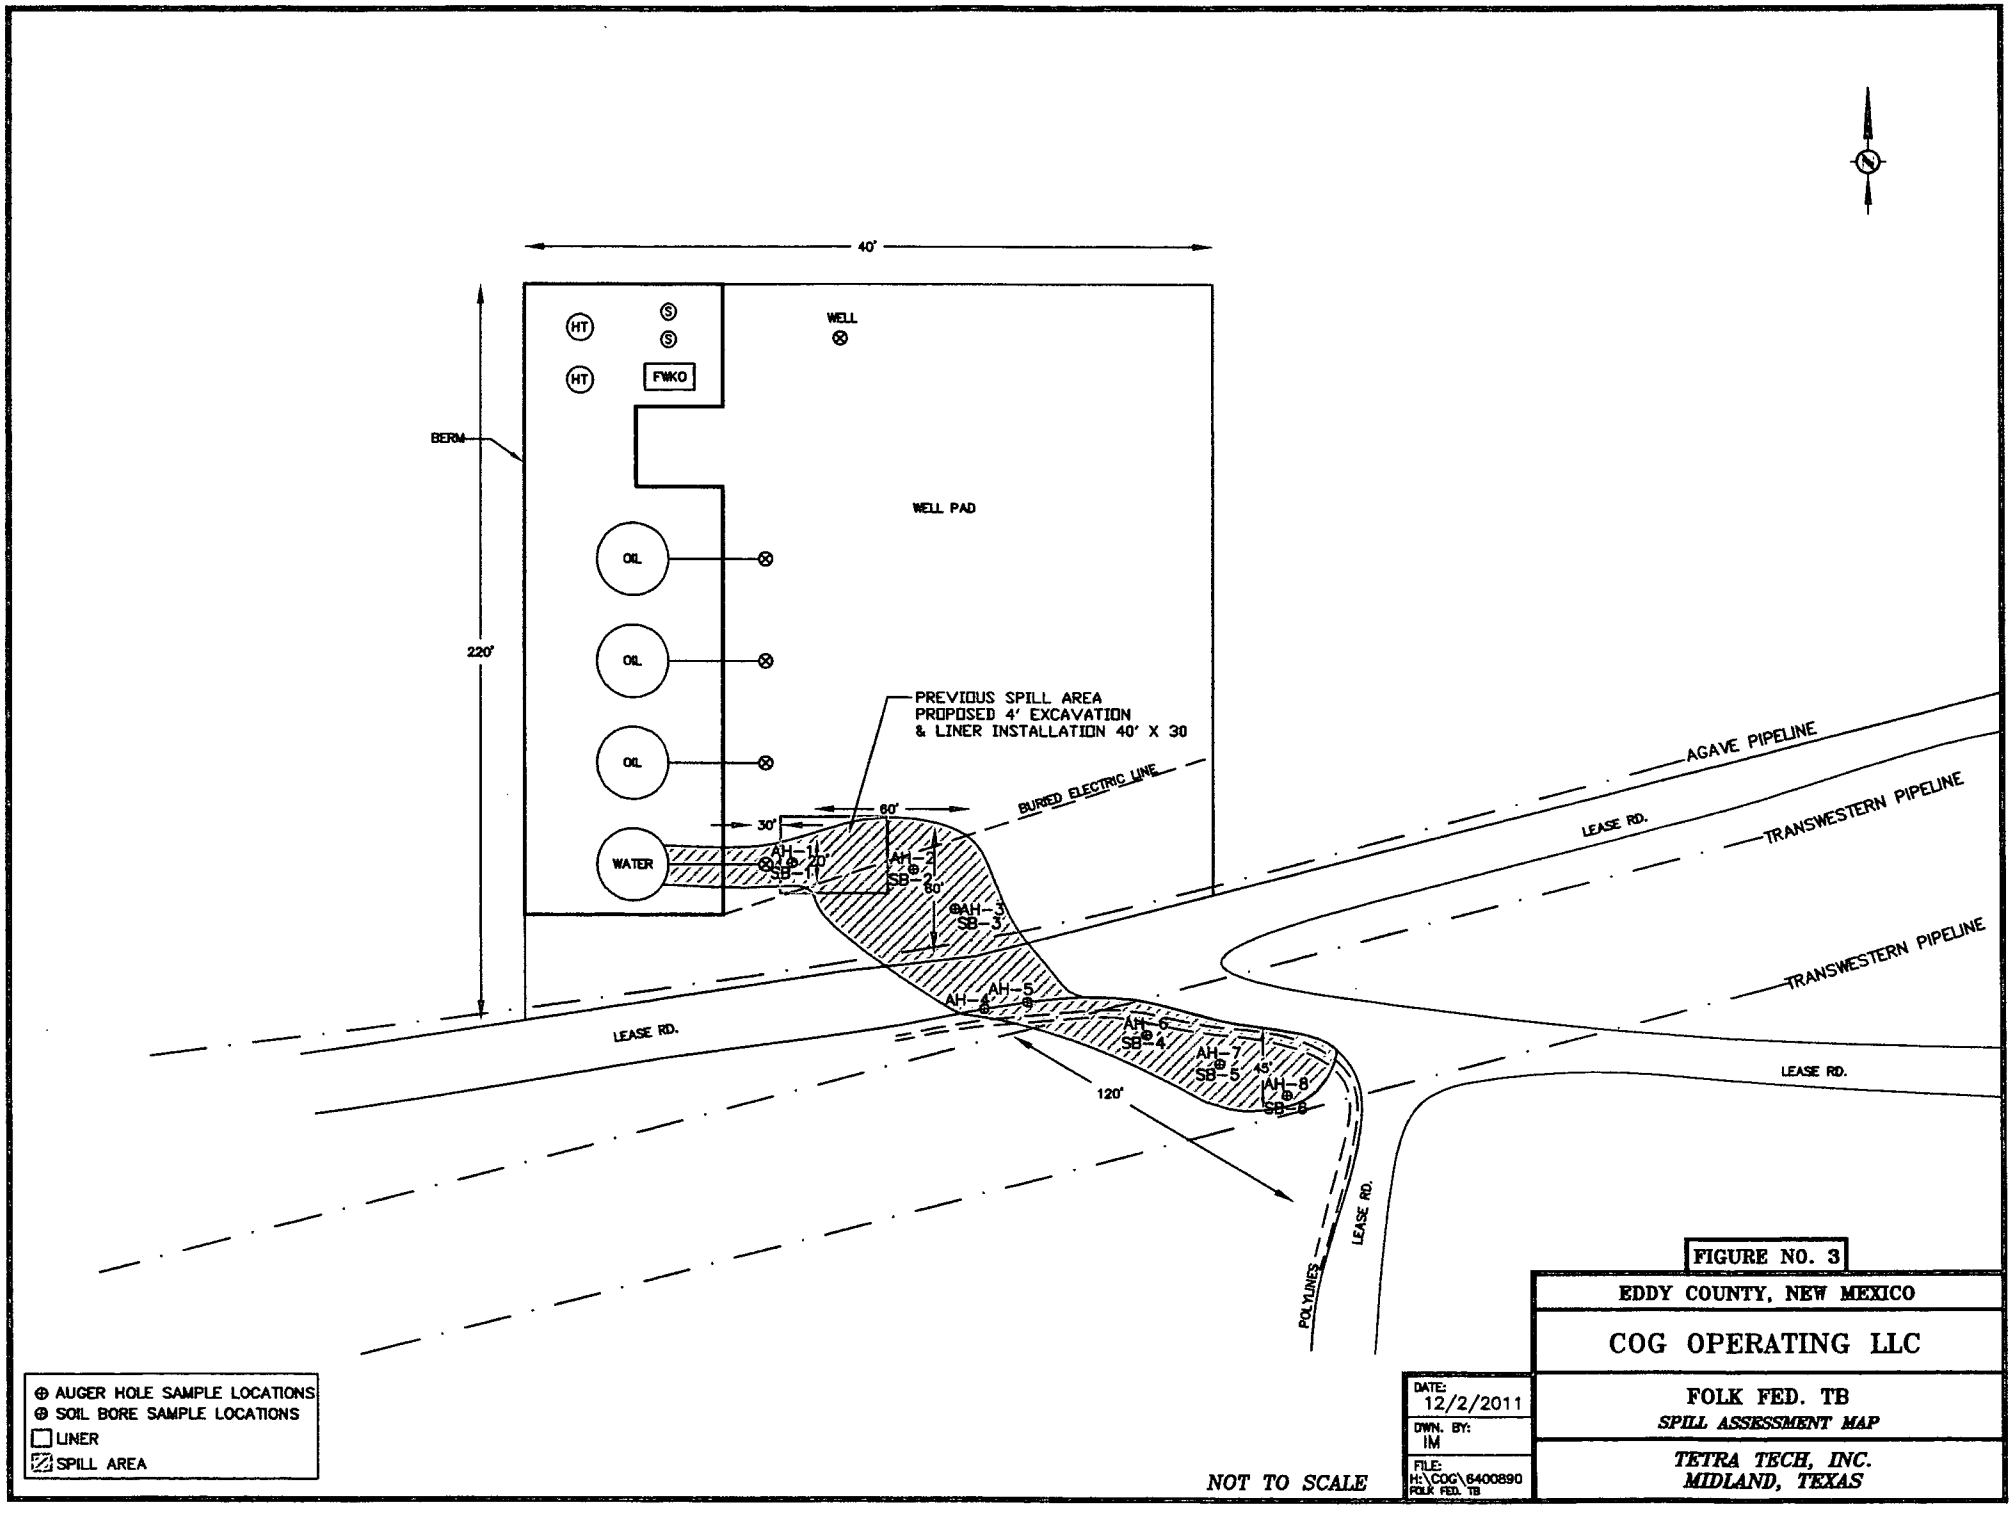
FIGURE NO. 3

On May 5, 2011, Tetra Tech personnel inspected and sampled the spill area. A total of eight (8) auger holes (AH-1 through AH-8) were installed using a stainless steel hand auger to assess the impacted soils. Selected samples were analyzed for TPH analysis by EPA method 8015 modified, BTEX by EPA Method 8021B and chloride by EPA method 300.0. Copies of laboratory analysis and chain-of-custody documentation are included in Appendix D. The sampling results are summarized in Table 1. The auger hole locations are shown on Figure 3.

Referring to Table 1, all submitted samples were below RRAL for TPH and BTEX. Elevated chloride concentrations were detected and not defined at all of the sample locations. Deeper samples could not be collected due to a dense formation. On the lease road, auger holes (AH-4 and AH-5) showed chloride concentrations at 0-1' of 1,060 mg/kg and 2,870 mg/kg, respectively.

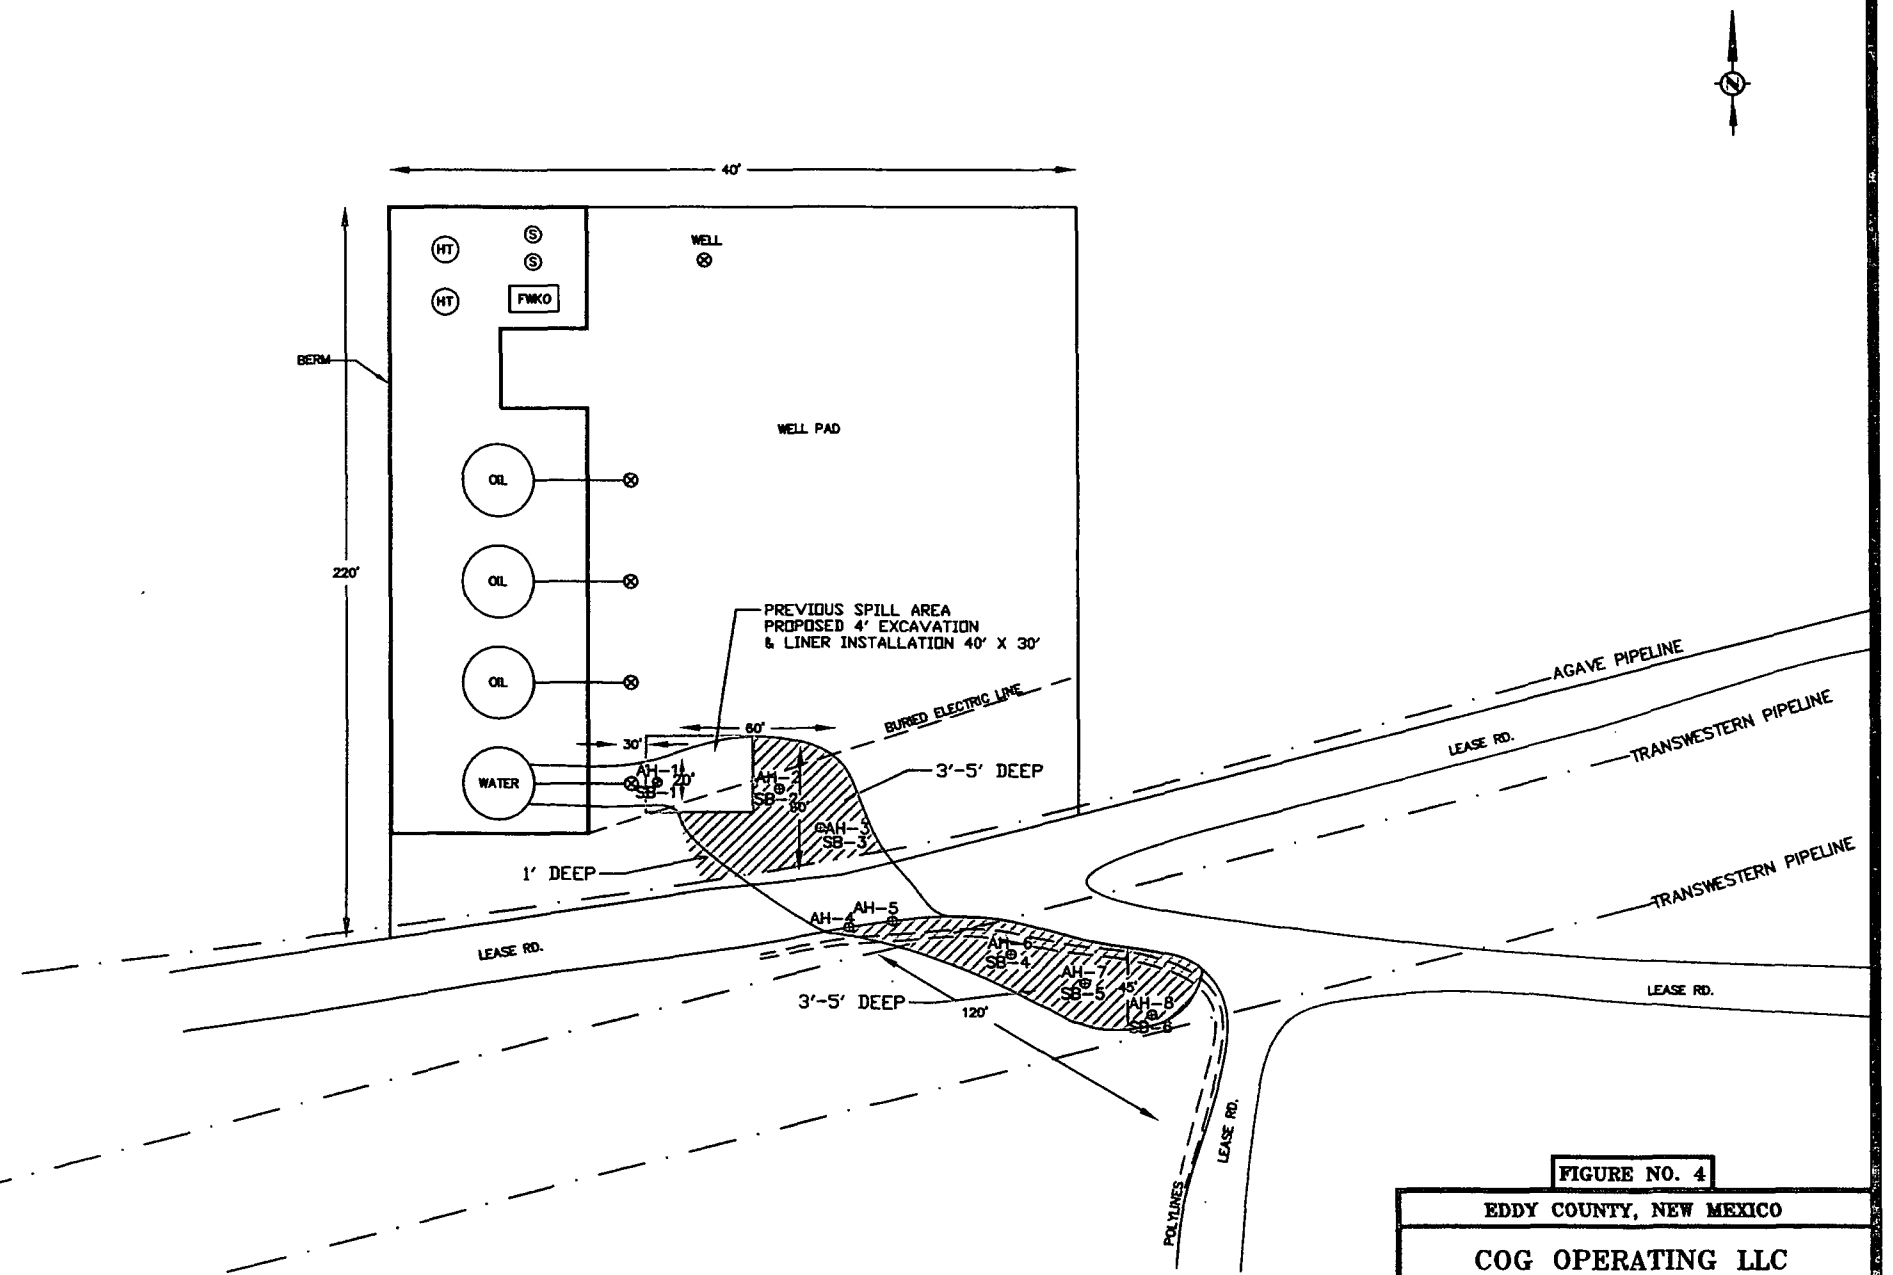
40'
HT
S
S
HT
FWKO
WELL
BERM
WELL PAD
220'
OIL
OIL
OIL
WATER
PREVIOUS SPILL AREA
PROPOSED 4' EXCAVATION
& LINER INSTALLATION 40' X 30'
60'
30'
BURIED ELECTRIC LINE
AH-1 @ 20'
SB-1
AH-2 @ 60'
SB-2
AH-3
SB-3
3'-5' DEEP
1' DEEP
AGAVE PIPELINE
LEASE RD.
TRANSWESTERN PIPELINE
TRANSWESTERN PIPELINE
AH-4
AH-5
AH-6
SB-4
AH-7
SB-5
15'
AH-8
SB-6
3'-5' DEEP
120'
LEASE RD.
LEASE RD.
POLYLINES
⊕ AUGER HOLE SAMPLE LOCATIONS
⊕ SOIL BORE SAMPLE LOCATIONS
LINER
PROPOSED EXCAVATION AREA
NOT TO SCALE
DATE: 4/26/2012
DWN. BY: IM
FILE: H:\COG\6400890 FOLK FED. TB
FIGURE NO. 4
EDDY COUNTY, NEW MEXICO
COG OPERATING LLC
FOLK FED. TB
PROPOSED EXCAVATION AREAS & DEPTHS MAP
TETRA TECH, INC.
MIDLAND, TEXAS

COG proposes to removal of impacted material as highlighted (green) in Table 1 and shown on Figure 4. As stated in the previous work plan, COG proposed the area of AH-1 be excavated to a depth of 3.0' to 4.0' and the bottom of the excavation capped with a 40 mil liner. In the areas of AH-4 and AH-5 (lease road), a surficial scrape will be performed due to the road activity and proximity of the Agave Pipeline and Transwestern Pipeline, which is a safety concern. AH-2 will be scraped approximately 1.0' and the remaining areas of AH-3, AH-6, AH-7 and AH-8 will be excavated to a depth of approximately 3.0' to 5.0' below surface.

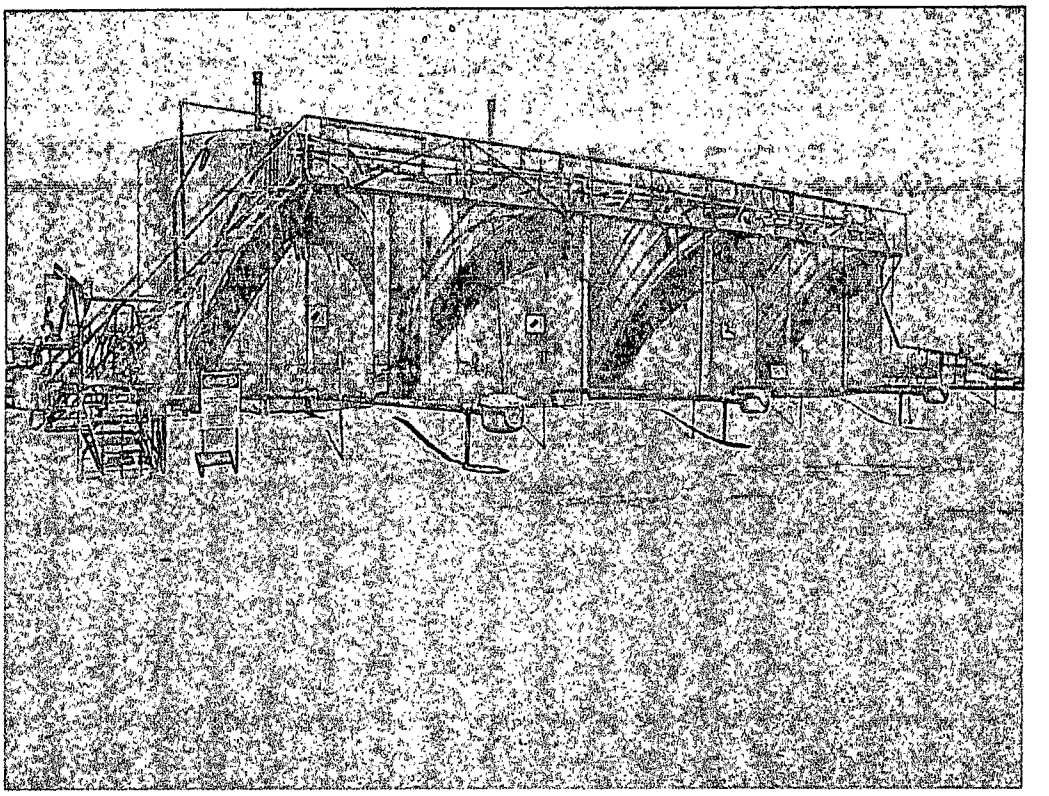
View south – Front of tank battery near AH-1

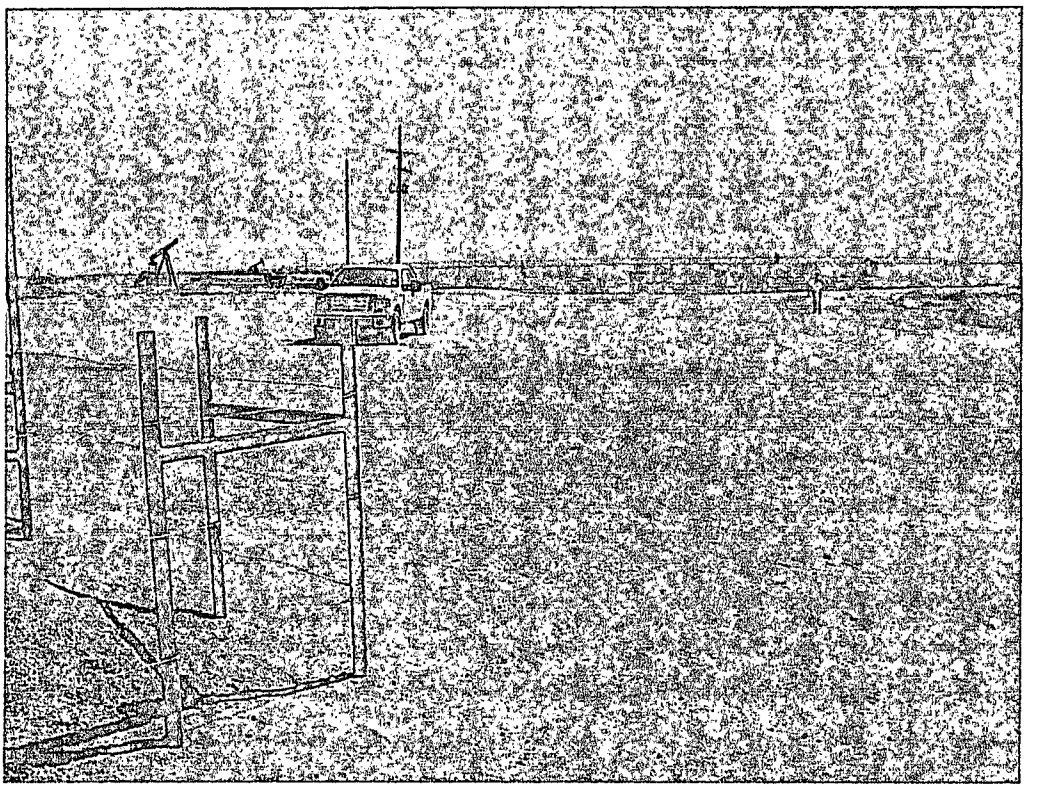
View east – Pad area near AH-1 and AH-2

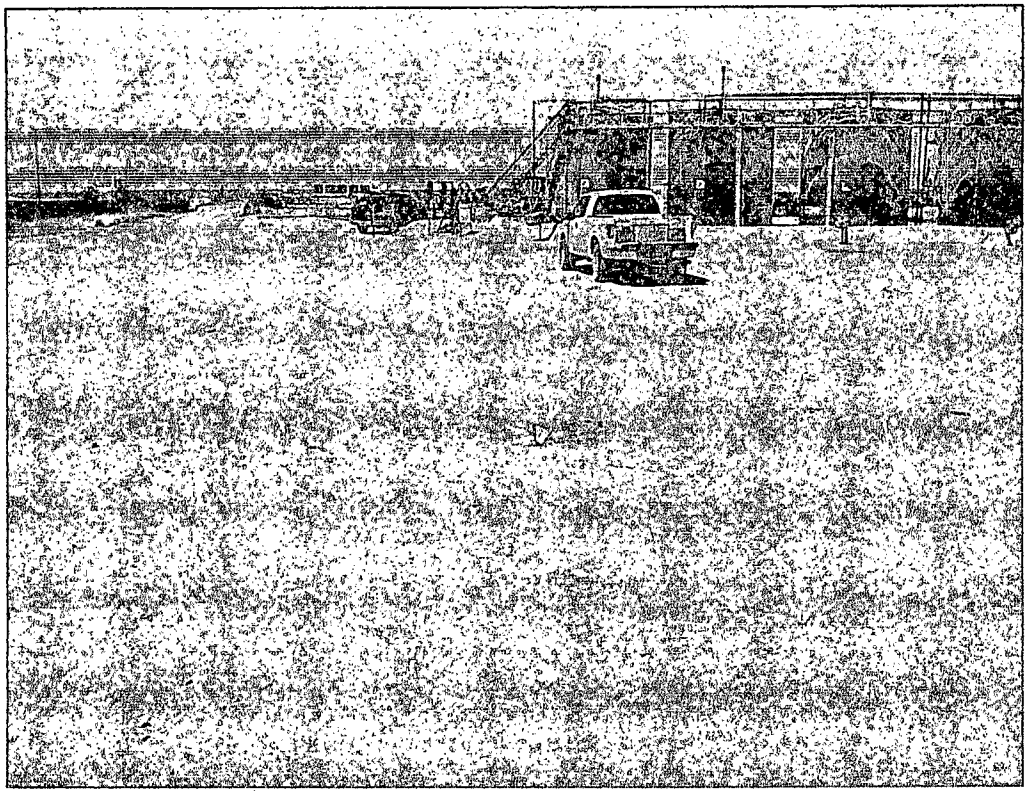
View west – Tank Battery Pad, area of AH-3

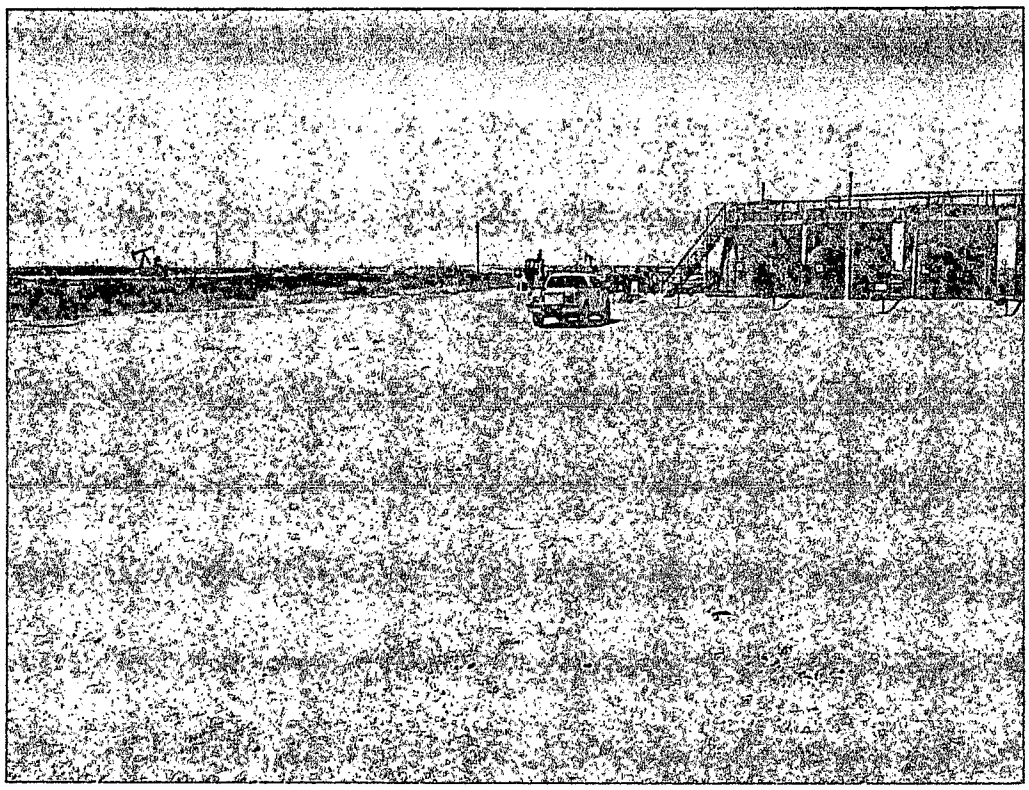
View west – Tank Battery Pad

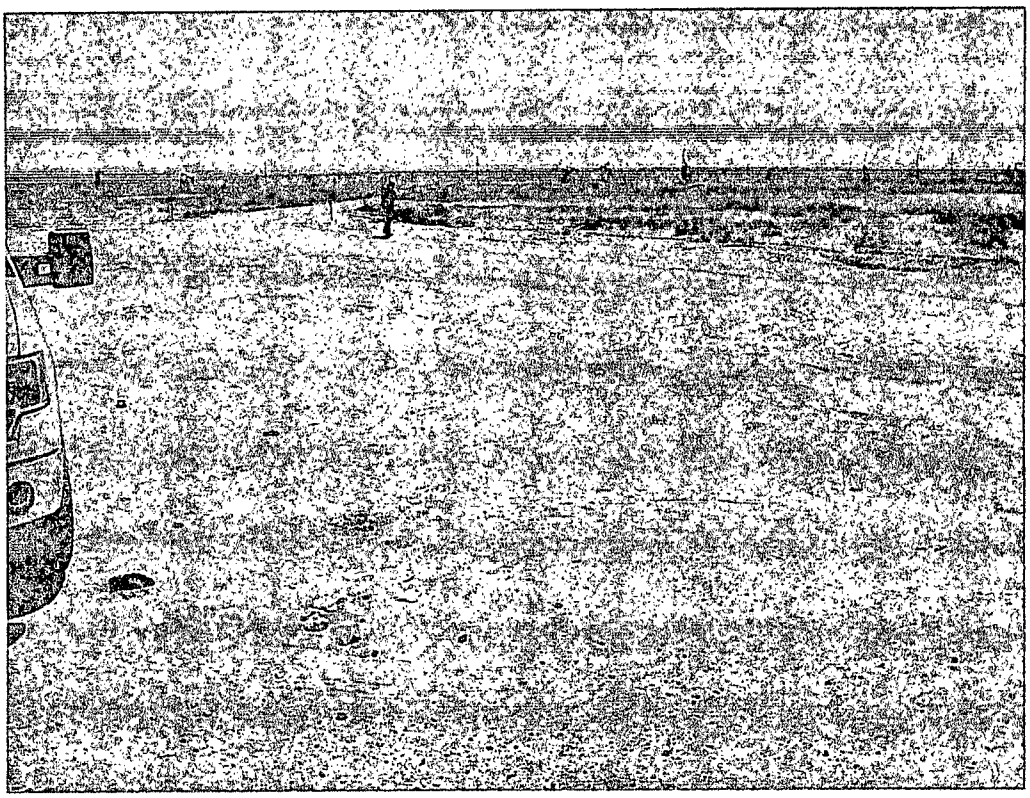
View southeast – Pad and lease road

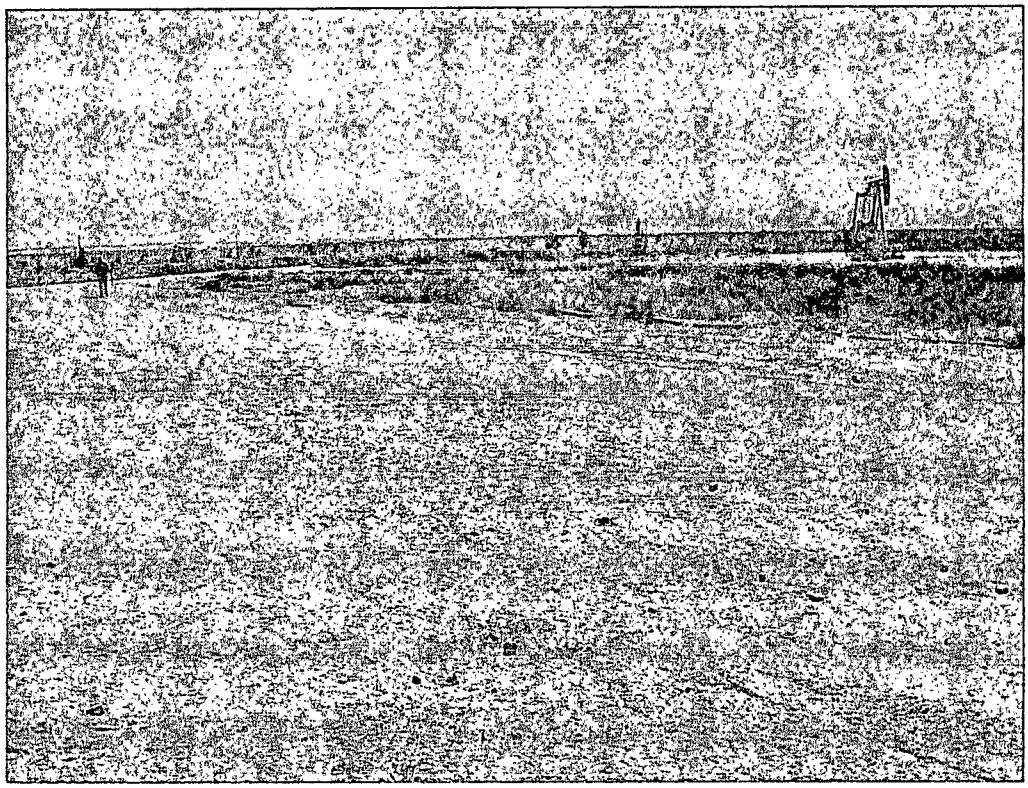
View southeast – Pad and lease road

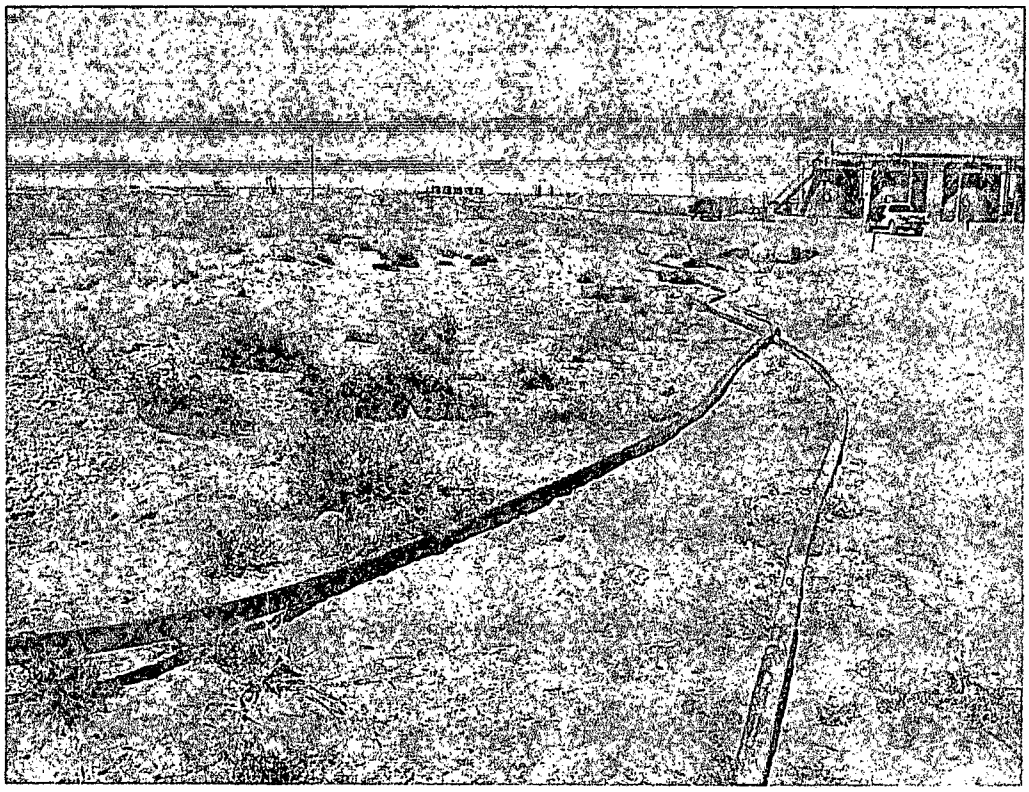
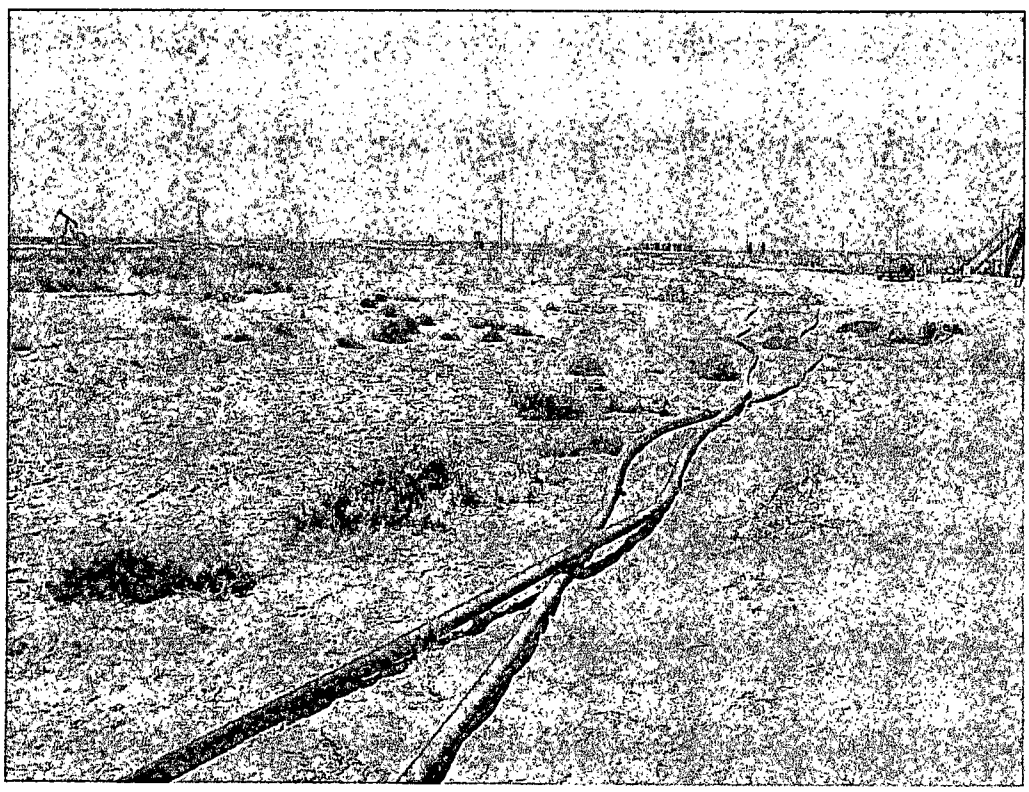
View west – area of AH-6, AH-7 and AH-8

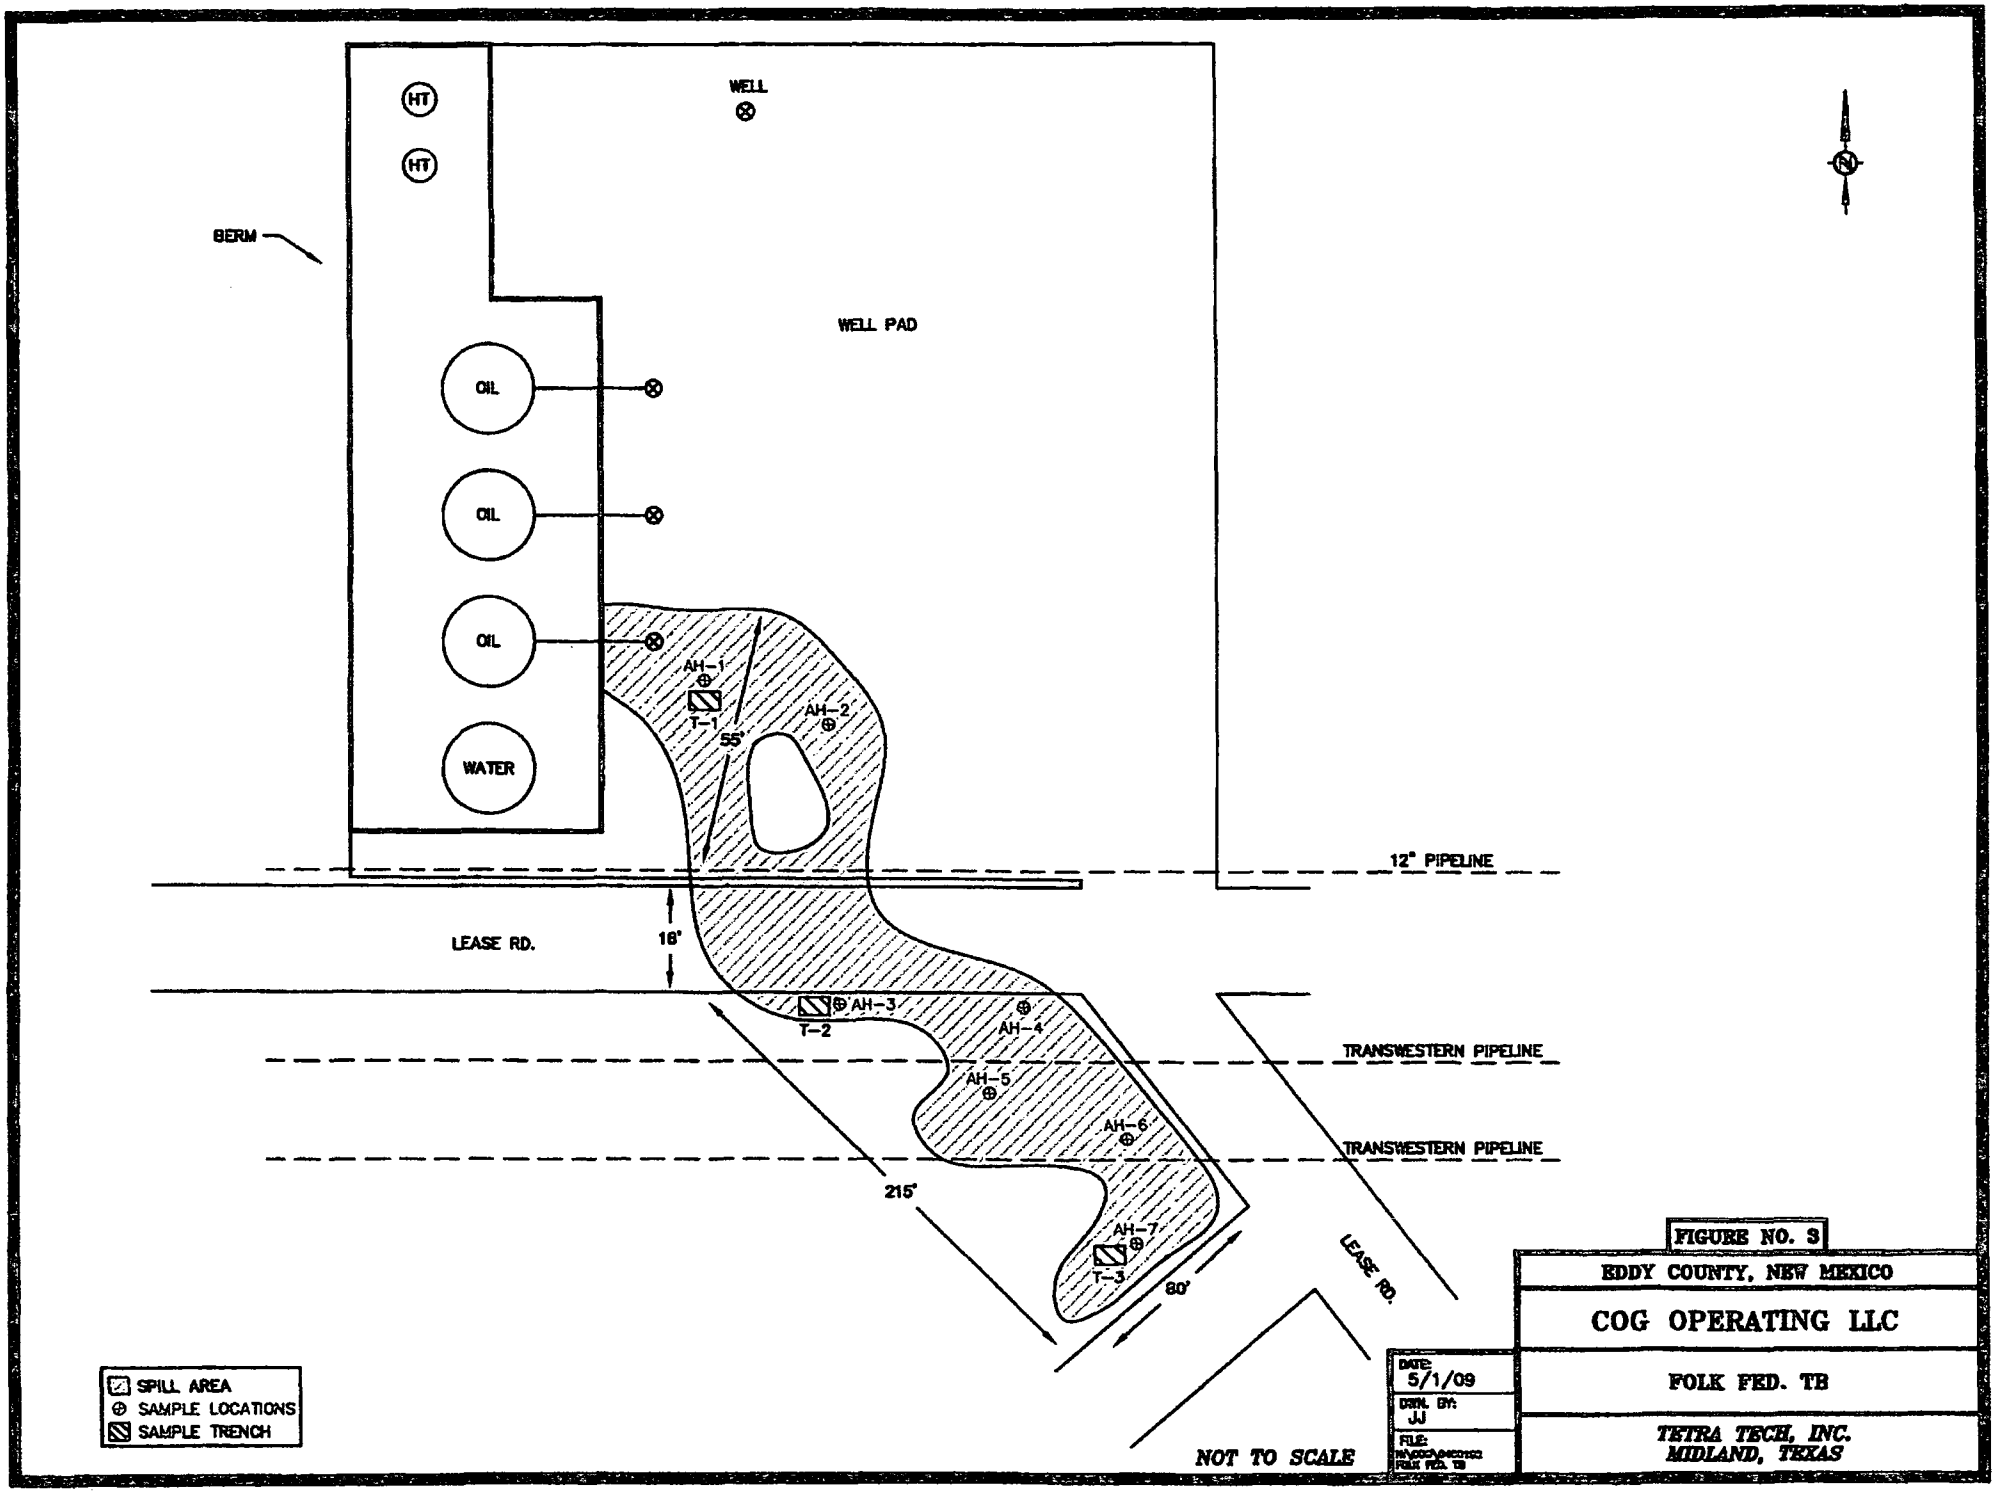
FIGURE NO. 3

On May 14, 2009, samples were collected from the spill area. A total of seven (7) auger holes were placed in the impacted area. The sample locations are shown on Figure 3. The soil samples were analyzed for TPH (Modified 8015), BTEX (8021 B), and Chloride (SM 4500-Cl B). Copies of the laboratory reports and chain of custody documents are included in Appendix C. The results are summarized in Table 1.

Referring to Table 1, none of the samples had TPH or BTEX concentrations exceeding the RRAL. Chloride impact was detected in the areas of AH-1, AH-3 and AH-7 and not vertically defined On May 20, 2009, Navajo excavated the areas (AH-1, AH-3 and AH-7) with the elevated chloride impact. Once excavated, three test trenches were installed to define chloride impact in these areas. Trench T-1 was placed near AH-1 and samples were collected to total depth of 8.0' below surface and the chloride impact was not defined at this location, with a chloride concentration of 2,310 mg/kg. The remaining trenches T-2 (AH-3) and T-3 (AH-7) declined with depth and had chloride concentrations of 531 mg/kg (T-2, 7.0') and 552 mg/kg (T-3, 2.0') respectively. The results are summarized in Table 1.

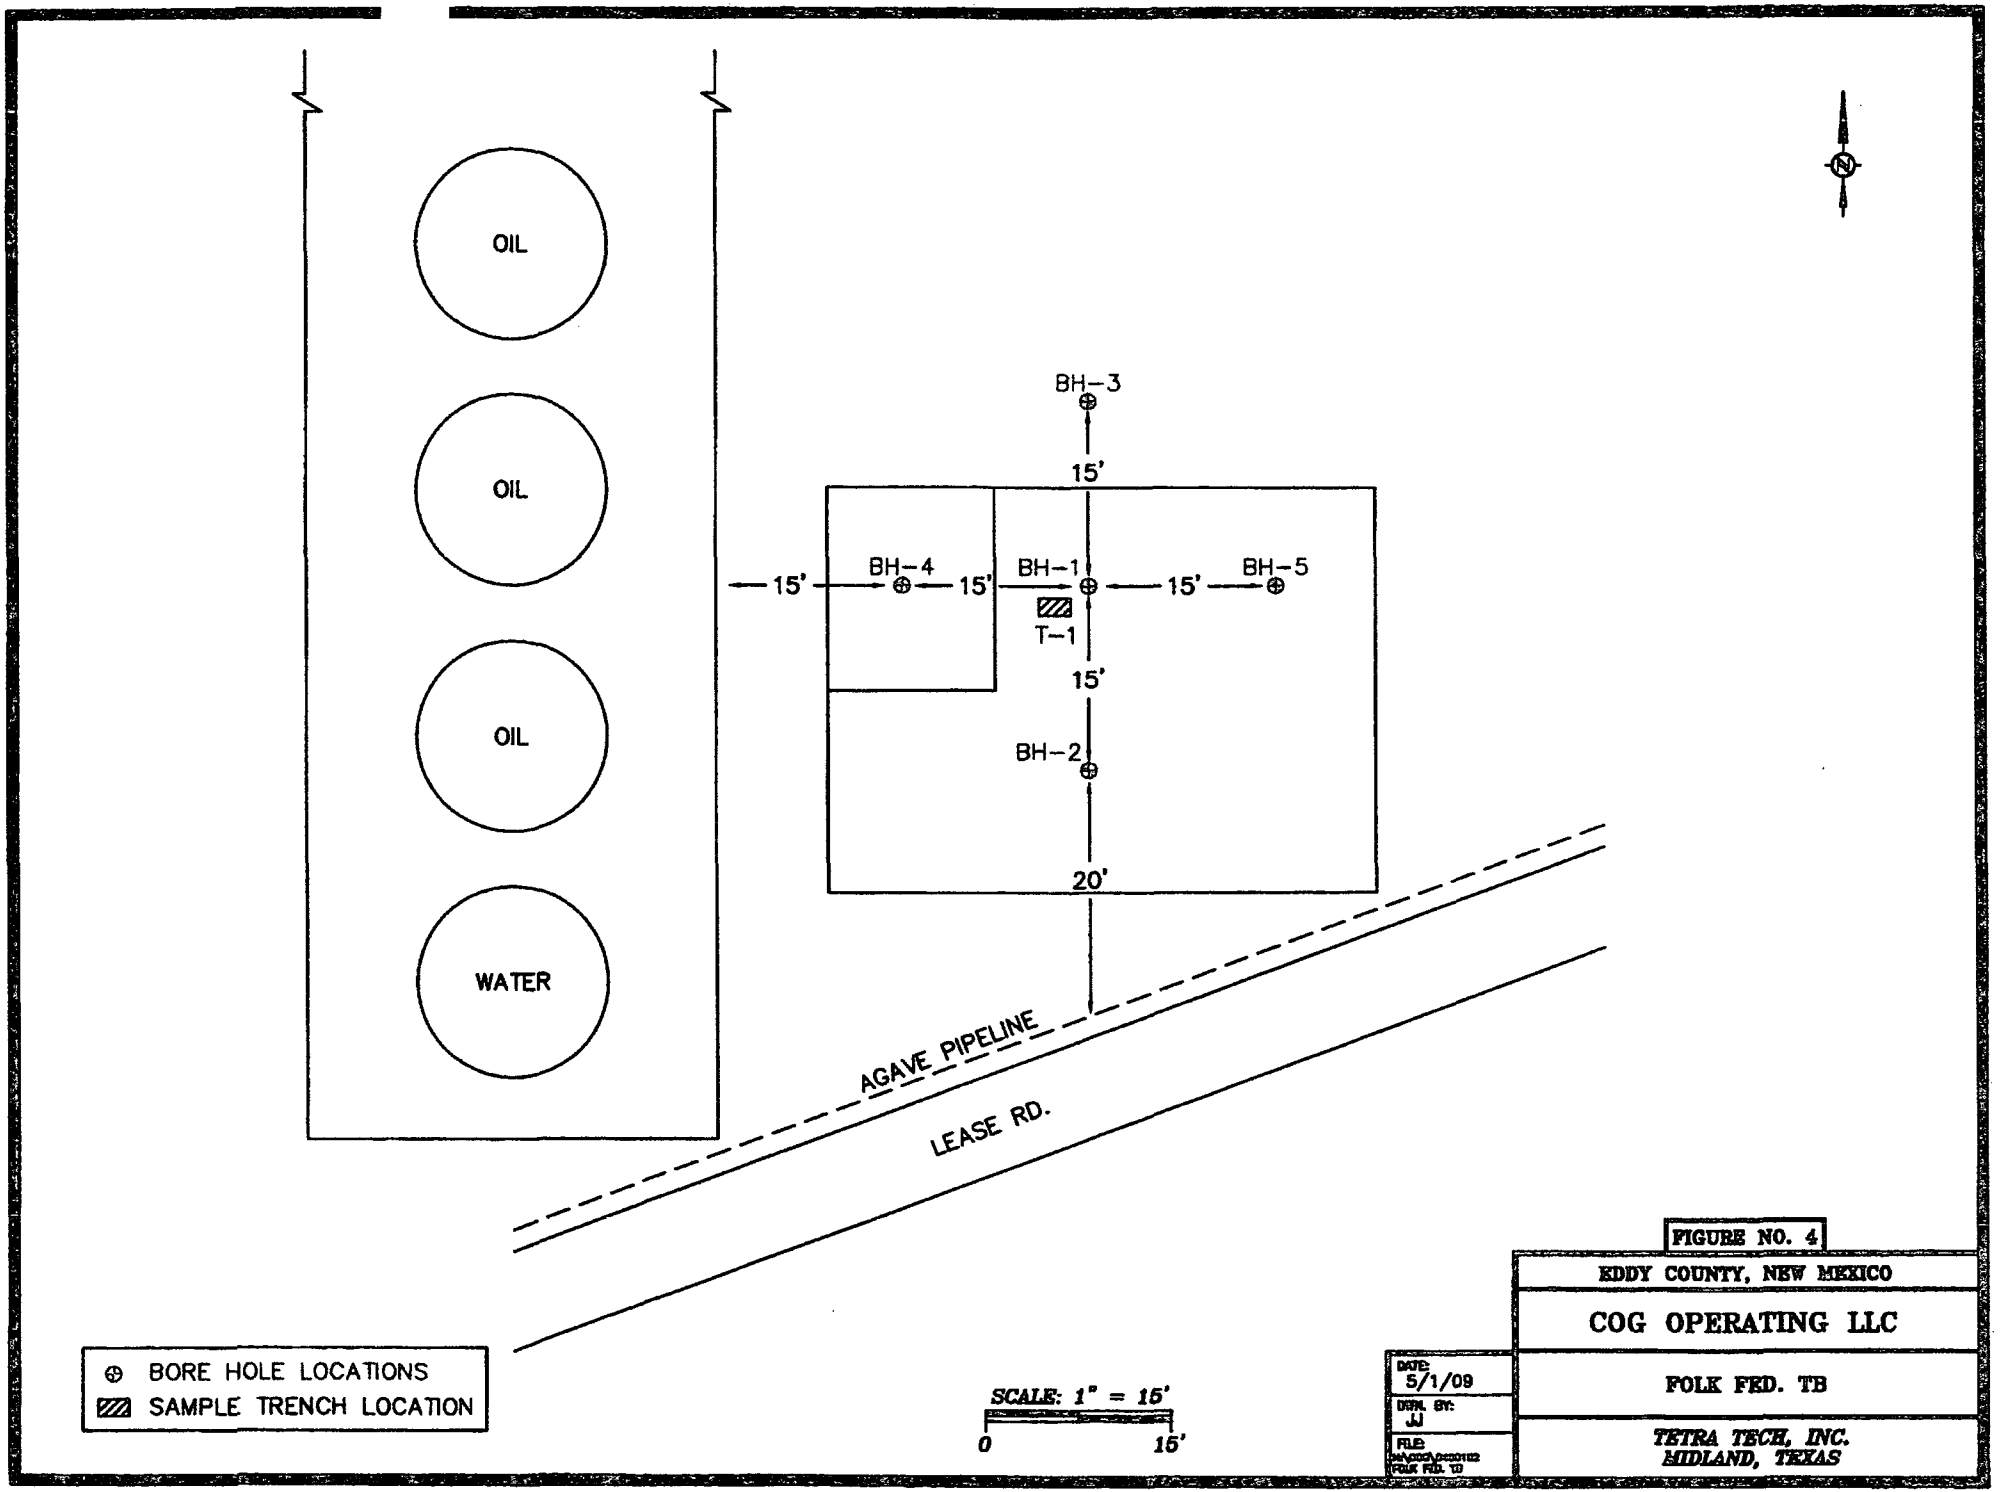
FIGURE NO. 4

On August 19, 2009 Tetra Tech installed boreholes to assess and define the extents area of AH-1. A total of five (5) boreholes were installed in the vicinity of AH-1. The borehole locations are shown in Figure 4. Copies of the laboratory reports and chain of custody documents are included in Appendix C. The results are summarized in Table 2

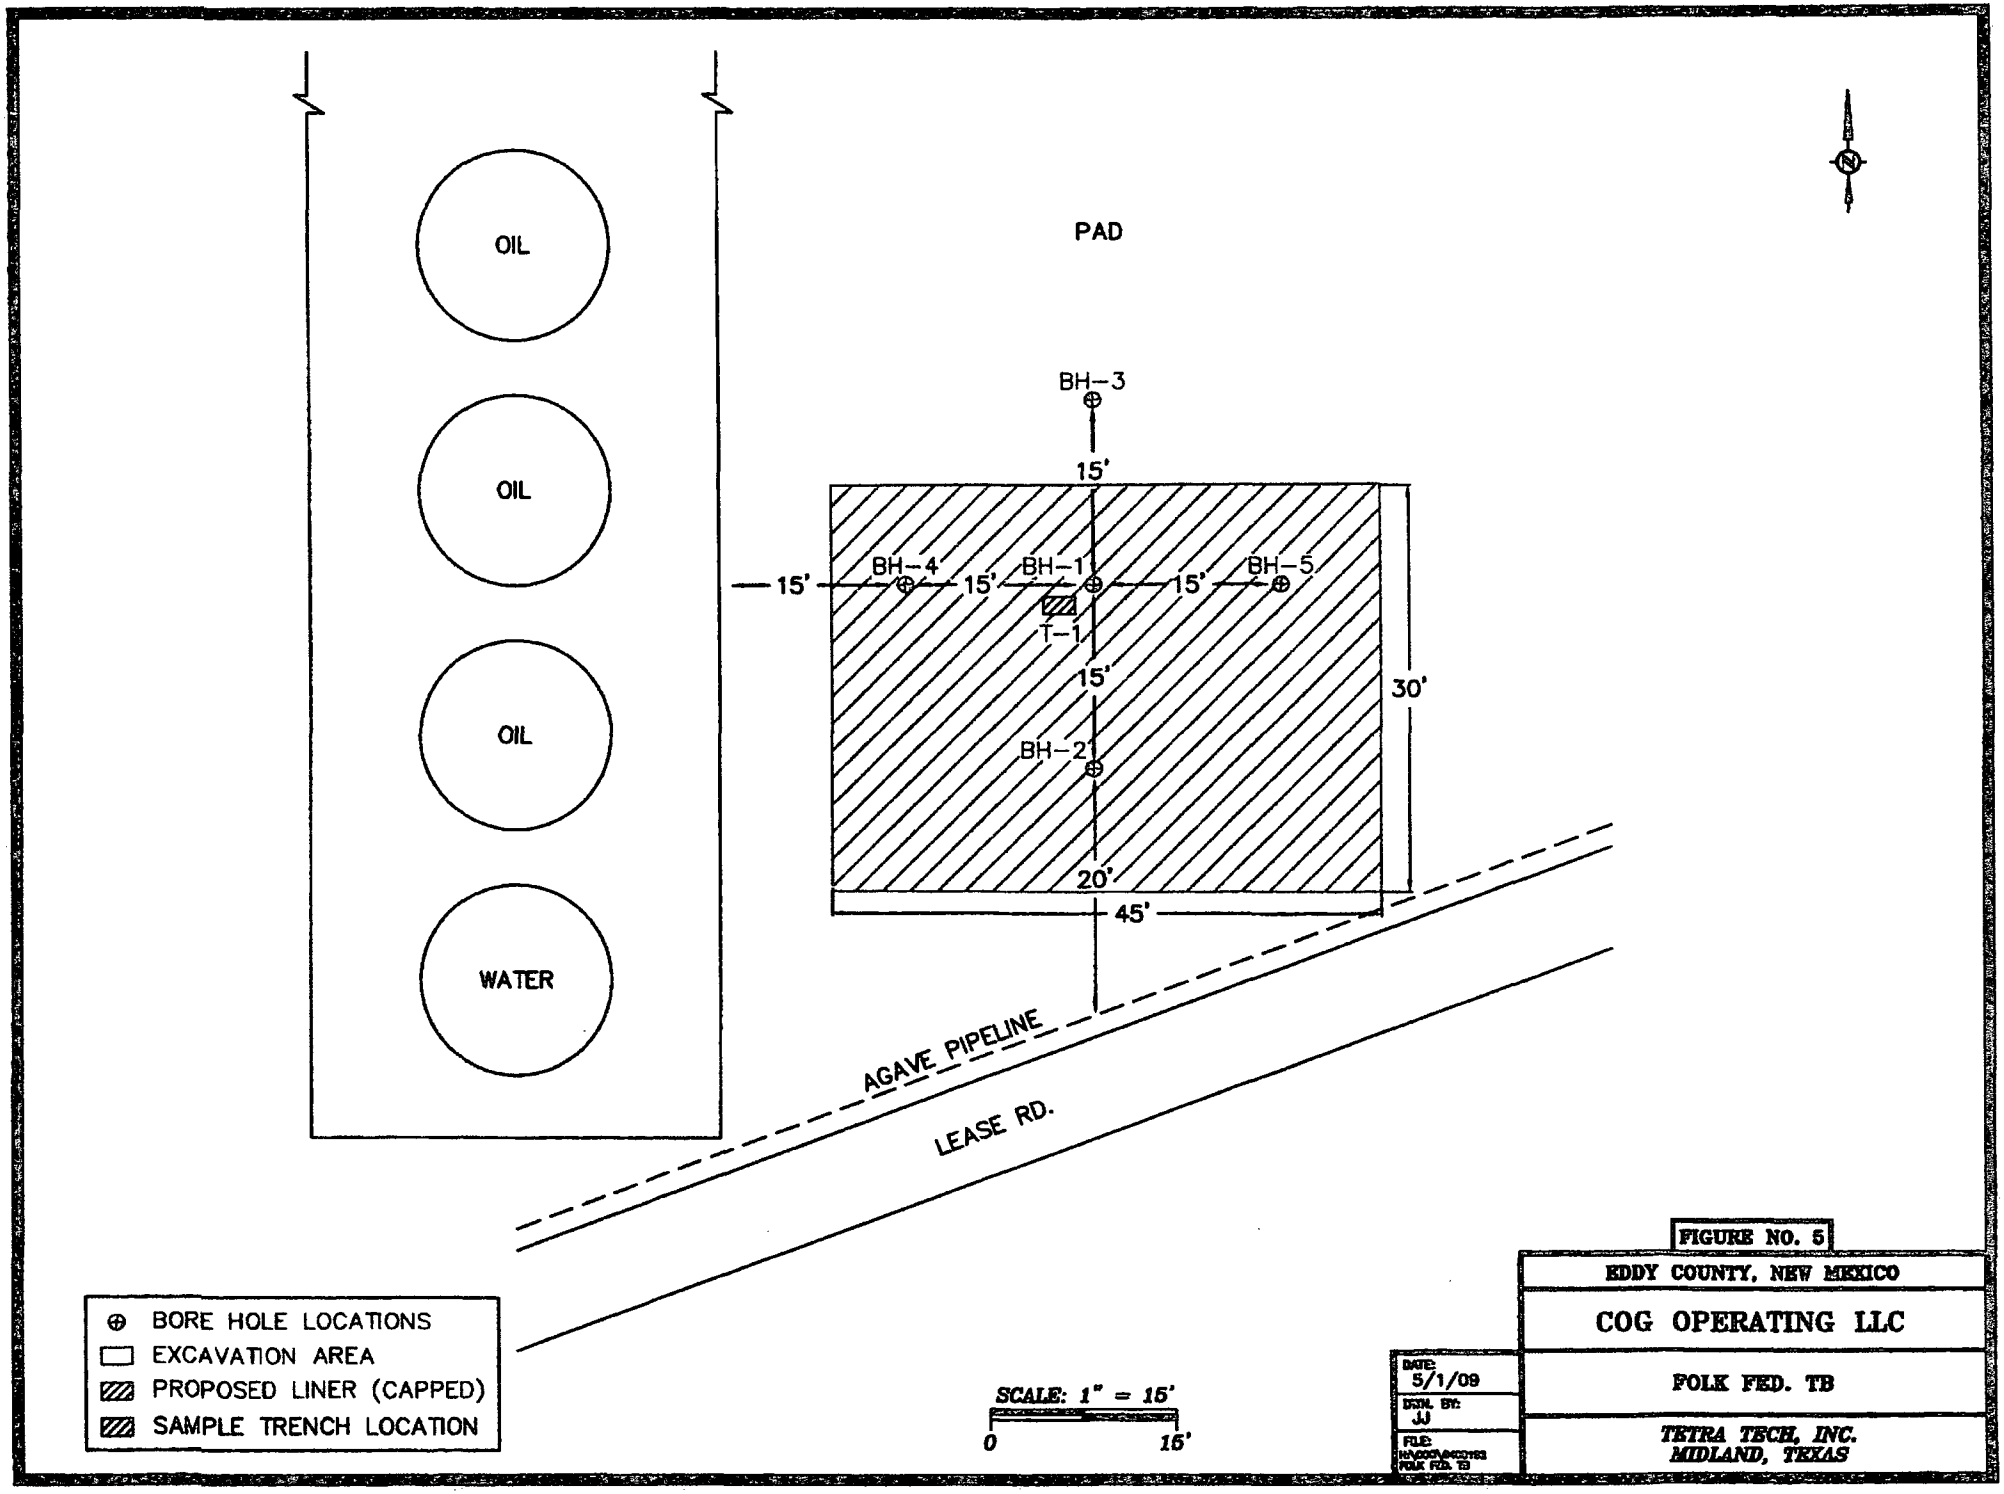
Referring to Table 2, all the boreholes showed chloride concentrations declining with depth. BH-3 showed slight chloride impact to the subsurface soils. Boreholes (BH-1 and BH-2) did show chloride impact above 1,000 mg/kg from 6.0' to 15.0', with chloride concentrations ranging from 1,160 mg/kg to 1,980 mg/kg. Borehole (BH-5) showed elevated chloride impact from 6.0' to 9.0' with concentrations of 1,680 mg/kg and 2,800 mg/kg, respectively. Borehole (BH-4) did show a chloride impact from surface to 15.0' below surface, with concentrations from 686 mg/kg at 6.0' to 5,660 mg/kg at 0-1'.

OIL
OIL
OIL
WATER
PAD
BH-3
15'
BH-4
15'
BH-1
15'
BH-5
15'
T-1
15'
30'
BH-2
20'
45'
AGAVE PIPELINE
LEASE RD.
BORE HOLE LOCATIONS
EXCAVATION AREA
PROPOSED LINER (CAPPED)
SAMPLE TRENCH LOCATION
SCALE: 1" = 15'
0
15'
FIGURE NO. 5
EDDY COUNTY, NEW MEXICO
COG OPERATING LLC
DATE: 5/1/09
DSN. BY: JJ
FOLK FED. TB
TETRA TECH, INC.
MIDLAND, TEXAS

Based on the results, the chloride impact on the pad appears to be from historical spills. In order to remove some of the chloride impacted soil, COG proposes to excavate the soil to a depth of 4.0' below surface and capped the area with a 40 mil liner. The proposed excavated area will measure approximately 30' x 45'. The excavated soil will be hauled to proper disposal. Once excavated and capped, the area will be backfilled with clean fill material. The proposed excavated area is shown on Figure 5.
