Report Type: Closure Report

General Site Information:		
Site:	Spruce Federal #1 Tank Battery (Two Spills)	
Company:	COG Operating LLC	
Section, Township and Range	Unit K - Sec 25 - T17S - R27E	
Lease Number:	NM96836	
County:	Eddy County	
GPS:	32.802409° N	103.233511° W
Surface Owner:	Federal	
Mineral Owner:		
Directions:	From the intersection of US Hwy 82 and CR-225 (Hilltop Road), travel south on CR-225 for 0.7 miles, turn left 0.1 miles to location on left.

Re: Closure Report for the COG Operating LLC., Spruce Federal #1 Tank Battery, Section 25, Township 17 South, Range 27 East, Unit K, Eddy County, New Mexico.

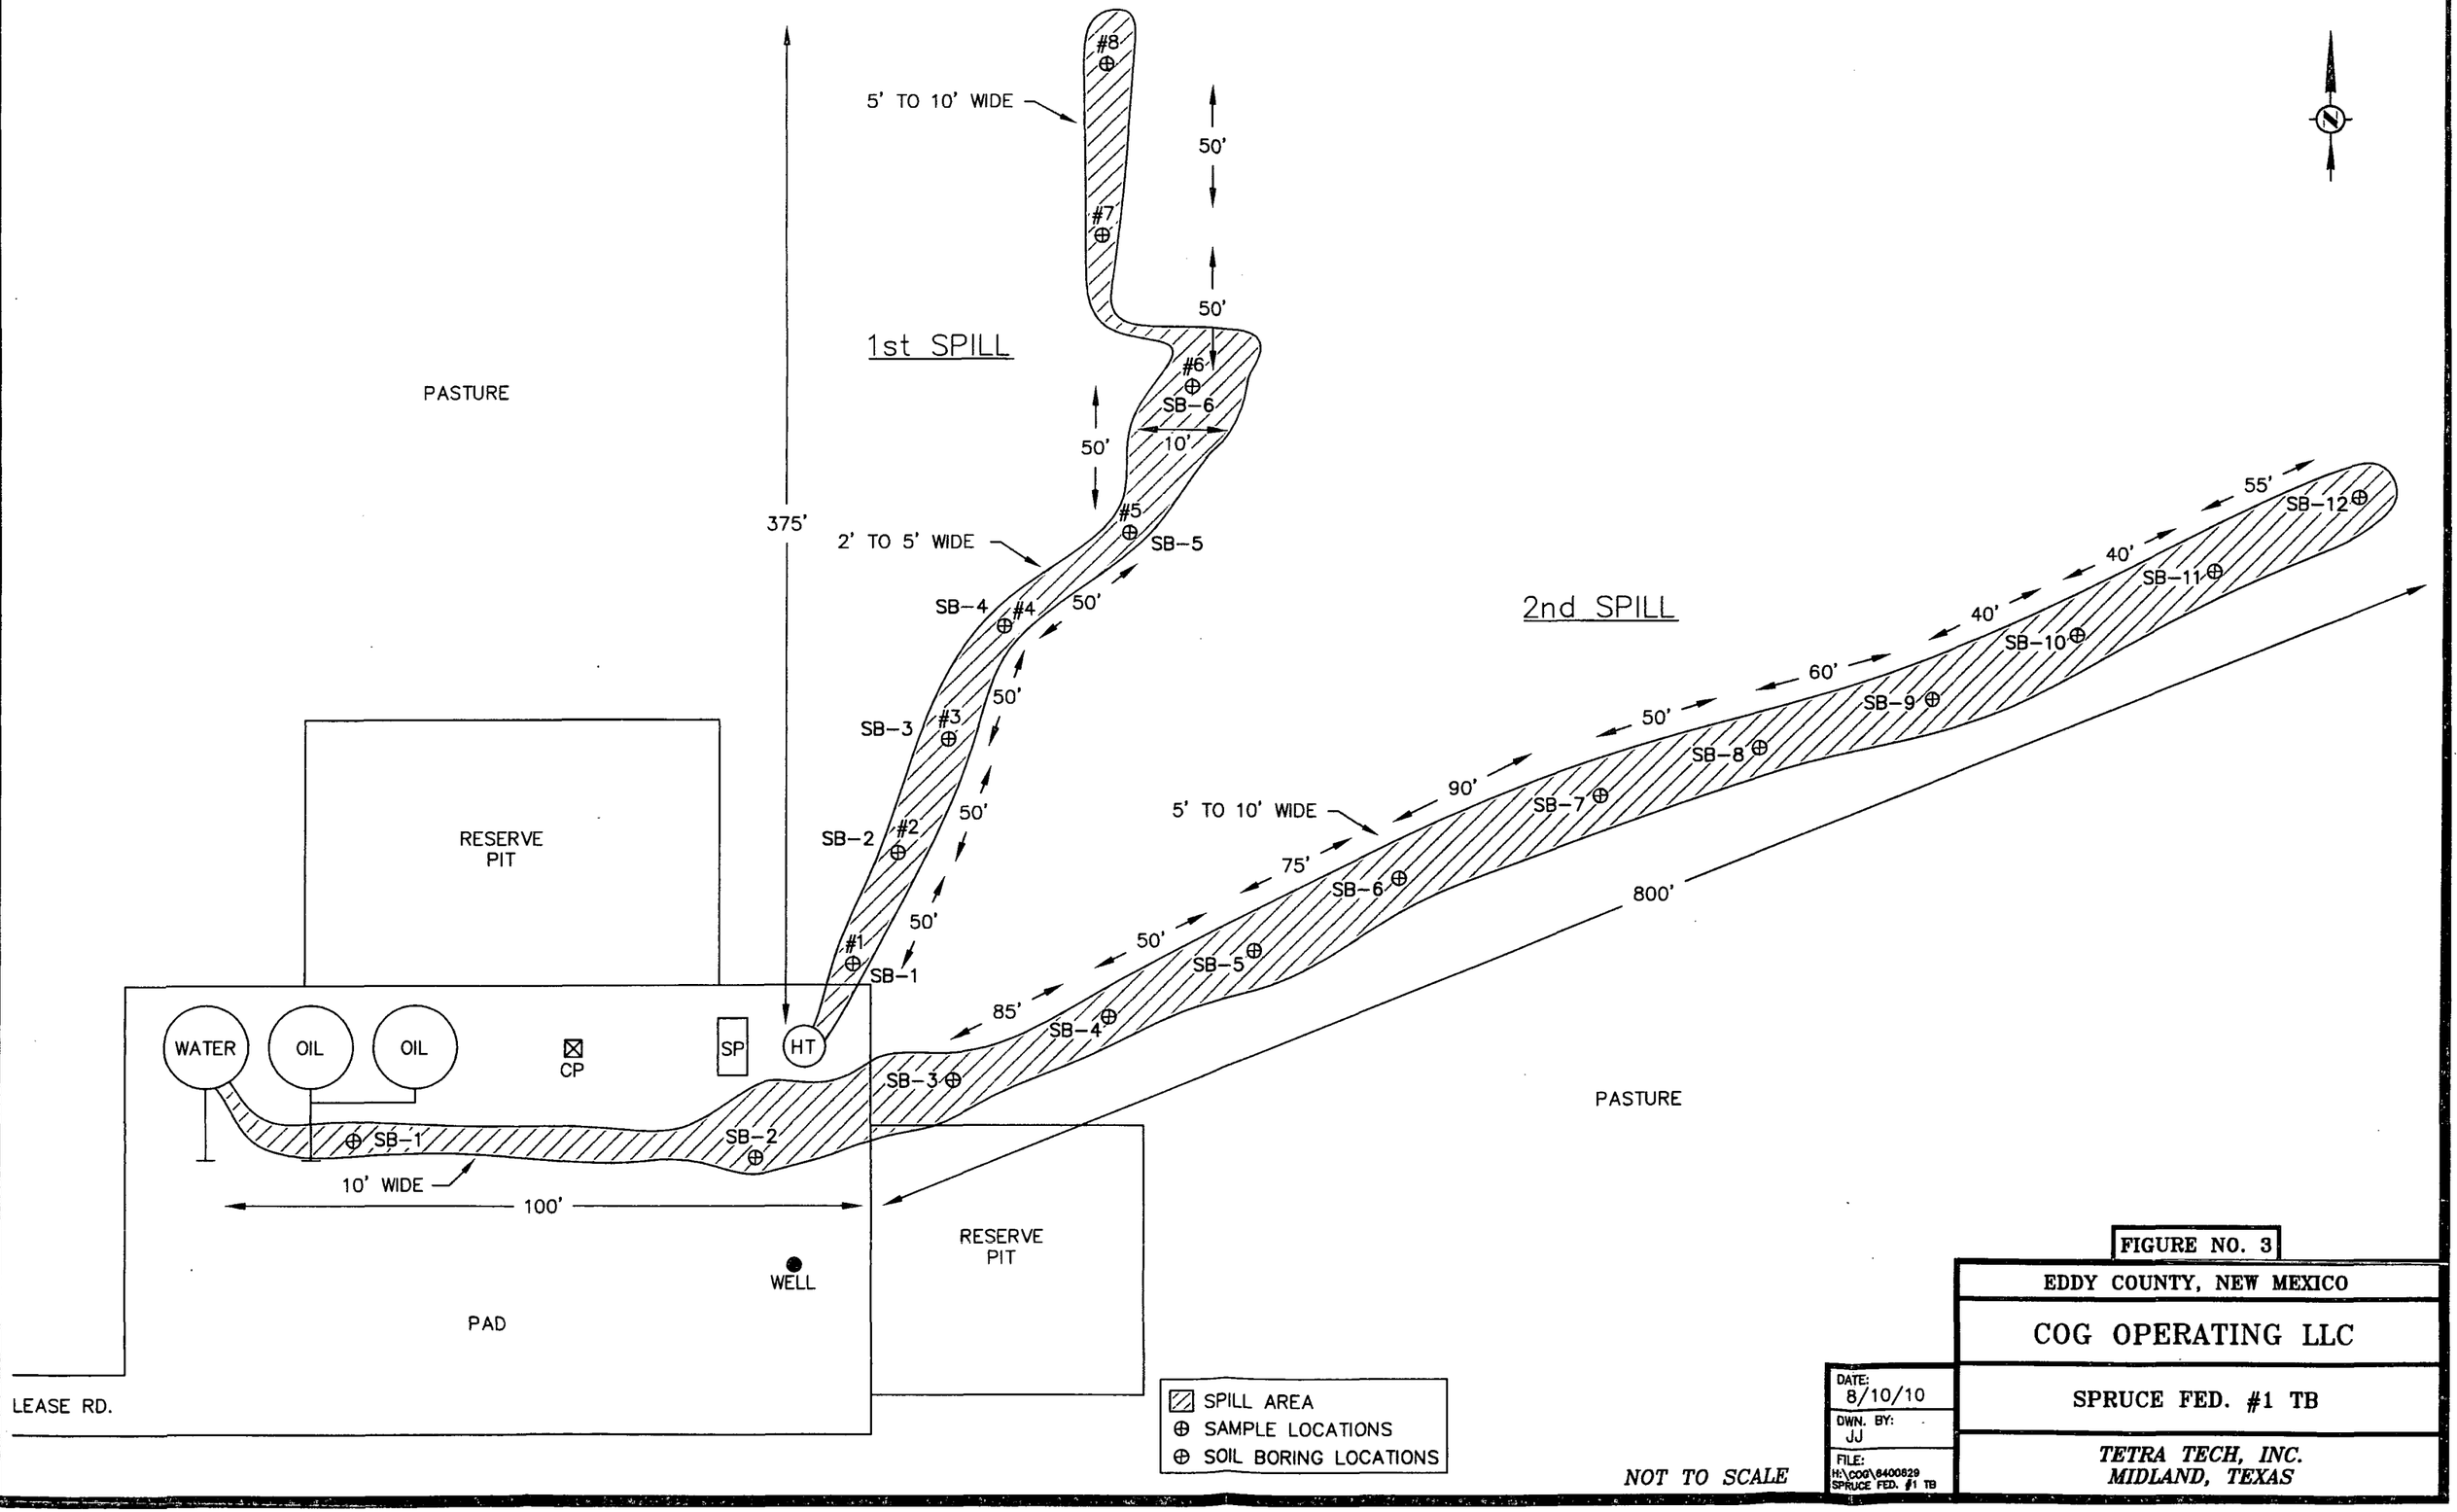
FIGURE NO. 3

On April 1, 2010, Tetra Tech personnel inspected and sampled the spill area. A total of eight (8) auger holes (AH-1 through AH-8) were installed using a stainless steel hand auger to assess the impacted soils. Select samples were analyzed for TPH analysis by EPA method 8015 modified, BTEX by EPA Method 8021B and chloride by EPA method 300.0. Copies of laboratory analysis and chain-of-custody documentation are included in Appendix C. The sampling results are summarized in Table 1. The auger hole locations are shown on Figure 3.

Referring to Table 1, all of the submitted samples were below the RRAL for TPH and BTEX. Elevated chloride concentrations were detected in the subsurface soils. Auger holes (AH-1, AH-2, AH-3, AH-4, AH-5 and AH-6) were not vertically defined. The auger hole bottom hole samples ranged from 690 mg/kg (AH-6 at 2.0') to 9,890 mg/kg (AH-4 at 2.0'). Auger holes (AH-7 and AH-8 were vertically defined and showed a shallow impact in the area. The background boring showed a chloride high of 382 mg/kg at 10.0' below surface. In order to define the vertical extents, an air rotary drilling rig was utilized to collect deeper samples.

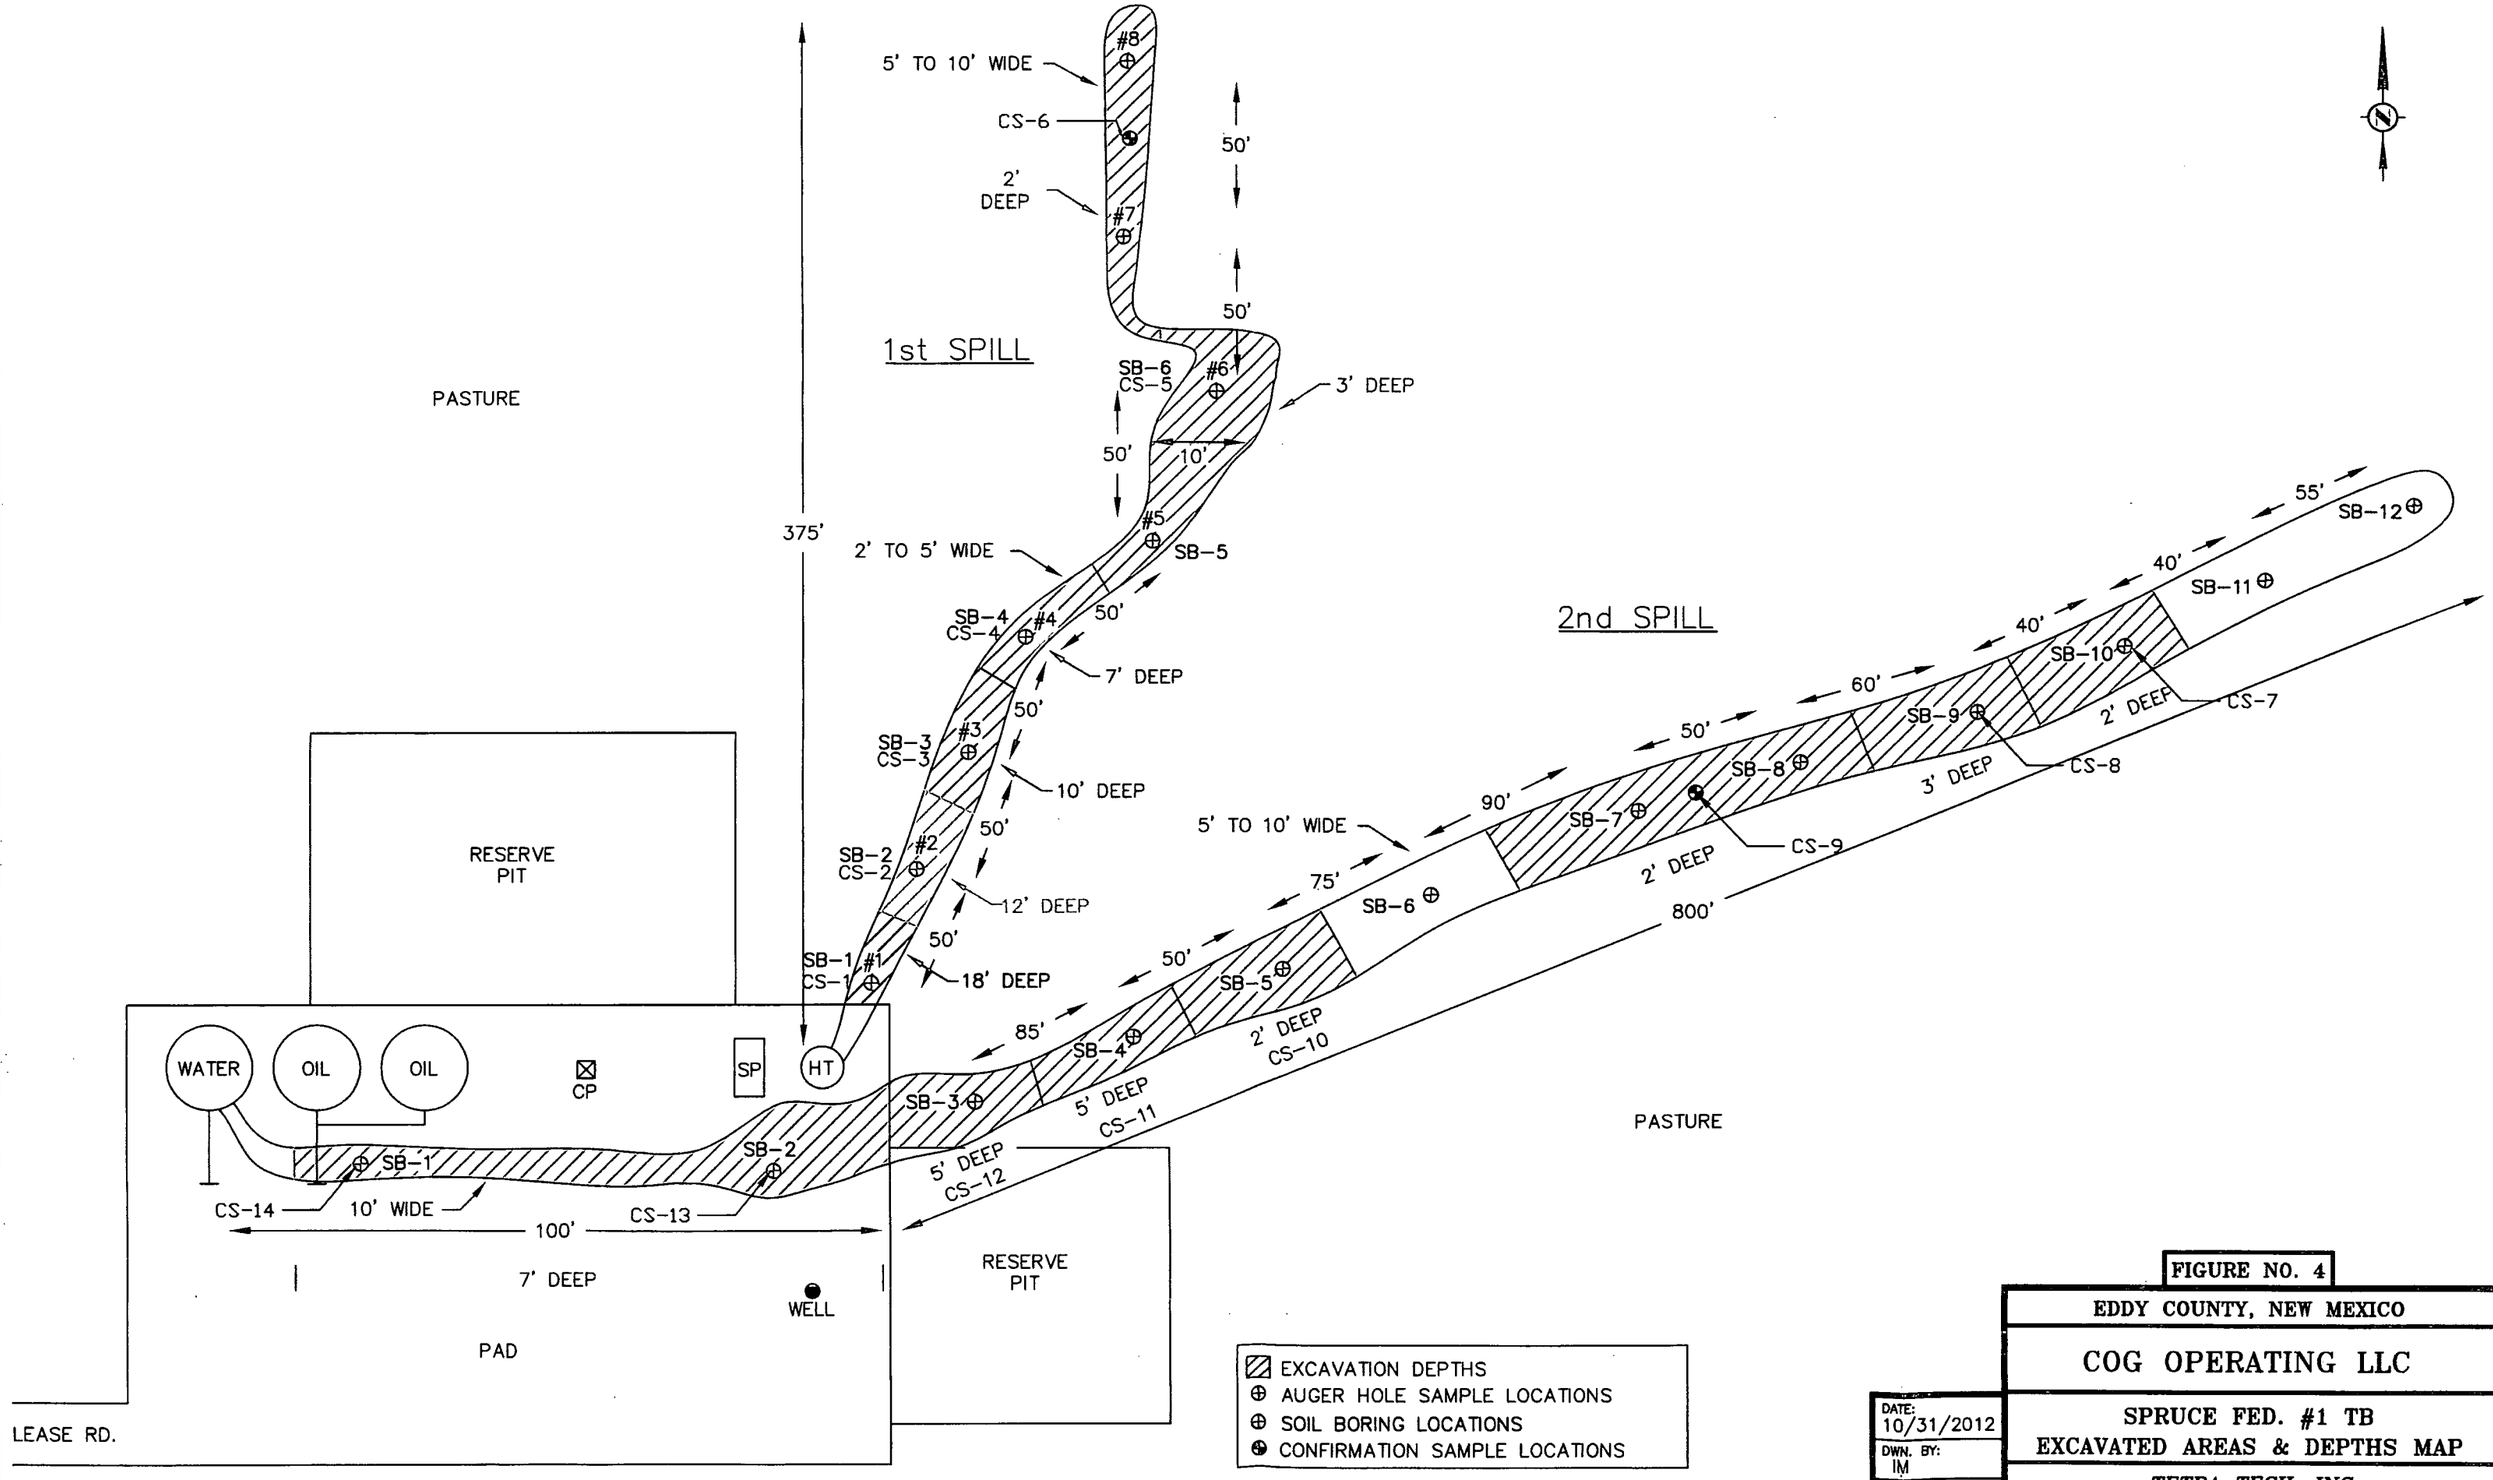
FIGURE NO. 4

On May 12, 2010, Tetra Tech personnel supervised and collected samples from the installation of soil borings. A total of six (6) soil borings (SB-1 through SB-6) were installed at the site. Additionally, a background soil boring (SB-BG) was installed approximately 150' east of the spill location in native soil. Copies of laboratory analysis and chain-of-custody documentation are included in Appendix C. The sampling results are summarized in Table 1. The soil bore locations are shown on Figure 4.

On August 23, 2010, Tetra Tech personnel supervised the installation of soil borings at the site. A total of twelve (12) soil borings (SB-1 through SB-12) were installed to assess the spill area. Selected samples were analyzed for TPH analysis by EPA method 8015 modified, BTEX by EPA Method 8021B and chloride by EPA method 300.0. Copies of laboratory analysis and chain-of-custody documentation are included in Appendix C. The results of the sampling are summarized in Table 2. The soil bore locations are shown on Figure 4.

Referring to Table 2, all of the submitted samples were below the RRAL for TPH and BTEX. All of the soil borings declined with depth and were vertically defined. The detectable chloride concentrations ranged from 205 mg/kg (SB-7) to 16,900 mg/kg (SB-1). The deepest impact was encountered in the areas of SB-1, SB-2 and SB-3, with chloride concentrations significantly declining at 5.0' to 7.0' below surface. The remaining soil borings (SB-4 through SB-10) did show shallow impact to the soil at surface (0-1'). Soil borings (SB-11 and SB-12) did not show an impact to the soil.

On March 14, 2011, Tetra Tech personnel supervised the excavation as outlined in the approved work plan. The spill footprint and final excavation depths of the soil remediation were met or exceeded as stated in the approved work plan. The excavated depths are highlighted in Table 1 and 2 and shown on Figure 5. Approximately 2,152 cubic yards of impacted material was removed and disposed of at the CRI Facility.

As recommended by the BLM, confirmation samples were collected from the excavation bottoms. Deeper excavations were not performed in some of the area due to safety concerns. The confirmation samples location are shown on Figure 4 and summarized in Table 1 and 2. Once completed, the BLM was contacted to inspect the remediation and approved the site for backfilling. The excavation was backfilled with clean soil to grade.

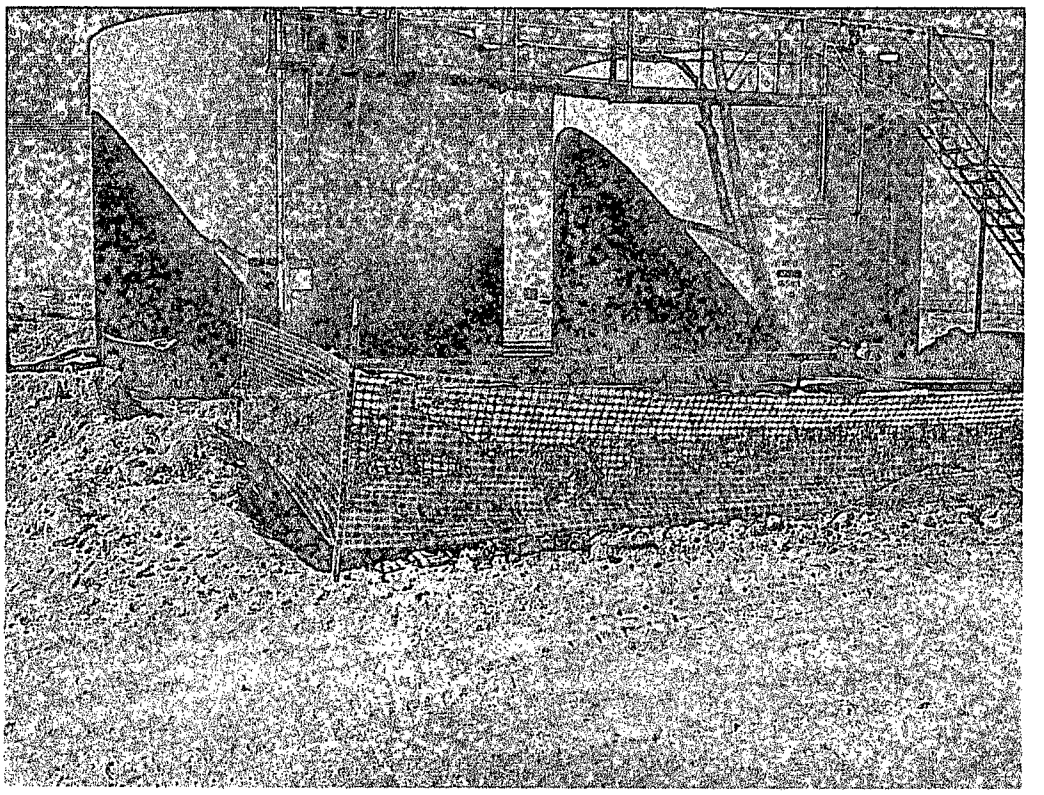
On July 20, 2010, a hole was discovered at the bottom of a fiberglass tank and released approximately sixty (60) barrels of produced water. Four (4) barrels of standing fluids were recovered. The spill migrated 900' northwest of the tank battery, with a width of 2.0' to 5.0'. The initial C-141 form is enclosed in Appendix A.

View west – Excavated area near source from spill #2

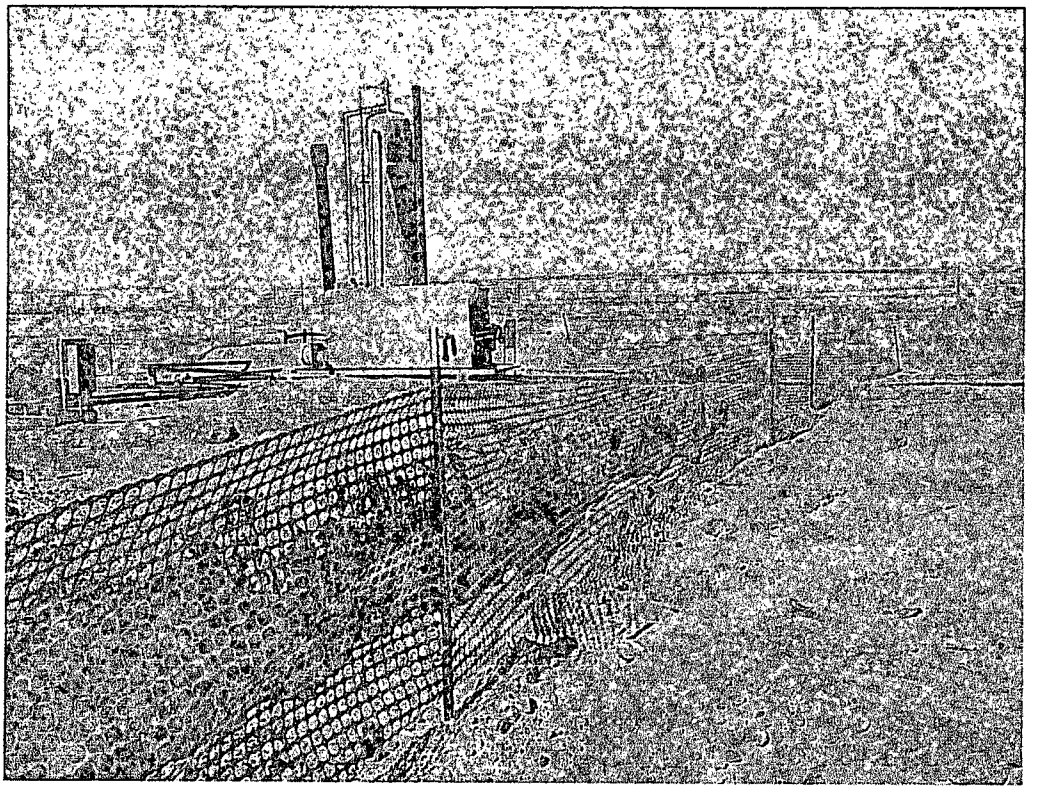
View northwest – Spill #2 excavation continued toward pasture

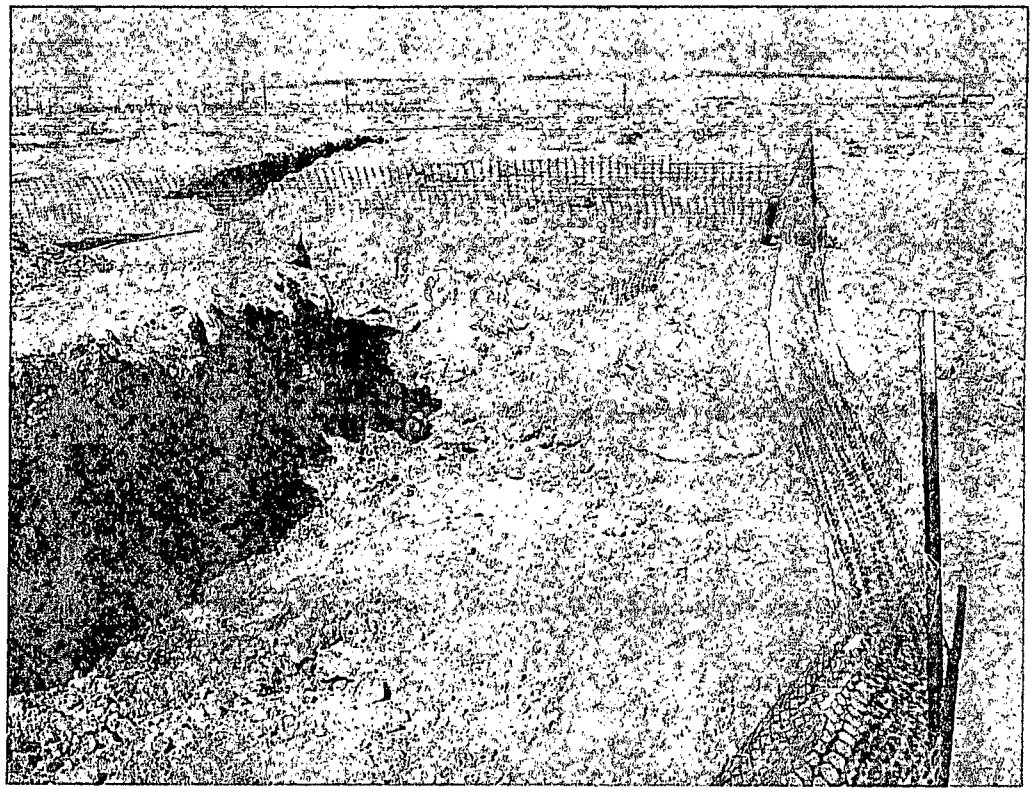
View north – Excavated pasture of spill #2

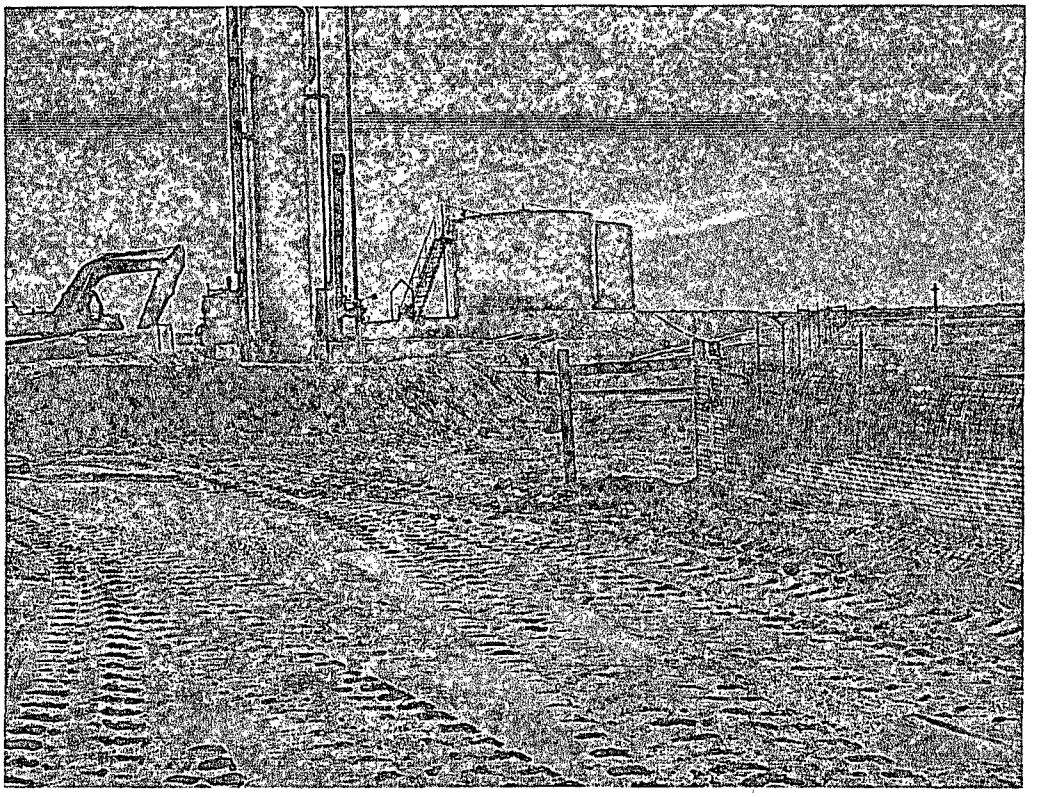
View north – Spill #1 near source

View west – Spill #1 excavation in pasture area
