TETRA TECH, INC.

November 4, 2010

RE: Request for Closure
MCA 2A Header Fiberglass Trunk Line
Lea County, New Mexico
Unit G, Sec. 29, T17S, R32E
1RP 2223

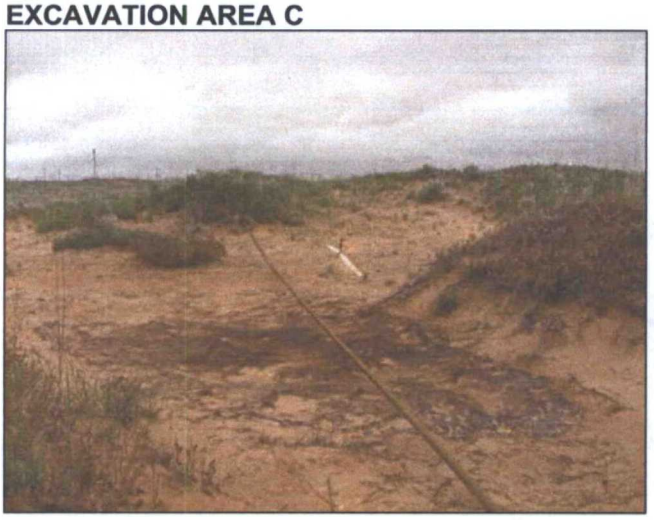
EXCAVATION AREA C

August 4, 2010
Clay Barrier

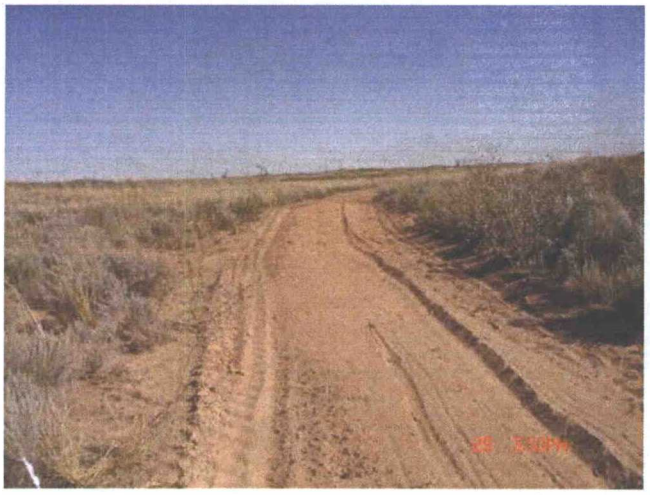
ACCESS ROAD

October 29, 2010
Before
