Pit, Below-Grade Tank, or Proposed Alternative Method Permit or Closure Plan Application

Williams Four Corners LLC
Below Grade Tank Closure Report
Facility Name: 32-8#2 – BGT1 – Produced Water
API Number: C-144-15942

Release Notification and Corrective Action

Remediation Excavation and Sampling Form

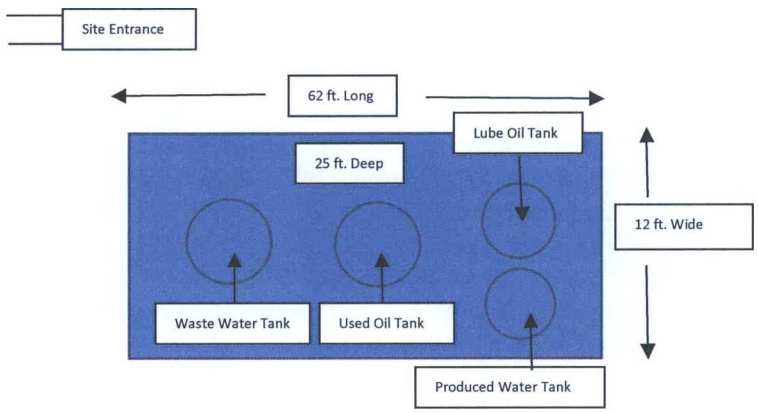
Excavation Diagram and Sample Locations

Clean up work began on 6/26/2017. Sampling took place on 6/7/2017 prior to the work beginning. Sampled again on 6/30/2017 after the tanks had been removed; no one from OCD was present for sampling. Contaminated soil was approximately 600 yards removed. Job Scope: Removed contaminated soil, disconnect and removed 2- 165 bbl below grade tanks, removed impacted soil, set 2 – new 165 bbl double wall double bottom tanks. Disconnected and moved the 300 bbl produced water and lube oil tanks to clean impacted soil. Set pre sprayed mat and re-set and connected tanks. Additional work to take place weather dependent, spray liner over berms, tie into mats and pits and set stairs.

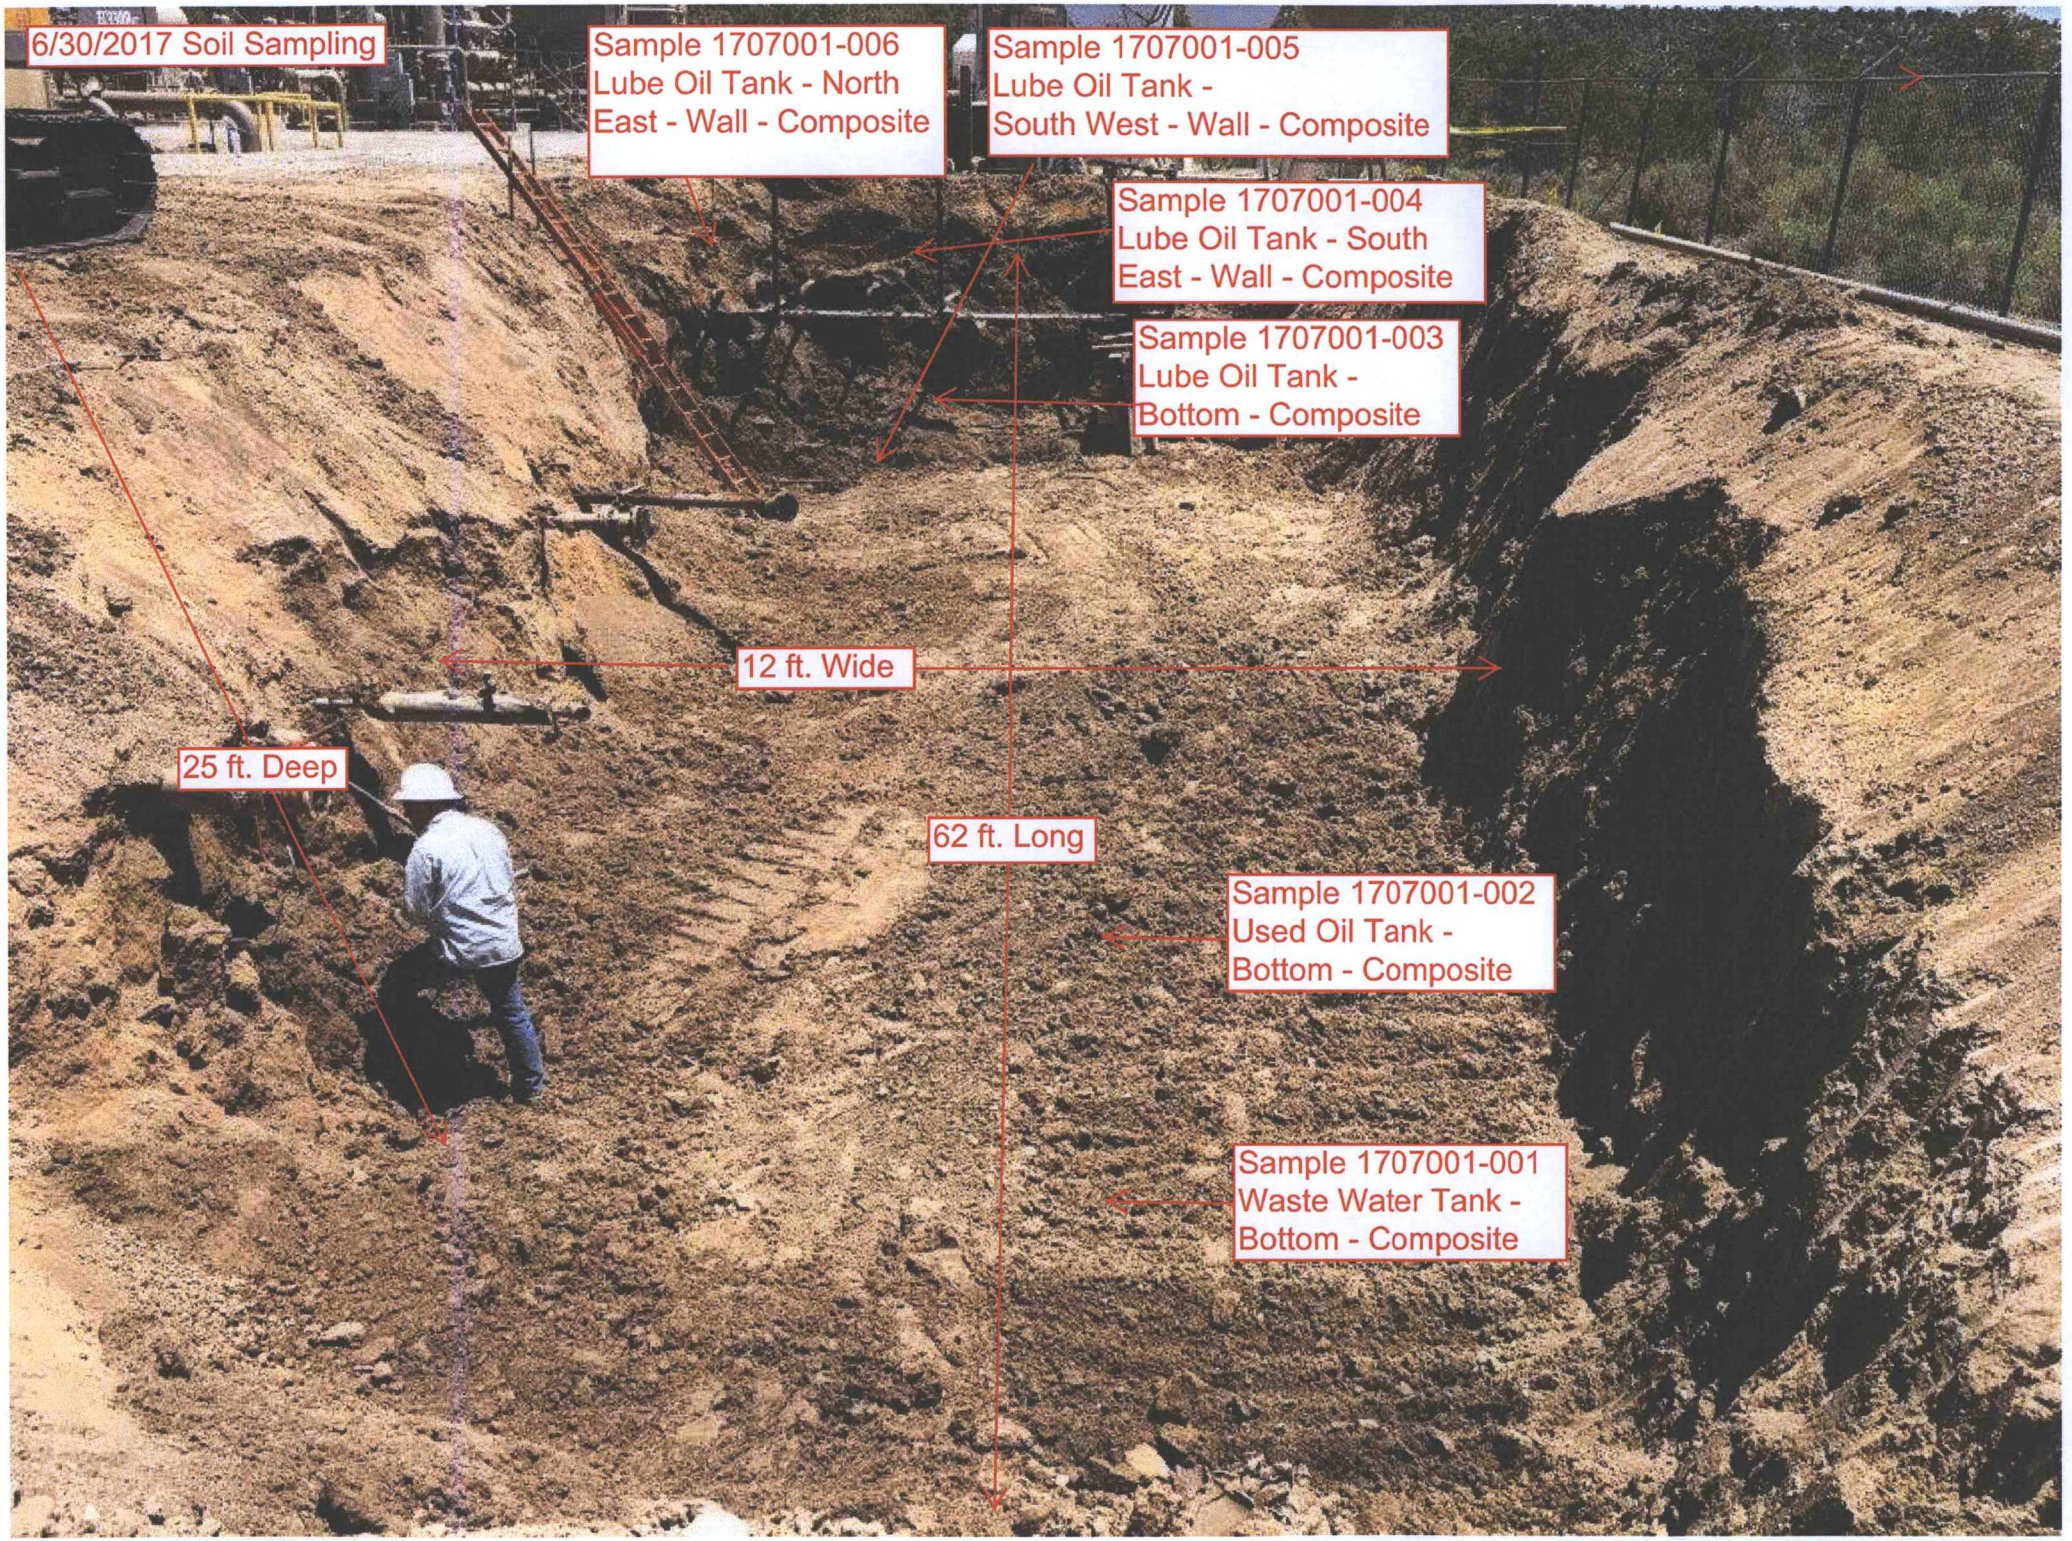
Describe Cause of Problem and Remedial Action Taken.*
A sight glass broke on a bulk lube oil storage tank. The lube oil was contained within the secondary containment area. The containment is unlined. The initial reported release volume was reported to be below 5 bbls. An investigation was performed by LT Environmental on August 18, 2016. Following completion of the investigation, it was determined that the volume of lube oil released was approximately 500 gallons. The cause of the sight glass break is unknown.

Describe Area Affected and Cleanup Action Taken.*
(Initial Findings) The attached figure documents the extent of the visible lube oil impacts during completion of the investigation. Seven hand auger borings (HA-1 through HA-7) were completed to evaluate the extent of impacts. It appears that heavy precipitation events following the release may have contributed to further migration of visible lube oil impacts within containment. The hand auger borings indicated the presence of a clay layer 19-inches below the containment floor that was non-impacted (impacts observed in soils above 19-inches). Remediation activities will be completed in the future to remove impacted soils from the containment. Confirmation soil samples from the excavation floor and sidewalls will be collected to demonstrate cleanup concentrations are achieved.

6/30/2017 Soil Sampling
Sample 1707001-006
Lube Oil Tank - North
East - Wall - Composite
Sample 1707001-005
Lube Oil Tank -
South West - Wall - Composite
Sample 1707001-004
Lube Oil Tank - South
East - Wall - Composite
Sample 1707001-003
Lube Oil Tank -
Bottom - Composite
12 ft. Wide
25 ft. Deep
62 ft. Long
Sample 1707001-002
Used Oil Tank -
Bottom - Composite
Sample 1707001-001
Waste Water Tank -
Bottom - Composite
