Form C-147
Revised April 3, 2017

Recycling Facility and/or Recycling Containment

DENIED
BY: Cory Smith
DATE: 11/8/18 (505) 334-6178 Ext. 115
Does Not meet Siting Criteria 19.15.34.11.A.2 NMAC
NMOCD
OCT 17 2018
DISTRICT III

OCD performed onsite inspection on October 26, 2018. Please reference the provided map with areas marked 1, 2, and 3.

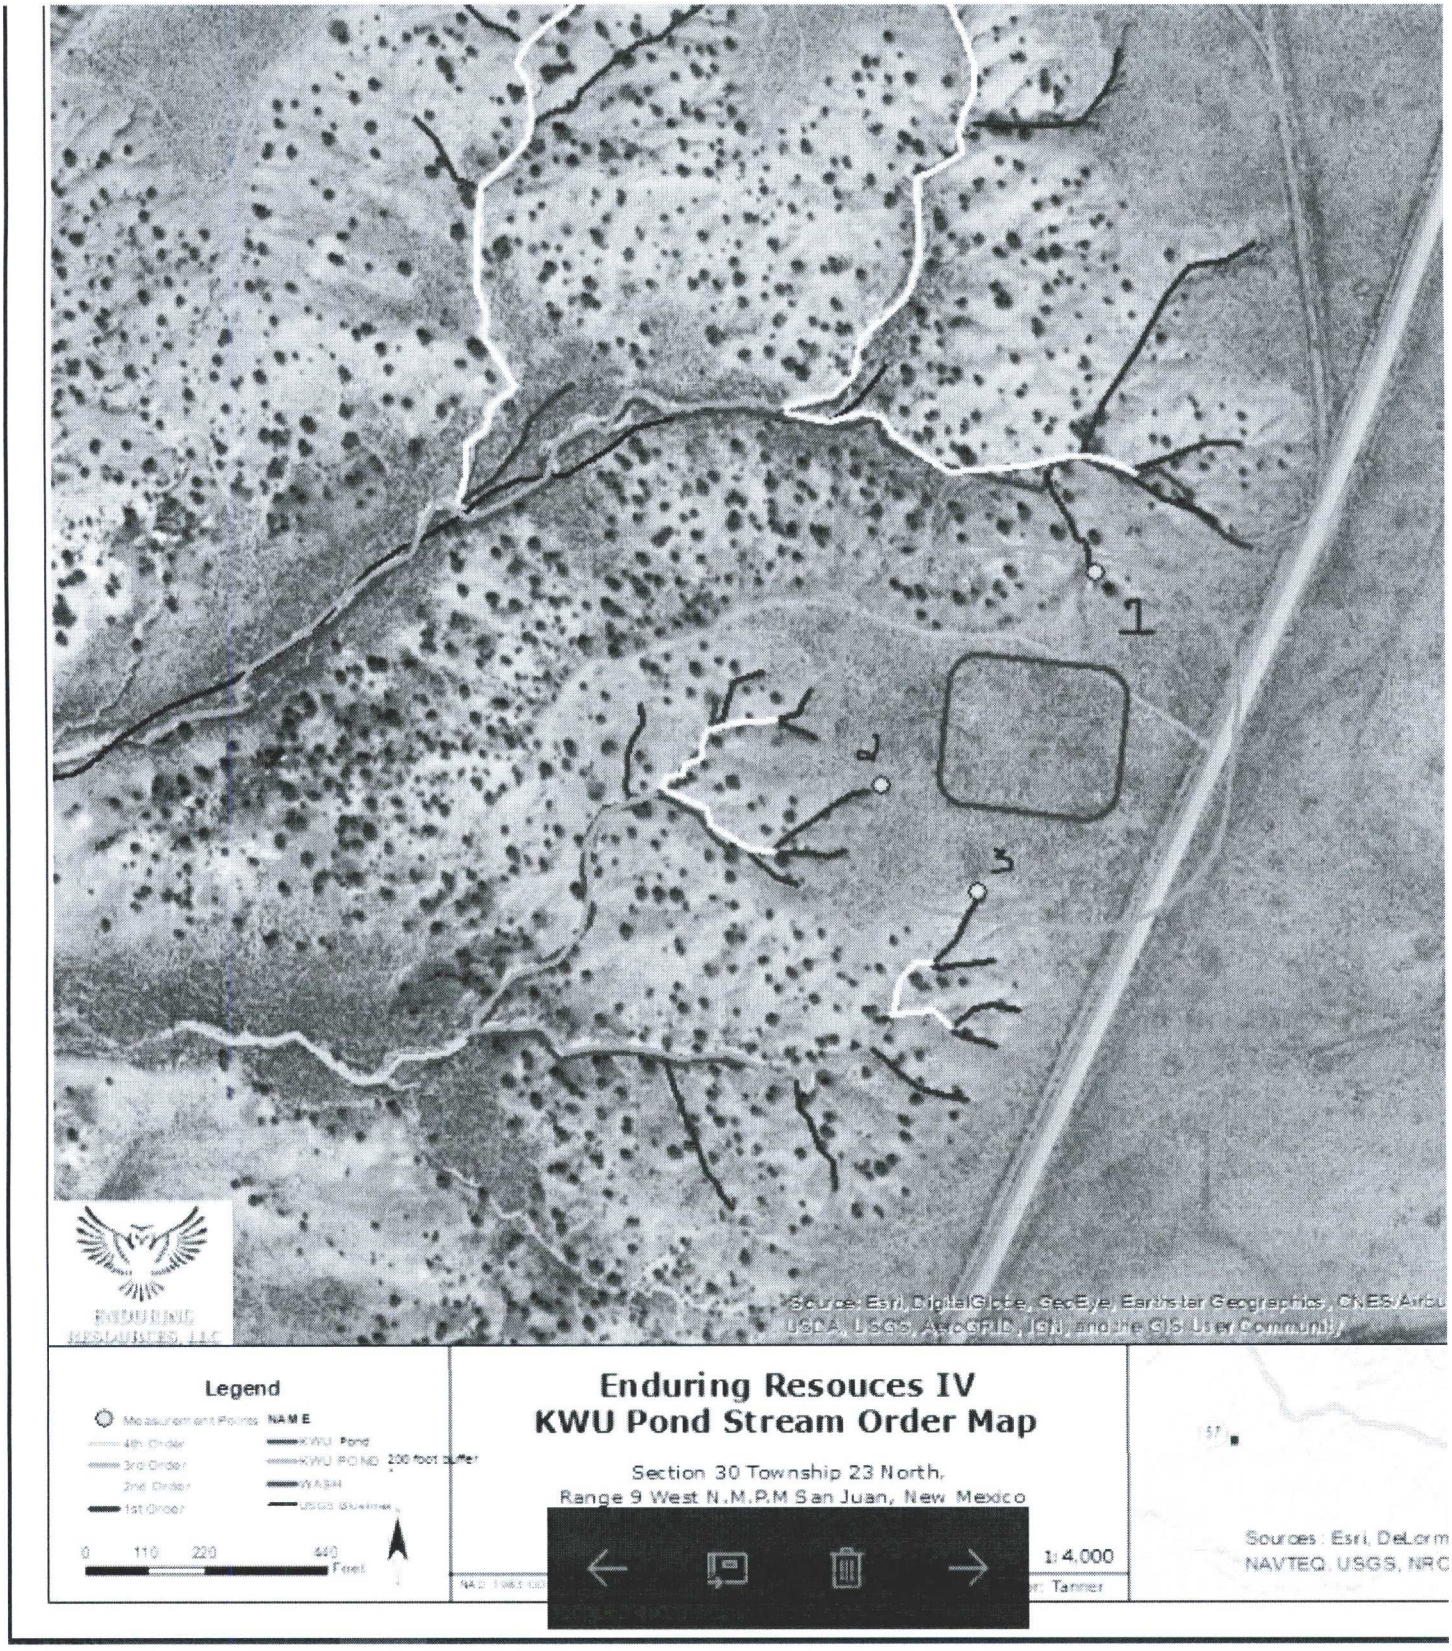
Area 1, North of the pond looking Back towards Pond location.

Start of significant water course with a defined bed and bank, 36.204223 -107.836581 within 200'
