Release Notification

Site Name San Juan 10-2 Water line (Near SJ 32-8 242A)	Site Type Pipeline
Date Release Discovered 1/14/2019 @ 2:30pm	API#

Pipeline leak near 32-8 242A

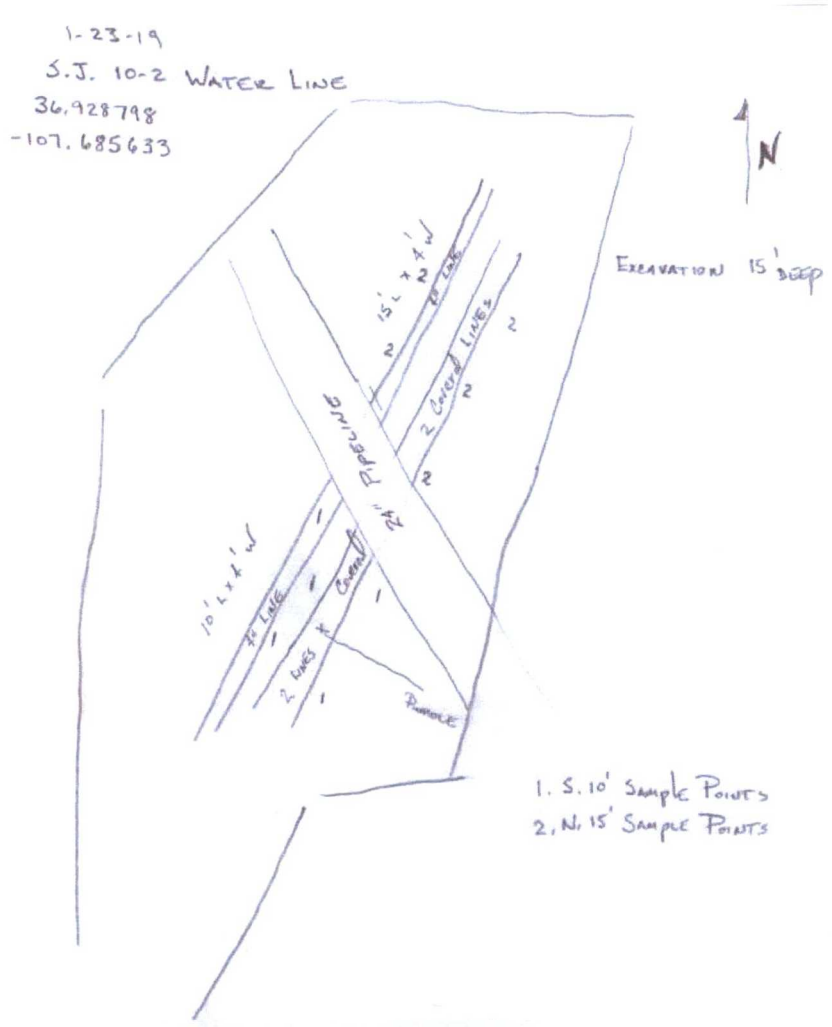
Field Data

1-23-19
S.J. 10-2 WATER LINE
36.928798
-107.685633
N
EXCAVATION 15' DEEP
15' L x 4' W
2" Line
2 Lines
2 Covered Lines
24" Pipeline
10' L x 4' W
4" Line
2 Lines
Covered
Powerline
1. S. 10' Sample Points
2. N. 15' Sample Points
