Closure Report: Junction N-29

RE: Jct. N-29, T21S, R37E, Section 29, Unit N; NMOCD Case # 1R0426-37

NMOCD case #: 1RO426-37

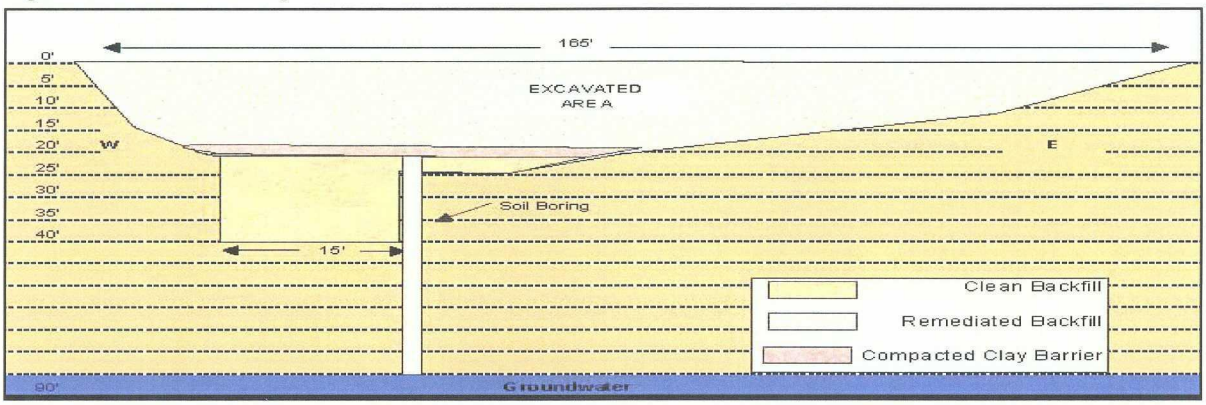
Figure 1: Profile View of Impact Area

Imported backfill placed in the deep excavation from 40 feet to 20 feet bgs was overlain by a compacted clay liner and additional backfill to ground surface to create a vadose zone remedy. The ground surface was graded to drain rainwater away from the area above the cap. The surface was then reseeded. Figure 1 presents a schematic of the excavation, backfill and clay layer installed at the site.

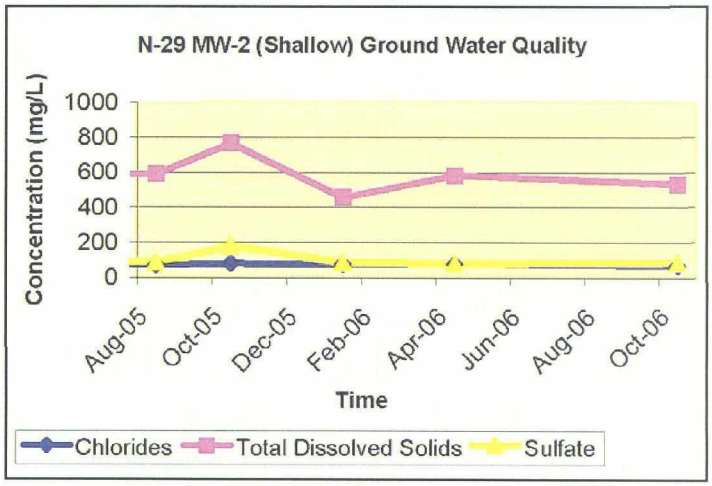
Figure 3: N-29 Ground Water Quality at MW-2

Table 4: MW-2 (Shallow) TDS & Chloride Concentrations

Depth To Water (ft.)	Sample Date	Chloride (mg/L)	TDS
89.50	8/30/05	73.1	590
89.90	10/18/05	82.8	766
89.30	1/17/06	78.8	454
89.42	4/17/06	79.2	584
89.17	7/12/06	89.2	566
89.11	10/5/06	70.1	534

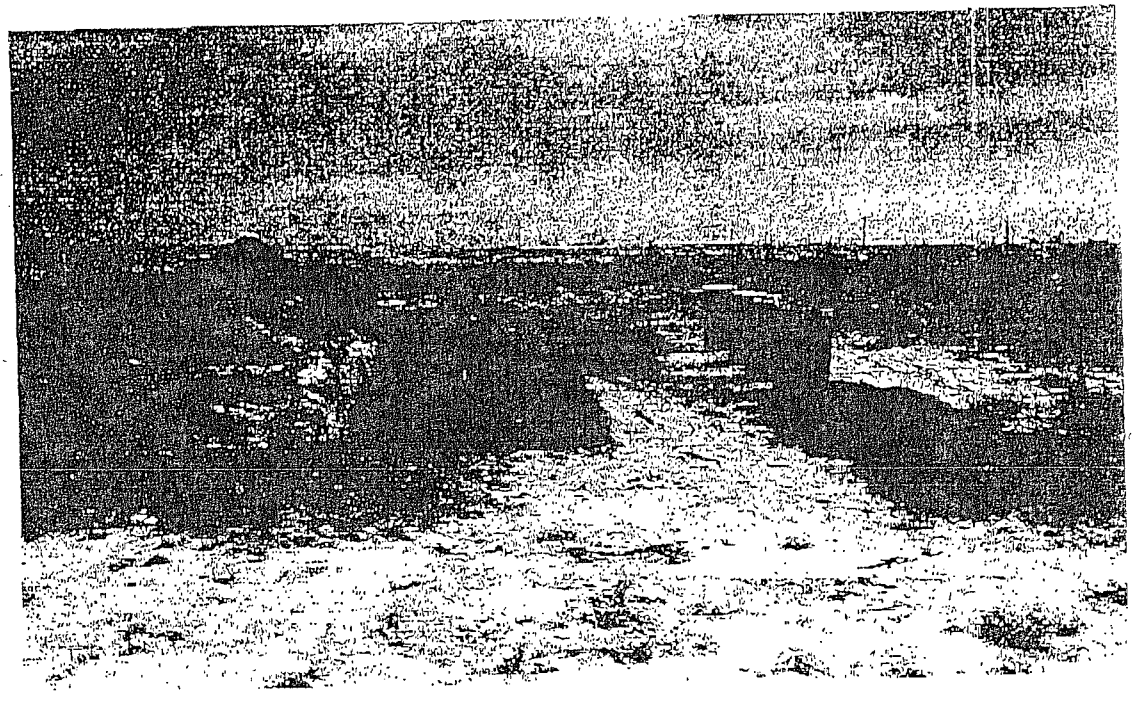
NORM excavation

General Description of Remedial Action: Delineation of this site found high TPH and chloride impact under the junction box site to 40' bgs. Results from a soil boring under the box site indicated the TPH stopped before reaching groundwater but the chlorides continue to groundwater. In order to place the boring machine close to the impact, the excavation was backfilled to 20'bgs with clean soil. An anomalous high chloride spot was found on the north wall of 12,000 ppm chlorides. Field chloride tests were run on samples taken around this spot with results ranging from 105 ppm to 2700 ppm chlorides. The results are enclosed. A poly liner will be installed above the impacted soil at 6' bgs. A compacted clay liner was installed @ 20' and tested. The excavation was backfilled with soil remediated on-site and contoured to the surrounding terrain. The backfill was packed in 5' lifts and a composite sample was taken from each lift and analyzed by a certified lab. A monitor well will be installed and sampled to monitor the ground water constituents. An annual report with the sampling results will be sent to the NMOCD. The site will be reseeded and a water proof junction box will be installed north of the remediated area.

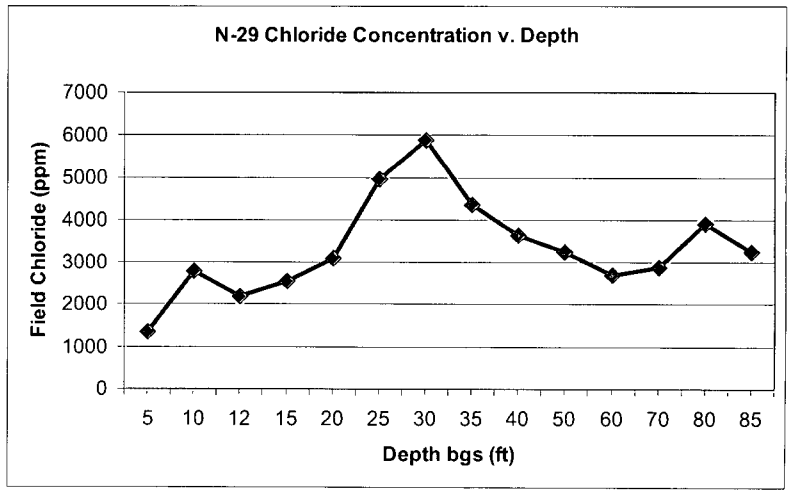
Rice Operating Company (ROC) prepared a Release Notification report and a Disclosure Report that summarizes activities to date. The Disclosure Report, which is part of the 2002 submission to NMOCD, is dated January 2, 2003. The soil borings show relatively constant chloride and TPH concentrations from near surface to a depth of 85 feet (ground water). As Figure 1 shows, consistent chloride concentrations suggest that the release created saturated conditions in the vadose zone. Saturated conditions distribute chloride relatively evenly throughout the vadose zone. Unsaturated flow conditions create different chloride distributions in the vadose zone.

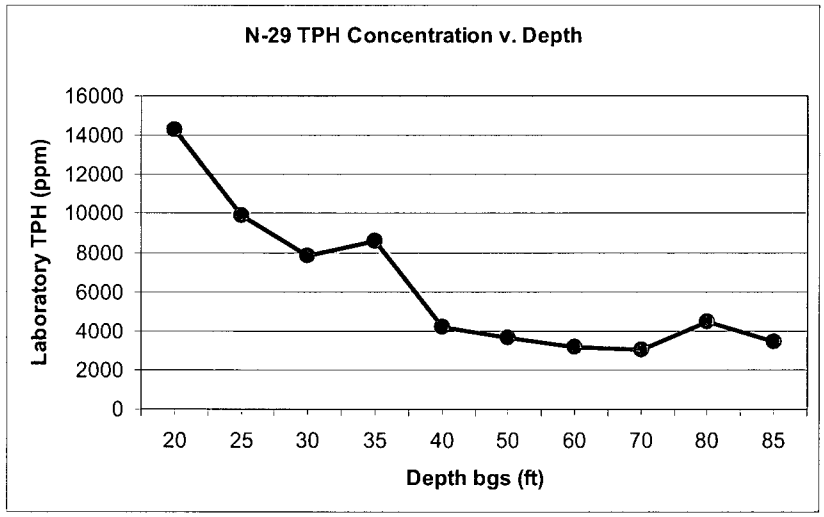
TPH decreases from 14,000 ppm at 20 feet below grade to about 4000 ppm at 40 feet (Figure 2), a 75% decrease. Because the release consisted of produced water from oil wells, laboratory analysis of soil samples detected volatile hydrocarbons in only one sample (less than 0.1 ppm of toluene and xylene). Volatile hydrocarbons are not commonly associated with crude oil as they are with refined products or water produced from natural gas wells. Regulated hydrocarbon constituents may not be present in ground water.

The soil boring data suggests potential ground water impairment by chloride. We propose installation of a ground water monitoring well, reclamation of the surface to its original productive capacity, and evaluation of the threat to ground water quality posed by the residual chloride and any hydrocarbon mass in the vadose zone.

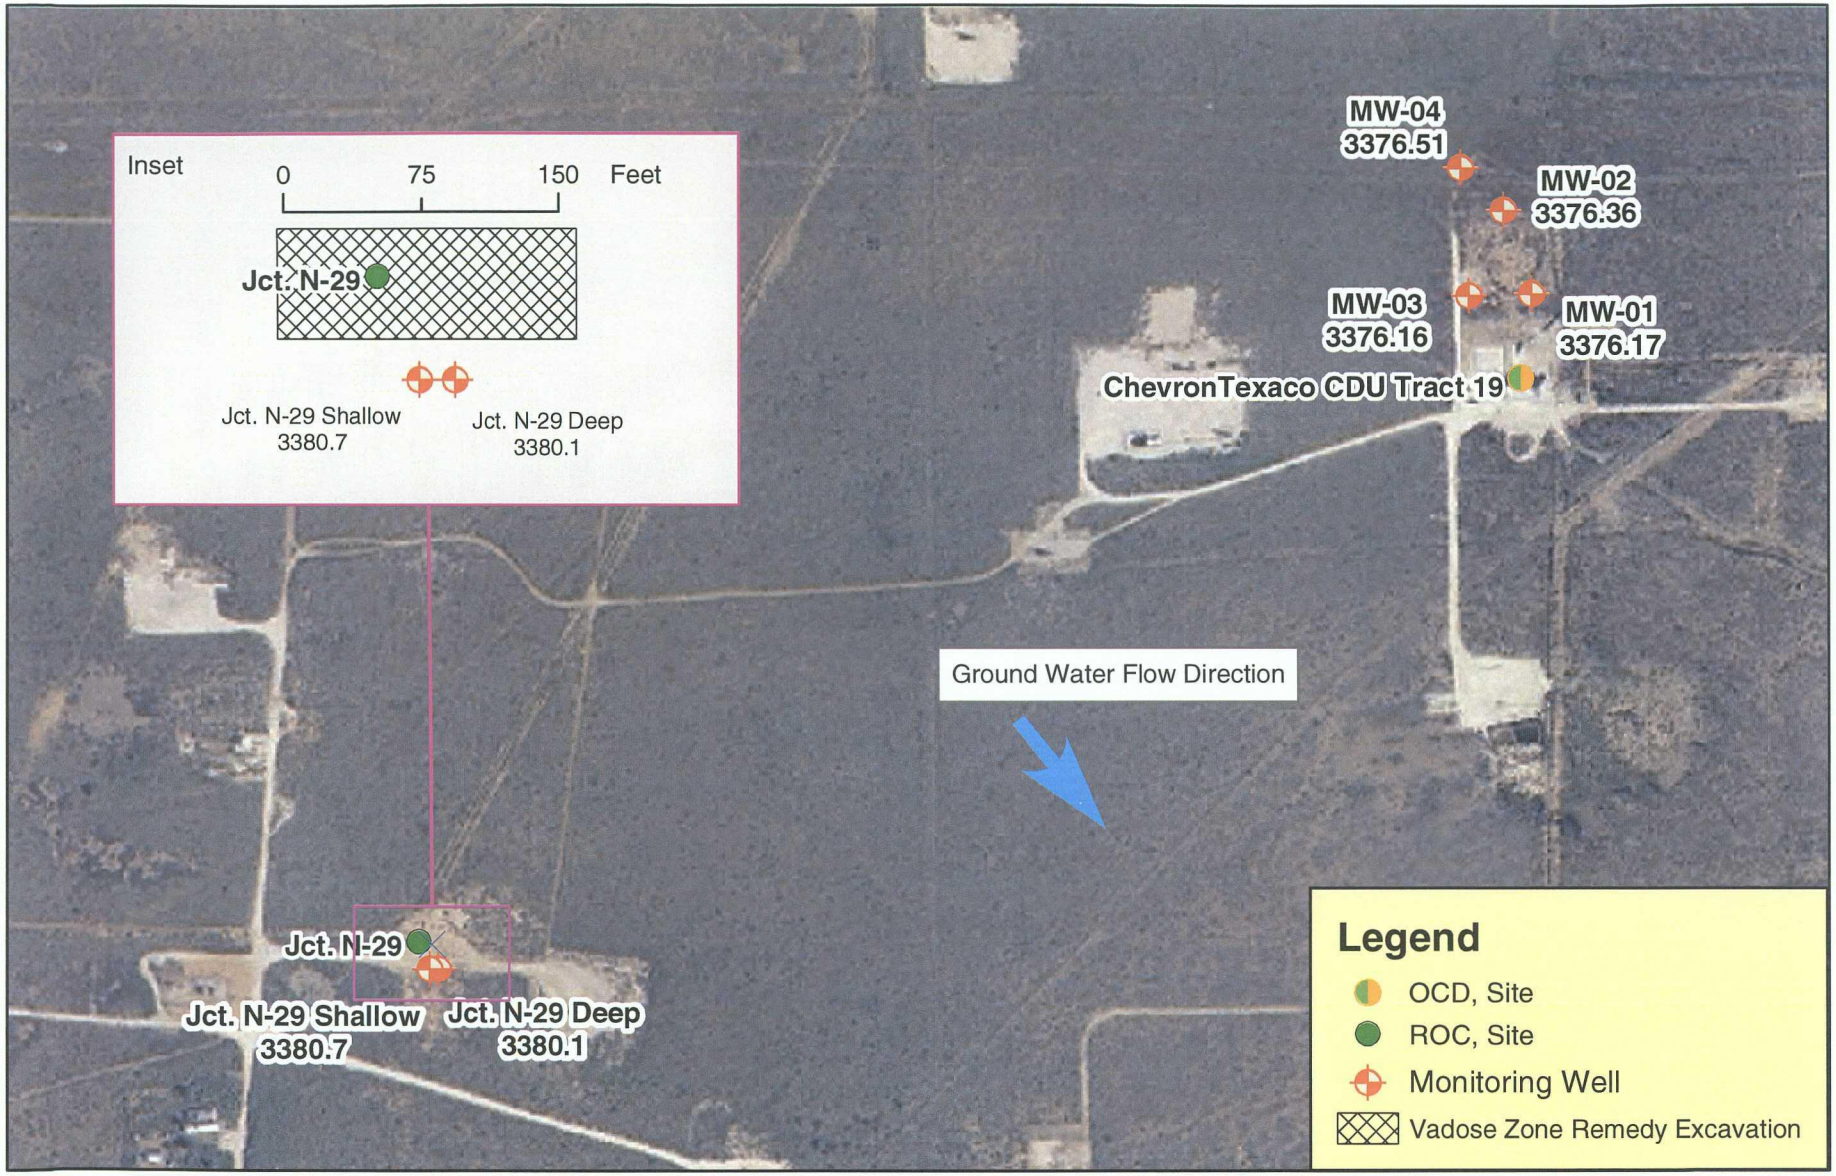
R.T. Hicks Consultants, Ltd 901 Rio Grande Blvd NW Suite F-142 Albuquerque, NM 87104 Ph: 505.266.5004	Ground Water Elevations (fmsl)	Plate 6
	ROC: Jct. N-29 (NMOCD #: 1R0426-37)	January 2006

Plate 6 presents a ground water map derived from 2005 ground water measurements at the N-29 junction box site and 2003 measurements from four wells at the ChevronTexaco site (CDU Tract 19, IRP-223) to the northeast of N-29. Appendix B presents a potentiometric surface map from a 2004 Chevron-sponsored report on the CDU Tract 19 site that confirms the south-southeast ground water flow direction. The deep and shallow Monitoring wells installed to the southeast of the old junction box are down gradient from any releases there.

Monitoring wells N-29 MW-Deep and N-29 MW-Shallow were installed approximately 66 feet to the southeast (down gradient) of the excavated area. The inset in Plate 6 shows the location of the wells relative to the vadose zone remedy excavation. Subsequent sampling of N-29 MW-Deep and N-29 MW-Shallow in August and October of 2005 confirmed that ground water was not impacted with BTEX, chloride, or TDS levels above WQCC standards. BTEX concentrations were below laboratory detection limit of 0.01 µg/L. Copies of the laboratory analytical report and chain of custody form for the most recent ground water sampling event are included in Appendix C. See Table 3 (attached) for the results of the two sampling events.

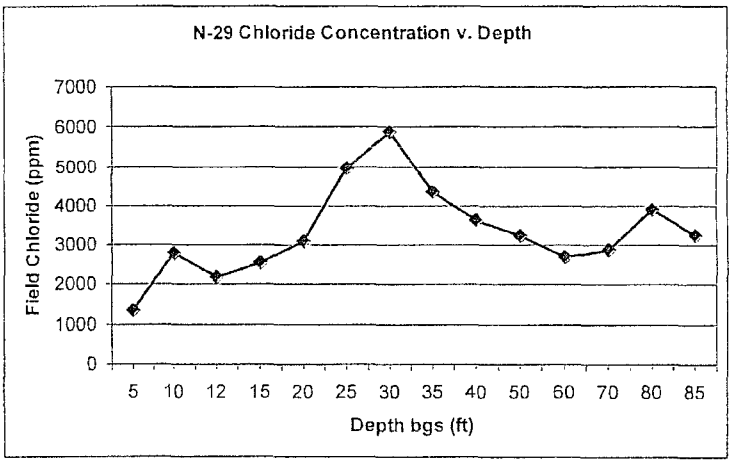
Rice Operating Company (ROC) prepared a Release Notification report and a Disclosure Report that summarizes activities to date. The Disclosure Report, which is part of the 2002 submission to NMOCD, is dated January 2, 2003. The soil borings show relatively constant chloride and TPH concentrations from near surface to a depth of 85 feet (ground water). As Figure 1 shows, consistent chloride concentrations suggest that the release created saturated conditions in the vadose zone. Saturated conditions distribute chloride relatively evenly throughout the vadose zone. Unsaturated flow conditions create different chloride distributions in the vadose zone.

The soil boring data suggests potential ground water impairment by chloride. We propose installation of a ground water monitoring well, reclamation of the surface to its original productive capacity, and evaluation of the threat to ground water quality posed by the residual chloride and any hydrocarbon mass in the vadose zone.

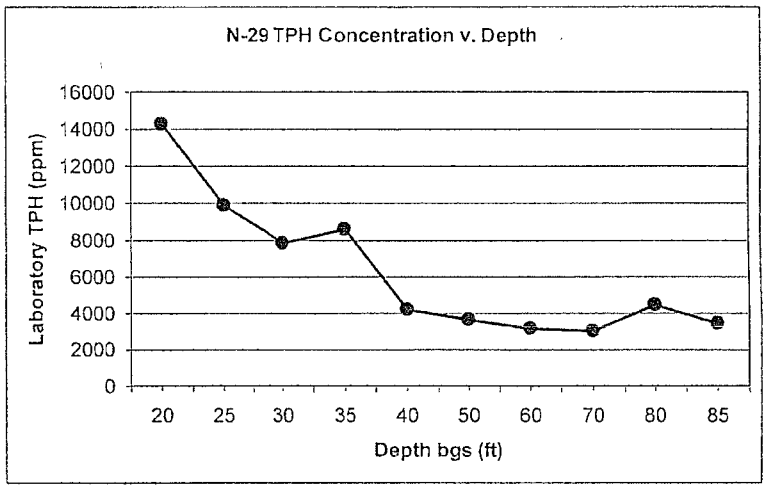
TPH decreases from 14,000 ppm at 20 feet below grade to about 4000 ppm at 40 feet (Figure 2), a 75% decrease. Because the release consisted of produced water from oil wells, laboratory analysis of soil samples detected volatile hydrocarbons in only one sample (less than 0.1 ppm of toluene and xylene). Volatile hydrocarbons are not commonly associated with crude oil as they are with refined products or water produced from natural gas wells. Regulated hydrocarbon constituents may not be present in ground water.
