I-29 Vent, NMOCD Case #1R0428-41

Rice Operating Company
Closure Report

RE: NMOCD Case #1R428-41, I-29-Vent
Hobbs SWD System Abandonment
Closure Report

Corrective Action Plan

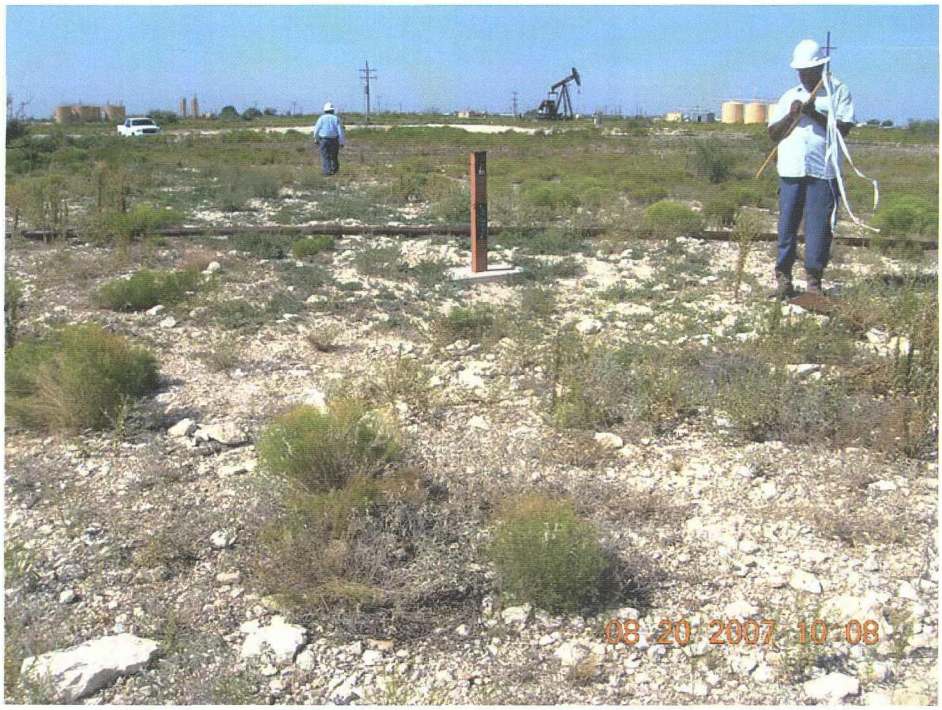
Figure 1: View of I-29-Vent showing re-vegetation

This letter and Appendices are the final Closure Report for the I-29 Vent. The NMOCD approved Corrective Action Plan (Section 4.0, page 3) included creating an infiltration barrier by re-vegetation of the ground surface at the I-29 Vent. Appendix A includes the junction box closure form. Appendix B provides a photograph of the re-vegetation at the site. Appendix C includes copies of previous submissions and the NMOCD approval email. As noted in the CAP, ROC plans to leave the well at this site in place pending investigation of other Section 29 sites.

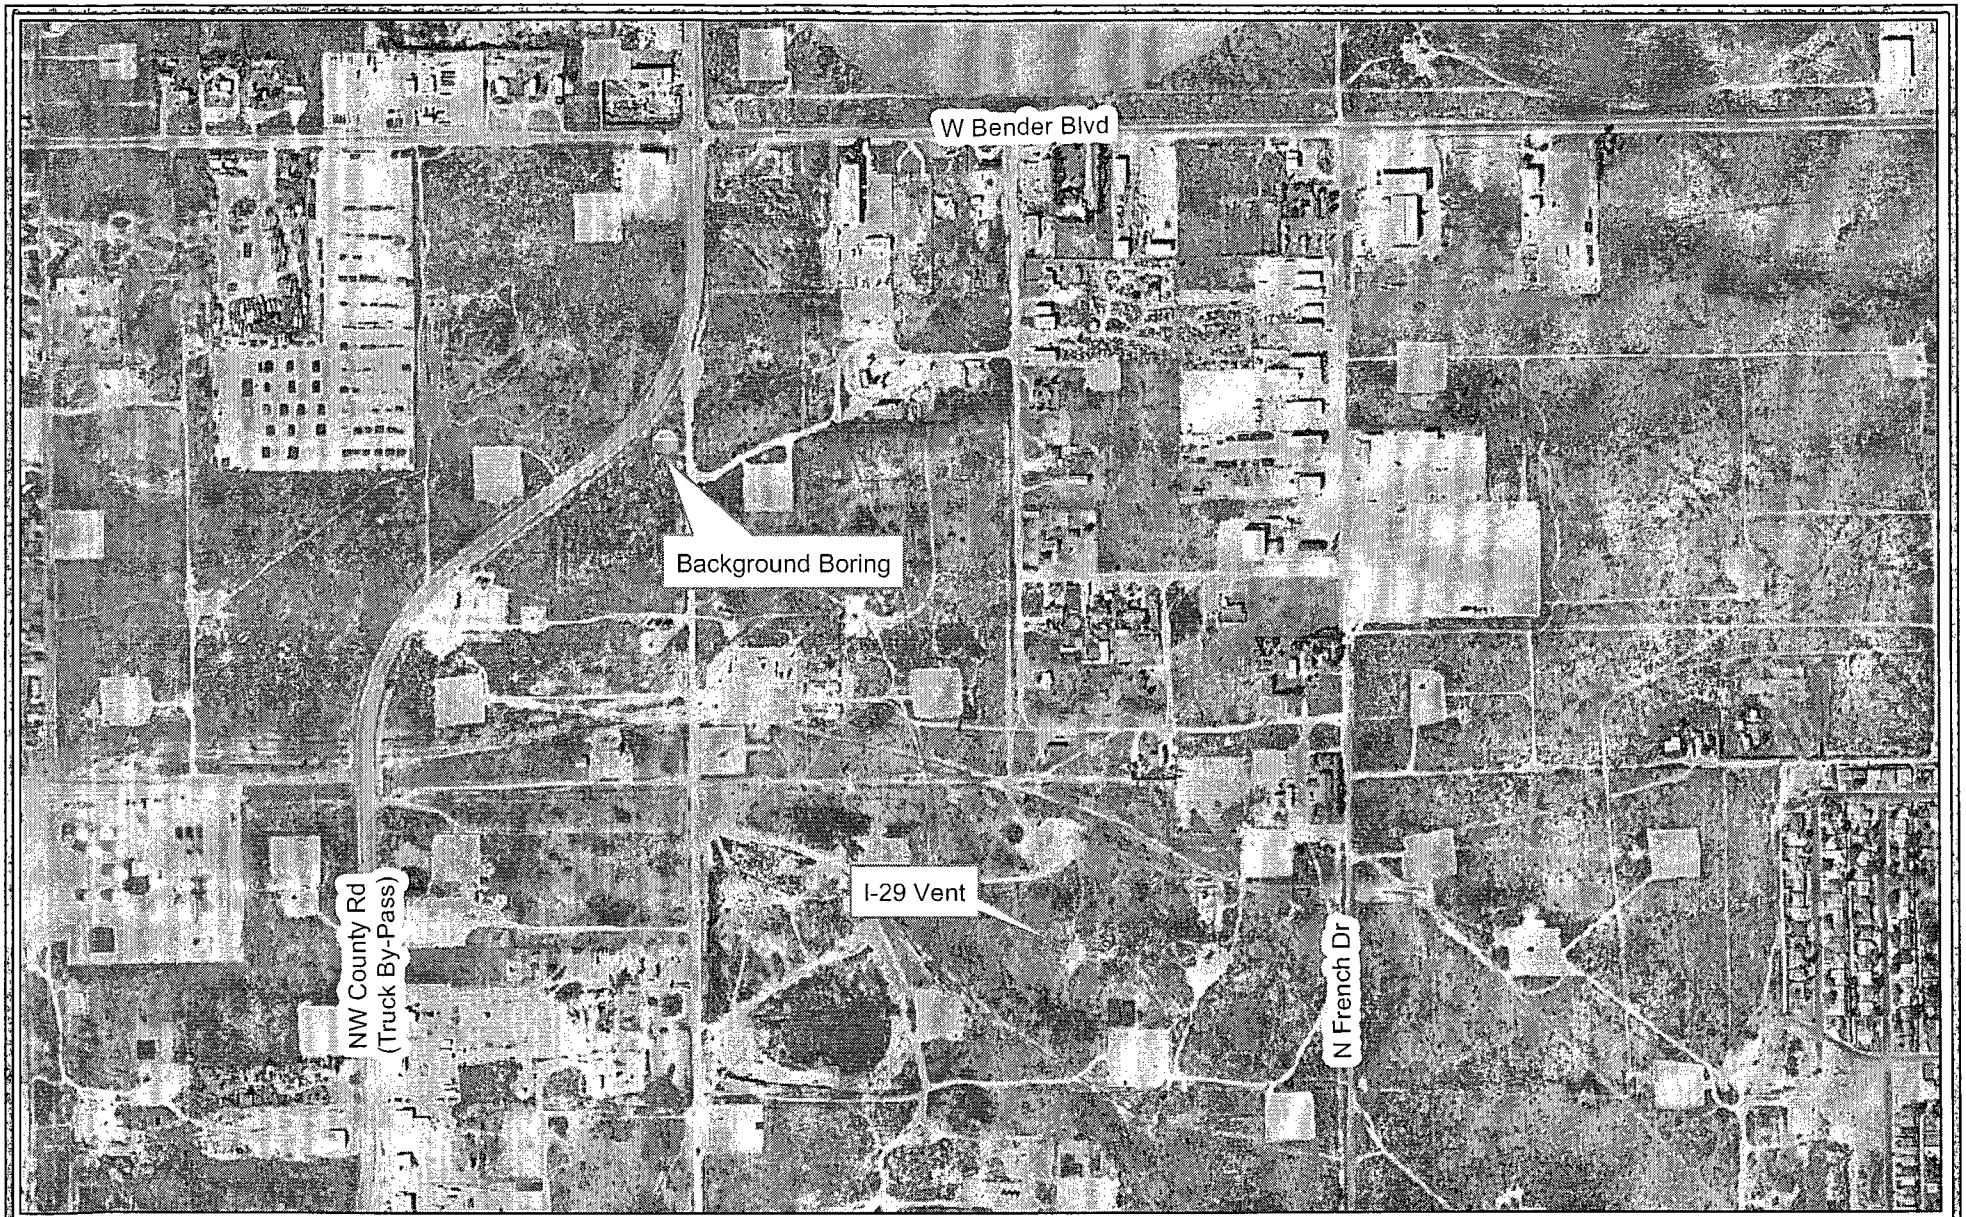
Detailed descriptions of characterization activities are provided in Appendix A. Appendix B shows the results of field chloride measurements. Plate 1 is an aerial photograph of the site when it was active, taken between 1996 and 1998, showing the locations of the boring and background boring.

R.T. Hicks Consultants, Ltd 901 Rio Grande Blvd NW Suite F-142 Albuquerque, NM 87104 Ph: 505.266.5004	2004 Aerial Photograph showing the I-29 Vent Site	Plate 1
	Rice Operating Company : I-29 Vent Site (NMOCD#: 1R0428-41)	February 2007

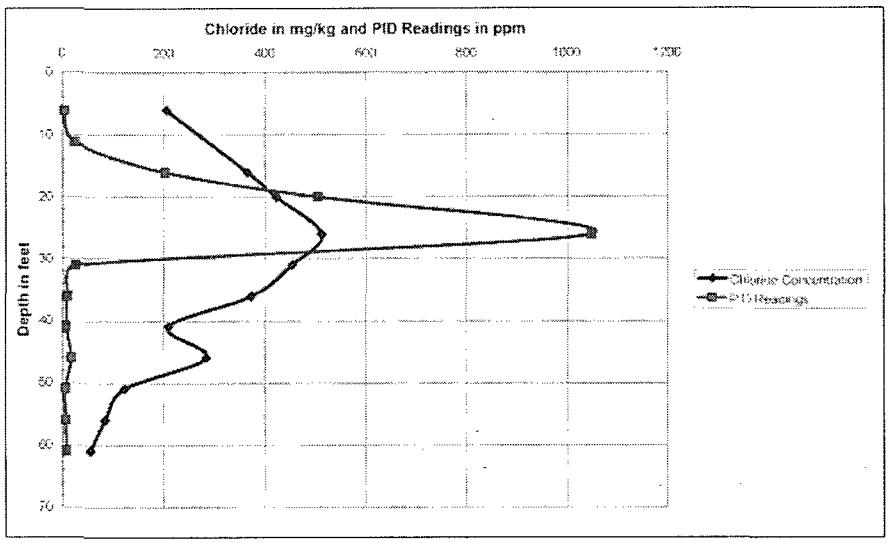
Figure A-1: Chloride Concentrations and PID Readings From Soil Boring Samples, I-29 Vent Site, November 4, 2004

The maximum chloride concentration in the soil is 512 ppm at 26 feet bgs and chloride declines with depth, as shown by Figure A-1.

Chloride concentrations reach approximate background levels (about 80 ppm) at a depth of 51 feet bgs. Field evidence demonstrates that the chloride mass resides in the upper two-thirds of the vadose zone.

PID readings follow a pattern similar to that of chloride, peaking at 26 feet bgs with 1049 ppm total organic vapors, and reaching background concentrations below 36 feet bgs.

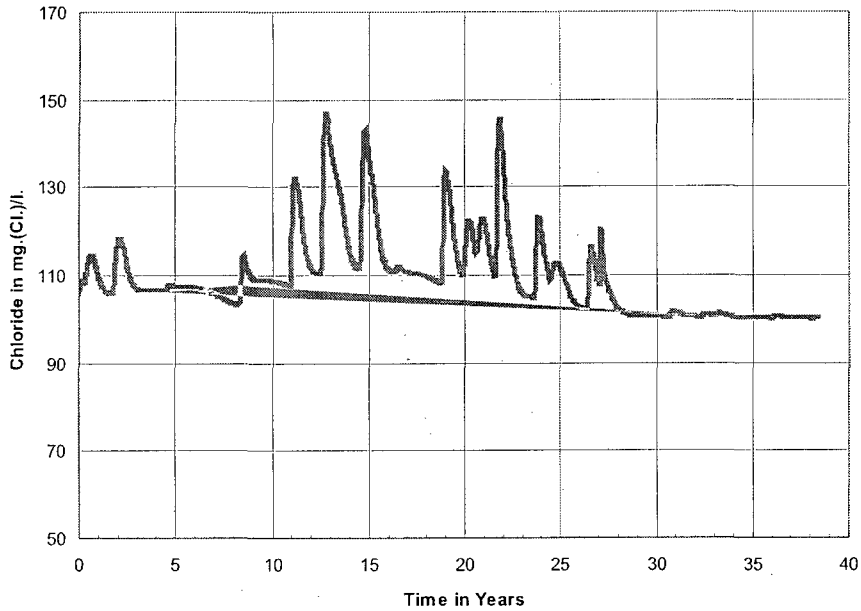
Figure C-1: Predicted Chloride Concentration in the Aquifer for the I-29 Site with No Vegetation

Using the input data described above, HYDRUS-1D and the ground water mixing model predict no exceedance of WQCC ground water standards at the I-29 Vent site (see Figure C-1). For this simulation, it was assumed that no vegetation is present at the site.

As field chloride data demonstrate, impacts at this site are marginally greater than background; thus, an insignificant impact to ground water quality would be expected. As shown in Figure C-1, chloride concentration in the aquifer attains a maximum of 147 ppm approximately 13 years from now. The effect of the chloride load is no longer distinguishable 29 years from now.

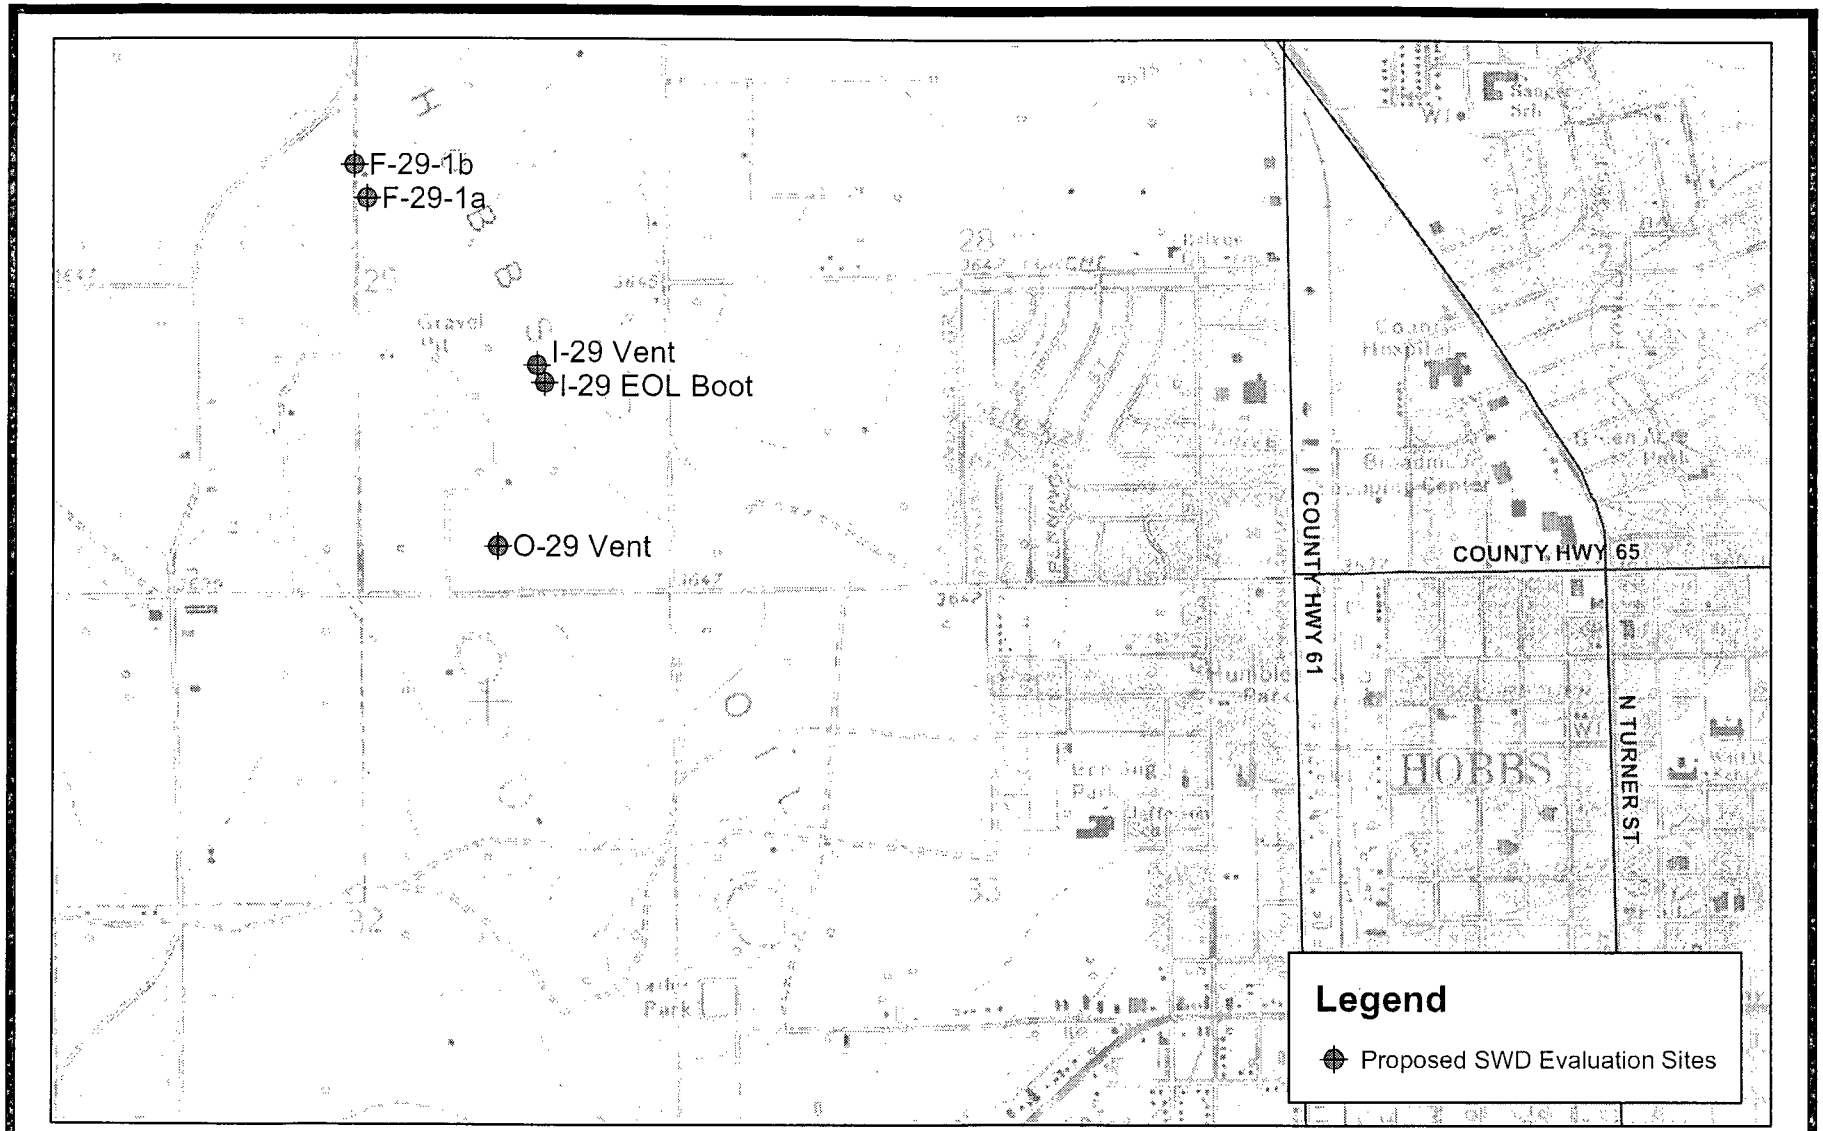
Location of Salt Water Disposal System	Plate 1
Rice Operating Company	March 2004
