F-29-1b, NMOCD Case #1R0428-45

Rice Operating Company
Closure Report

RE: NMOCD Case # 1R0428-45, F-29-1b Junction Boot
Hobbs SWD System Abandonment
Closure Report

Corrective Action Plan

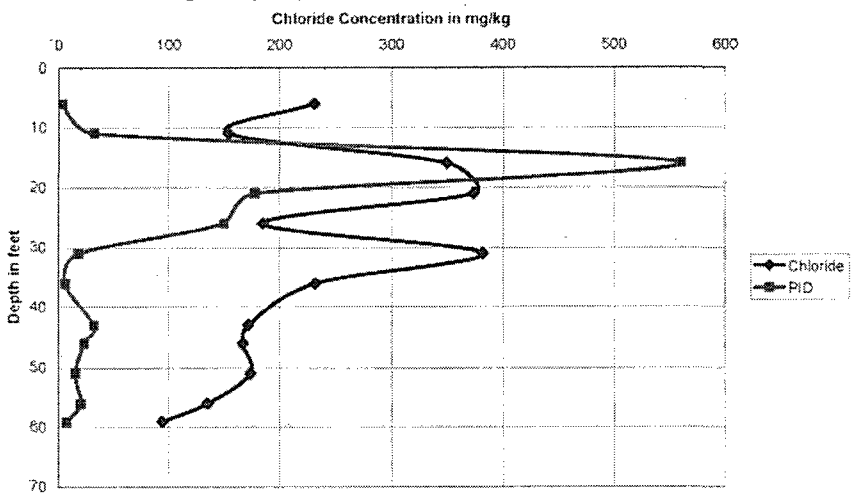
Chloride concentrations reach approximate background levels at a depth of 56 feet bgs. Field evidence demonstrates that the chloride mass resides in the upper two-thirds of the vadose zone.

Figure A-1: Chloride Concentrations and PID Readings From Soil Boring Samples, F-29-1b Vent Site, November 4, 2004

The soil sample obtained at 16 feet bgs contained 560 ppm total organic vapors. PID readings decline from 16 feet bgs, reaching background concentrations below 26 feet bgs.

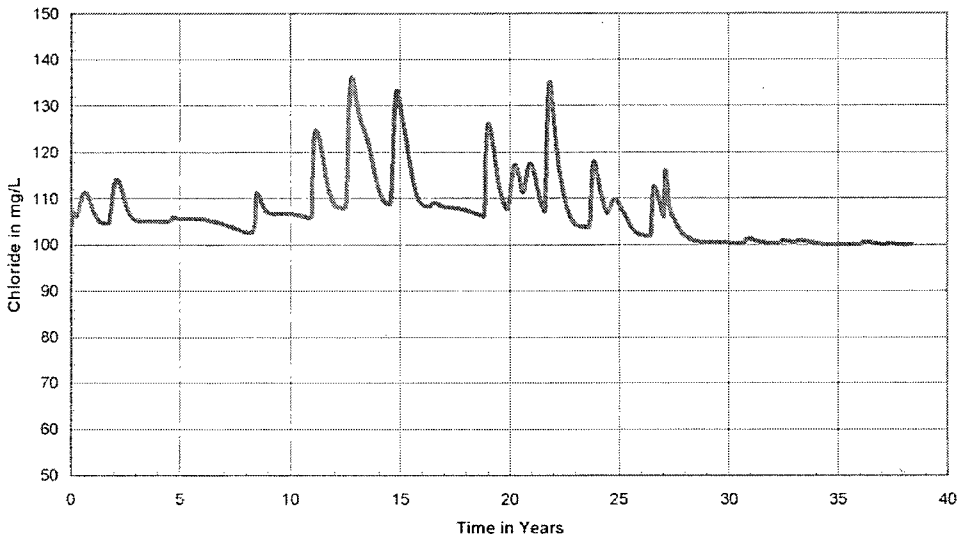
impact to ground water quality would be expected. As shown in Figure C-1, chloride concentration in the aquifer attains a maximum of 136 ppm approximately 13 years from now. The effect of the chloride load is no longer distinguishable 28 years from now.

Figure C-1: Predicted Chloride Concentration in the Aquifer for the F-29-1b Site with No Vegetation

Hicks Consultants recommends that ROC create an infiltration barrier through re-vegetation of the ground surface at the F-29-1b Junction site. This remedy is protective of ground water quality, human health, and the environment. Upon documentation of this action, a closure report/request will be submitted to NMOCD.
