RE: **Groundwater Impacts**
Chevron USA – Mark #13 Drill Pit 30-025-37385
UL-G (SW ¼ of the NE ¼), Section 3, T 22 S, R 37 E
Latitude: 32° 25' 22.65"; Longitude: 103° 08' 46.23"
NMOCD Ref. #1NSL-5227-A; EPI Ref. #200074

SITE CLOSURE PROPOSAL

MARK #13 DRILL PIT

JANUARY 2008

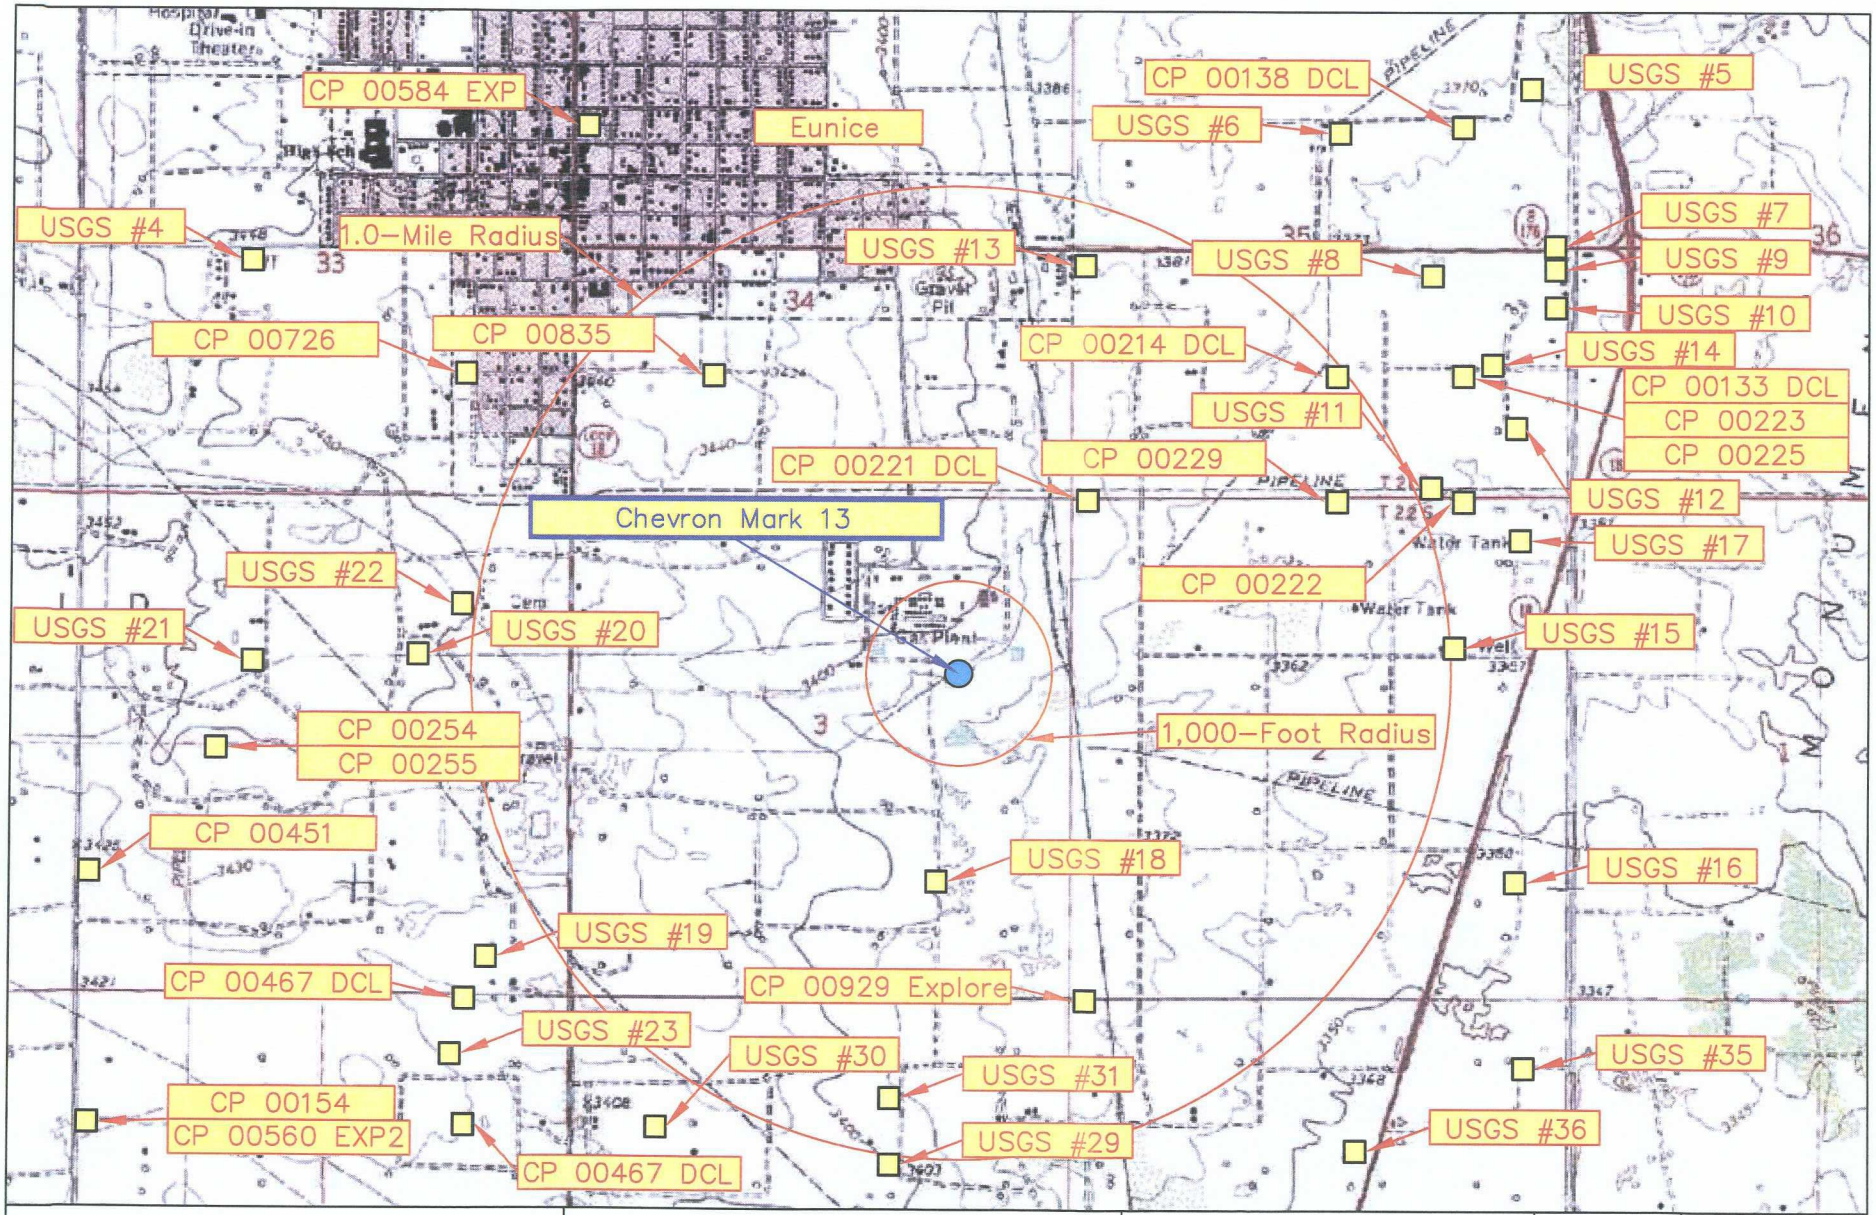
Figure 2
Site Location Map
Chevron Corporation
Mark 13

2.9 Area Water Wells
No water wells exist within a 1,000-foot radius of the site (reference *Figure 2*).

2.10 Area Surface Water Features
No surface water features exist within a 1,000-foot radius of the site (reference *Figure 2*).

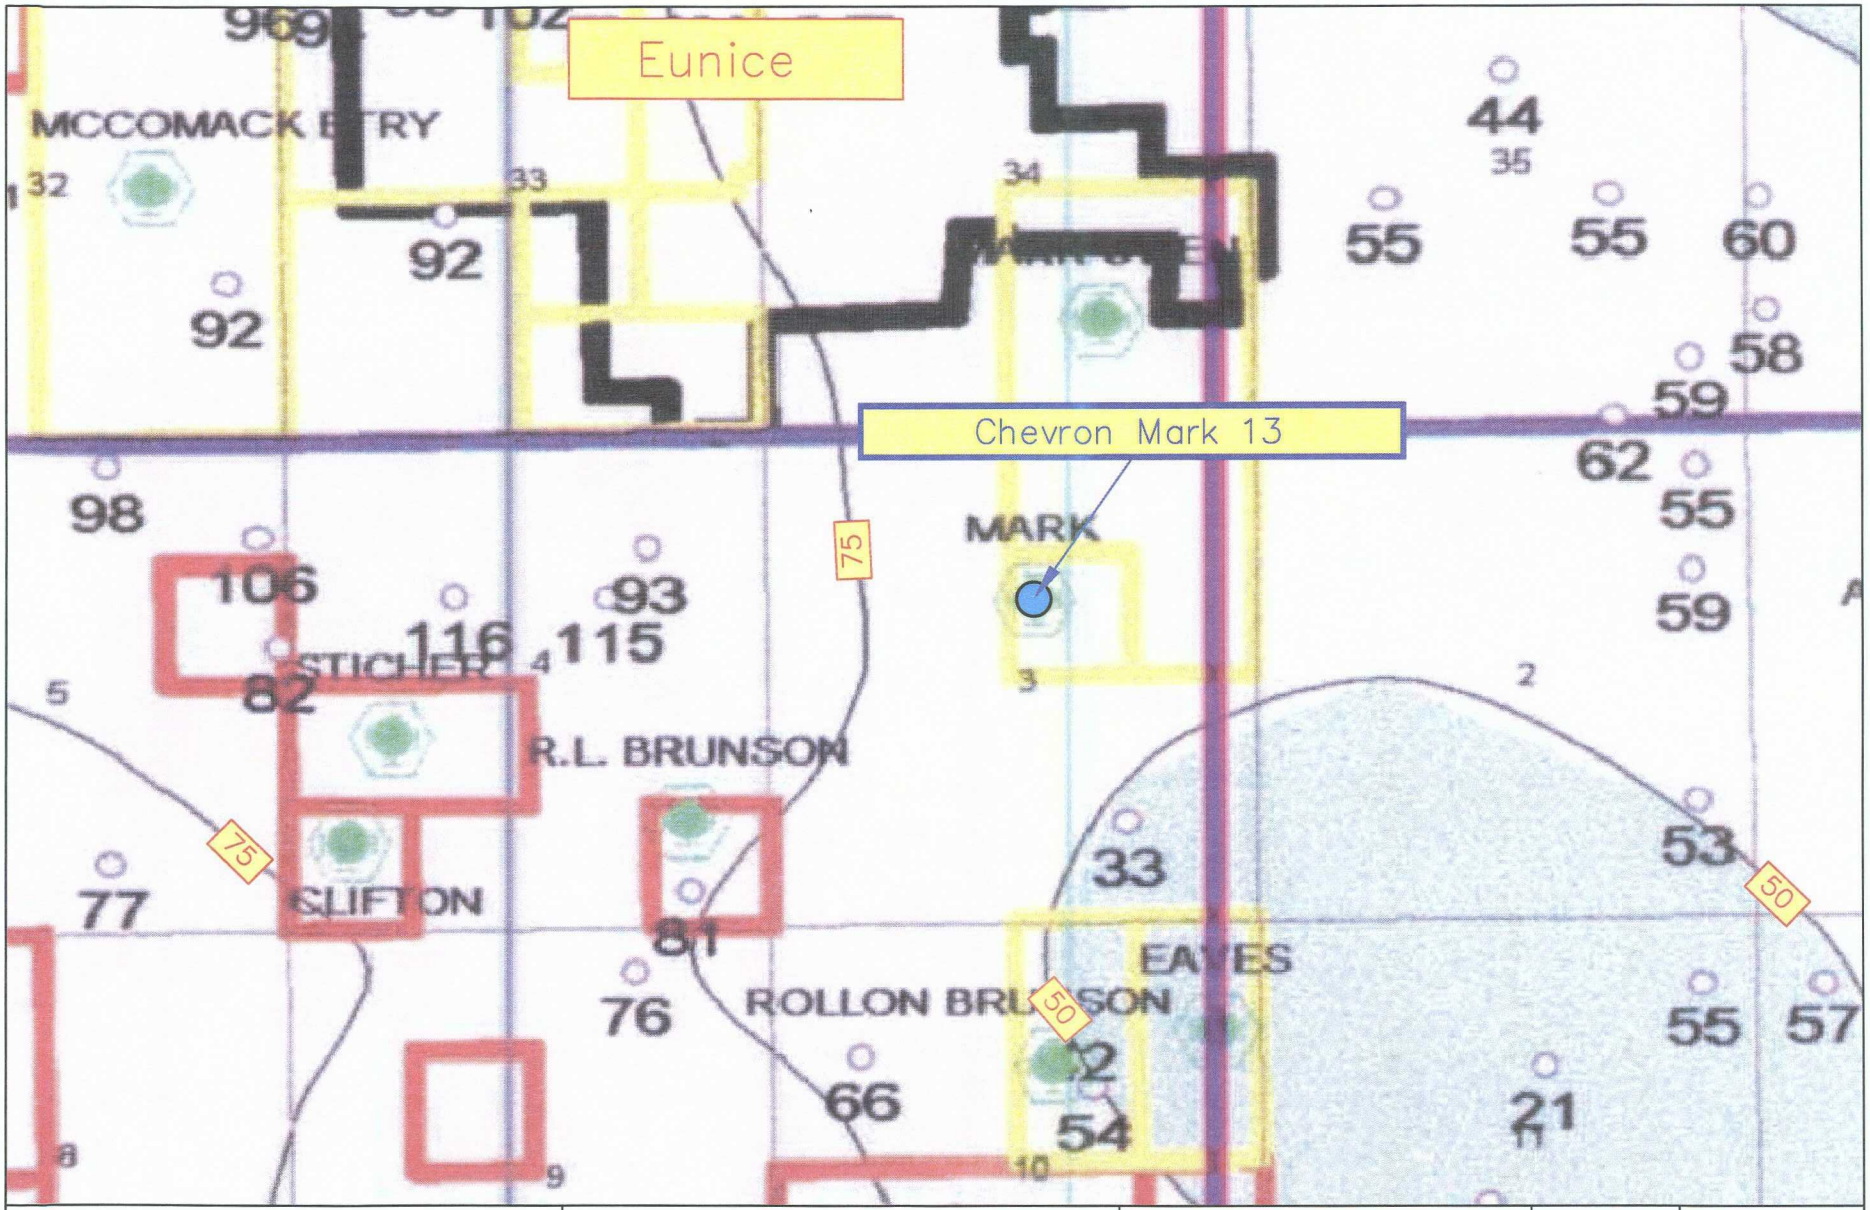
Figure 4 Groundwater Map Chevron Corporation Mark 13	Lea County, New Mexico SW 1/4 of the NE 1/4, Sec. 3, T22S, R37E N 32° 25' 22.65" W 103° 08' 46.23" Elevation: 3,390 feet amsl	DWG By: Daniel Dominguez February 2006 0 2,000 4,000 Feet	REVISED: SHEET 1 of 1 N

2.8 Area Groundwater
Unconfined groundwater aquifer at this site is projected to be ~ 63 feet (ft) bgs based on water depth data obtained from the New Mexico State Engineers Office, United States Geological Survey data base and Chevron's Ground Water Gradient Maps (reference *Table 1 and Figure 4)*).

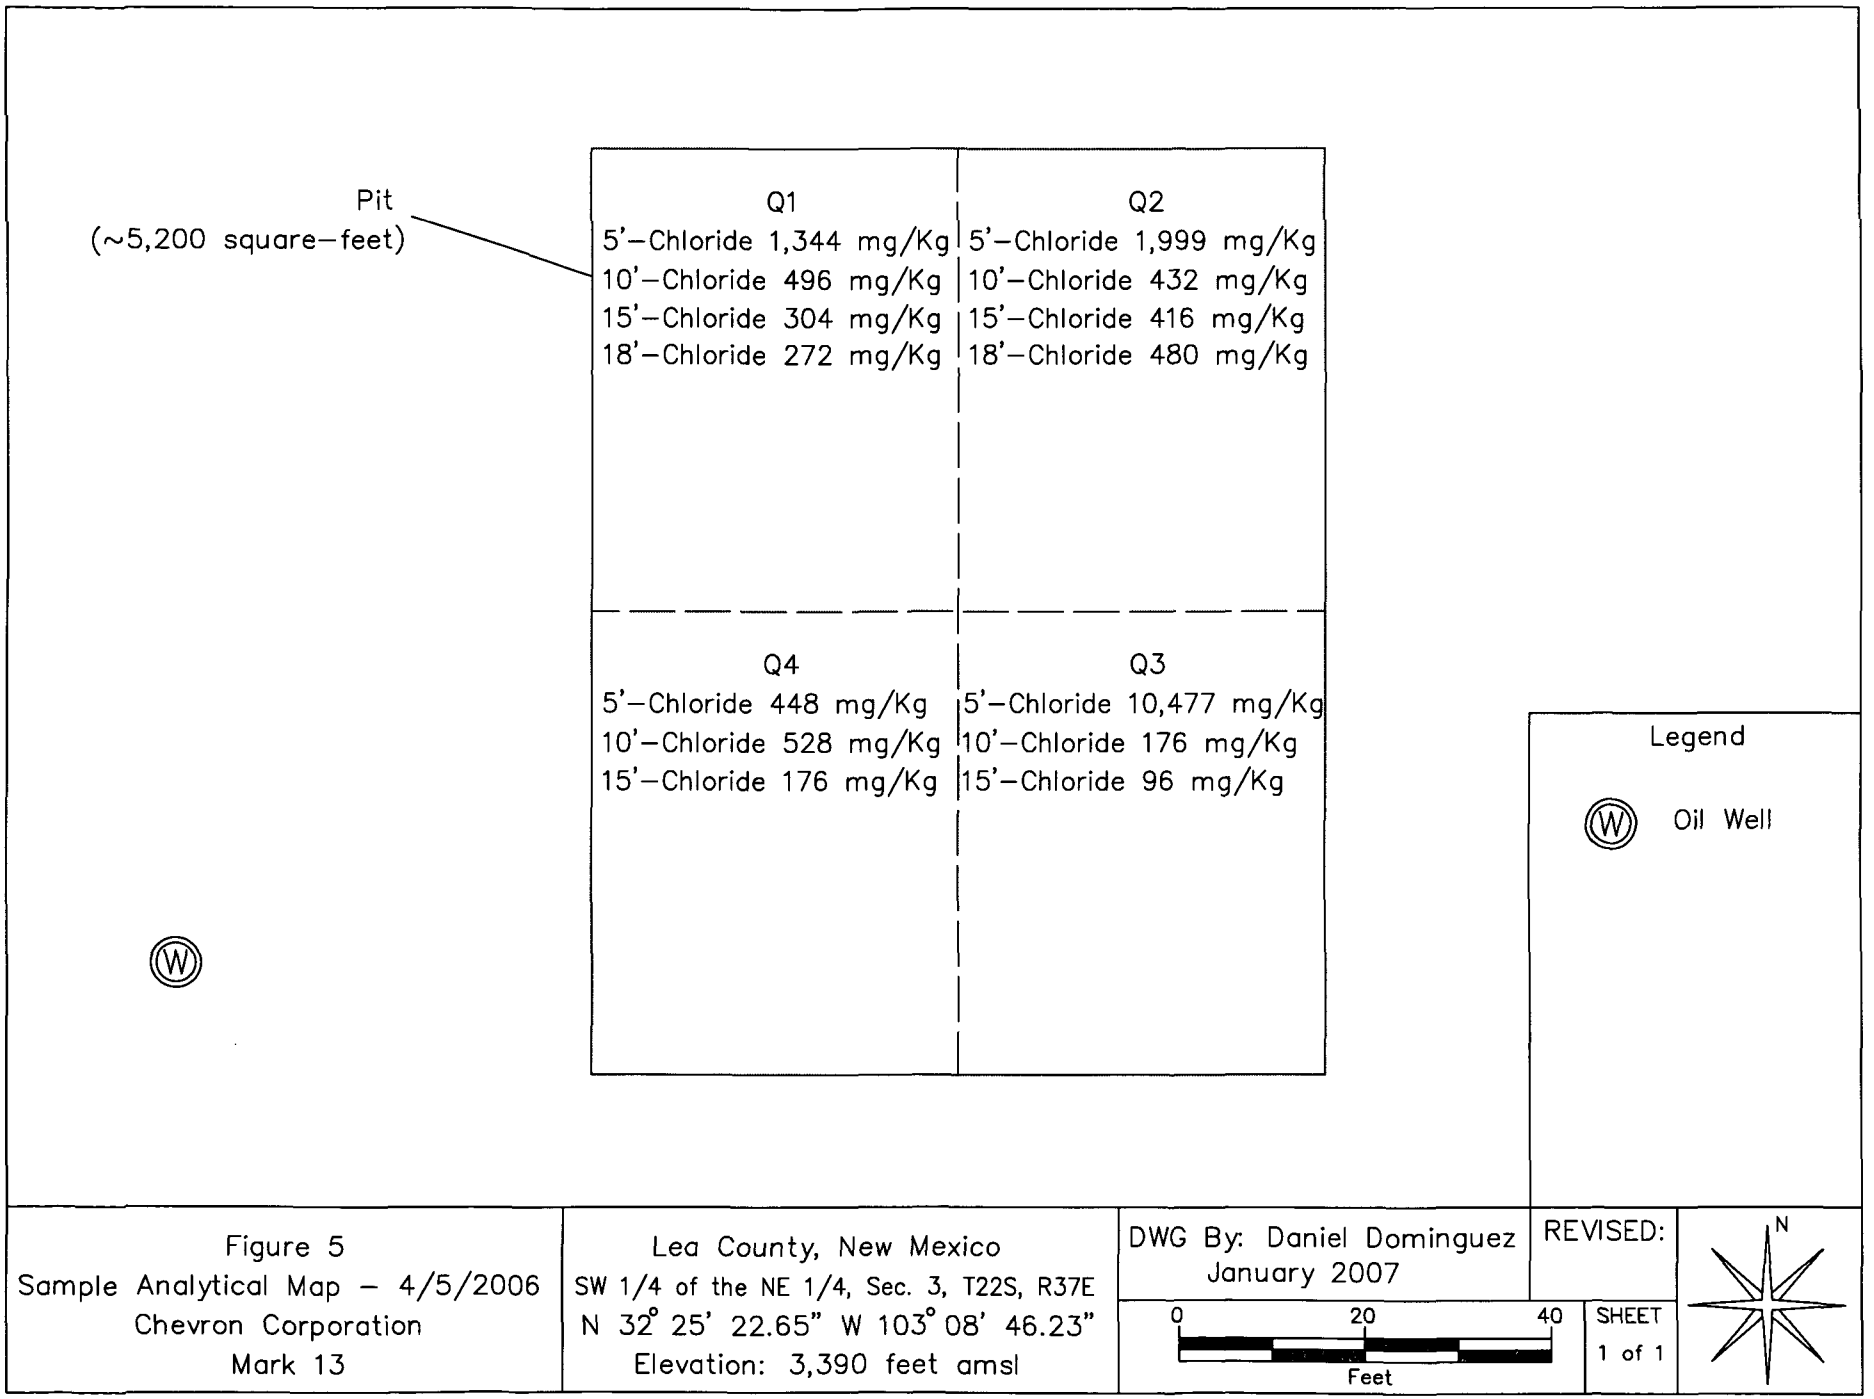
Figure 5
Sample Analytical Map - 4/5/2006
Chevron Corporation
Mark 13

Soil samples were collected from the drill pit on April 5, 2006 (20-ea.), April 6, 2006 (7-ea.) and January 8, 2007 (5-ea.). Two (2) soil borings were advanced on January 12, 2007 with twelve (12-ea.) soil samples collected. Soil samples were collected from the overflow area on January 30, 2007 (9-ea.). *Figure #5* through *Figure #8* provide soil sample information with respect to sample point locations (i.e., sidewall or bottom of the excavations). *Table #2* and *Table #3* provide soil samples field analyses and laboratory analytical data. Soil sample locations within the drill pit and overflow areas were chosen to provide the best representative location for delineating vertical and horizontal extents of impacted soil.

Primary emphasis for soil samples collected on April 5-6, 2006 from sidewalls and bottom of the drill pit excavation was quantification of chloride concentrations. Laboratory analyses indicate chloride concentrations ranged from a high of 18,394 mg/Kg (ESSW @ 5-ft. bgs) to a low of 16 mg/Kg (ENSW @ 10-ft. bgs). Thirteen (13) soil samples were collected from the excavation sidewalls and bottom with only two (2) indicating chloride concentrations below remedial threshold goals of 250 mg/Kg (reference *Figure 6* for locations). Coincidental with sidewall and bottom soil sampling event, test trenches were excavated from four (4) quadrants (Q1 through Q4) in the bottom to delineate vertical extent of chloride impacted soil (reference *Figure 5*). Laboratory analytical data indicated in situ chlorides diminish in concentrations with vertical depth.

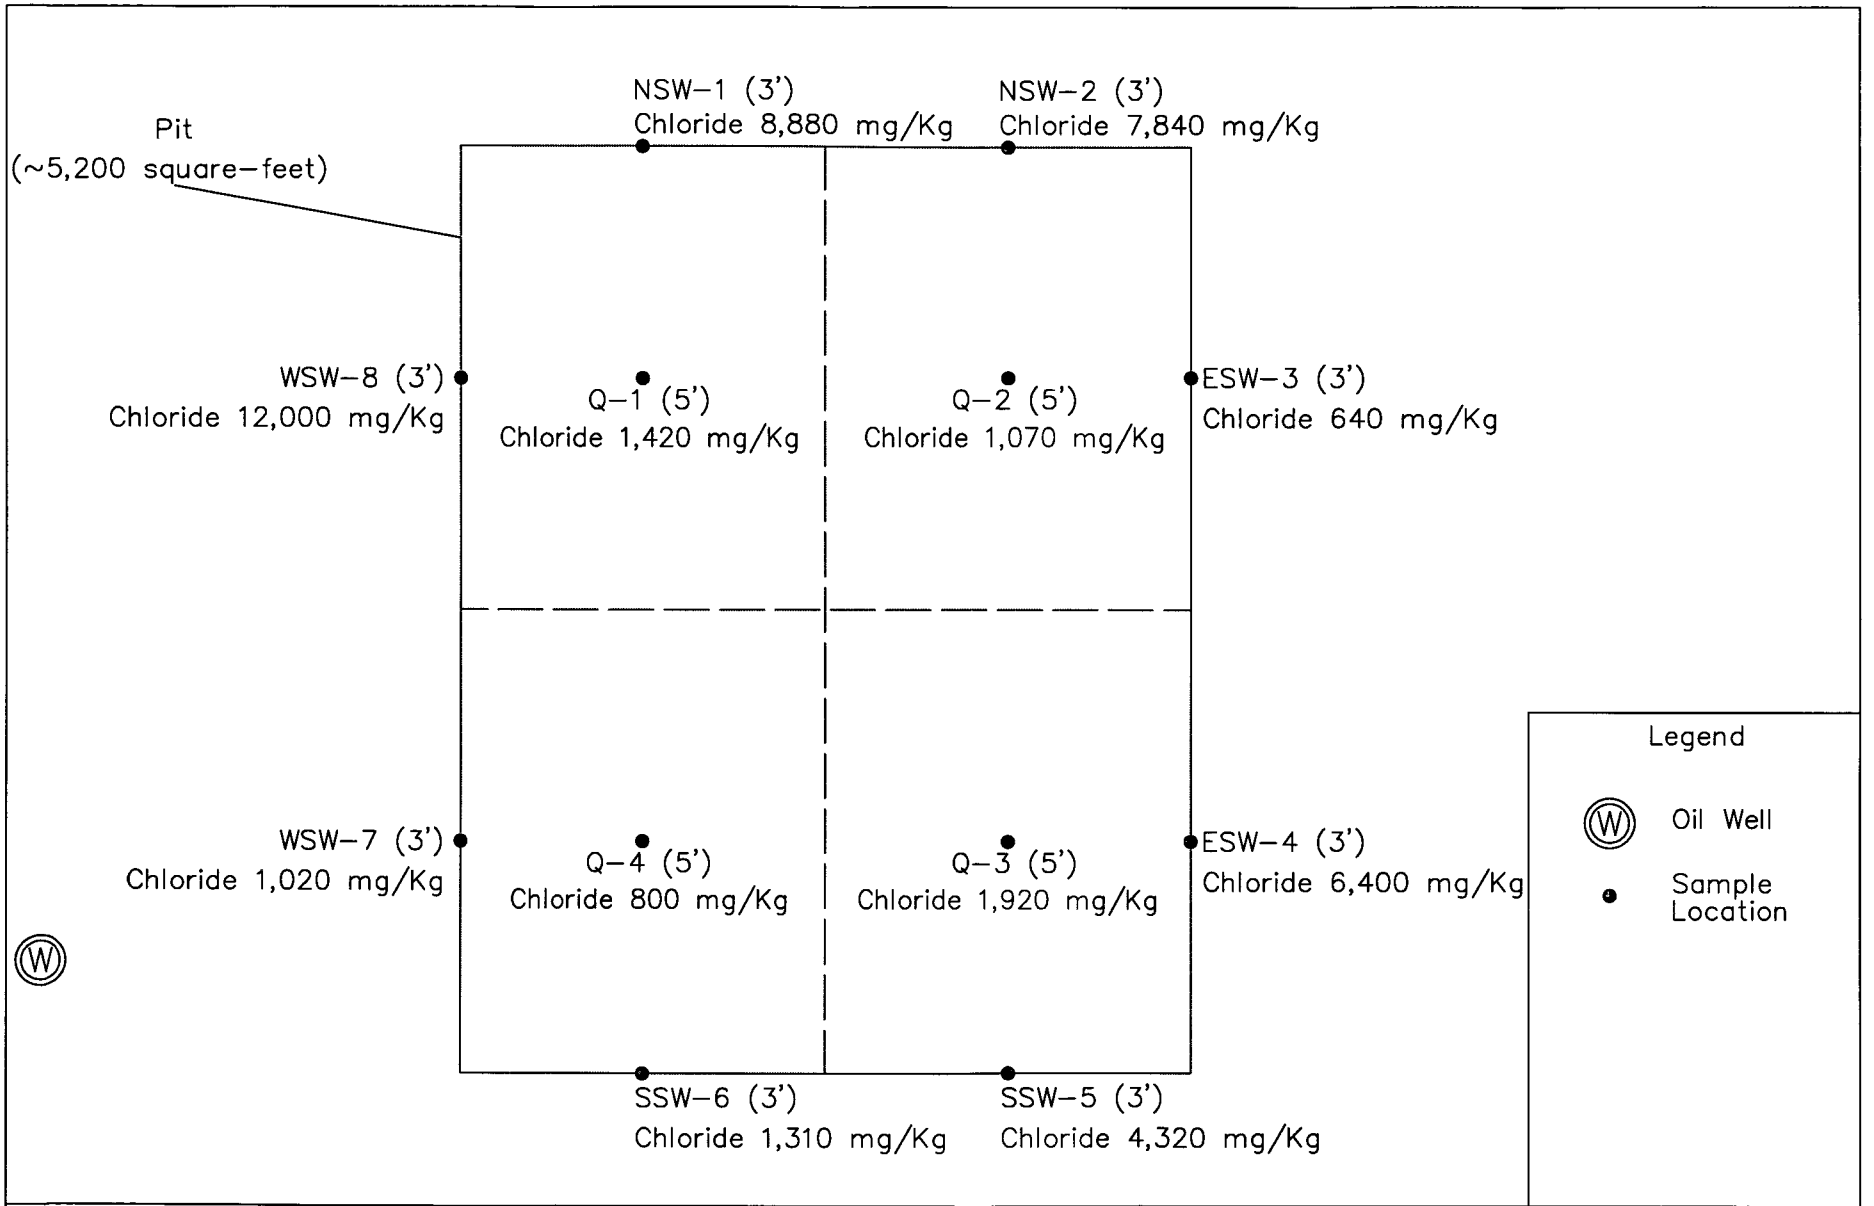
Figure 7 Sample Analytical Map – 1/12/2007 Chevron Corporation Mark 13	Lea County, New Mexico SW 1/4 of the NE 1/4, Sec. 3, T22S, R37E N 32° 25' 22.65" W 103° 08' 46.23" Elevation: 3,390 feet amsl	DWG By: Daniel Dominguez January 2007 0 20 40 Feet	REVISED: SHEET 1 of 1

After additional excavation of sidewalls in the drill pit, soil samples were collected on January 12, 2007 from the four (4) quadrants bottom and sidewalls from sample point locations previously sampled on April 5-6, 2006. Bottom soil samples in quadrants Q2 (5') and Q3 (5') indicate chloride concentrations lower than previous laboratory analytical results. Quadrant Q1 (5') soil sample chloride concentration was comparable with the previous concentration. Quadrant Q4 (5') soil sample concentration was higher than previous concentration. Soil samples collected from sidewalls displayed no predictable pattern for chloride concentrations with respect to delineation efforts (i.e., to establish whether additional sidewall excavation will reduce chloride concentrations to remedial threshold goals of 250 mg/Kg) (reference *Table #2*).

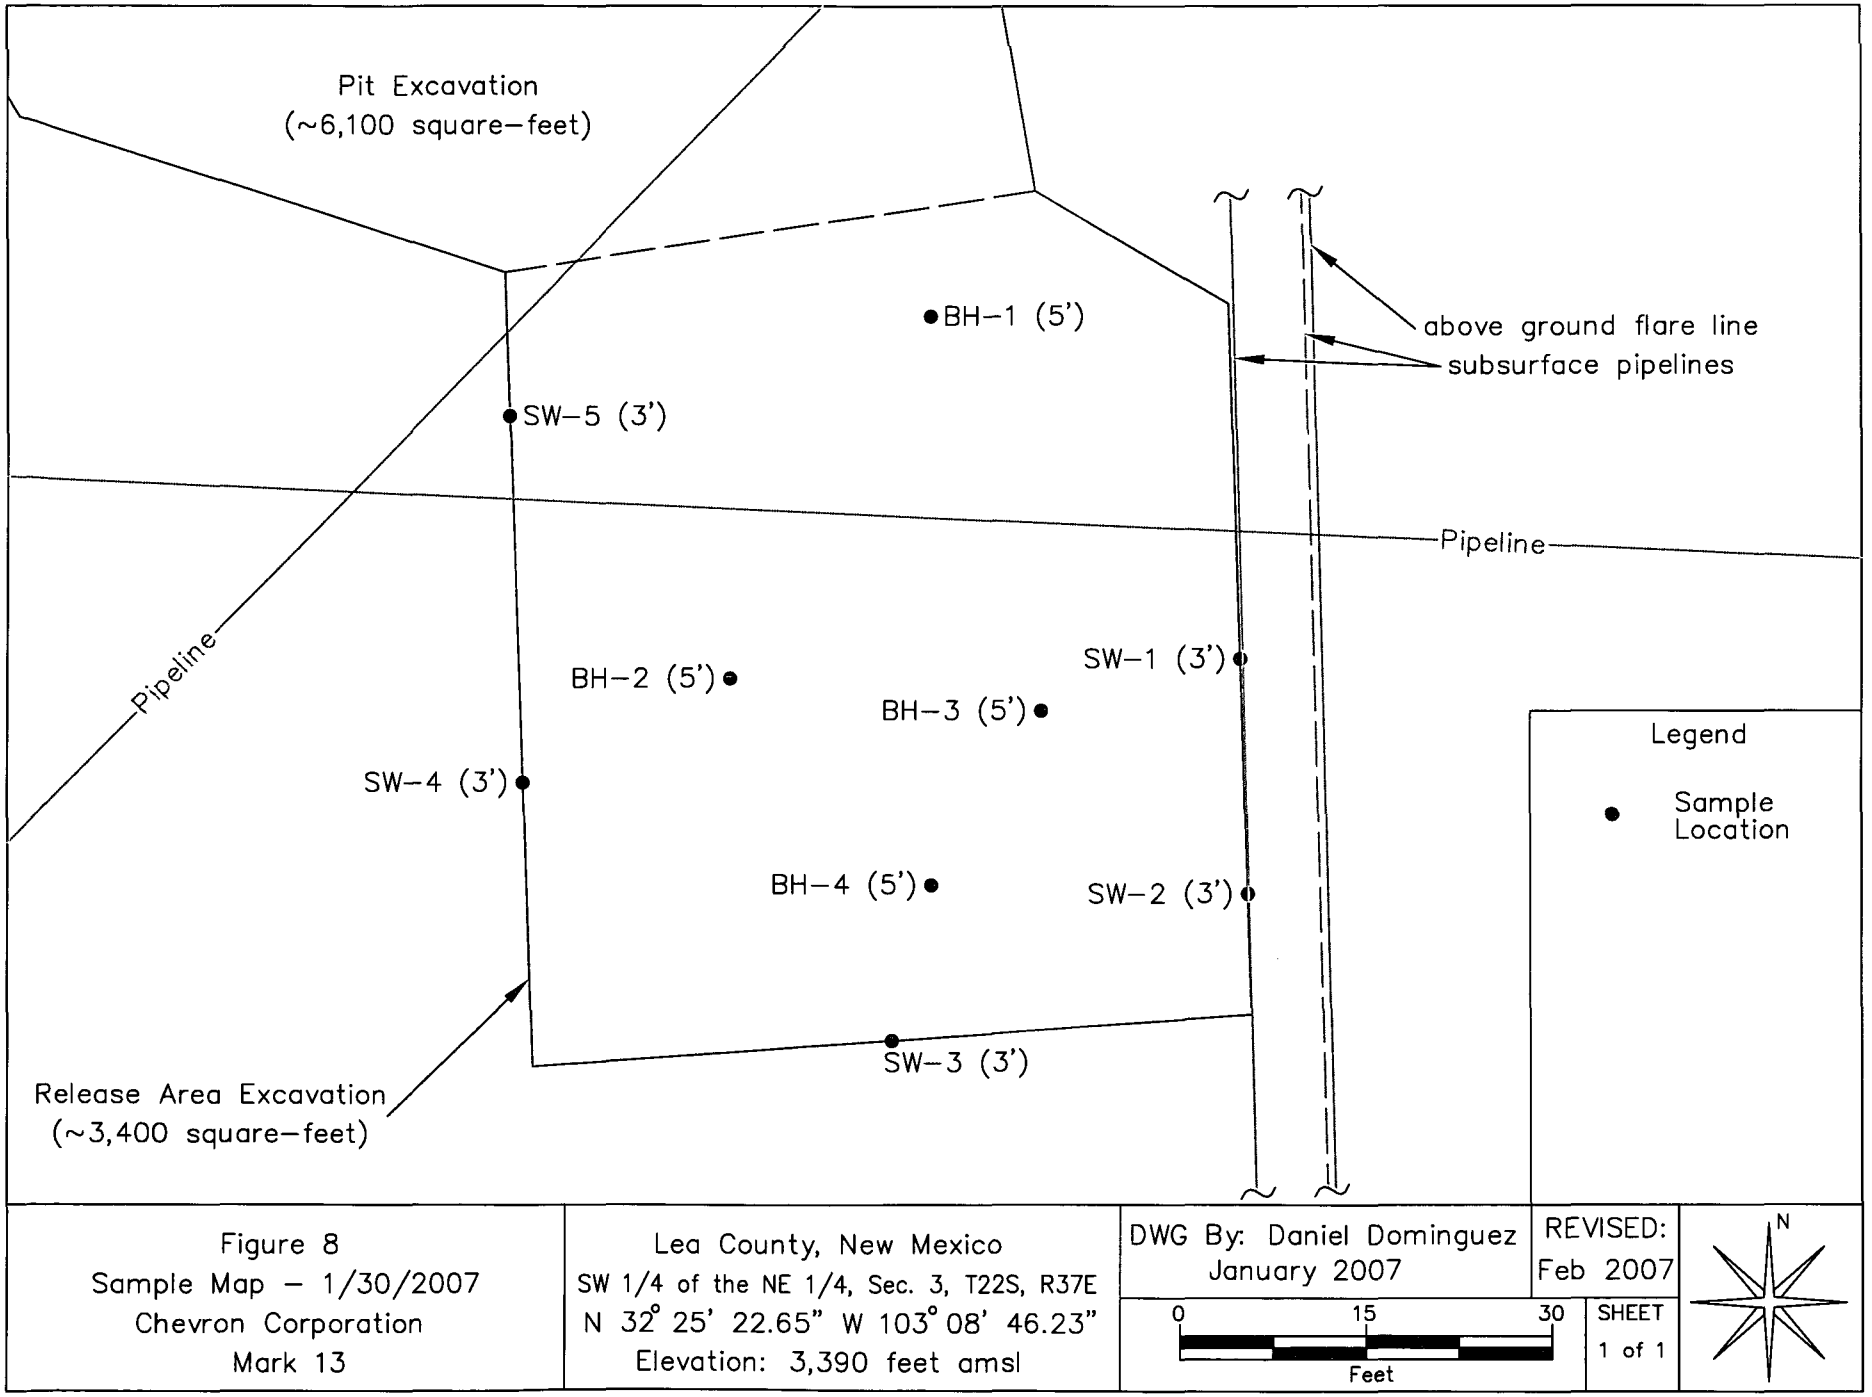
Figure 8 Sample Map – 1/30/2007 Chevron Corporation Mark 13	Lea County, New Mexico SW 1/4 of the NE 1/4, Sec. 3, T22S, R37E N 32° 25' 22.65" W 103° 08' 46.23" Elevation: 3,390 feet amsl	DWG By: Daniel Dominguez January 2007	REVISED: Feb 2007	N
		0 15 30 Feet	SHEET 1 of 1

Soil samples collected on January 30, 2007 from sidewalls and bottom of the overflow area excavation indicated chloride concentrations in excess of remedial threshold goal of 250 mg/Kg remain in situ (reference *Figure 8* for locations and *Table 2* for laboratory analytical results). Concurrent with the soil sampling event, one (1) soil boring was advanced within the interior perimeter of the overflow area excavation. A second (2) soil boring was advanced to the south of the overflow area as a background reference. Both soil borings displayed identical traits of high chloride concentrations from five (5) feet bgs to fifteen (15) feet bgs. Chloride concentrations within remedial threshold goals of 250 mg/Kg were attained in the fifteen (15) feet bgs to twenty (20) feet bgs zone (reference *Figure 8* for soil sample locations, *Figure #9* for soil boring locations and *Table 3* for laboratory analytical results).

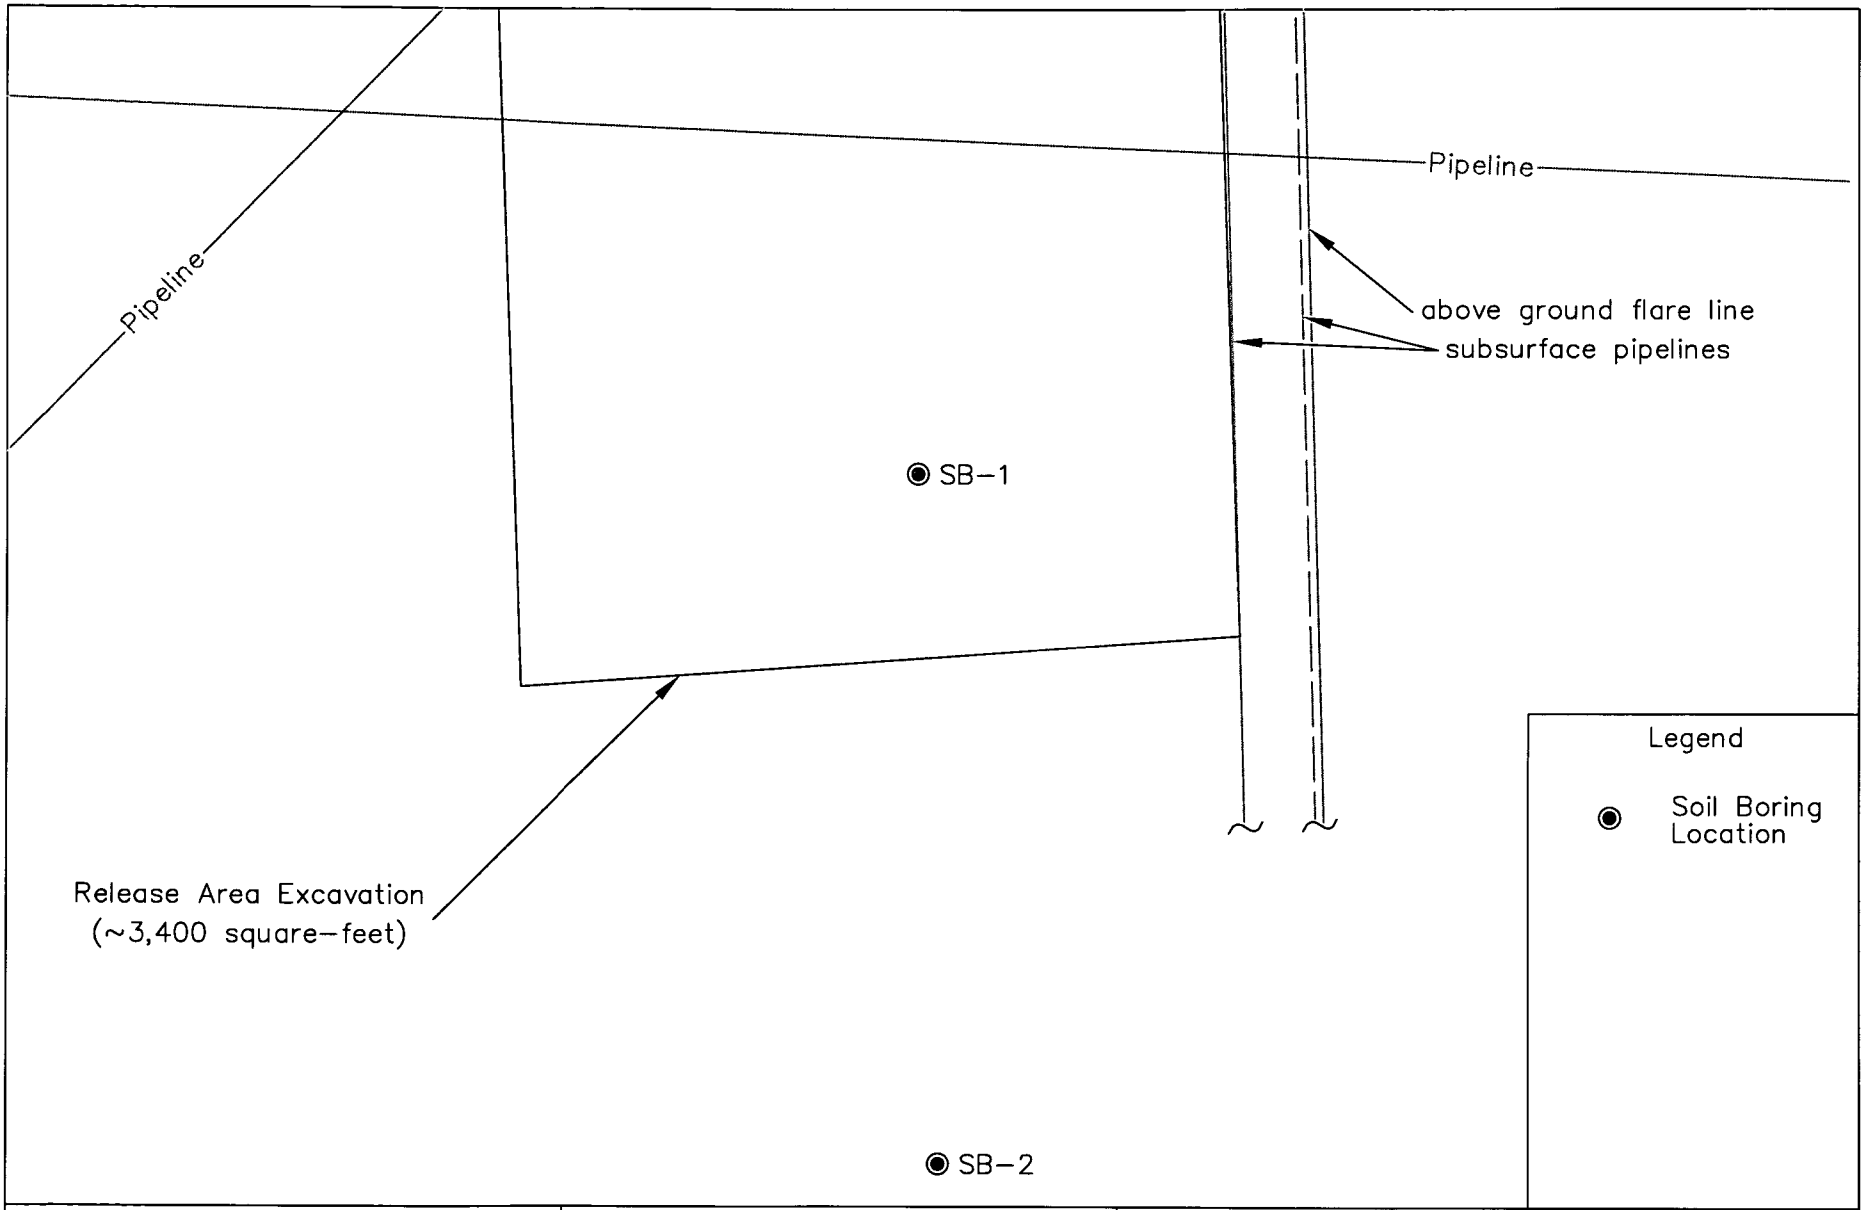
Figure 9 Soil Boring Map Chevron Corporation Mark 13	Lea County, New Mexico SW 1/4 of the NE 1/4, Sec. 3, T22S, R37E N 32° 25' 22.65" W 103° 08' 46.23" Elevation: 3,390 feet amsl	DWG By: Daniel Dominguez January 2007	REVISED: May 2007	SHEET 1 of 1

As areas surrounding the drill pit and overflow area are chloride impacted as indicated by laboratory analytical results for soil boring SB-2, efforts to remediate the area by continued excavation will not be successful. Test trenches and soil borings have indicated chloride impacted soil exist to approximately eighteen (18) feet bgs. Surface and subsurface physical barriers make additional excavation of the overflow area in the easterly direction impossible. Of particular concern is projected depth between potential groundwater (~63-feet bgs) and field determination of existing groundwater (~24-feet bgs). During advancement of soil borings, a dense layer of limestone was encountered at ~20-feet bgs. Soil borings indicated perched water may exist at this depth indicative the limestone layer is acting as a barrier to retard migration of contaminants. Groundwater samples collected from TMW-3 and TMW-4 at 24-feet bgs indicated groundwater was moderately impacted with chlorides being the largest contributor. Chloride concentrations were in excess of NMWQCC Ground Water Standards of 250 mg/L (reference *Table #4*). To further impede migration of in situ chloride contaminants, an impervious 40-mil thick liner will be installed over the bottom of the drill pit excavation. The polyethylene liner will be sandwiched between two (2) layers of cushion sand (over/under). The remainder of the excavation will be backfilled with caliche from cushion sand to surface elevation of existing production pad. A 20-mil thick liner will be placed over the bottom of the overflow area excavation. As this is a non-traffic bearing area, the polyethylene liner is to be sandwiched between one (1) foot layers of cushion sand (over/under). The overflow area excavation will be backfilled with clean topsoil from cushion sand to original ground surface. Upon completion, both areas will be contoured for natural drainage. The overflow area will be seeded with a blend approved by the property owner.

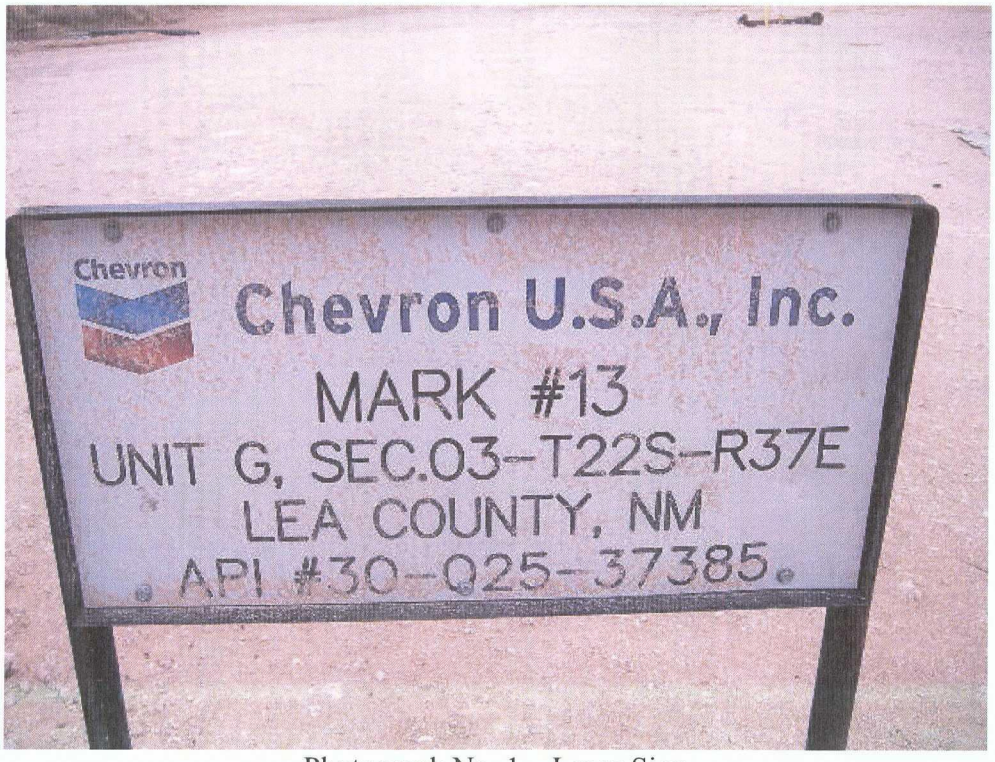
Photograph No. 1 – Lease Sign

Photograph No. 2 – Looking northerly at west bank of drill pit excavation
