RICE OPERATING COMPANY
JUNCTION BOX FINAL REPORT

F-33 Vent, NMOCD Case #1R0428-58

Rice Operating Company
Closure Report

RE: NMOCD Case # 1R0428-58, F-33 Vent
Hobbs SWD System Abandonment
Closure Report

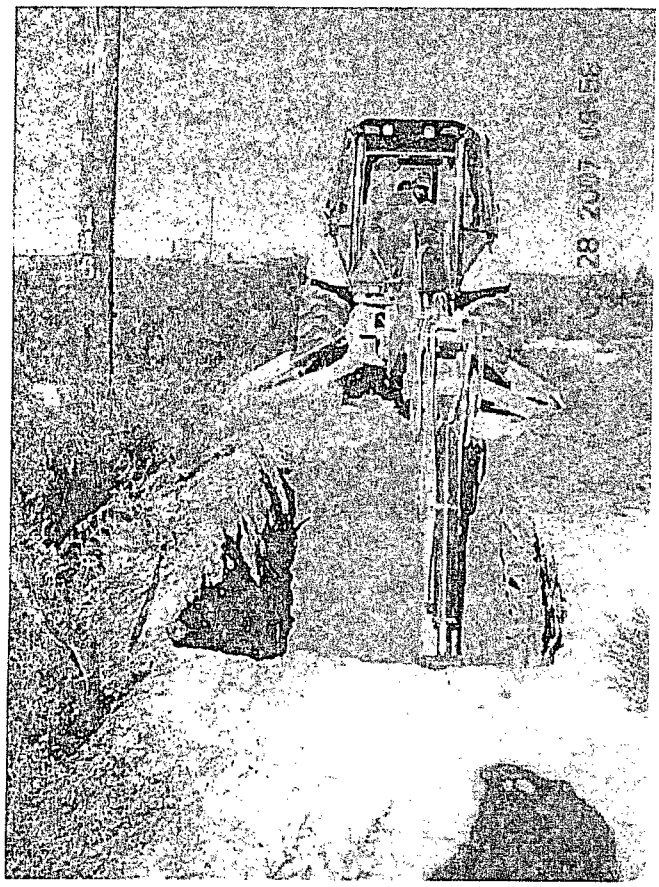
Hobbs F-33 vent
Excavating 10' x 10' x 12' hole

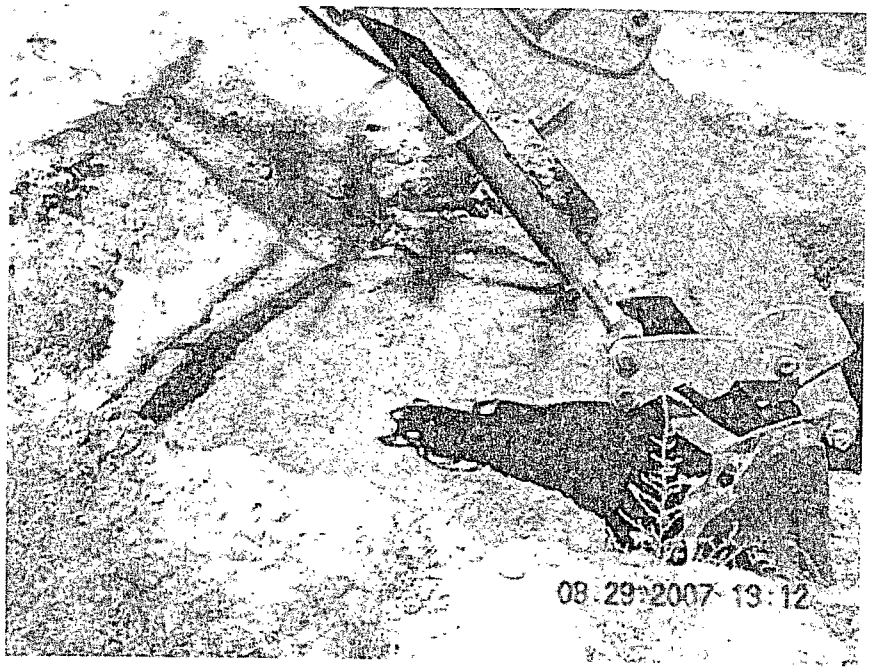
Hobbs F-33 vent
Laying Clay Layer @ 4'

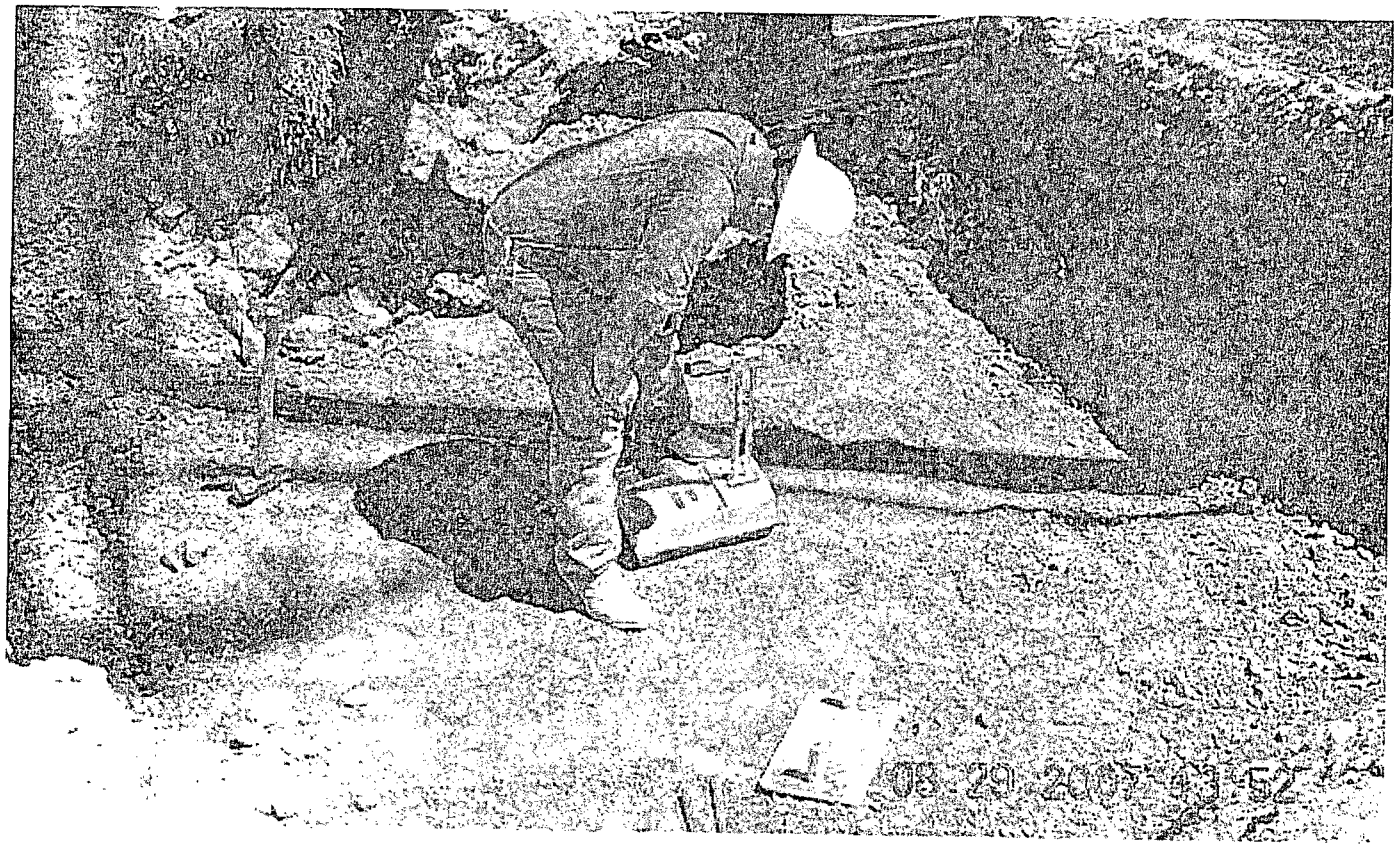
Hobbs F-33 vent
Compaction Layer Test

Hobbs F-33 vent
Seeding disturbed area

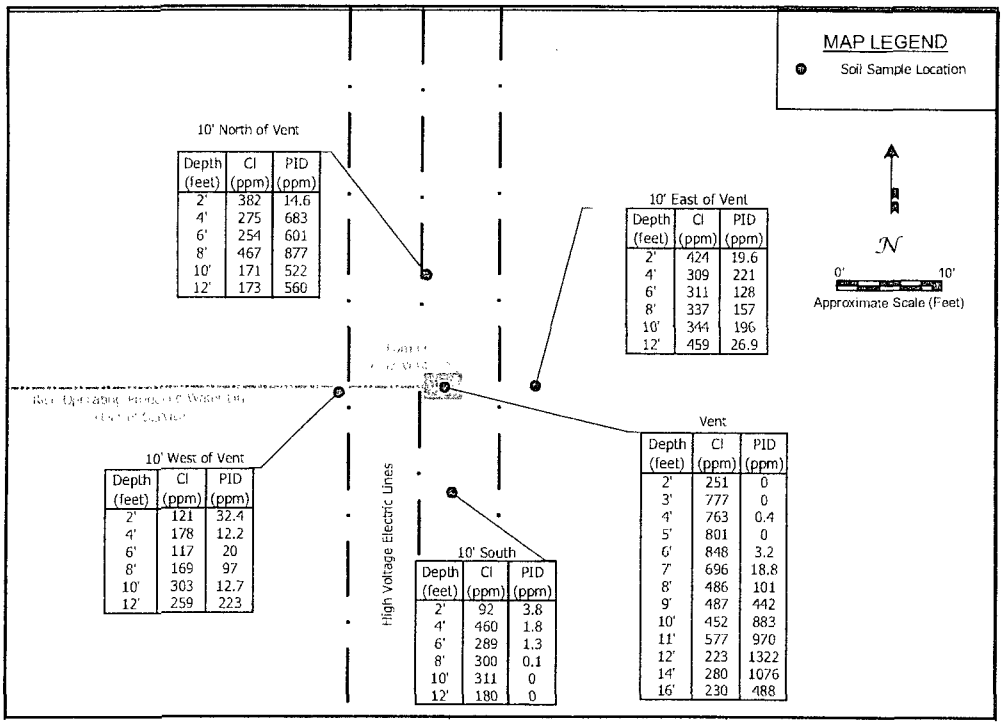
Based on the results from the backhoe and soil boring sampling activities hydrocarbon-impact was confirmed in the upper vadose zone and is confined within the near vicinity of the F-33 vent. All data shows that there is negligible chloride impact to the vadose zone. Appendix B presents the results of the field program.

Figure 1 is a map depicting the preliminary field screening results at the site.

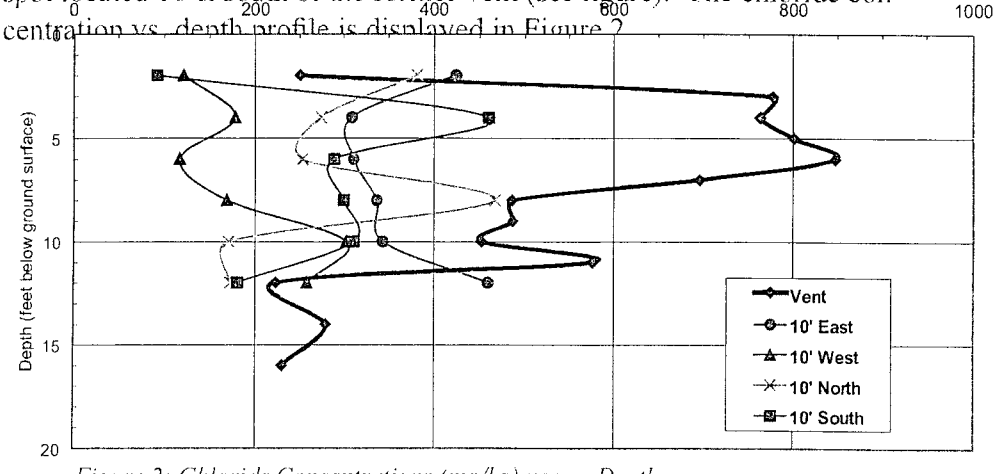
Figure 2: Chloride Concentrations (mg/kg) versus Depth

Chloride concentrations ranged from a maximum of 848 ppm at a point 6 ft below the vent source to a concentration of 92 ppm at a point 2 ft below a spot located 10 ft south of the former vent (see figure). The chloride concentration vs. depth profile is displayed in Figure 2.

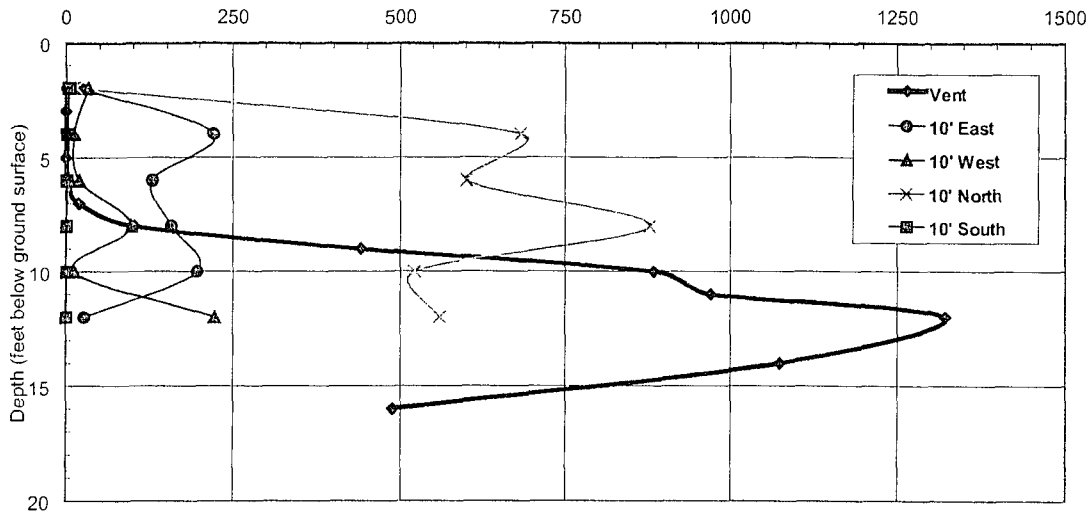
Figure 3: PID Readings (ppm) versus Depth

Soil samples with the highest PID readings and the deepest intervals were submitted to the laboratory for detailed hydrocarbon analysis using Methods 8260 for BTEX constituents and Method 1006 (a modified 8015 gas chromatography) for gas and diesel range organics (GRO and DRO) and carbon fractionation. The laboratory analytical reports and chain of custody documentation are included in Appendix C. The PID readings vs. depth profile is displayed in Figure 3.

Based on the backhoe sampling results hydrocarbon-impact exists in the upper 16 feet of vadose zone and is confined within the near vicinity of the F-33 vent (less than 10-foot radius from the vent). Results of the laboratory analyses for regulated hydrocarbons are summarized in Table 1 below.

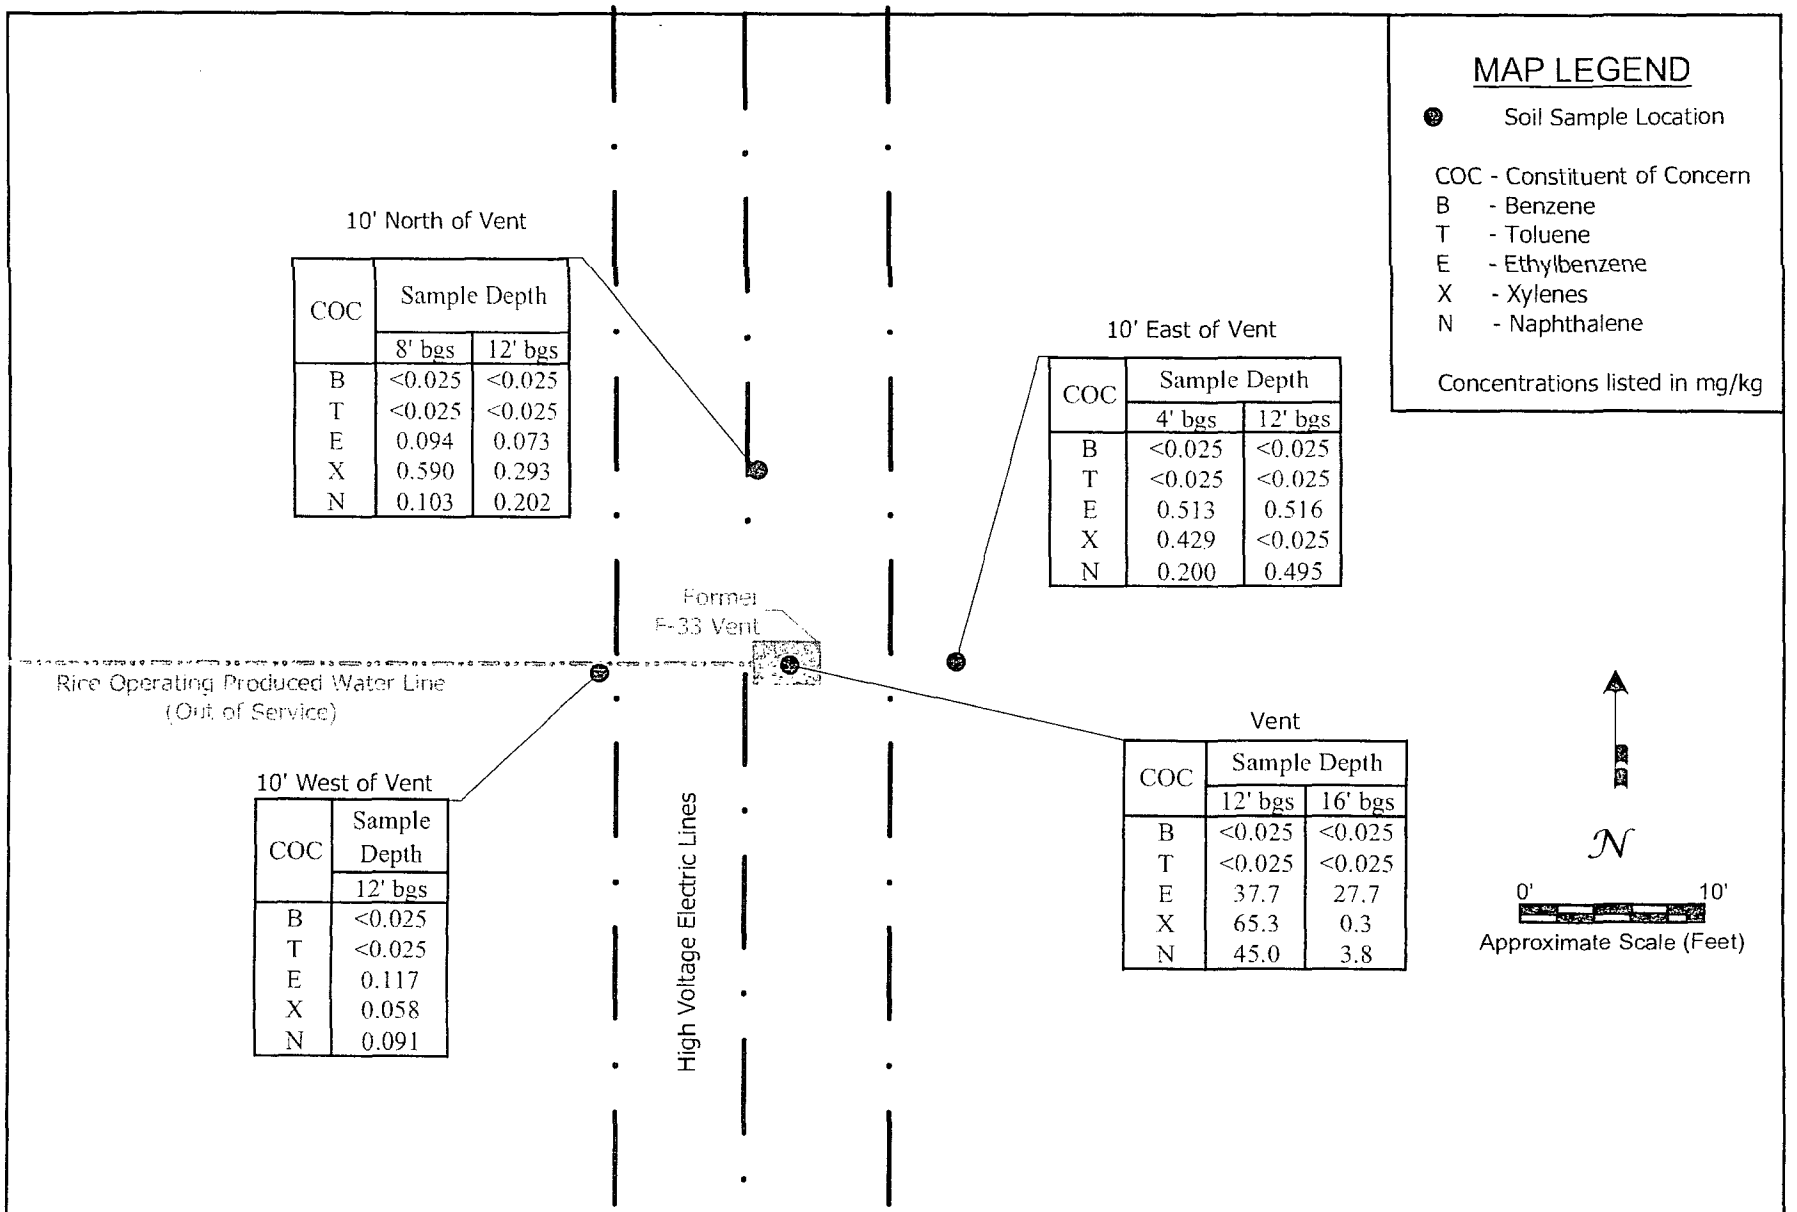
R. T. HICKS CONSULTANTS, LTD. P. O. Box 7624, Midland TX 79708	Site: F-33 Vent Site Date: May 22, 2006 Sampled By: Rice Operating Company Approximate Scale: 1 inch = 10 feet	SITE MAP HYDROCARBON SAMPLING RESULTS
