Hobbs I-29 EOL

JUNCTION BOX CLOSURE REPORT

RE: Final Site Closure Report:
I-29 EOL Boot
NMOCD Case No.: not assigned

Final Site Closure Report: I-29 EOL Boot

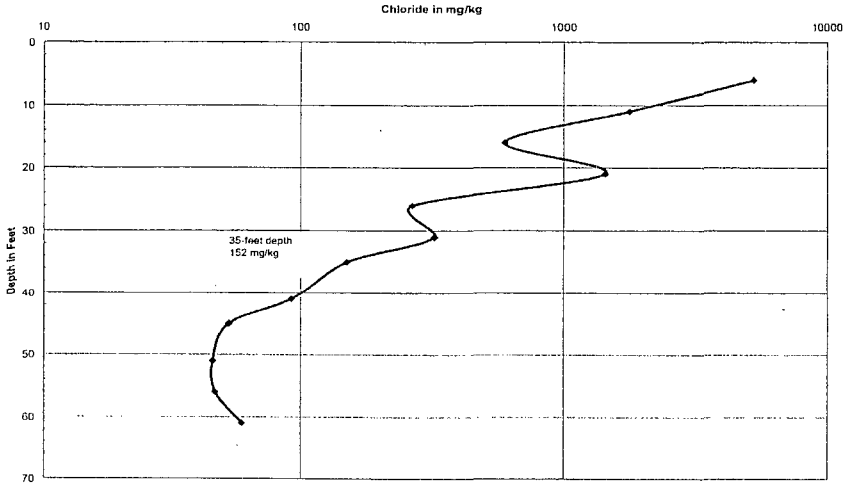
Soil bore samples show that downward transport of chloride ceased at about 35 feet below ground surface, which is 30 feet above ground water. As shown in Figure 1 (from the Corrective Action Plan), chloride concentrations are less than 250 mg/kg from 35 feet bgs to the total depth of the boring. The high concentration of chloride at 6 feet below ground surface verifies that this boring is located within the release footprint and is representative of the Vadose zone below the release.

Figure 1: Soil Chloride Concentration at the I-29 EOL Boot Site vs. Depth

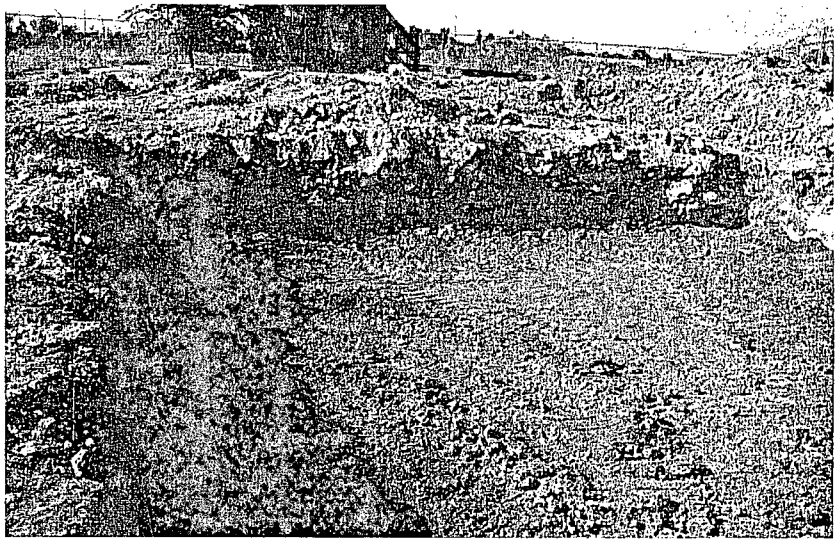
and installed the infiltration barrier in accordance with the NMOCD-approved plan. Appendix D and Figure 2 present photodocumentation of the installed ET barrier at the site. Appendix D also includes disposal manifests verifying that 70 cubic yards were removed from the site and disposed of properly. As the area is located inside an active battery, the caliche pad was restored upon backfill. The surface will be reclaimed upon abandonment of the battery.

Figure 2. Clay barrier installed at four feet below ground surface at site.

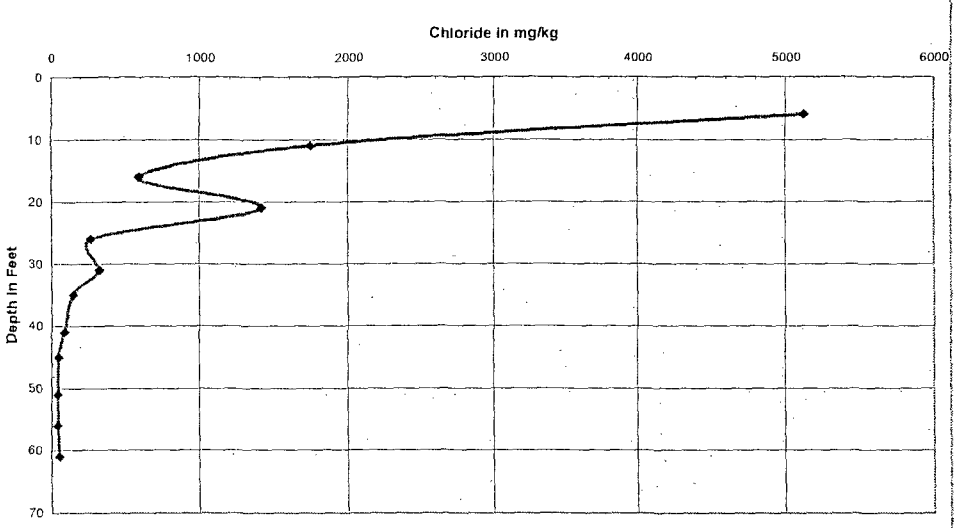
Figure 1
Soil Chloride Concentrations at the I-29 EOL Boot Site v. Depth

From discussions with individuals familiar with these systems and from field inspection of the surface soils, R. T. Hicks Consultants concluded that periodic overflow events occurred at the I-29 EOL Boot site. ROC field chloride concentration measurements and laboratory data demonstrate that the mass of constituents of concern remains above 35-feet bgs (see Figure 1 and Appendix B). Although these samples were from cuttings associated with the air-rotary drilling process, Hicks Consultants believes they represent the chemistry of the vadose zone. These data support a release model where saturated conditions between the surface and ground water did not exist.

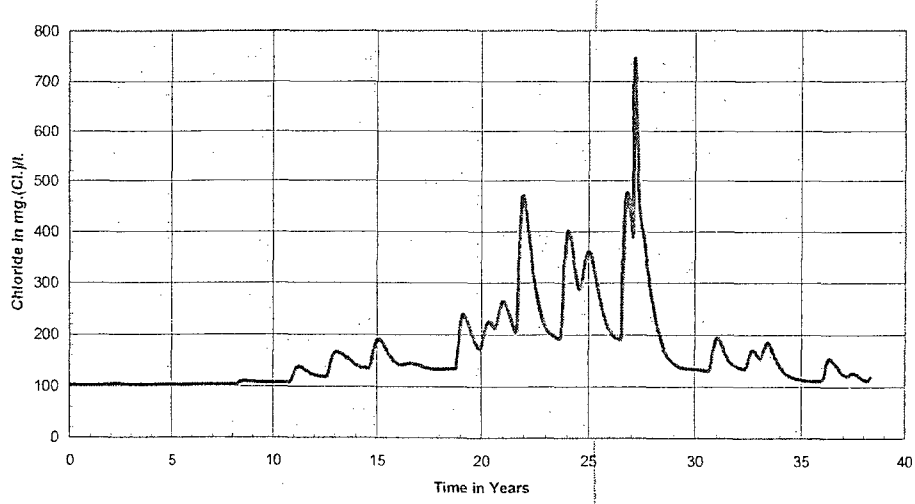
Modeling of the current condition (Scenario 1) indicates that chloride concentrations in ground water may exceed 250 mg/l during the time from 21 years through 29 years from now (Figure 2). Scenario 1 establishes a baseline condition to which possible remedies may be compared.

Figure 2. Chloride Concentration in the Aquifer for I-29 EOL Boot (Scenario 1)

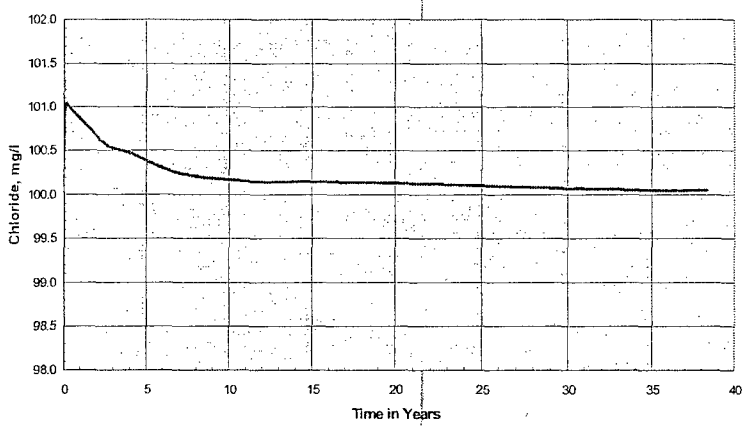
causes the moisture content in the profile to decline over time. Lower moisture content causes a commensurate reduction in unsaturated hydraulic conductivity. Without infiltration, the vadose zone flux into the aquifer is so diminished that chloride concentration in the aquifer is indistinguishable from background concentration (Figure 3).

Figure 3. Chloride Concentration in the Aquifer for I-29 EOL Boot with a Barrier Installed (Scenario 2)

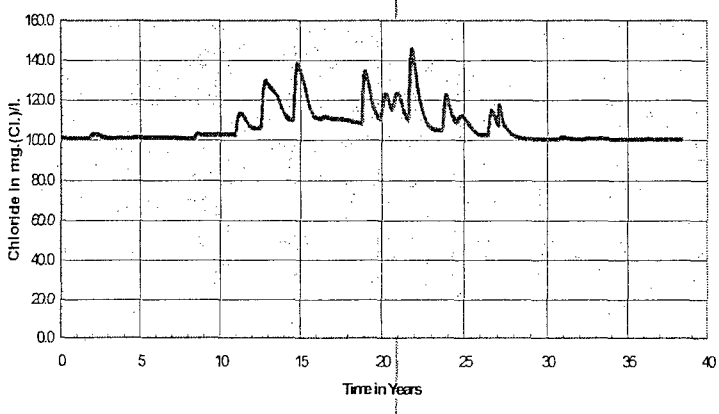
The second possible remedy, Scenario 3, evaluated the removal of the upper 10-feet of soil and replacement with clean fill assumed to contain a background chloride concentration of 80 mg/kg. To evaluate this alternative, a second HYDRUS-1D soil profile was used (see Appendix A and Plate 3) with this adjusted chloride load.

Figure 4. Chloride Concentration in the Aquifer with an Excavated Upper 10 feet of Soil Profile, I-29 EOL Boot v. Time (Scenario 3)

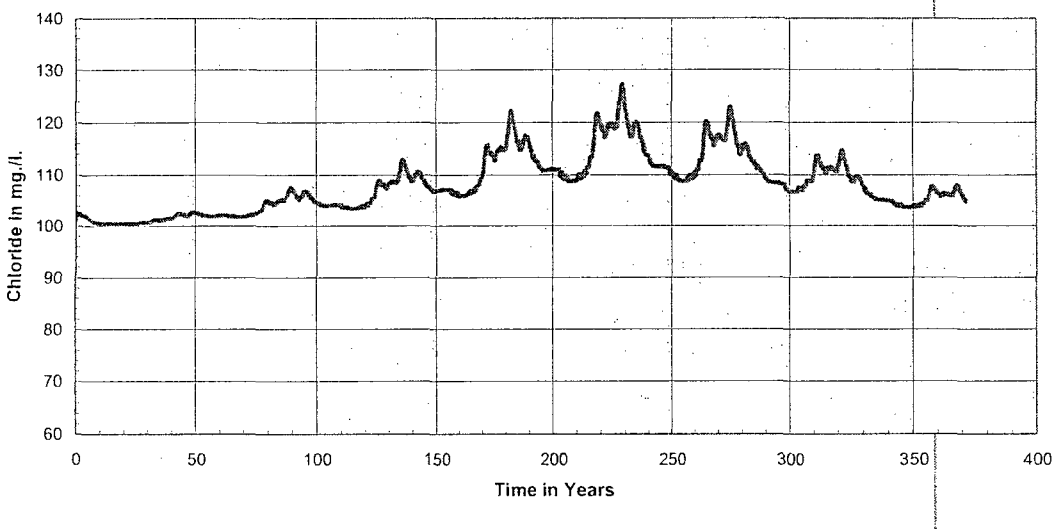
to ground water quality (see Appendix A). Figure 5 presents the result of this simulation showing that the chloride mass enters ground water through a diminished flux because of lowered infiltration. Ground water chloride concentrations are increased less than 30 ppm above background concentrations (100 ppm).

Figure 5. Chloride Concentration in the Aquifer for I-29 EOL with a Clay Cap v. Time, (Scenario 4)

R. T. Hicks Consultants recommends that ROC remove the upper 4-feet of soil at this site and replace this with 1-foot of clay and 3-feet of top fill installed with a slight crown to promote surface runoff (Scenario 4). The maximum predicted chloride concentration in ground water is represented in Figure 5.

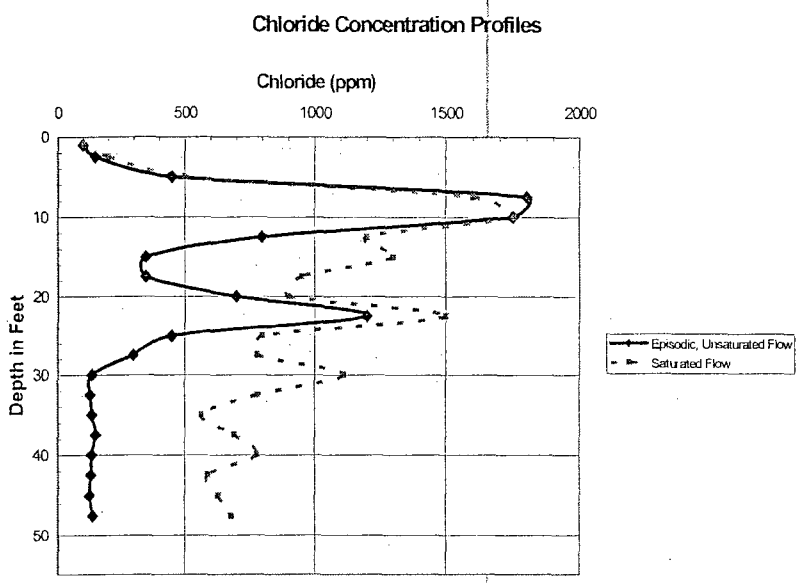
Figure 1. Schematic representations of field chloride analyses that are common for the two different release scenarios.

In the absence of vadose zone saturation, the arid climate of New Mexico creates such a low flux to ground water that one can observe sequestration of the constituents of concern in the upper vadose zone (10-20 feet below land surface) for many years. Borehole data from these types of releases show high concentrations of chloride below the release site and a relatively sharp decline in chloride concentration to background conditions with depth. If the release is not recent, natural processes can reduce the concentrations of any residual hydrocarbons and eliminate any environmental risk to ground water. Figure 1 presents schematic representations of field chloride analyses that are common for saturated and unsaturated release scenarios.

In summary, sites where chloride or other constituents of concern penetrated deep into the vadose zone probably experienced long-term releases of relatively large volumes of water; or crude was not released with the water and the filling of soil pores with asphaltic material did not occur. Where penetration of the vadose zone was less than 20-30 feet, the release was episodic and consisted of a relatively small volume of fluid.

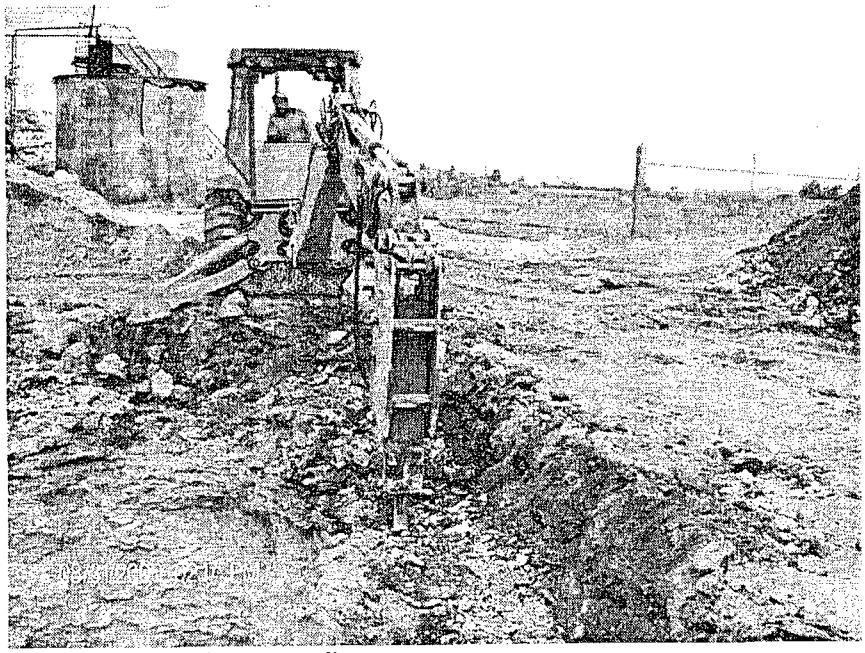
Figure 1: Excavating east wall

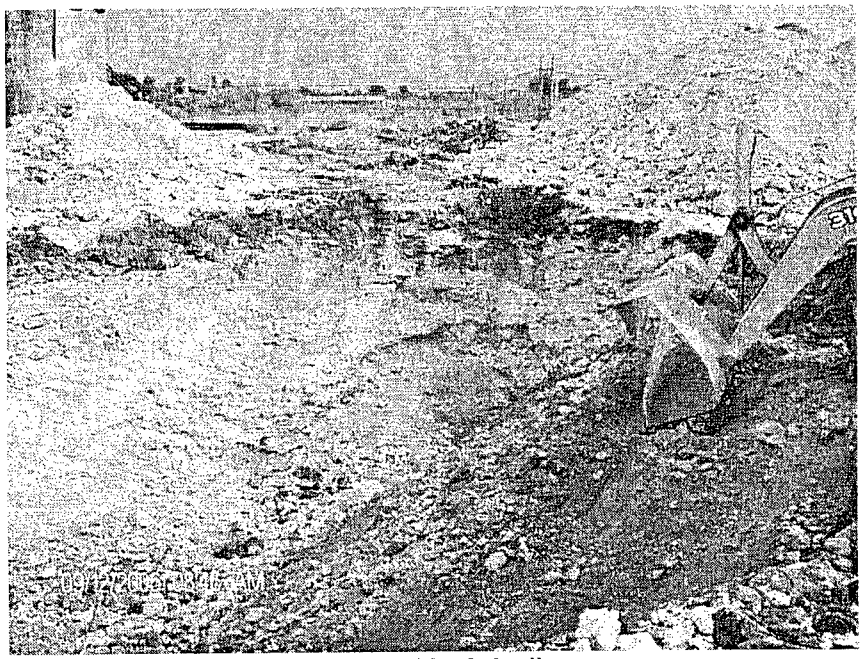
Figure 3: Backfilling excavation with blended soil

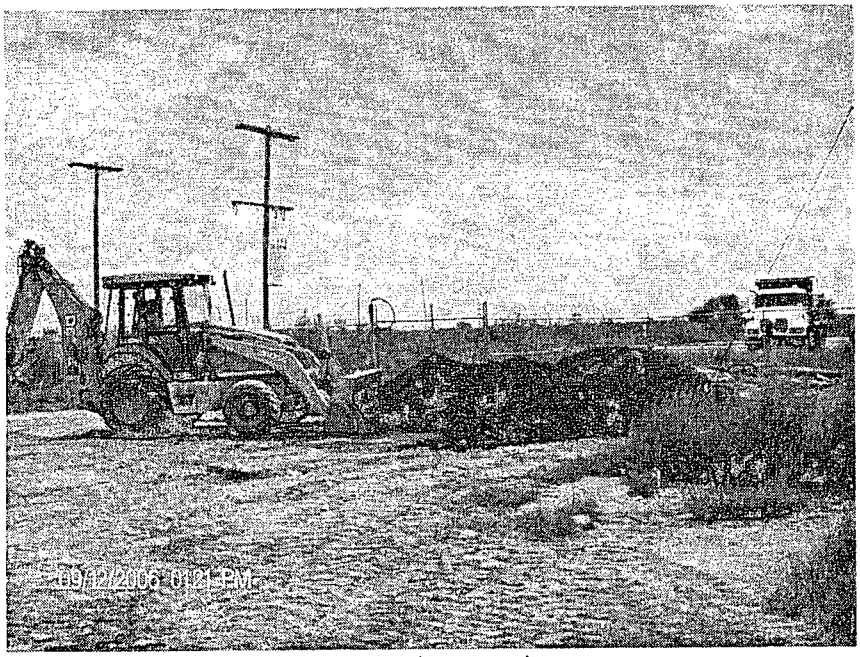
Figure 4: Loading clay for placement in excavation

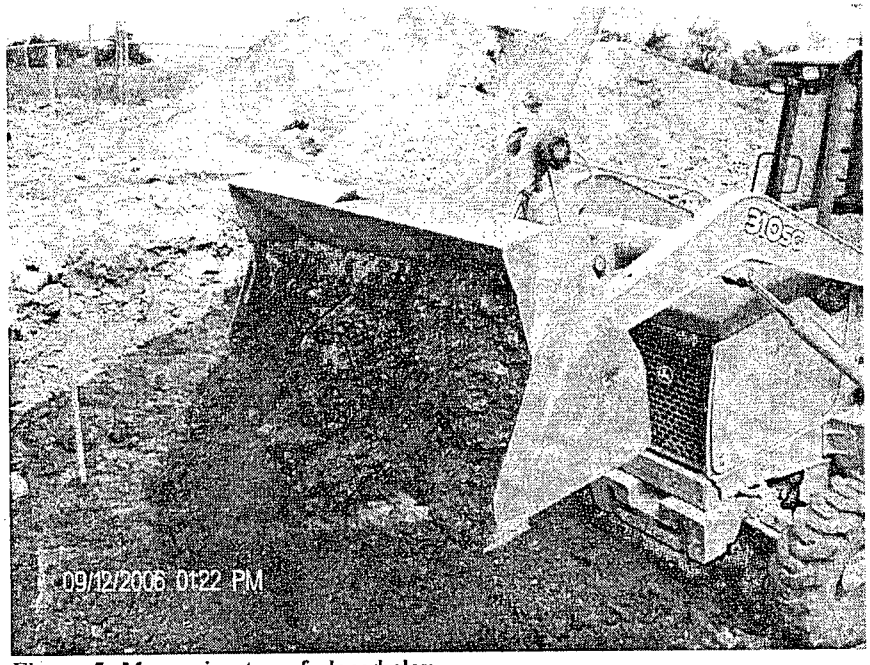
Figure 5: Measuring top of placed clay

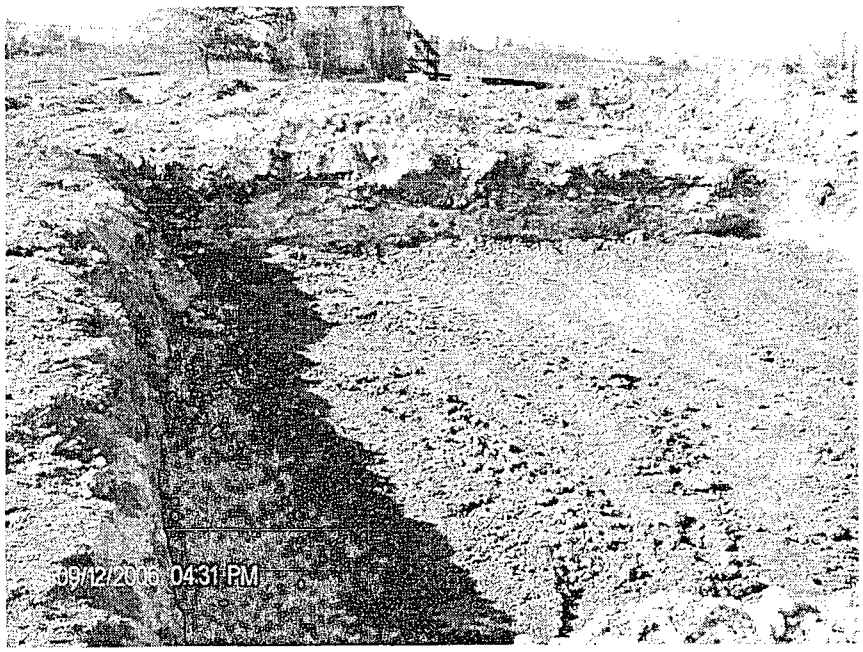
Figure 8: Clay placed in excavation

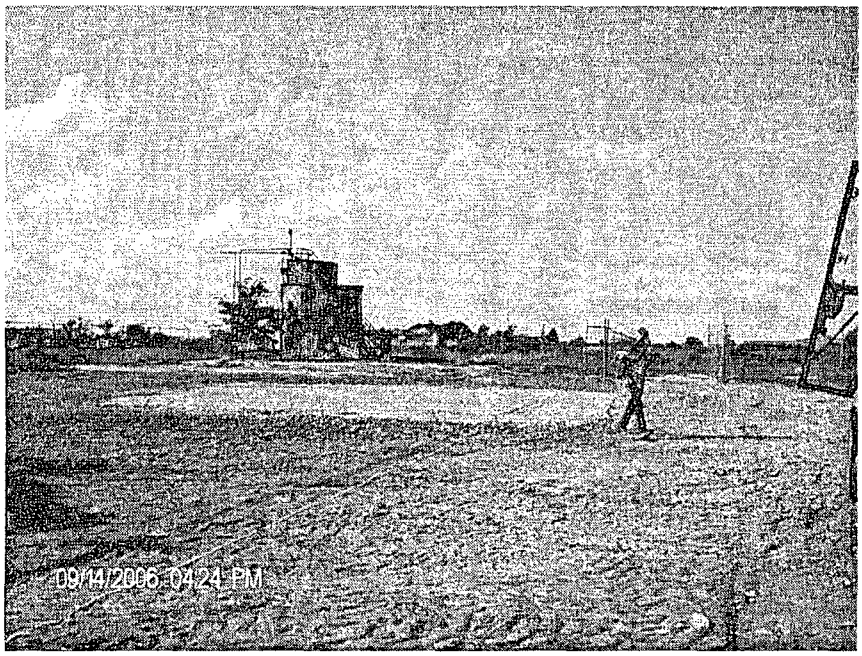
Figure 10: Completed barrier with caliche cap

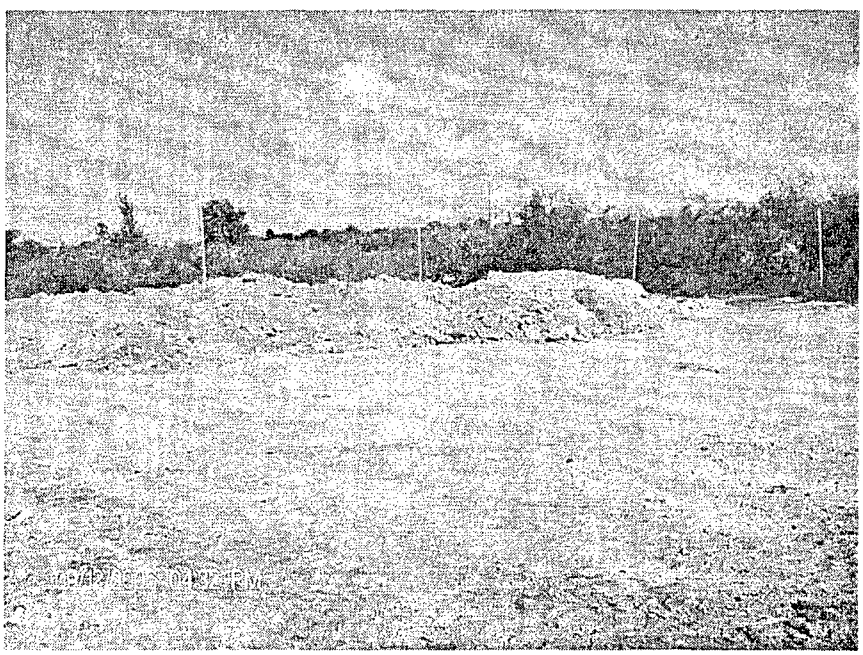
Figure 11: Segrated material for disposal
