3R113

ANNUAL GROUNDWATER REPORT

2007

HANEY GAS COM B #1E
(M) SECTION 20 – T29N – R10W, NMPM
SAN JUAN COUNTY, NEW MEXICO

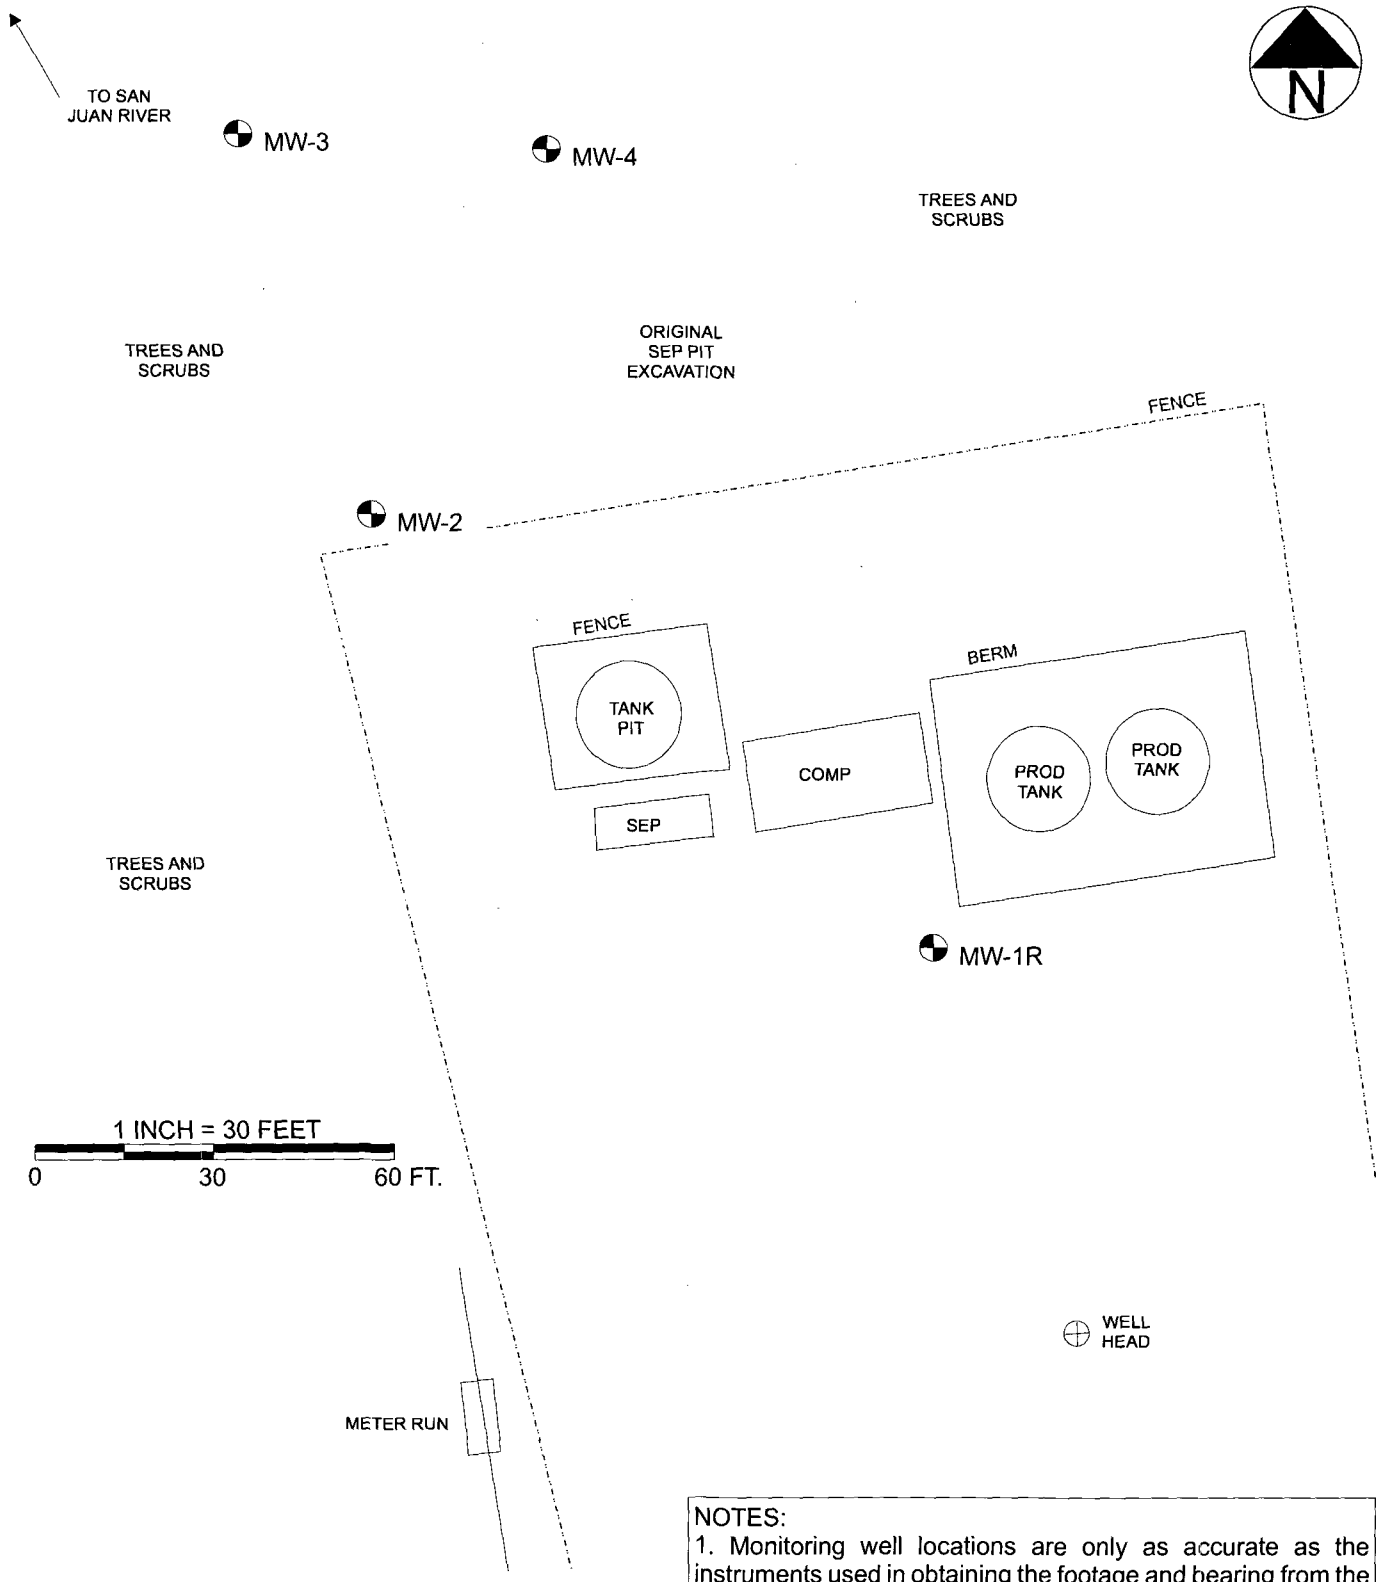
Lodestar Services, Inc PO Box 3861 Farmington, NM 87499	HANEY GAS COM #1E SW/4 SW/4 SEC. 20, T29N, R10W SAN JUAN COUNTY, NEW MEXICO	PROJECT: XTO GROUND WATER DRAWN BY: ALA REVISED: 01/24/07	FIGURE 1 SITE MAP

A site map is presented as Figure 1.

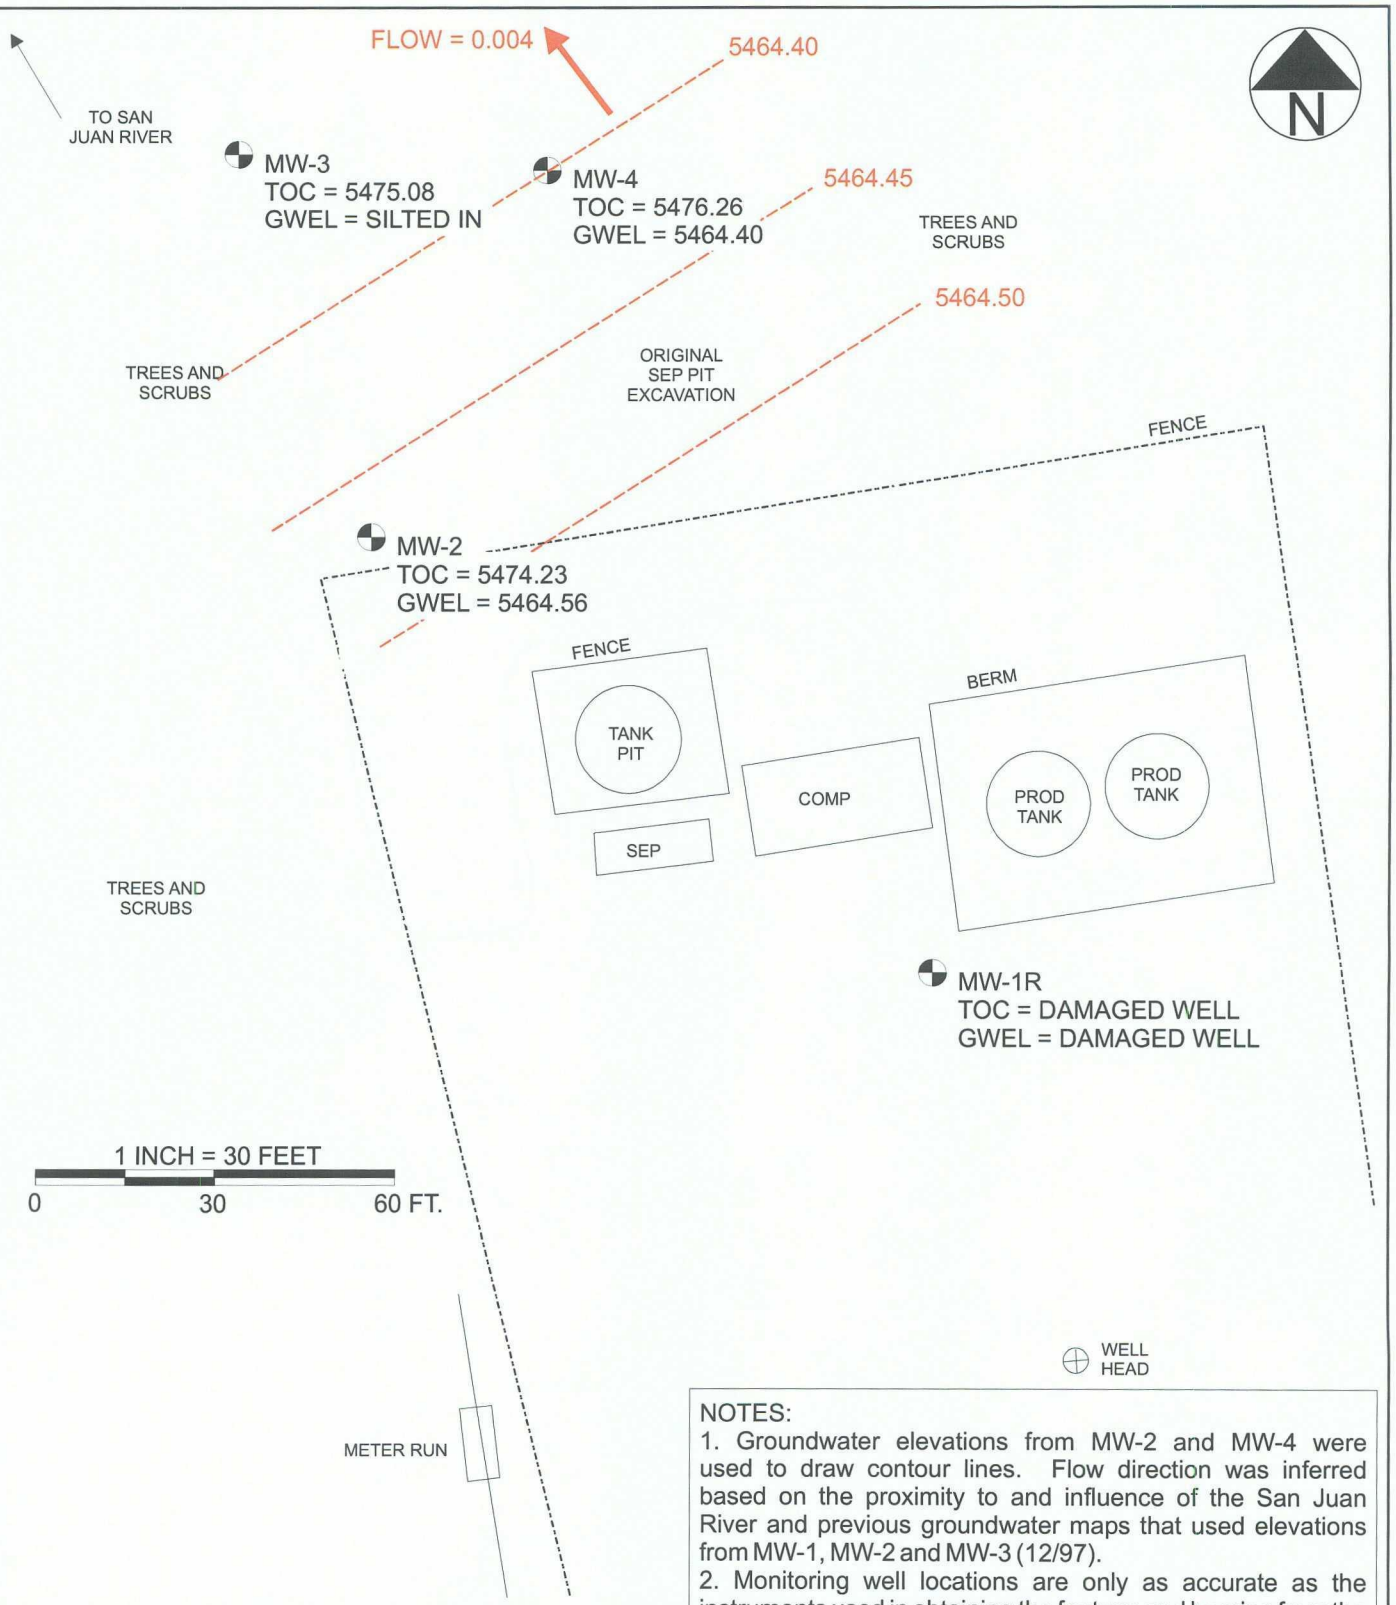
Lodestar Services, Inc PO Box 3861 Farmington, NM 87499	HANEY GAS COM #1E SW/4 SW/4 SEC. 20, T29N, R10W SAN JUAN COUNTY, NEW MEXICO	PROJECT: XTO GROUND WATER DRAWN BY: ALA REVISED: 12/04/06	GROUNDWATER GRADIENT MAP FIGURE 2 09/26/2006

Field data collected during site monitoring activities indicate a groundwater gradient that trends towards the north with a northwest component. Figures 2 - 4 illustrate the estimated groundwater gradients for 2006 and 2007.

1. Groundwater elevations from MW-2 and MW-4 were used to draw contour lines. Flow direction was inferred based on the proximity to and influence of the San Juan River and previous groundwater maps that used elevations from MW-1, MW-2 and MW-3 (12/97).
2. Monitoring well locations are only as accurate as the instruments used in obtaining the footage and bearing from the well head (Brunton Compass and Laser Range Finder). All other structures displayed on the site map are solely for reference and may not be to scale.

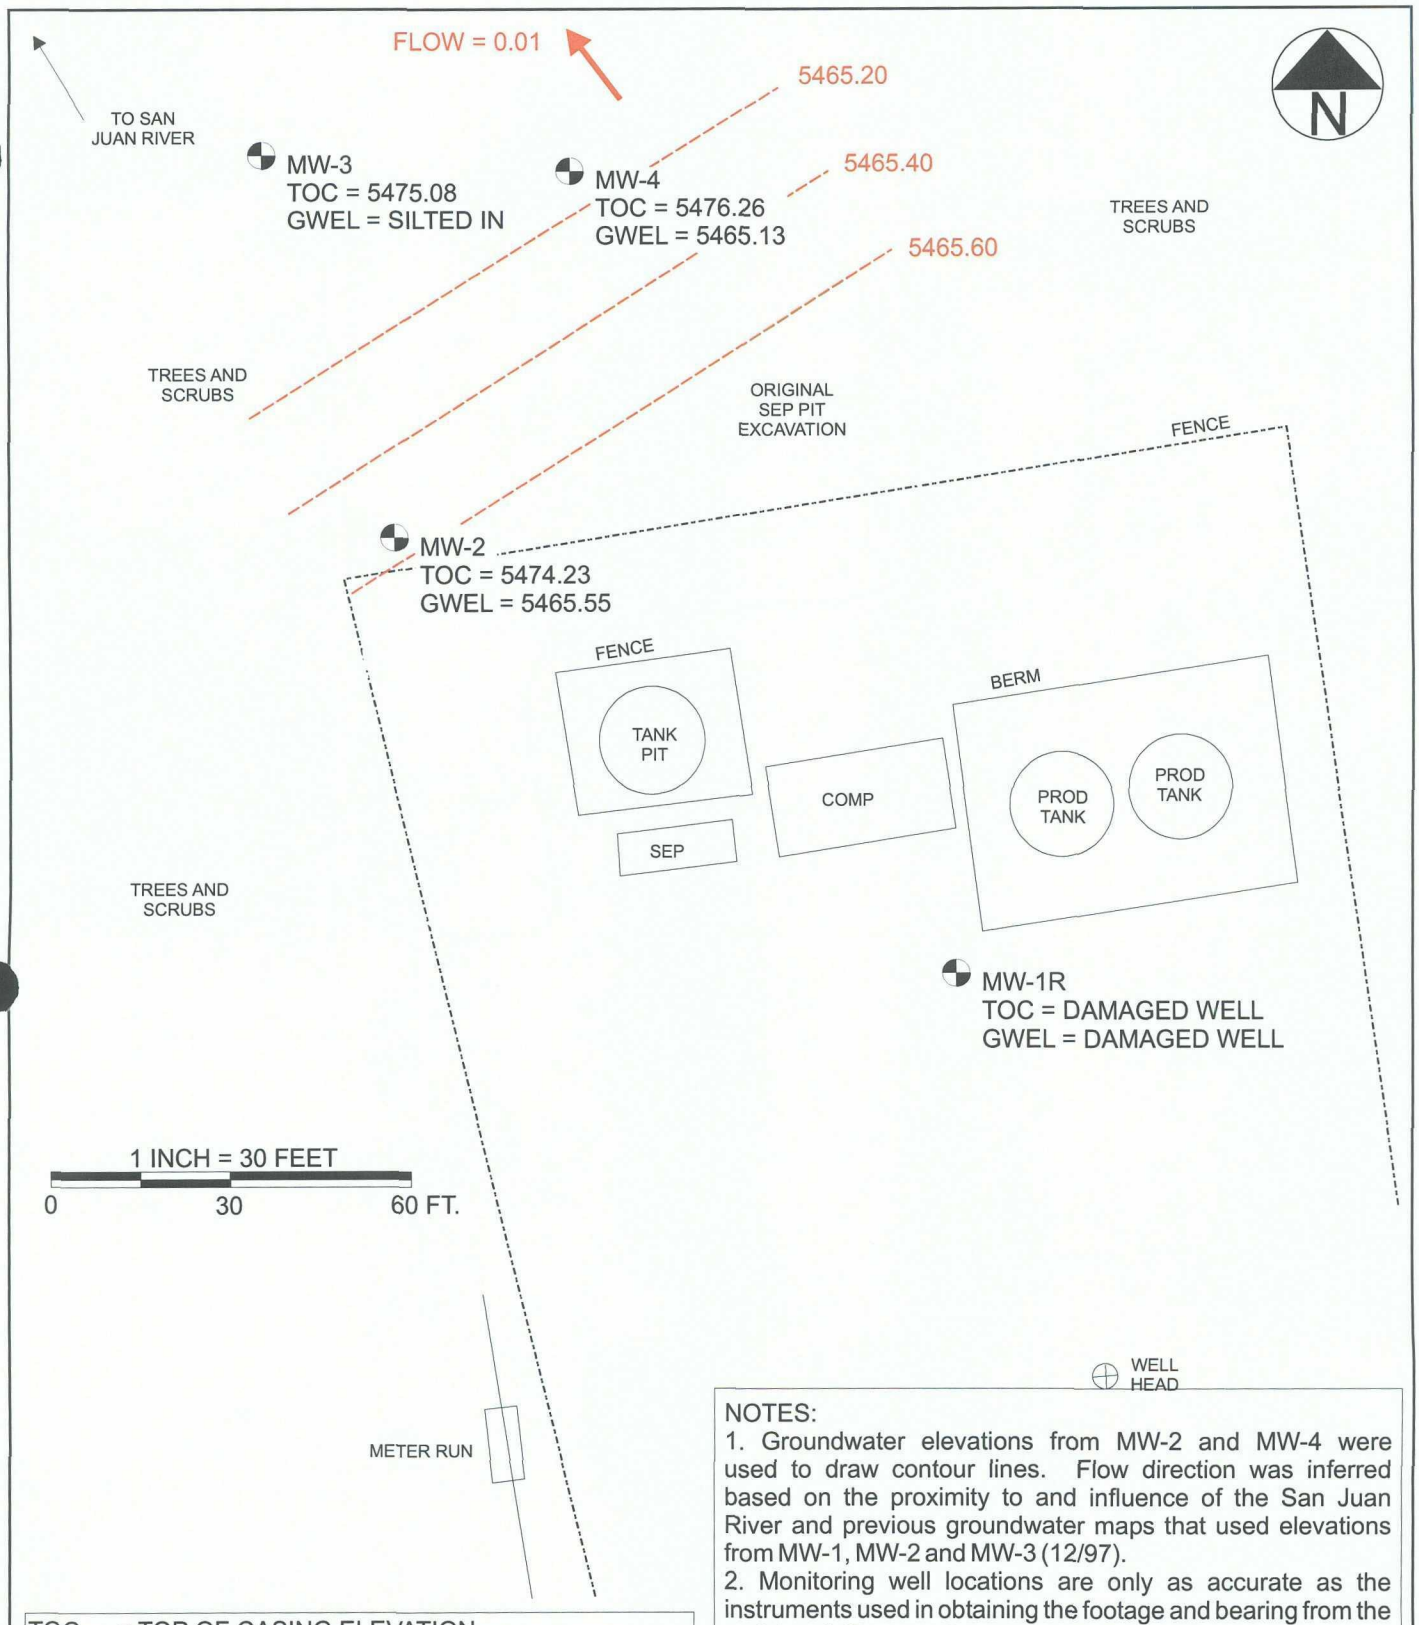
Lodestar Services, Inc PO Box 3861 Farmington, NM 87499	HANEY GAS COM #1E SW/4 SW/4 SEC. 20, T29N, R10W SAN JUAN COUNTY, NEW MEXICO	PROJECT: XTO GROUND WATER DRAWN BY: ALA REVISED: 01/05/07	GROUNDWATER GRADIENT MAP FIGURE 3 12/06/2006

1. Groundwater elevations from MW-2 and MW-4 were used to draw contour lines. Flow direction was inferred based on the proximity to and influence of the San Juan River and previous groundwater maps that used elevations from MW-1, MW-2 and MW-3 (12/97).
2. Monitoring well locations are only as accurate as the instruments used in obtaining the footage and bearing from the well head (Brunton Compass and Laser Range Finder). All other structures displayed on the site map are solely for reference and may not be to scale.

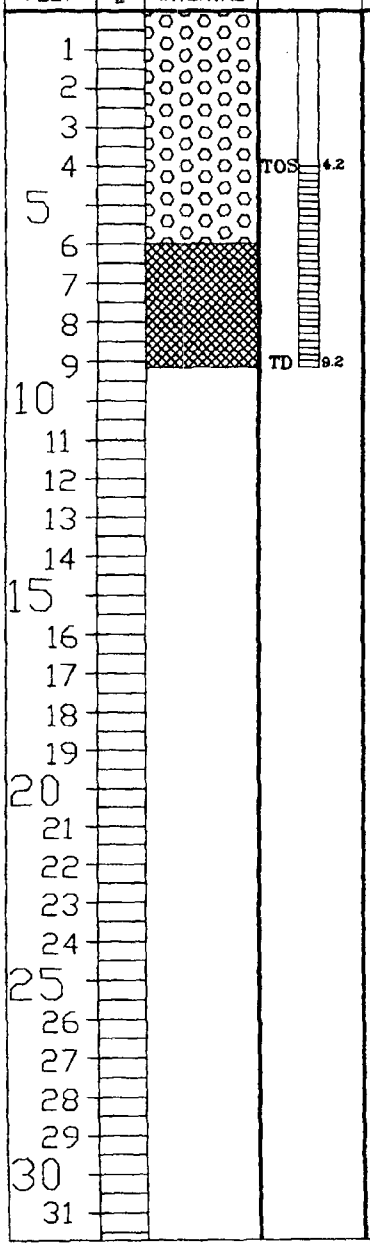
FIGURE 5

DARK YELLOWISH BROWN SAND AND GRAVEL, NON COHESIVE, SLIGHTLY MOIST, LOOSE TO FIRM, NO APPARENT HYDROCARBON ODOR DETECTED (0.0 - 6.0 FT. INTERVAL).

▼ GW DEPTH ON 12/18/97 = 5.95 FT. (APPROX.) FROM GROUND SURFACE.

DARK GRAY SILTY SAND & GRAVEL, NON COHESIVE, SLIGHTLY MOIST, LOOSE TO FIRM, NO APPARENT HYDROCARBON ODOR DETECTED (6.0 - 9.2 FT. INTERVAL).

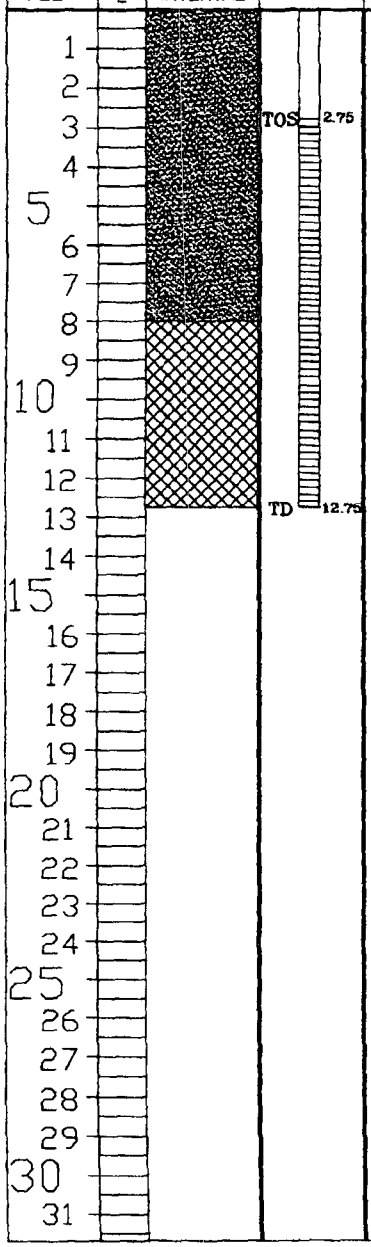
FIGURE 6

DARK YELLOWISH BROWN SAND, NON COHESIVE, SLIGHTLY MOIST, LOOSE TO FIRM, NO APPARENT HYDROCARBON ODOR DETECTED (0.0 - 8.0 FT. INTERVAL).

▼ GW DEPTH ON 12/18/97 = 6.82 FT. (APPROX.) FROM GROUND SURFACE.

LIGHT GRAY SILTY SAND & GRAVEL, NON COHESIVE, SLIGHTLY MOIST, LOOSE TO FIRM, NO APPARENT HYDROCARBON ODOR DETECTED (8.0 - 12.75 FT. INTERVAL).

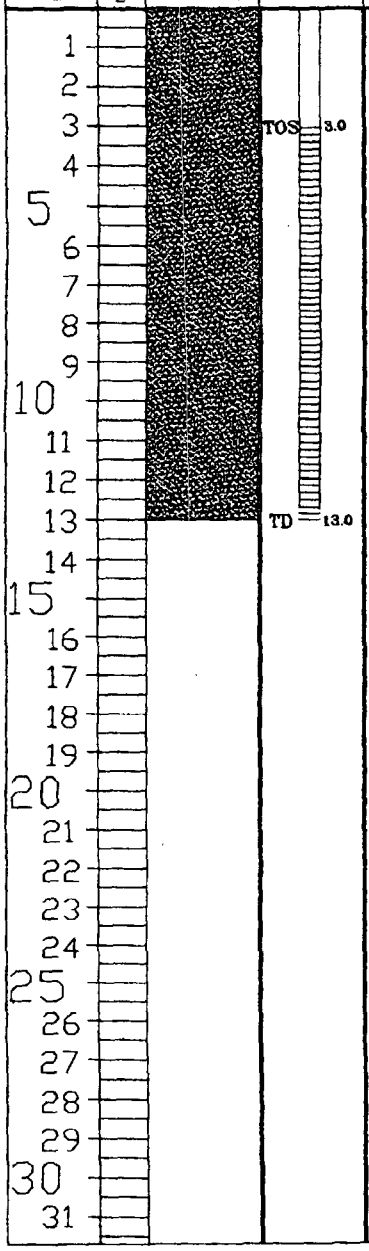
FIGURE 7

DARK YELLOWISH BROWN SAND THROUGHOUT ENTIRE BORING, NON COHESIVE, SLIGHTLY MOIST, LOOSE TO FIRM, NO APPARENT HYDROCARBON ODOR OR DISCOLORATION DETECTED (0.0 - 13.0 FT. INTERVAL).

▼ GW DEPTH ON 12/18/97 = 8.34 FT. (APPROX.) FROM GROUND SURFACE.

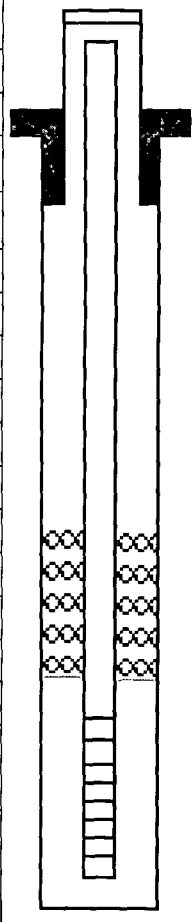
FIGURE 9
MONITORING WELL INSTALLATION RECORD

Cannot install bumper posts b/c of cobbles. Will flag protective casing.

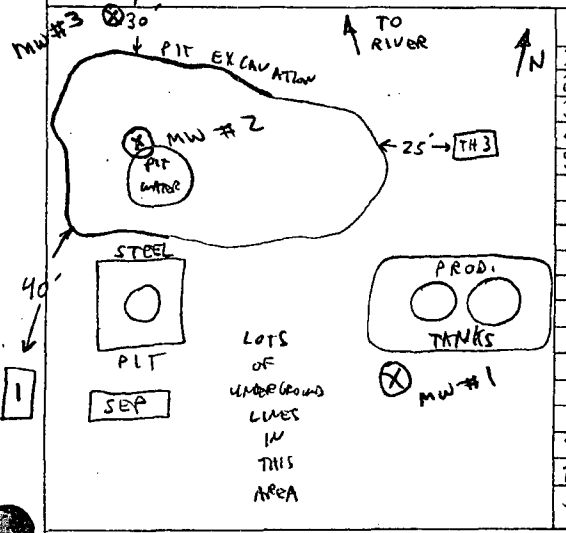
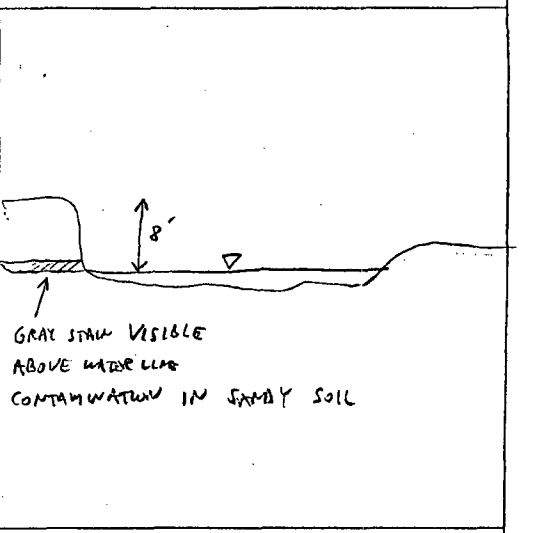
SOIL MIXTURE OF SAND - SILT - CLAY - COBBLE - EXCAVATED INTO GROUNDWATER ~ 1-2' GRAY STAINED SOIL ABOVE WATER TABLE. PIT HAS BEEN PUMPED - NEED TEST HOLES DUG.
TH1 ENCOUNTERED DARK GRAY CONTAMINATED SOIL @ 3.5' - GROUNDWATER AT 8' - HEAVY ODOR - NO SAMPLE COLLECTED.
TH2 " " " " " @ 7' - GROUNDWATER AT 10' - HEAVY ODOR - NO SAMPLE.
TH3 SILTY SILTY OVER SAND - LIGHT GRAY / BROWN - SAMPLE OF G.W. COLLECTED
ADDITIONAL EXCAVATION WILL BE DONE. TH4=55' WEST OF STEEL PIT (20' WEST OF EXCAVATION)
