JR Phillips
NMOCD Case #: 1R-427163

Corrective Action Plan

R.T. Hicks Consultants, Ltd.
901 Rio Grande Blvd. NW, Suite F-142
Albuquerque, NM 87104

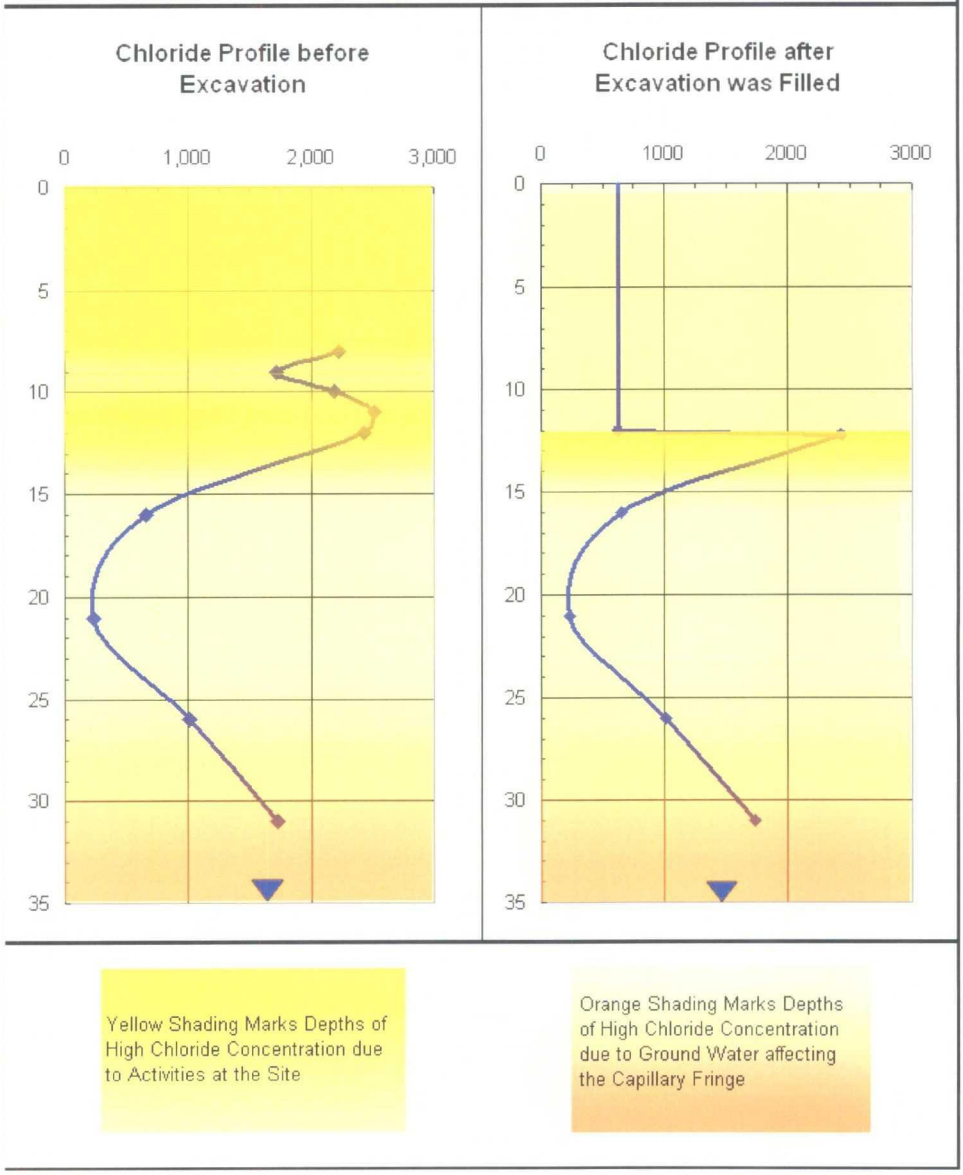
Figure 2: Chloride Profiles at the Center of the Former JR Phillips Junction Box (SB-1)

Figure 2 shows chloride concentrations versus depth at the center of the former junction box before the excavation to a depth of 12 feet. Also shown on Figure 2 is the chloride concentration profile that exists at present after filling the excavation with blended fill material (624 mg/kg). Chloride concentration data is from field and laboratory data.

Superimposed on the graphs are transparent shadings varying in intensity with chloride concentration. The yellow shading represents chloride from activities at the site in the upper vadose zone. The orange shading represents chloride in the capillary fringe connected with ground water.

Between these two depth intervals, chloride concentrations decrease from 663 mg/kg (16-feet) to 227 mg/kg at the depth of 21 feet. These low chloride concentrations demonstrate that produced water (which exhibits chloride concentrations in excess of 30,000 mg/L, based upon ROC data) has not migrated through this depth interval and therefore has not entered ground water. Saturated flow of produced water through the vadose zone always leaves a "footprint" of chloride concentrations that typically exceed 1500 mg/kg (see Appendix B).

Below the depth of 21 feet, chloride concentration increases to 1,730 mg/kg at a depth of 31 feet. The water table has risen about 6 feet from 2004 to 2006 at nearby monitoring wells and is now about 35 feet below ground surface. With the accompanying rise of the capillary fringe (the saturated vadose zone connected to ground water), the chloride concentrations in the sample at 31 feet, which we believe is near the capillary fringe, is about twice the chloride concentration measured in ground water.

However, the ground water samples are from wells with a minimum of ten feet of screen below the water table; and are therefore, composite samples over this depth interval. About 900 feet to the southeast is a water well with the top of its 40-foot screen set ten feet below the water table. Groundwater samples from this well have chloride concentrations less than one-fifth that of the monitoring wells, and are representative of this screened interval. These facts suggest that chloride concentration in ground water is higher near the water table and lower near the bottom of the aquifer. Within the ground water-vadose zone interface, the well data and the soil samples suggest that chloride concentration may be about twice that of samples from the monitoring wells. Therefore, chloride concentrations in the capillary fringe are a result of connection with ground water (see Appendix B).

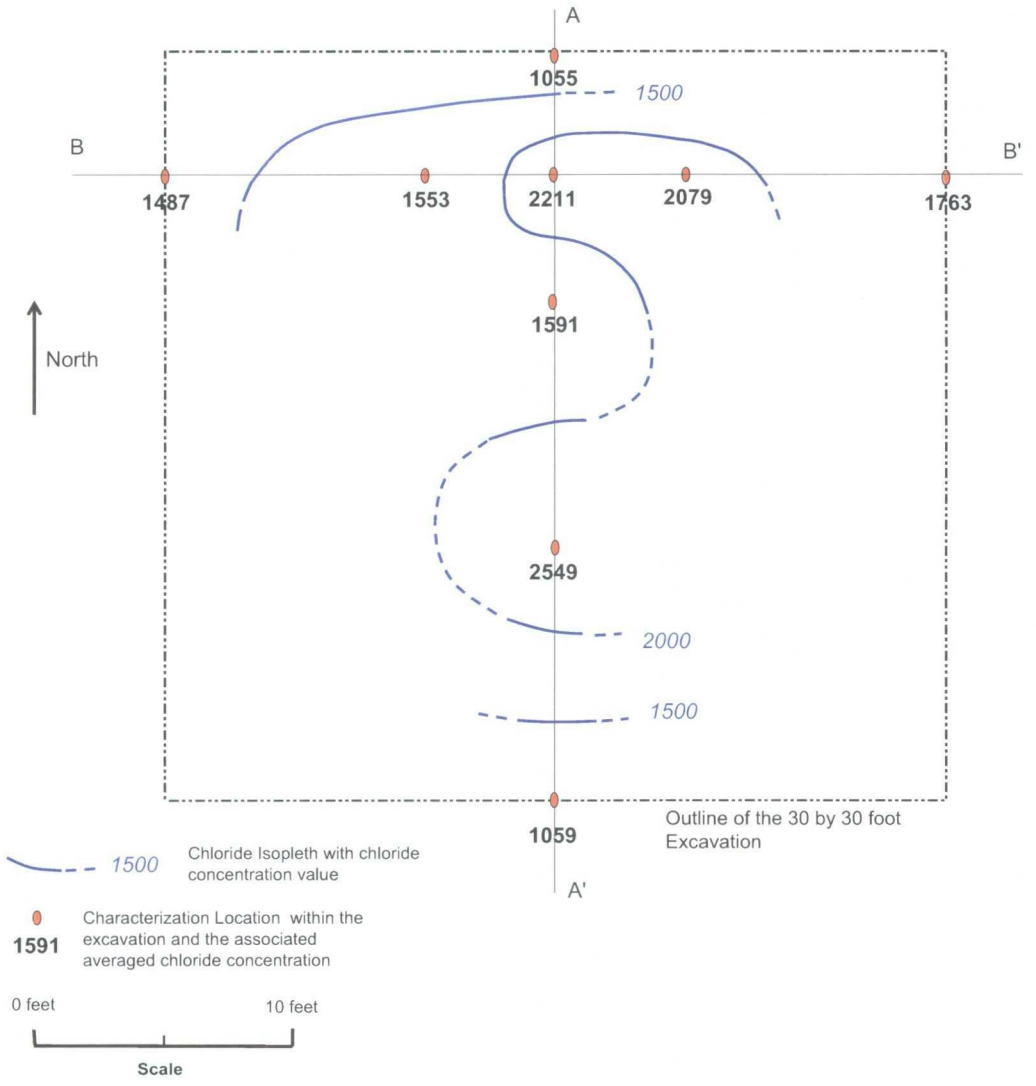
R.T. Hicks Consultants, Ltd 901 Rio Grande Blvd NW Suite F-142 Albuquerque, NM 87104 505-266-5004	JR Phillips Site	Plate 4
		May, 2008

Plate 4 shows the excavated area centered over the EOL and the locations of the characterization trenches. Plotted with each trench is the averaged chloride concentration of the samples obtained at depths of 8, 9, 10, 11, and 12 feet. Isoplaths (contours of constant chloride concentration) are plotted using these data.

1) Chloride concentrations are greater than or equal to 1,000 mg/kg at the edges of the excavation.
2) Regardless of direction and local topography, none of the averaged chloride concentrations decline below 1,000 mg/kg at the edge of the excavated area.
3) The highest chloride concentration encountered is 15 feet south of the junction box (deep vadose chloride concentrations are higher in SB-2 than in SB-1)

1) Because the averaged chloride concentrations do not materially decline below 1,000 mg/kg with distance or direction from the EOL, the EOL is not the source of the

1000 mg/kg or greater average chloride concentration observed at the edges of the excavated area.

2) The EOL is the source of chloride where ispleths show concentrations greater than 2000 mg/kg. The geometry of the hypothesized 2000 mg/kg isopleths shown in Plate 4 is consistent with a small surface depression near the EOL.

Isoplath Map of Chloride Concentrations at JR Phillips Site. Chloride Concentrations from the 8, 9, 10, 11, and 12 foot depths are averaged and contoured.	Client: Rice Operating Company Project Name: JR Phillips Site	Location: Section 6, T20S, R37E

Hicks Consultants recommends that ROC re-vegetate a 50-foot by 50-foot area centered over the former excavation at the EOL site to reduce infiltration. This remedy is protective of ground water quality, human health, and the environment. Upon documentation of this action, a closure report/request will be submitted to NMOCD.

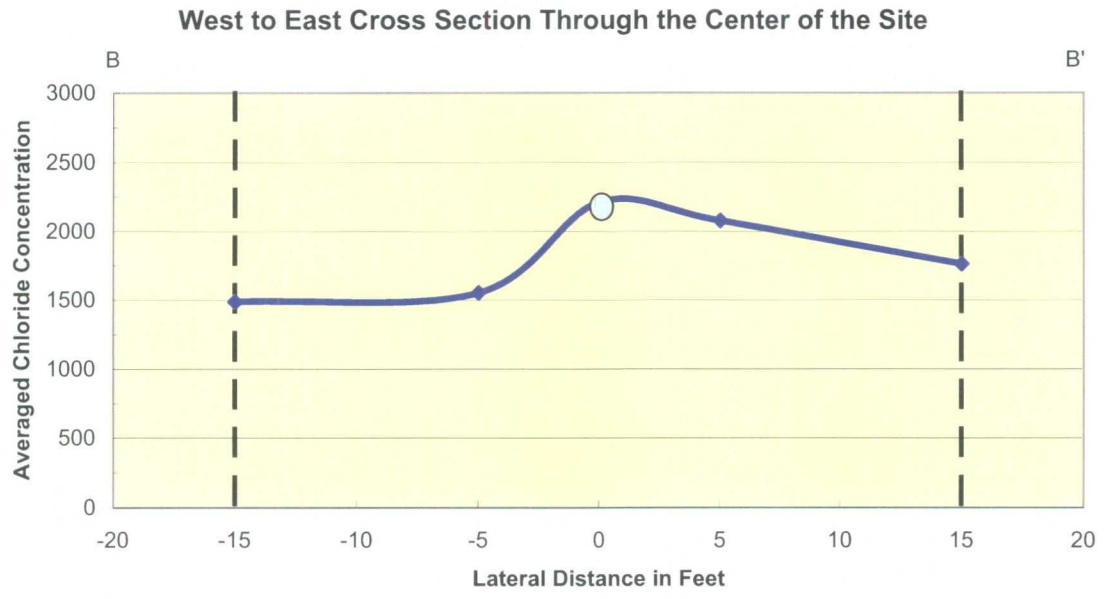
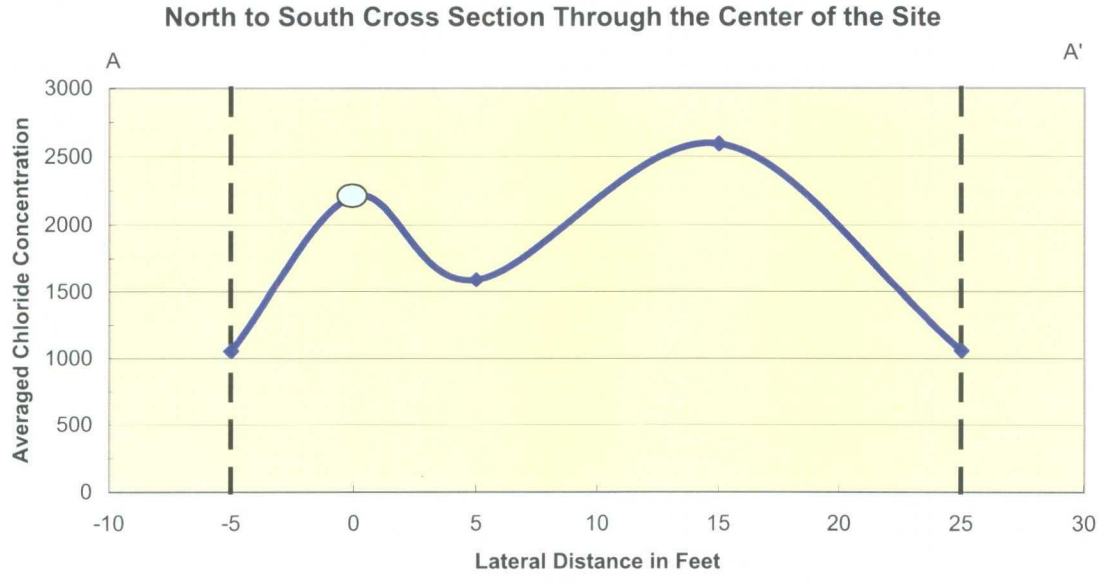
R.T. Hicks Consultants, Ltd 901 Rio Grande Blvd NW Suite F-142 Albuquerque, NM 87104 505-266-5004	**JR Phillips Site**	**Plate 5** **May, 2008**

Plate 5 presents North-South and East-West cross-sections through the center of the site. Averaged chloride concentrations are shown plotted against lateral distance from the center of the site (placed at (0, 0)). The vertical dashed lines show the limits of the excavated area from the center of the site.

Averaged chloride concentrations (from 8, 9, 10, 11, and 12 foot depths at each location) plotted by distance from the center of the site. Dashed lines mark the limits of the excavation.	**Client:** Rice Operating Company **Project:** JR Phillips Site	**Location:** Section 6, T20S, R37E

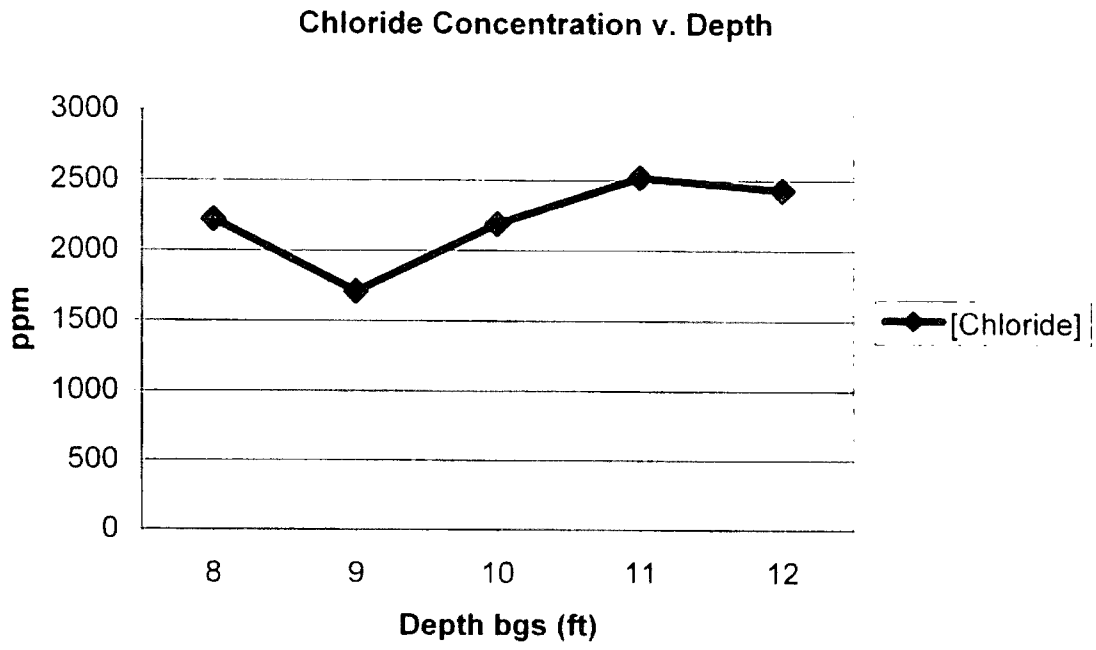
Vertical Delineation at Source

Depth bgs (ft)	[Cl⁻] ppm
8	2219
9	1709
10	2189
11	2519
12	2429

Groundwater = 35 ft

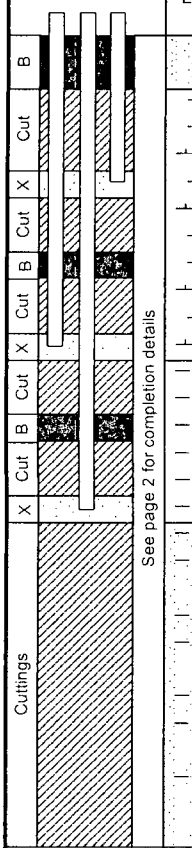
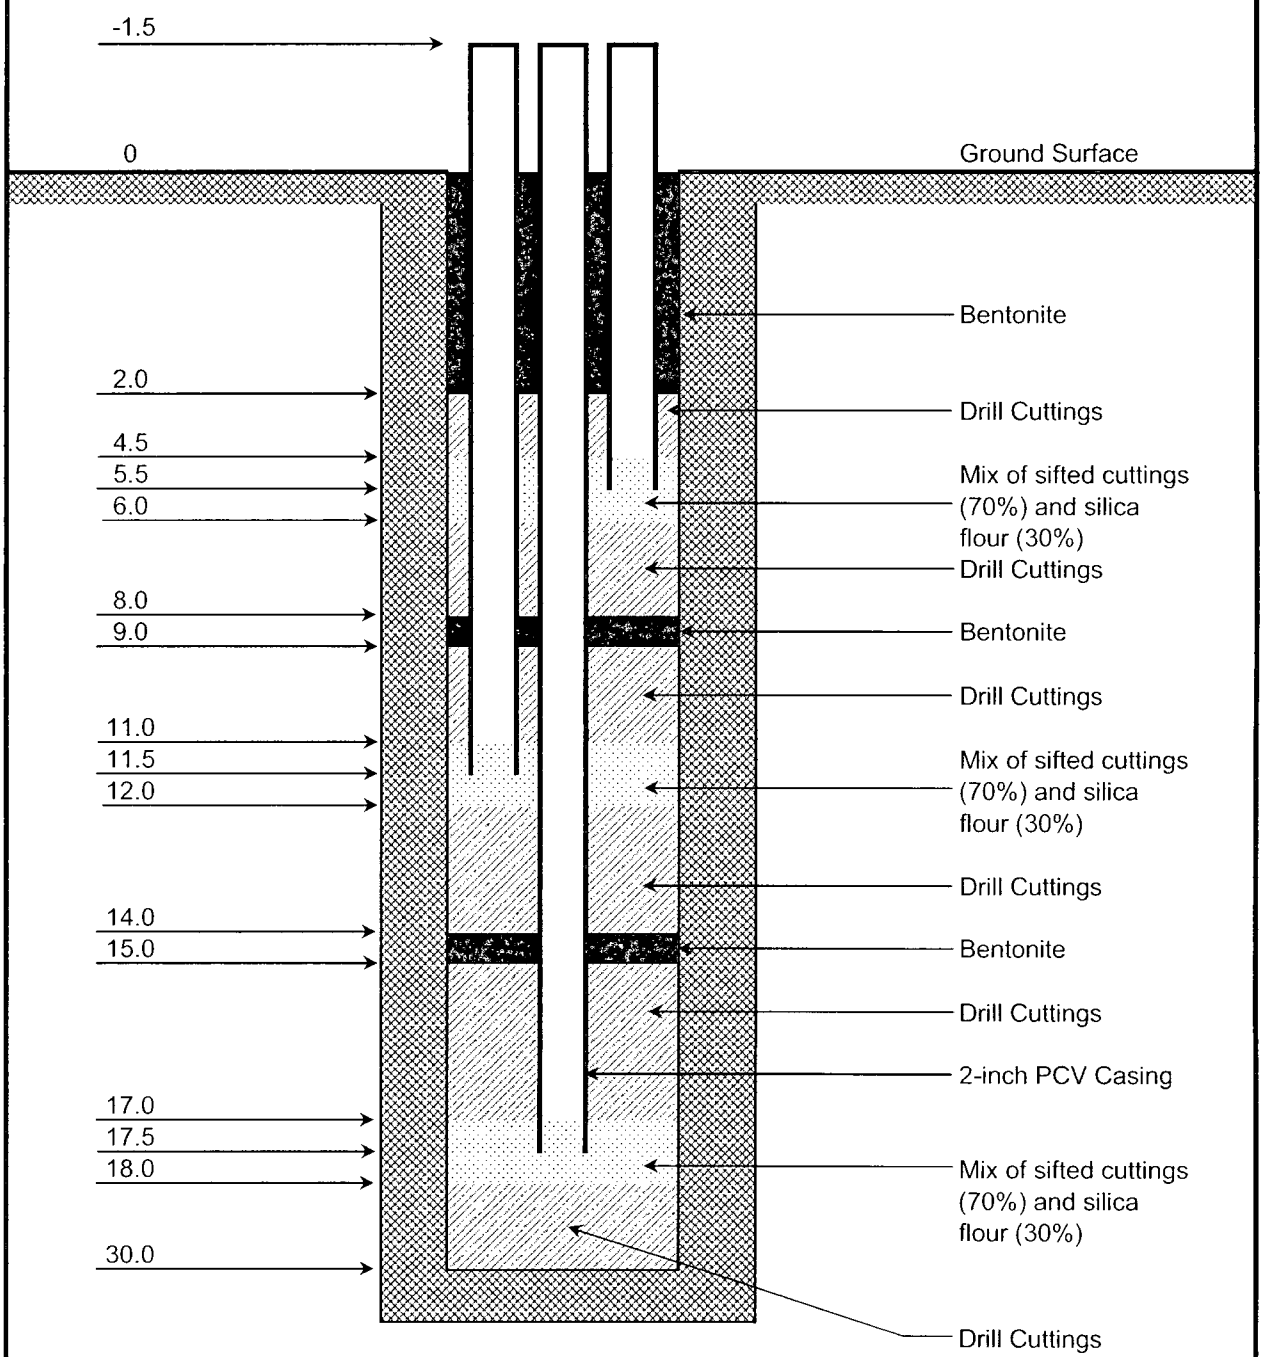
R T Hicks Consultants Ltd	SITE: ROC EME SWD JR Phillips		**Soil Boring SB-2**
	DATE: 12/21/07	REV. NO.: 1	
	AUTHOR: DTL	TECH: DTL	
	DRILLER: H & C	FILE: \Lithlog 12-07

Depth	Samples Type	Cl (fld)	PID	LITHOLOGIC DESCRIPTION: LITHOLOGY, COLOR, GRAIN SIZE, SORTING, ROUNDING, CONSOL., DIST. DEATURES
				SAND Brown, fine grain, well sorted, angular.
5	excav	3,059	0	SILT AND CALICHE Brown to grayish brown (fill material).
	excav	2,609	0	
10	excav	2,579	0	
	excav	2,219	0	
	excav	2,279	0	
15	cut	700	--	SILT Light brown with some caliche and sand grains.
			--	
20	cut	418	--	SILTY SAND Brown to reddish brown, medium grain, poorly sorted, sub angular, 30% silt, decreasing with depth.
			--	
25	cut	480	--	
			--	
30	cut	629	--

TD = 30 Feet
