ANNUAL MONITORING REPORT

RE: REQUEST FOR PERMANENT CLOSURE
BP America Production Company (formerly Amoco Production Co.)
Groundwater Monitoring Report
Jacquez LS #3, UNIT D, SEC. 30, T30N, R8W, NMPM
San Juan County, New Mexico

GROUNDWATER REMEDIATION REPORT

JACQUEZ LS #3
(D) SECTION 30, T30N, R8W, NMPM
SAN JUAN COUNTY, NEW MEXICO

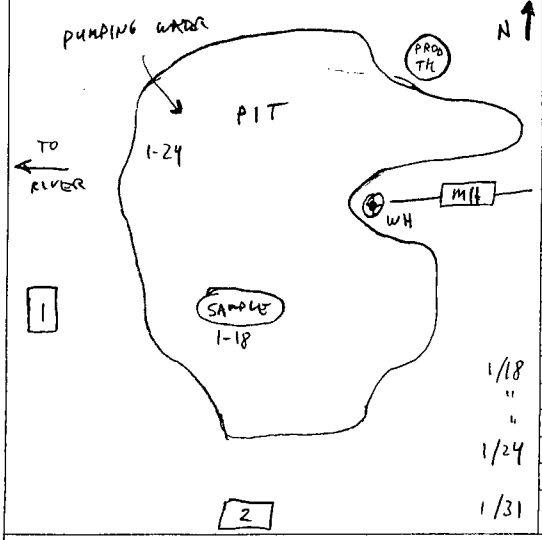
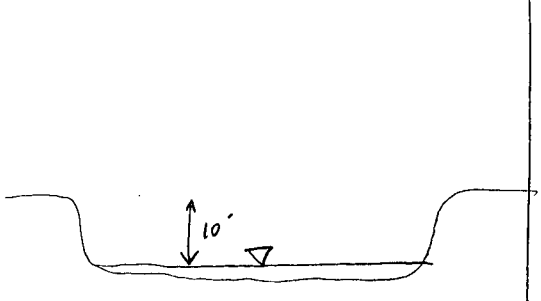
FIELD REPORT: PIT CLOSURE VERIFICATION

LARGE PIT EXCAVATION TO GROUNDWATER - SAND + COBBLE.
WATER SAMPLES COLLECTED FROM PIT + TWO TEST HOLES DOWN-GRADIENT
BUBBLING OBSERVED IN WATER NORTH OF WELL.
REMEDIATION SYSTEM INSTALLED AS PIT BACKFILLED TO REMEDIATE REMAINING CONTAMINATION IN GROUNDWATER AND AROUND WELLHEAD, METER HOUSE, AND PRODUCTION TANK.

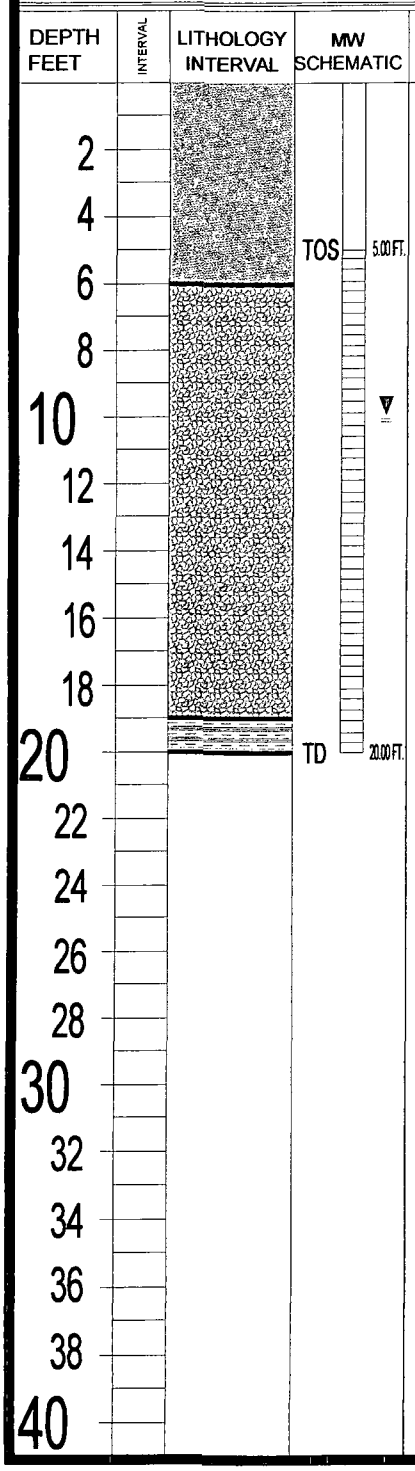
BORING #.....	BH - 1
MW #.....	1
PAGE #.....	1
DATE STARTED	8/1/07
DATE FINISHED	8/1/07
OPERATOR.....	DP
PREPARED BY	NJV

MODERATE YELLOWISH BROWN SAND, NON COHESIVE, SLIGHTLY MOIST, FIRM, NO APPARENT HYDROCARBON ODOR DETECTED PHYSICALLY WITHIN AUGER CUTTINGS (0.0 - 6.0 FT. BELOW GRADE).

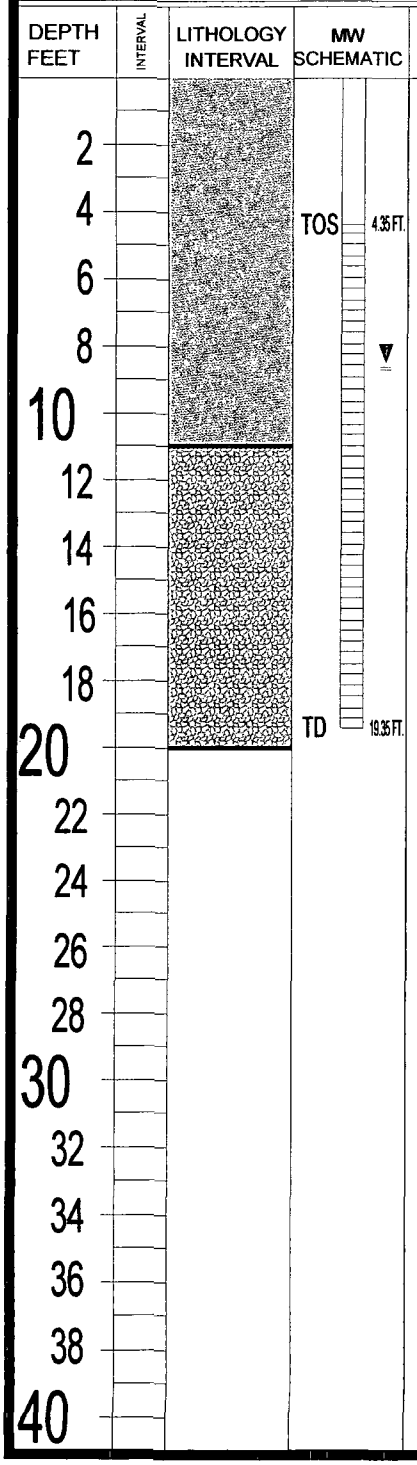
BORING #.....	BH - 2
MW #.....	2
PAGE #.....	2
DATE STARTED	8/1/07
DATE FINISHED	8/1/07
OPERATOR.....	DP
PREPARED BY	NJV

Soil lithology at the site consists of primarily coarse grained sand with varying size gravel, non cohesive, and firm. Grayish black sand and gravel mix with no apparent hydrocarbon odor was observed from the drill cuttings at an estimated 11-20 feet below grade within the source area boring only (MW #2).

MODERATE YELLOWISH BROWN SAND, NON COHESIVE, SLIGHTLY MOIST TO WET, FIRM, NO APPARENT HYDRO-CARBON ODOR DETECTED PHYSICALLY WITHIN AUGER CUTTINGS (0.0 - 11.0 FT. BELOW GRADE).

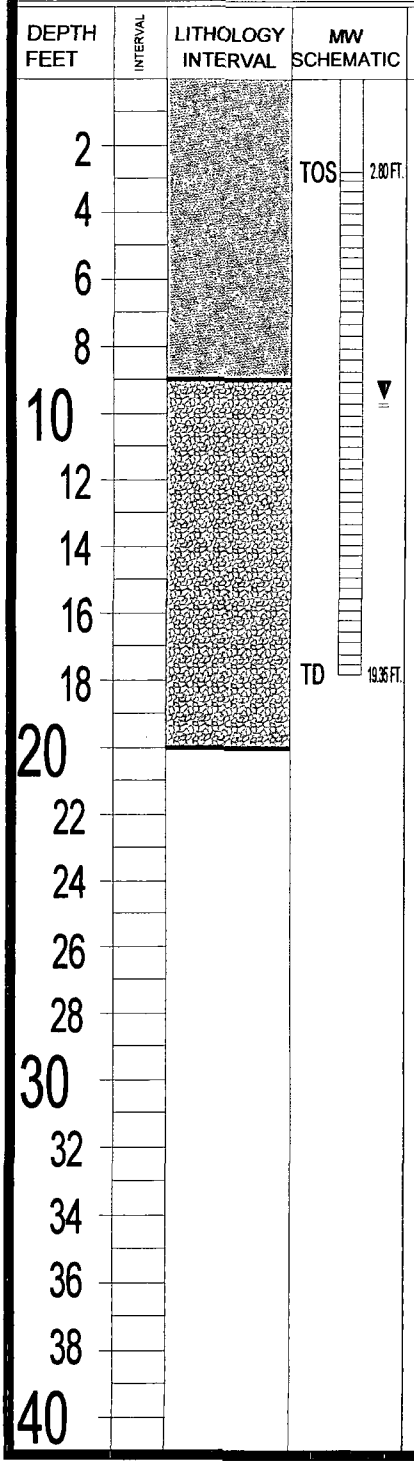
BORING #.....	BH - 3
MW #.....	3
PAGE #.....	3
DATE STARTED	8/1/07
DATE FINISHED	8/1/07
OPERATOR.....	DP
PREPARED BY	NJV

MODERATE YELLOWISH BROWN SAND, NON COHESIVE, SLIGHTLY MOIST TO MOIST, FIRM, NO APPARENT HYDRO-CARBON ODOR DETECTED PHYSICALLY WITHIN AUGER CUTTINGS (0.0 - 9.0 FT. BELOW GRADE).

MODERATE YELLOWISH BROWN SAND AND GRAVEL, NON COHESIVE, MOIST TO SATURATED, FIRM, NO APPARENT HYDROCARBON ODOR DETECTED PHYSICALLY WITHIN AUGER CUTTINGS (9.0 - 20.0 FT. BELOW GRADE).

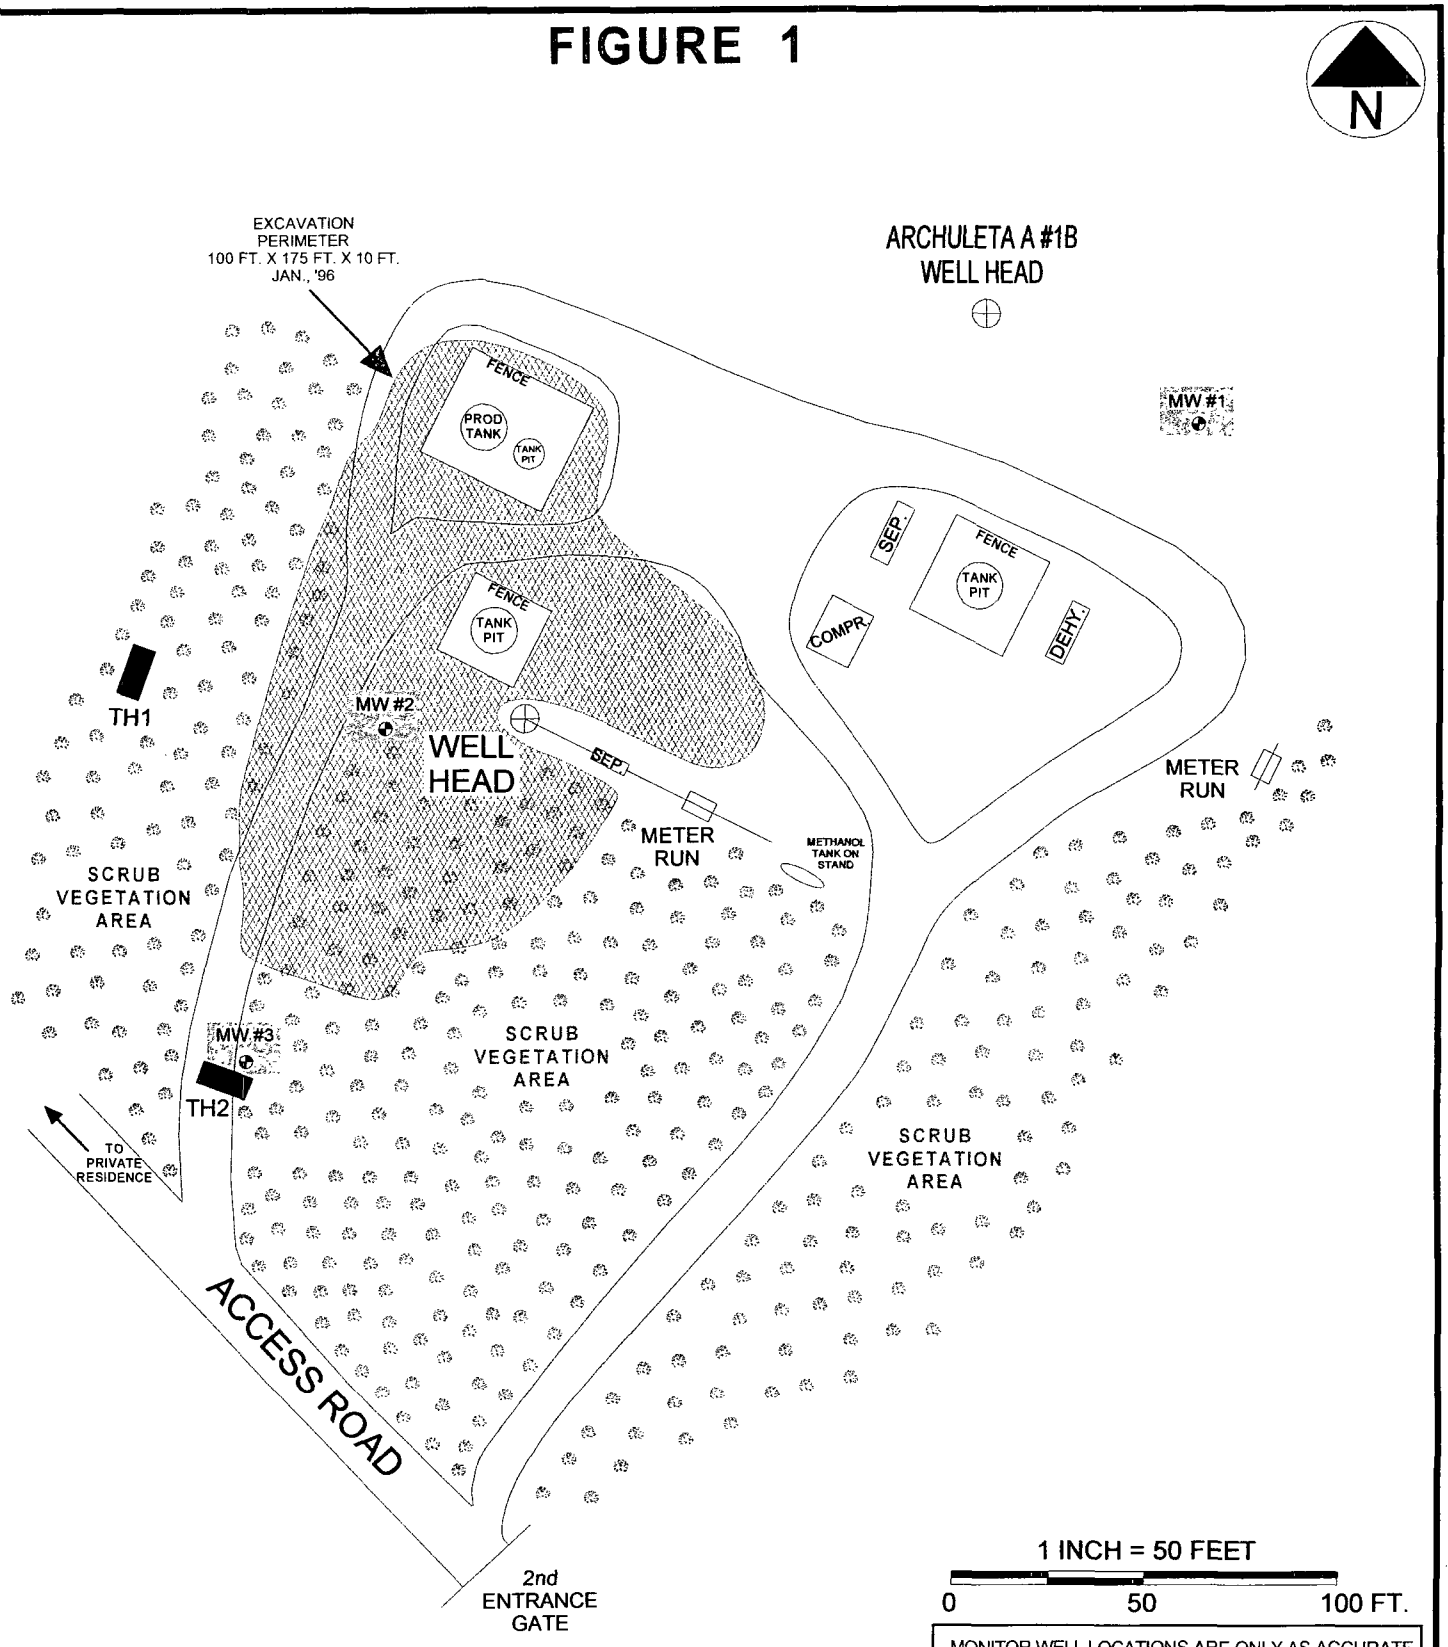
FIGURE 1

Groundwater monitor wells were installed in August 2007 to test groundwater quality (see Figure 1). Boring logs for all three (3) monitor wells along with well completion information are contained within this report. There are no known receptors impacted by the previous discovery of impacted soil and/or groundwater.

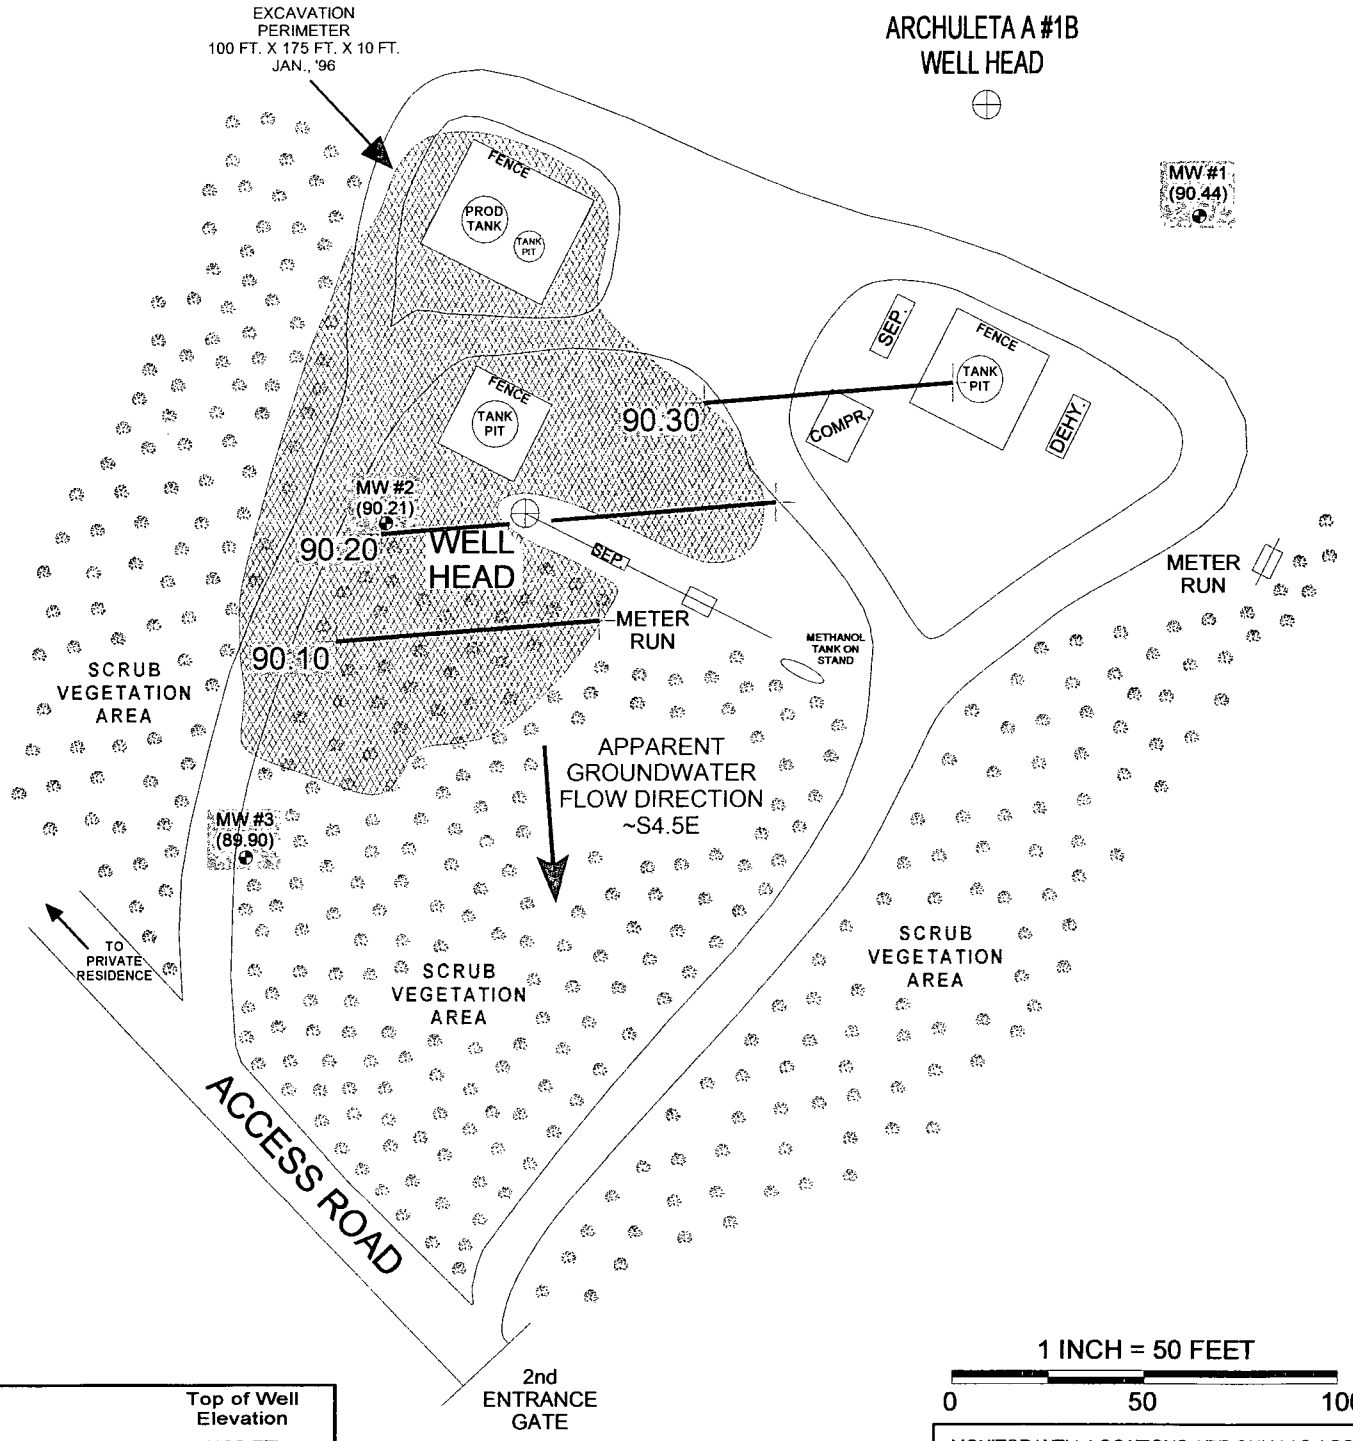
FIGURE 2
(3rd 1/4, 2007)

Groundwater elevations have consistently been measured with a gradient towards the south-southeast direction (Figure 2 through Figure 5).

Top of Well Elevation
MW #1	(102.77)
MW #2	(100.90)
MW #3	(101.80)
MW #1 (90.44)	Groundwater Elevation as of 8/9/07.

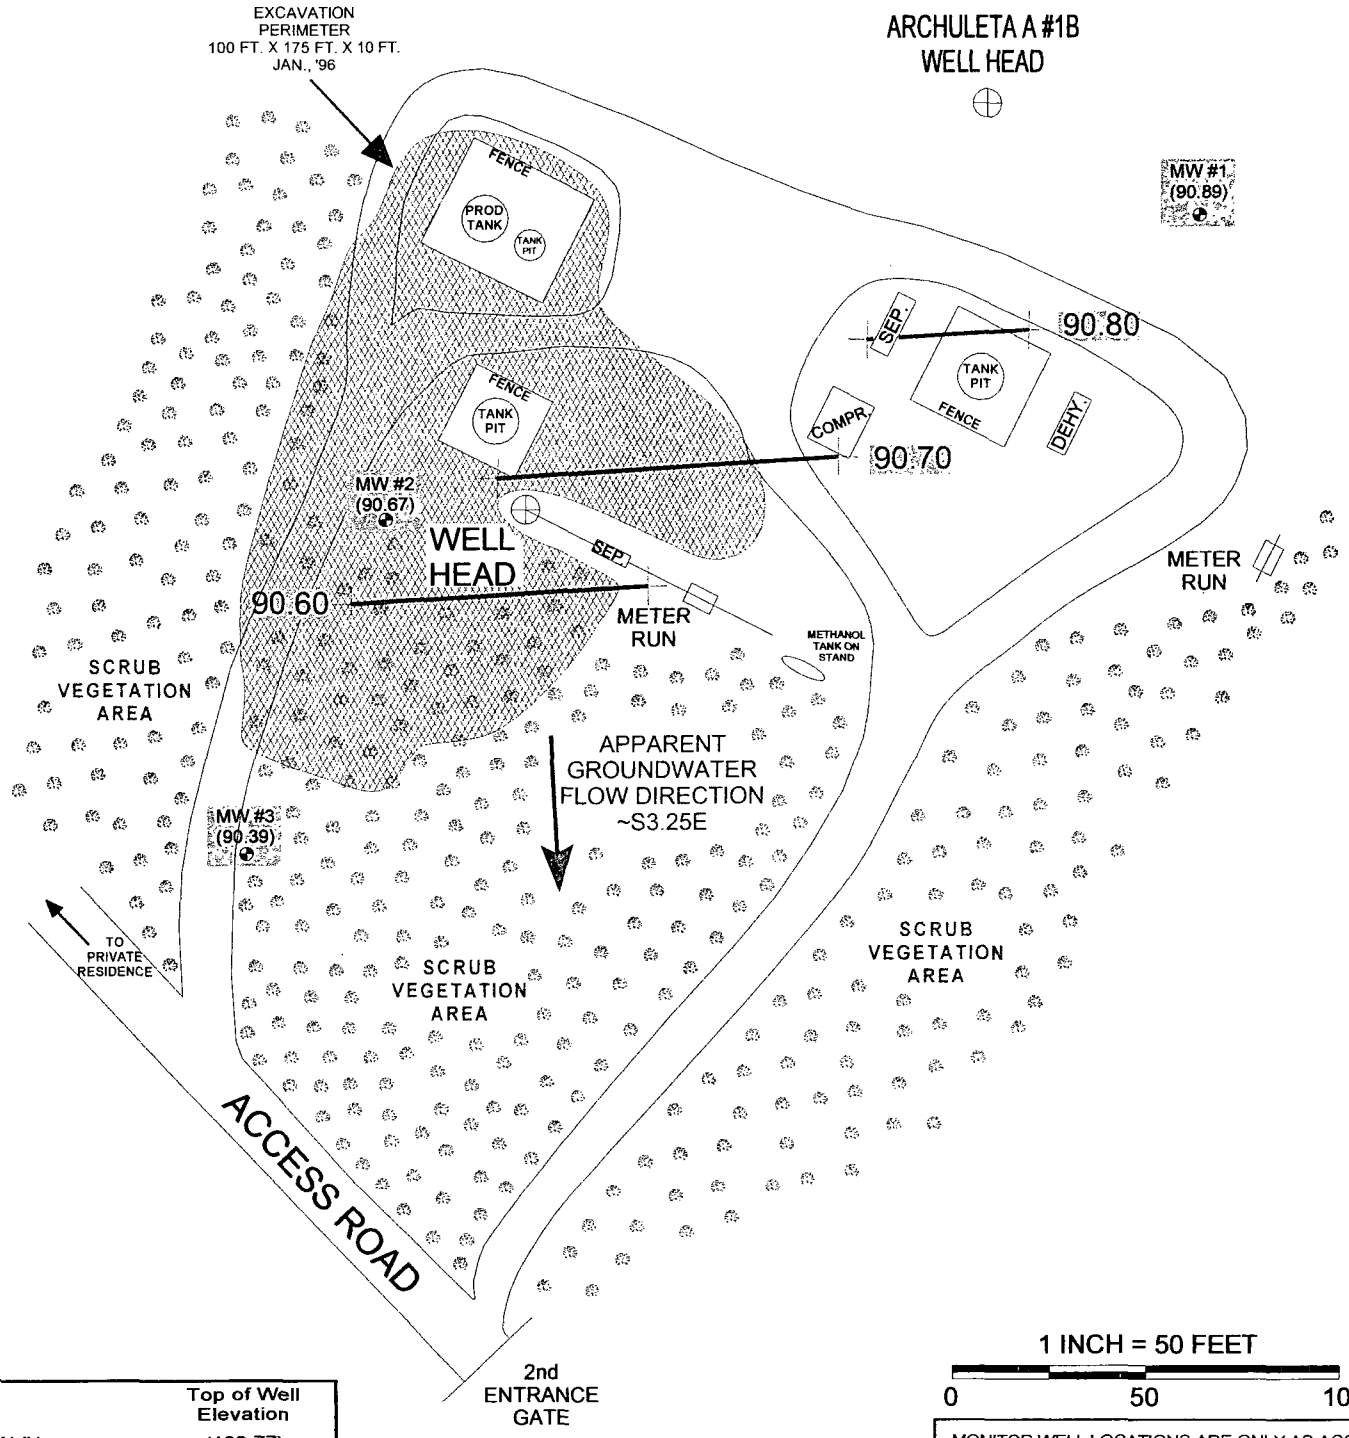
FIGURE 3
(4th 1/4, 2007)

Top of Well Elevation
MW #1	(102.77)
MW #2	(100.90)
MW #3	(101.80)
MW #1 (90.89)	Groundwater Elevation as of 11/20/07.

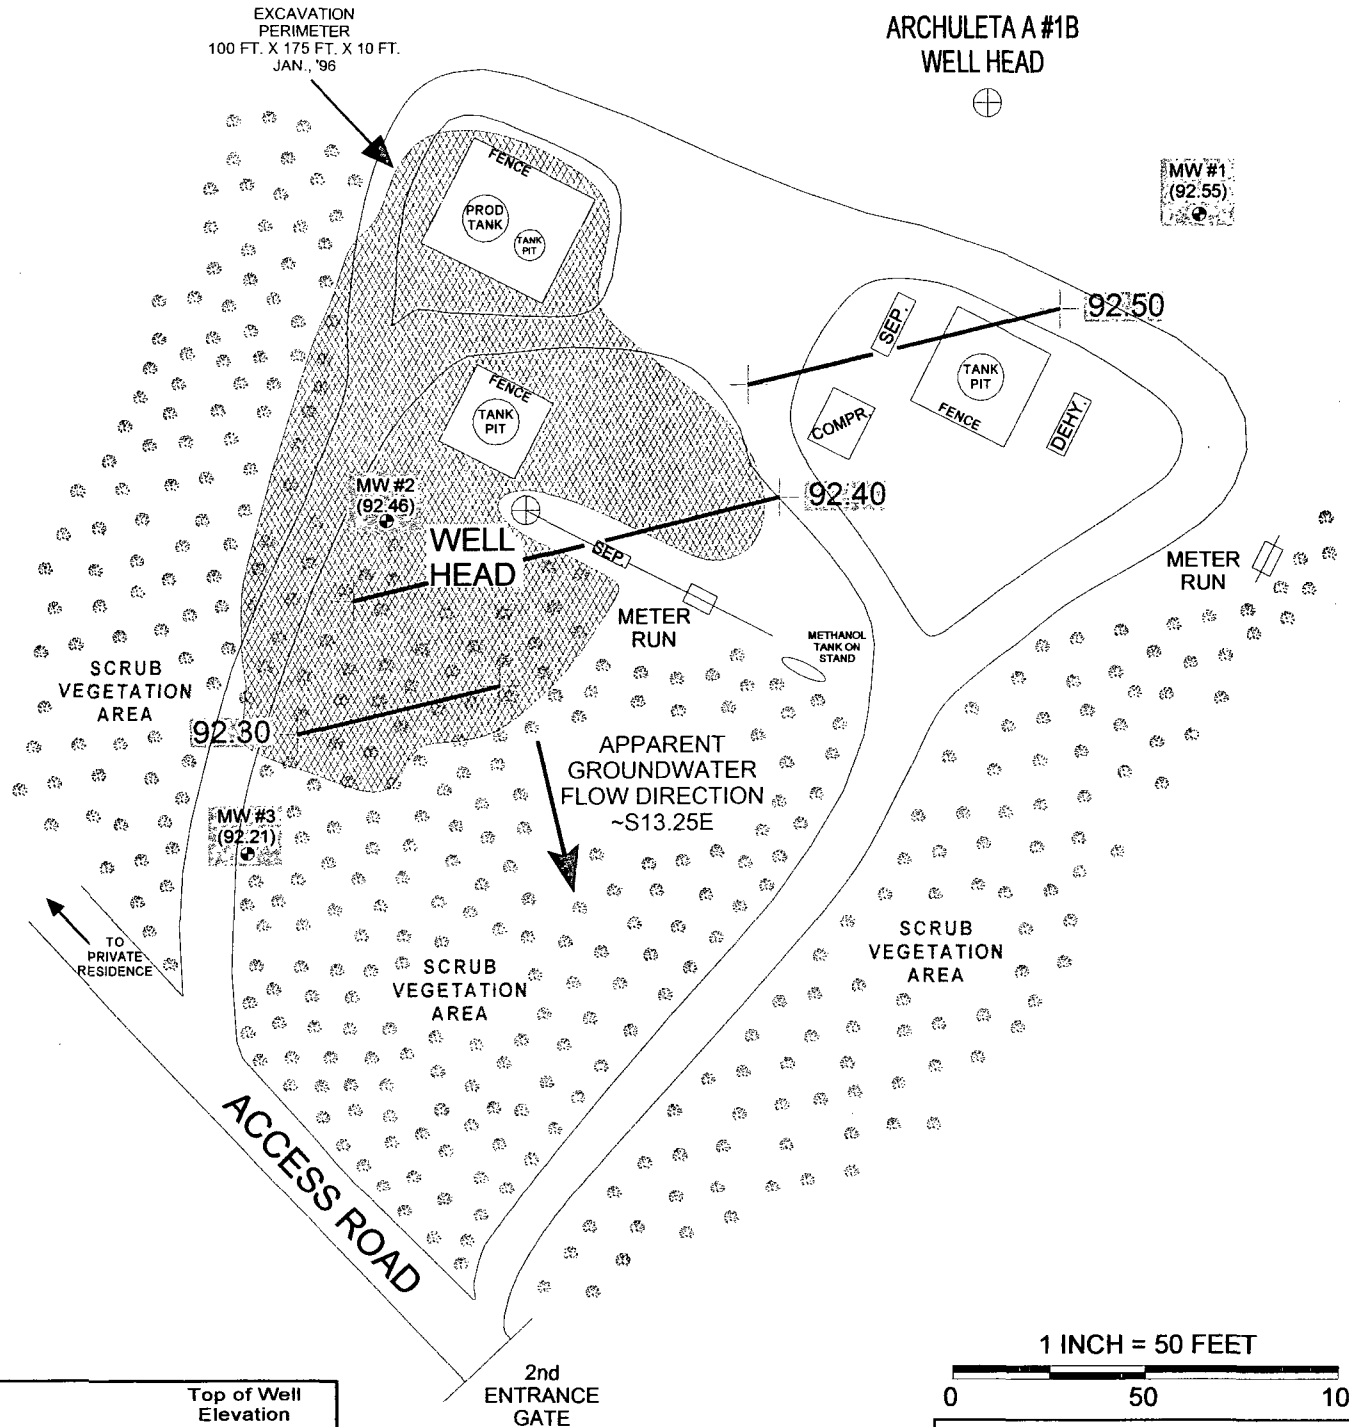
FIGURE 4
(2nd 1/4, 2008)

Top of Well Elevation
MW #1	(102.77)
MW #2	(100.90)
MW #3	(101.80)
MW #1 (92.55)	Groundwater Elevation as of 4/07/08.

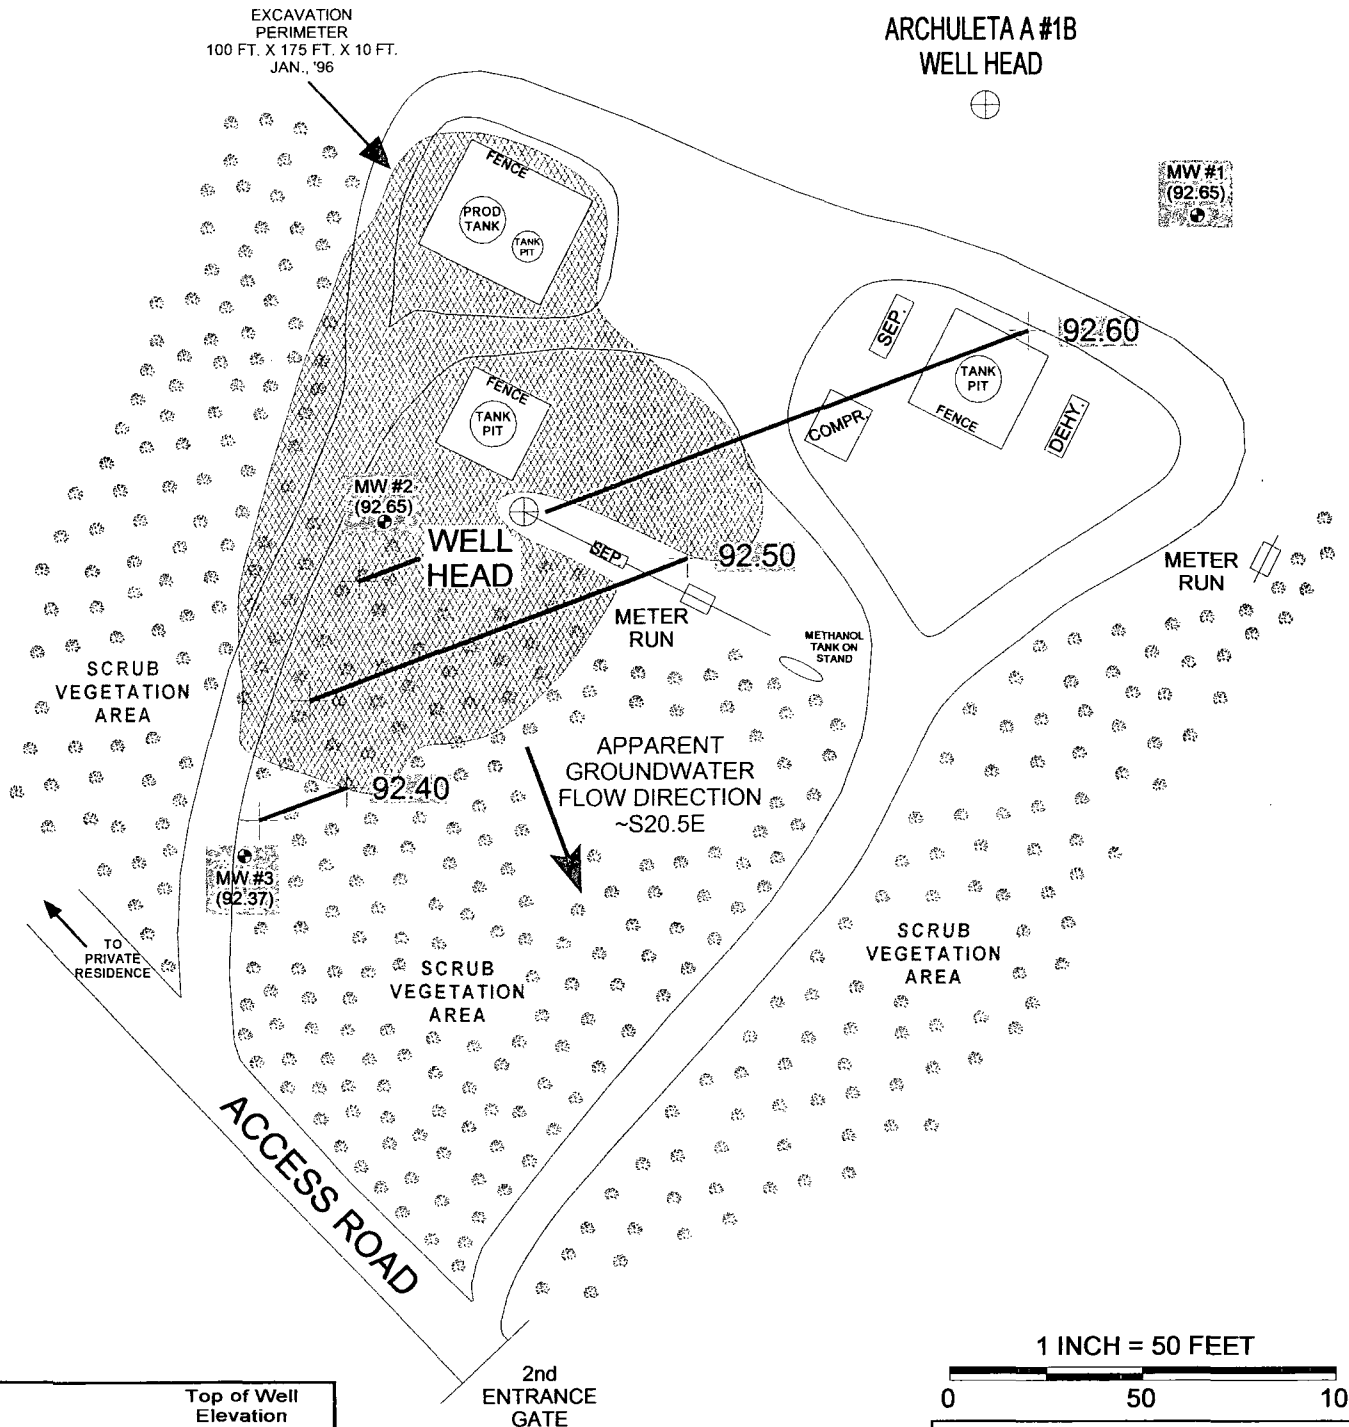
FIGURE 5
(2nd 1/4, 2008)

Top of Well Elevation
MW #1	(102.77)
MW #2	(100.90)
MW #3	(101.80)
MW #1 (92.65)	Groundwater Elevation as of 6/10/08.
