Release Notification and Corrective Action

Name of Company CHI Operating, Inc.	Contact JOHN QUALLS
Address P.O. Box 1799 Midland, TX 79702	Telephone No. 432-685-5001
Facility Name INBOUNDS COM 1Y	Facility Type

PRELIMINARY SITE INVESTIGATION REPORT and REMEDIATION/CLOSURE PLAN

Chi Operating, Inc.
Inbounds Com #1
Eddy County, New Mexico
COI 08-03-1001

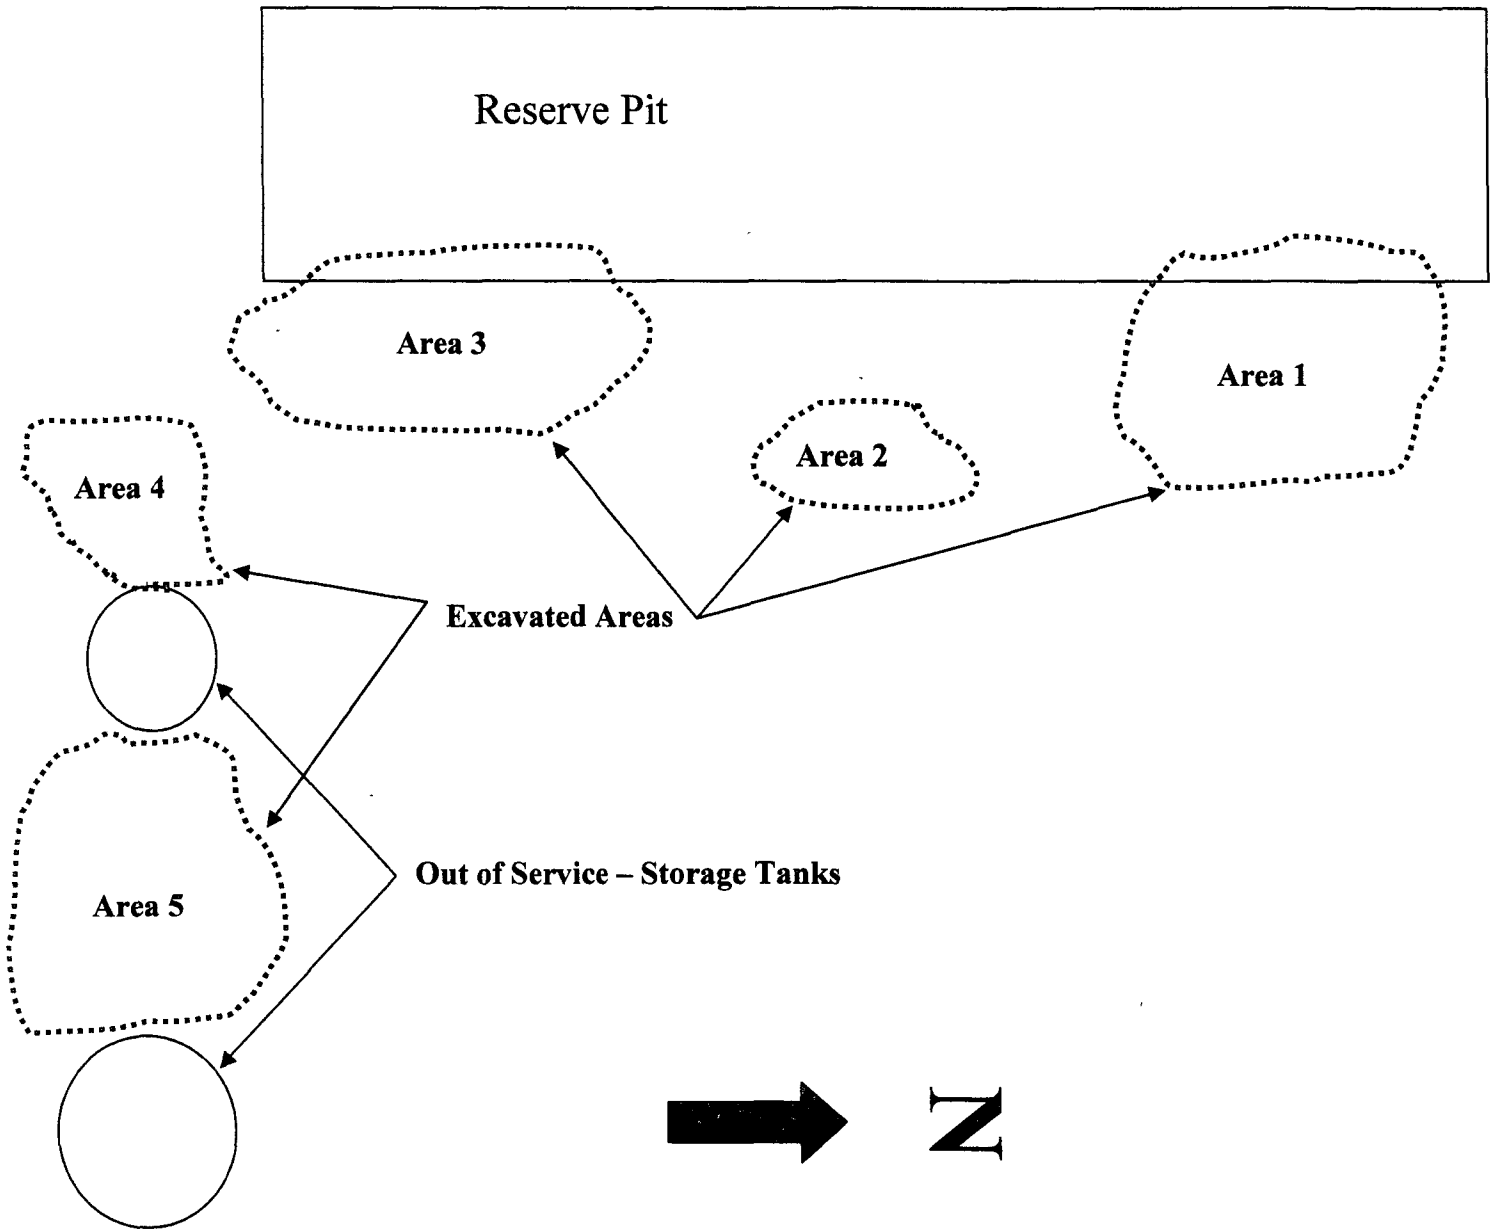
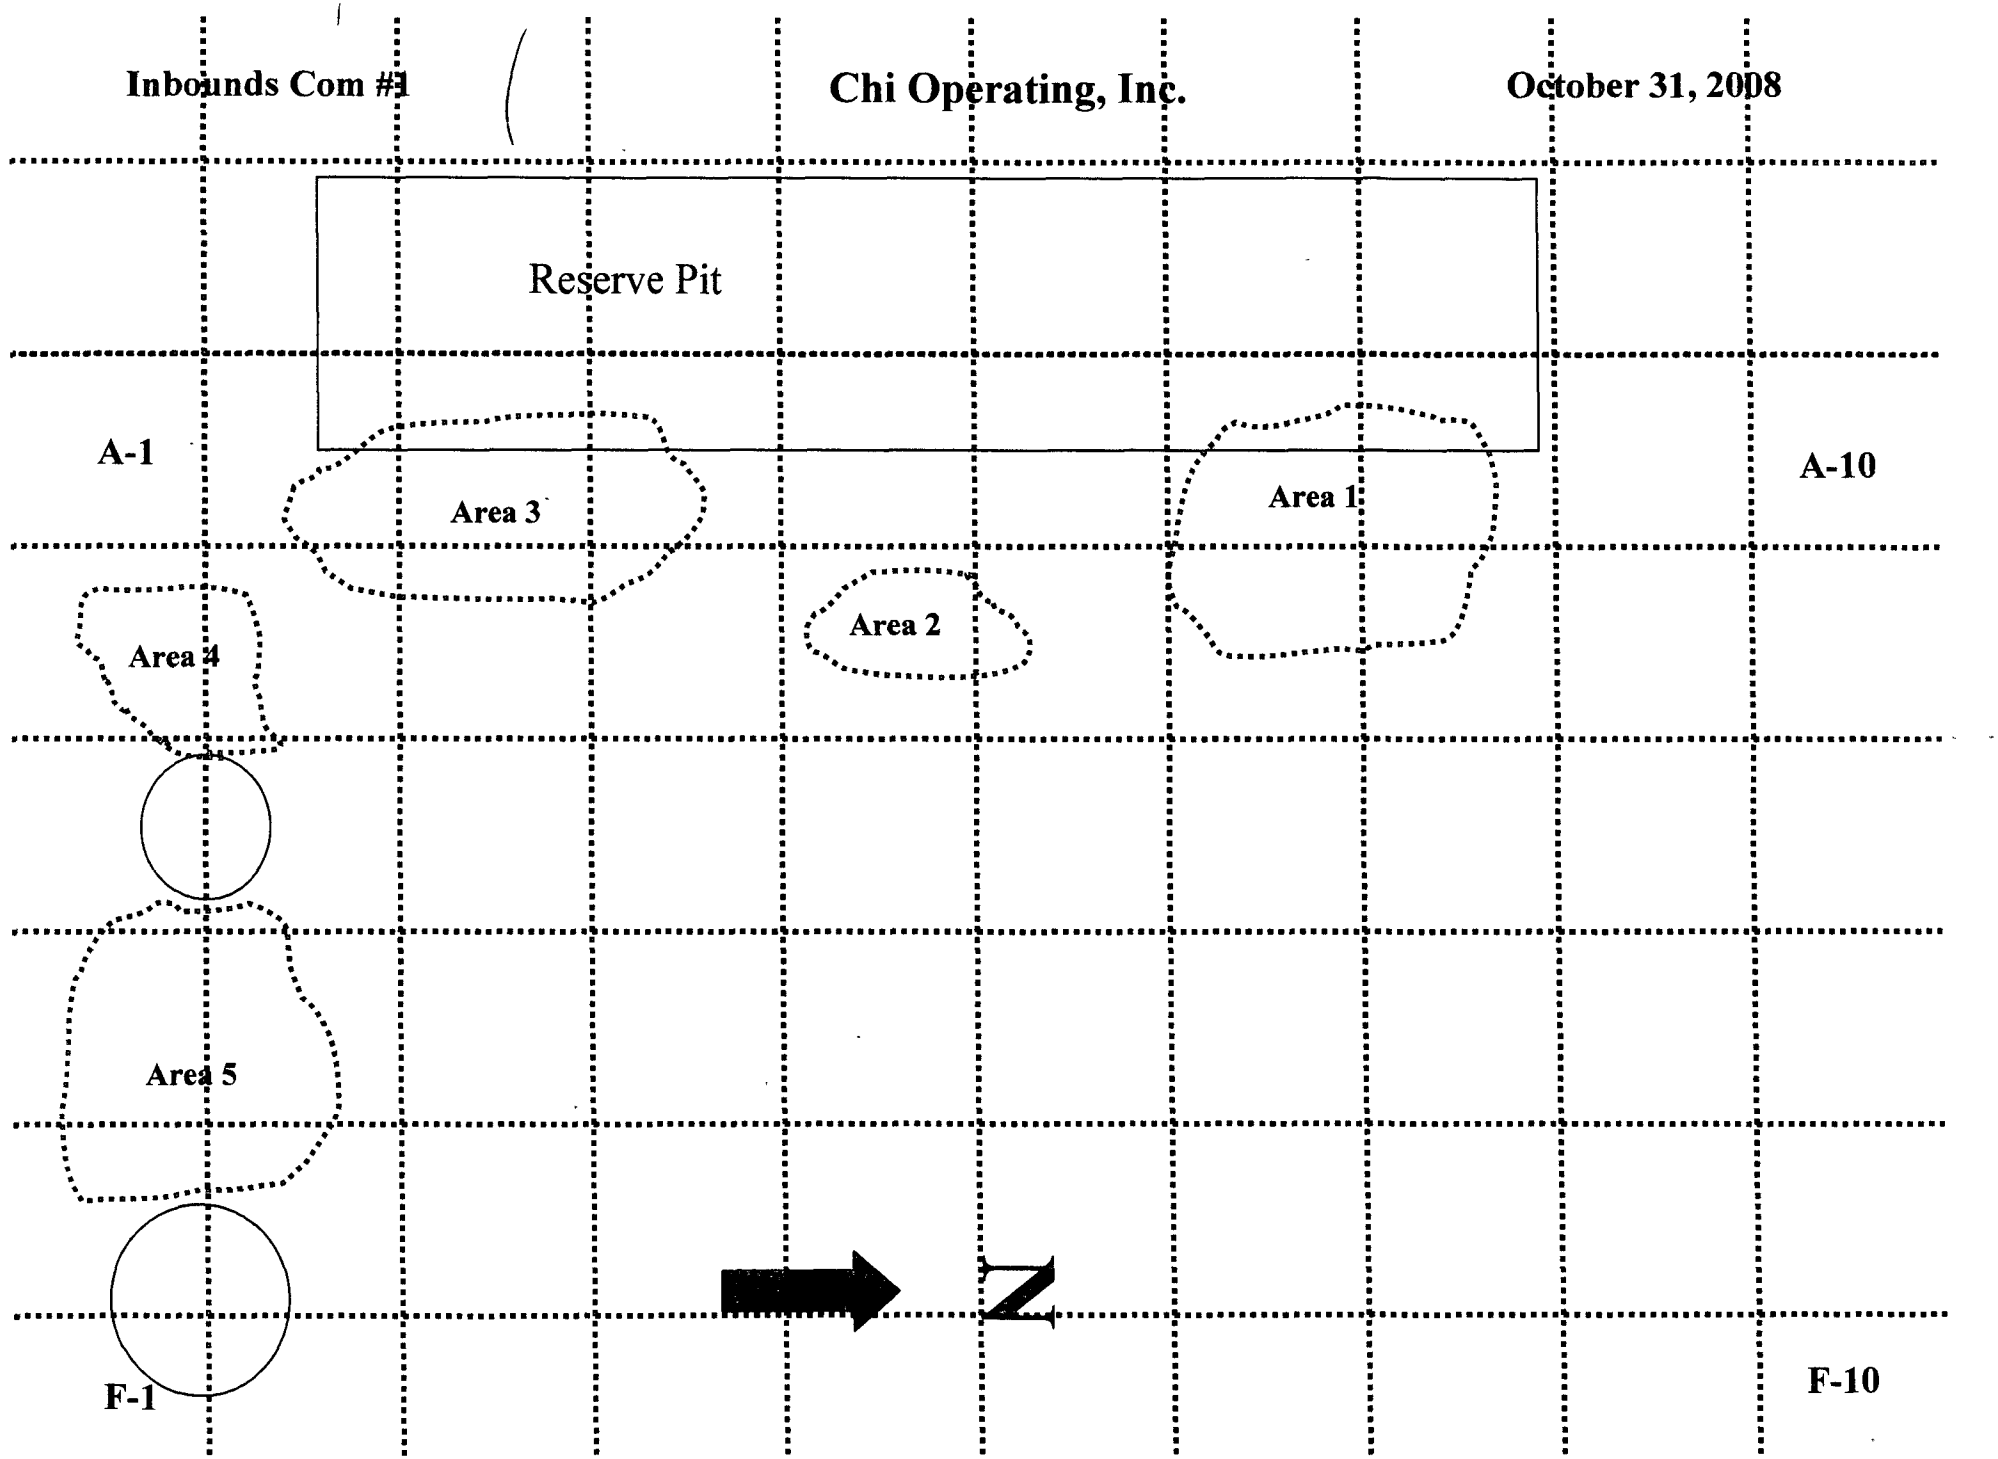
Site Plan

TCI went to the location at the request of COI and found an area that had salt crystals on the surface. The impacted soil was excavated and hauled to disposal. The site was delineated to insure that the impacted material was removed. The excavated area was analyzed for chloride content. The results are shown in Attachment II.

Inbounds Com #1
Chi Operating, Inc.
October 31, 2008
Reserve Pit
A-1
A-10
Area 3
Area 1
Area 2
Area 4
Area 5
F-1
F-10

In October, 2008, TCI responded to the site located in Eddy County, New Mexico under the direction of the COI personnel. The impacted area at the well was excavated to a maximum depth of three feet (3') on the location. Vertical and horizontal extent of the impacted area has been delineated. TCI obtained samples to delineate horizontal and vertical extent of contamination. Samples were collected on twenty foot (20') intervals in both the North-South and East-West orientation in the impacted areas. Elevated chloride levels were then delineated to their origin at the base of the reserve pit wall. Two areas were found to have been the source of the chloride levels present at the site. There were a total of five (5) areas impacted with chlorides. They are labeled areas 1 through 5. Area 1 was excavated to a depth of 3' before encountering clean soil. Area 2 was excavated to a depth of 2 ½' before encountering clean soil. Area 3 was excavated to a depth of 2 ½ ' before encountering clean soil. Areas 4 and 5 were excavated to a depth of 10" before encountering clean soil. TCI excavated the material that had been impacted and placed new plastic at the site of the ruptures in the original containment. All samples were analyzed in the field using Hach titrators the soil was then replaced and the contour of the excavated area was returned to level.
